# **INDOOR AIR QUALITY REASSESSMENT**

**John R. Briggs Elementary School  
96 Williams Road  
Ashburnham, Massachusetts**

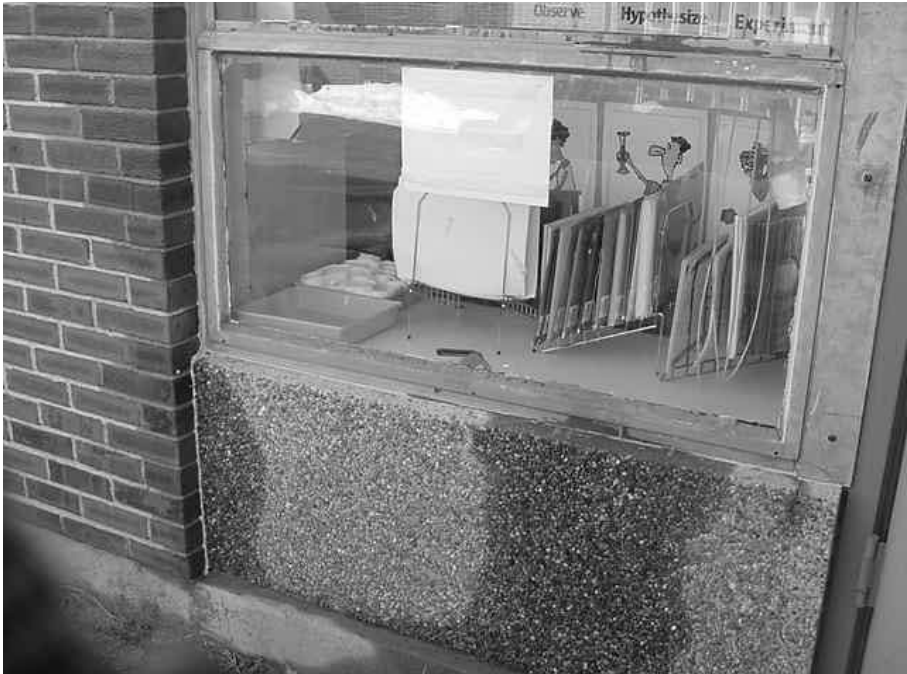
**Close Up Of Water Damage in Picture 3**

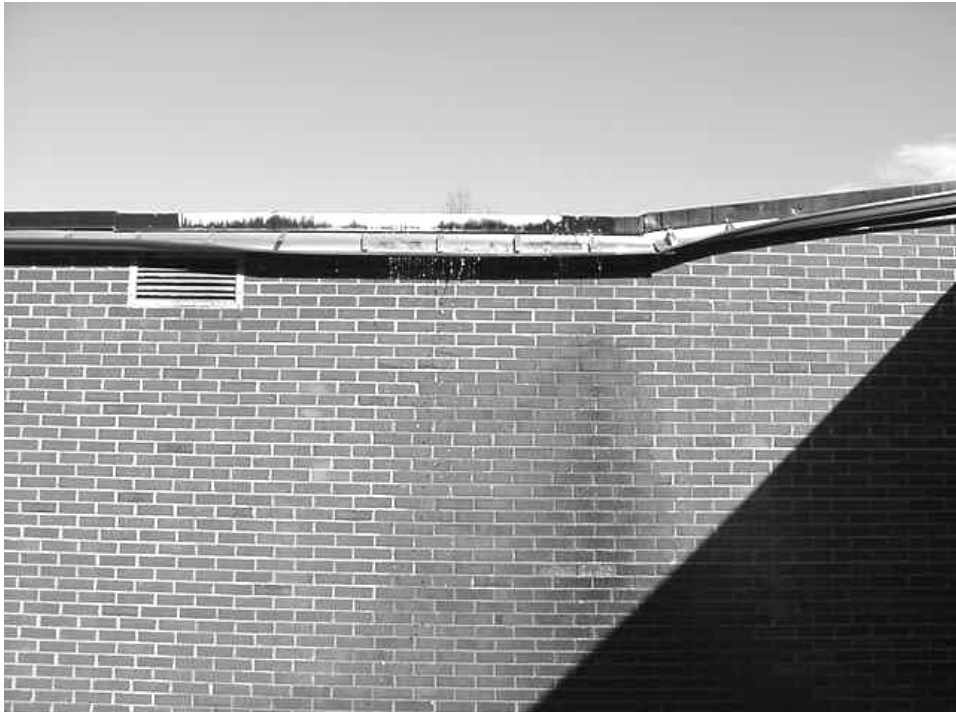
**Damaged Gutter Wetting the Exterior Wall System**

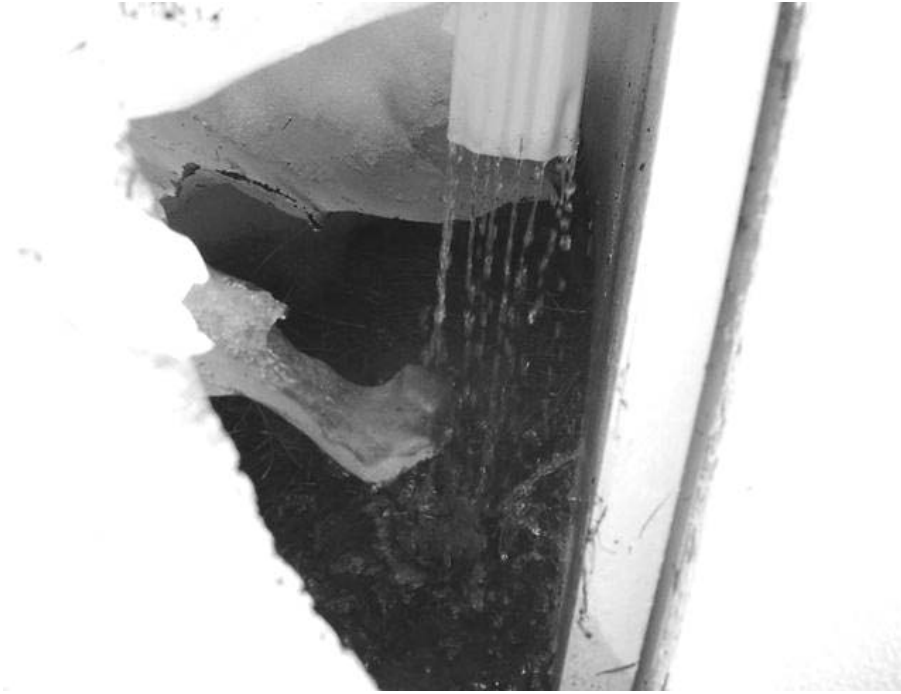
**Downspout of Modular Roof Emptying at Base of Exterior Wall**
