INDOOR AIR QUALITY ASSESSMENT

**Quincy Health Department
1585 Hancock Street
Quincy, Massachusetts**

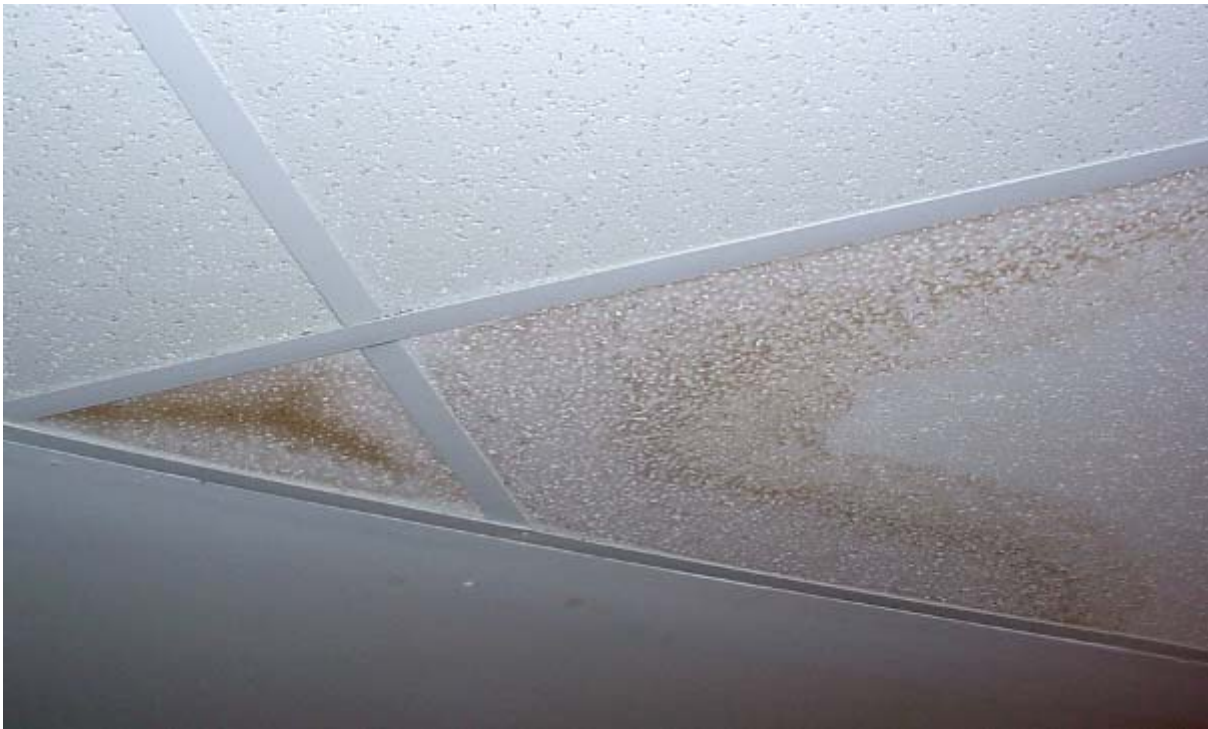
Water Damaged Ceiling Tiles in Reception Area Lobby

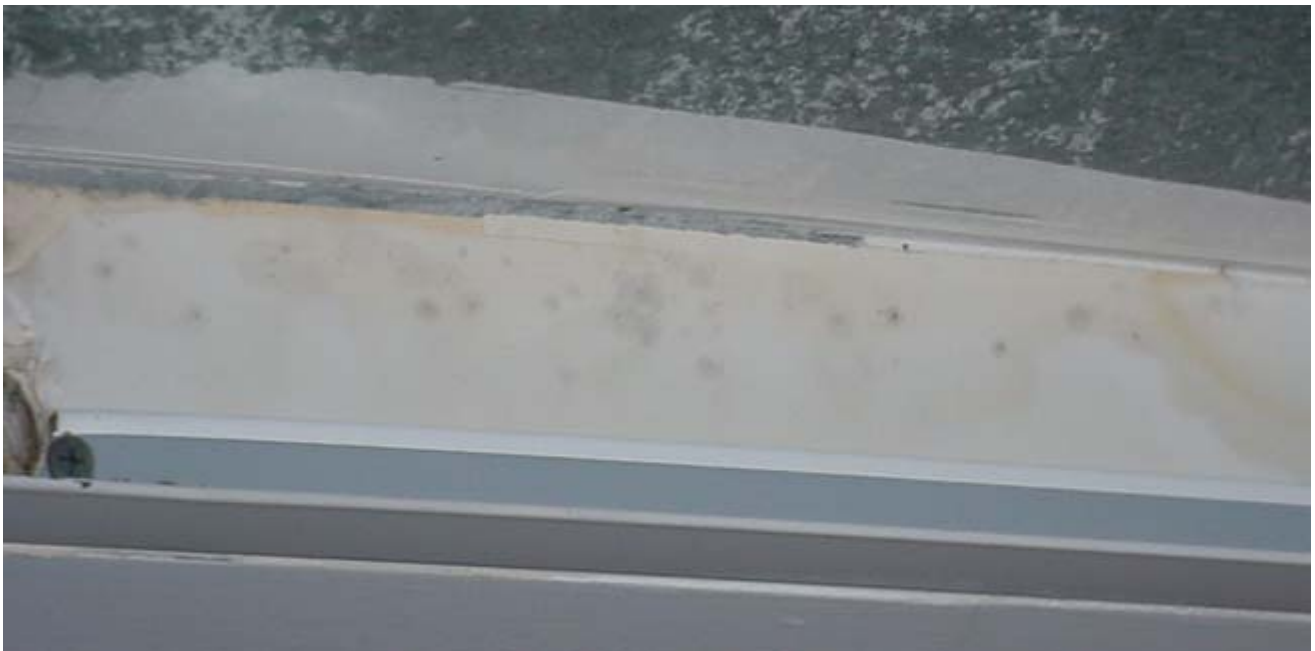
Visible Mold Growth (as Indicted by Dark Stains) on GW above Water Damaged Ceiling Tiles in Reception Area Lobby, Shown in Preceding Picture

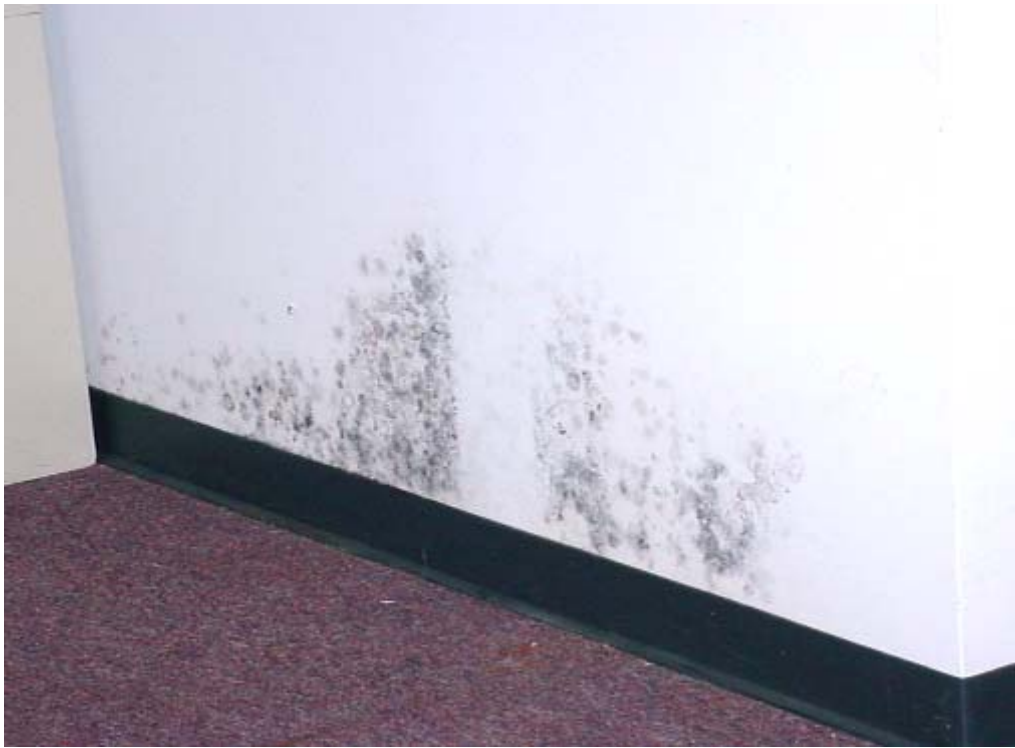
**Visible Mold Growth (as Indicted by Dark Stains) on GW behind File Cabinets
in Central Inspector's Area**

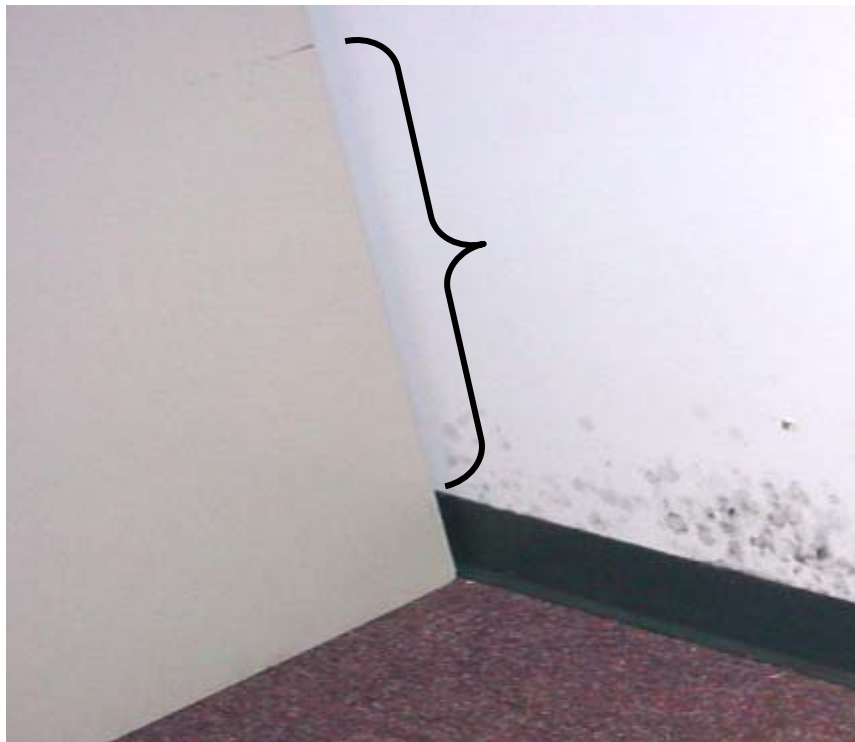
Close-Up of File Cabinets Directly against Wall in Central Inspector's Area

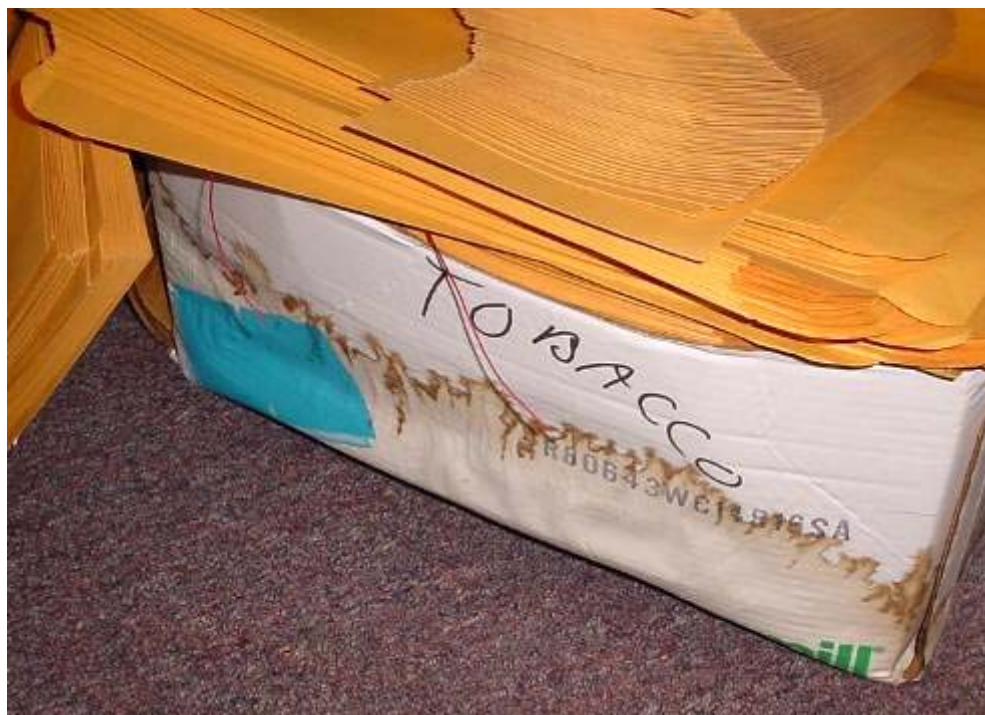
Water Damaged Cardboard Box Stored in Area of Historic Water Damage

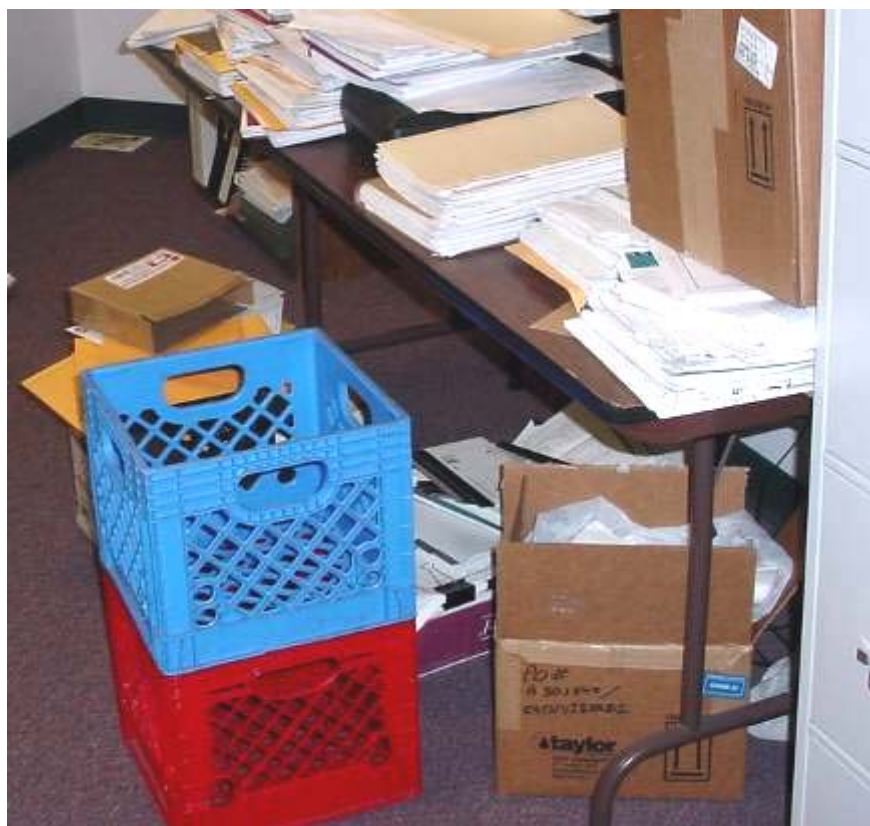
Porous Materials (Boxes, Papers) Stored in Area of Historic Water Damage

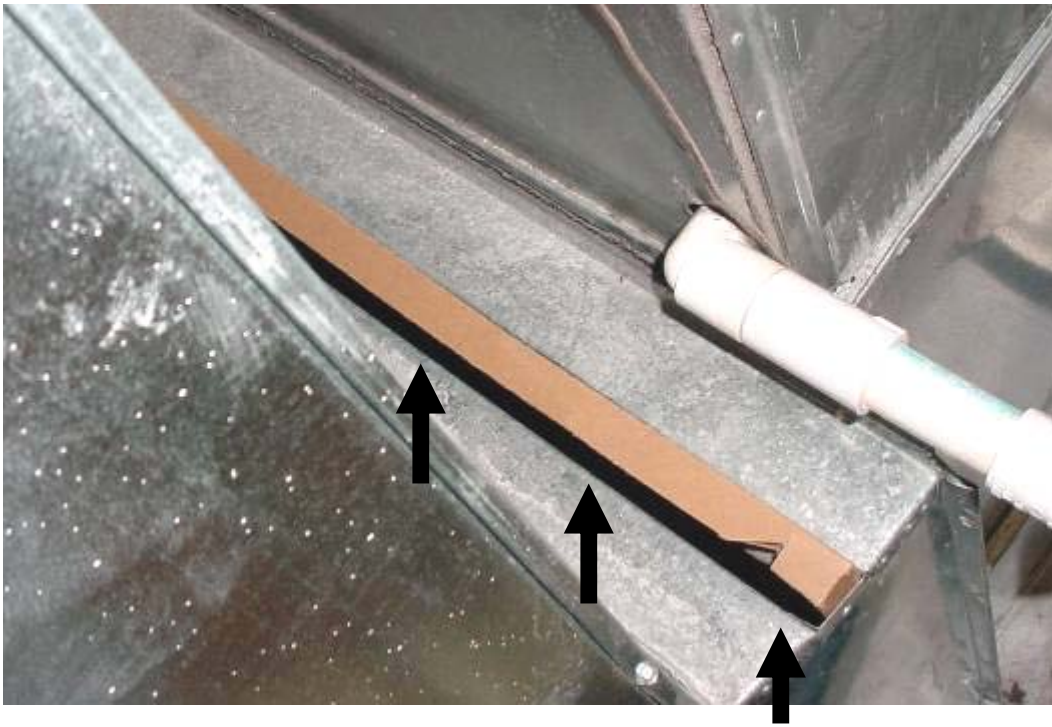
Open Spaces around Cardboard Filter for Heat Pump
