# **INDOOR AIR QUALITY ASSESSMENT**

**Casimir Pulaski Elementary School  
1097 Braley Road  
New Bedford, MA 02745**

Prepared by:  
Massachusetts Department of Public Health  
Bureau of Environmental Health  
Indoor Air Quality Program  
February 2009

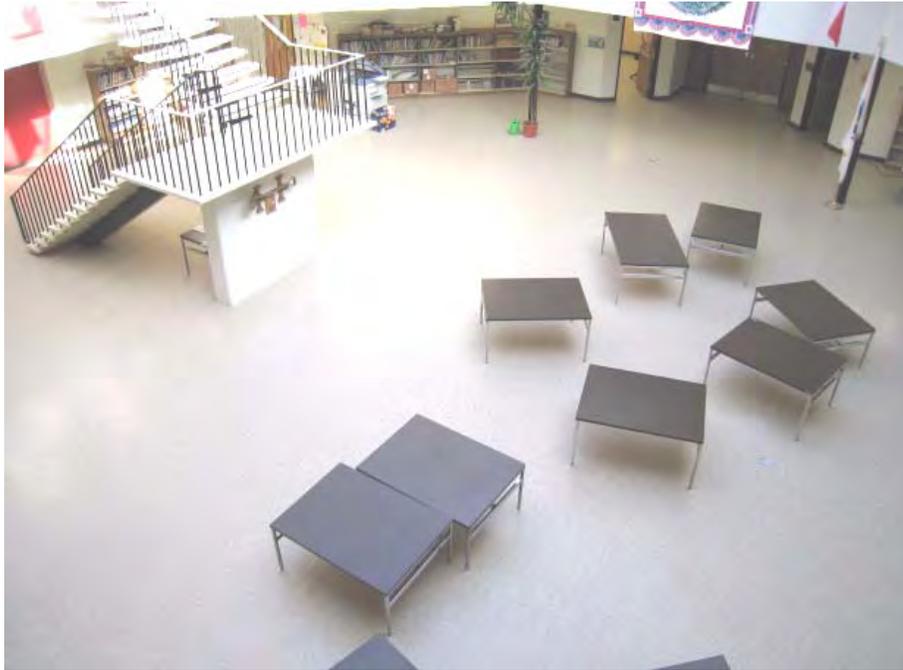
**Picture 1**

replace with non-porous floor tiles as funds become available. As previously discussed, carpeting in the library and adjacent areas has been removed. Windows are openable throughout the building.

**Carpeting Removed in Lower Level Media Center and Replaced with Tile**

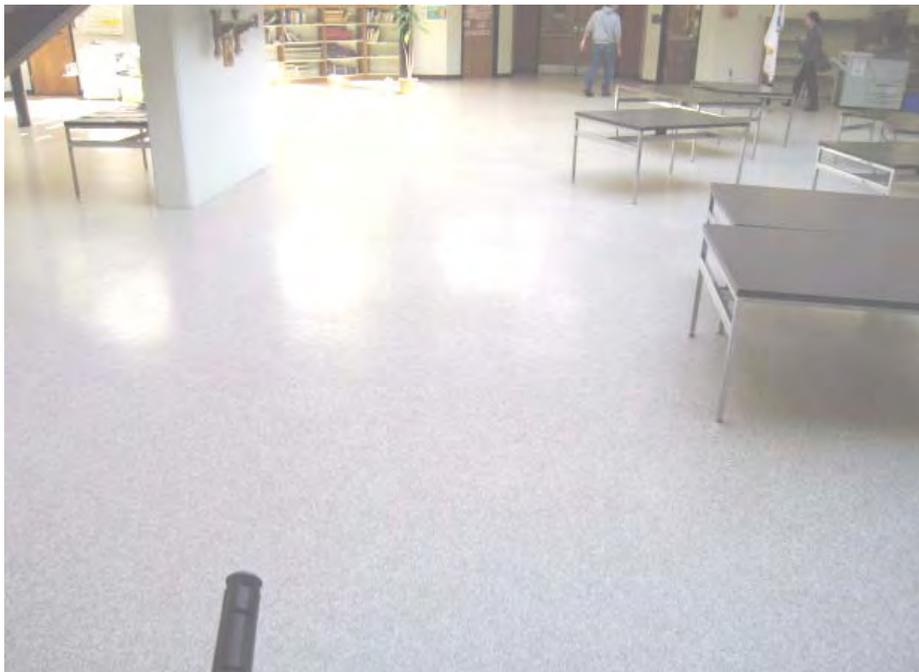
**Picture 2**

**Carpeting Removed in Lower Level Media Center Replaced with Tile**

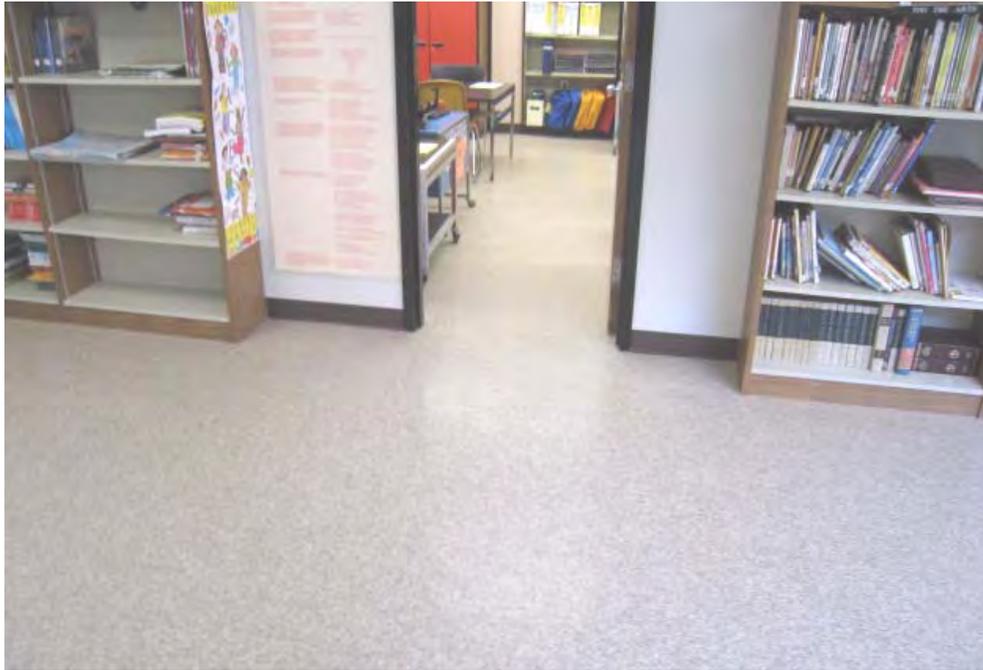
**Picture 3**

**Carpeting Removed in Lower Level Media Center/Perimeter Rooms  
and Replaced with Tile**

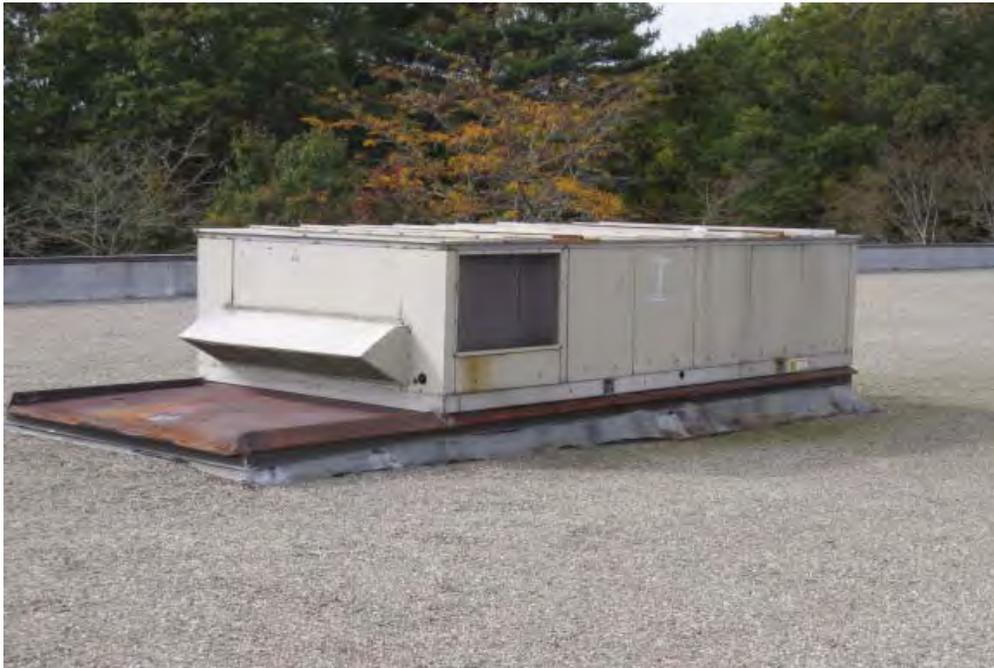
**Picture 4**

Mechanical ventilation for classrooms is supplied by rooftop air-handling units (AHUs) (Picture 4). Fresh air supplied by the AHUs is ducted to classrooms via ceiling mounted fresh air diffusers (Picture 5). Exhaust air is drawn through wall or ceiling-mounted vents and ducted back to the AHUs (Picture 6). Ventilation for common areas (auditorium, cafeteria, gymnasium) is provided by ceiling-mounted AHUs. These systems were functioning at the time of the assessment. It is important to note however, that rooftop AHUs appear to be original 1970s era equipment, making them approximately 30+ years old. Efficient function of such equipment can be difficult to maintain since compatible replacement parts are often unavailable.

**Rooftop Air Handling Unit**

1. Contact an HVAC engineering firm for an assessment of the ventilation system’s control system (e.g., controls, air intake louvers, thermostats). Based on the age, physical deterioration and availability of parts for ventilation components, such an evaluation is recommended to determine the operability and feasibility of repairing/replacing the equipment.

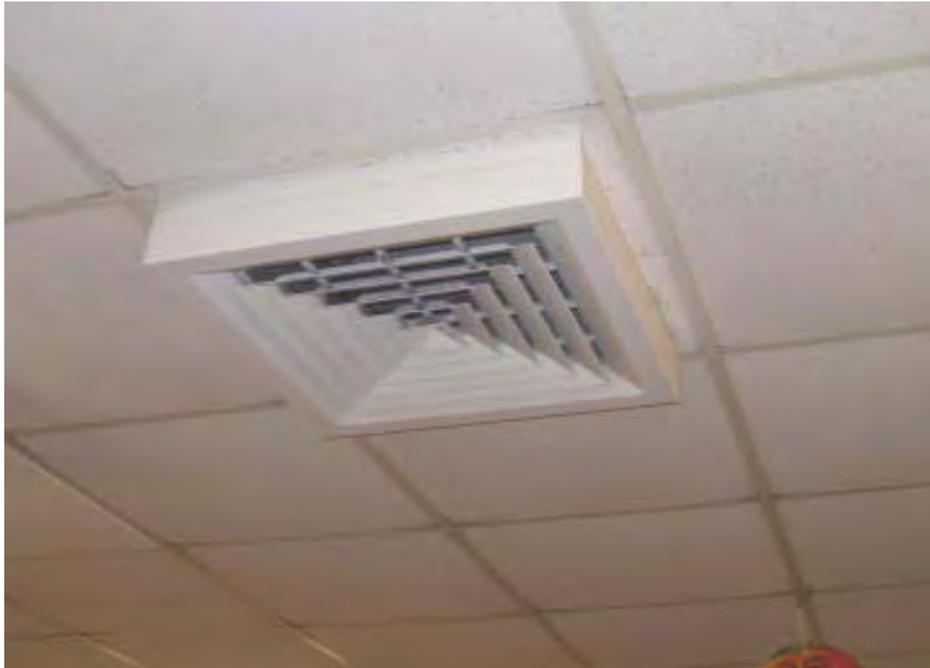
**Picture 5**

**Ceiling-Mounted Supply Diffuser**

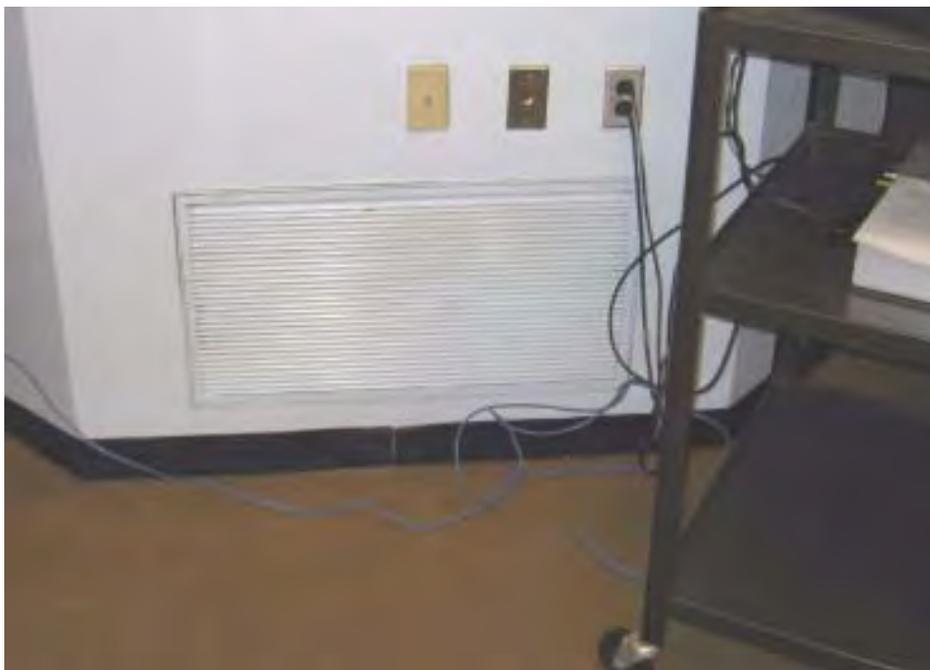
**Picture 6**

**Wall-Mounted Exhaust Vent in Classroom**

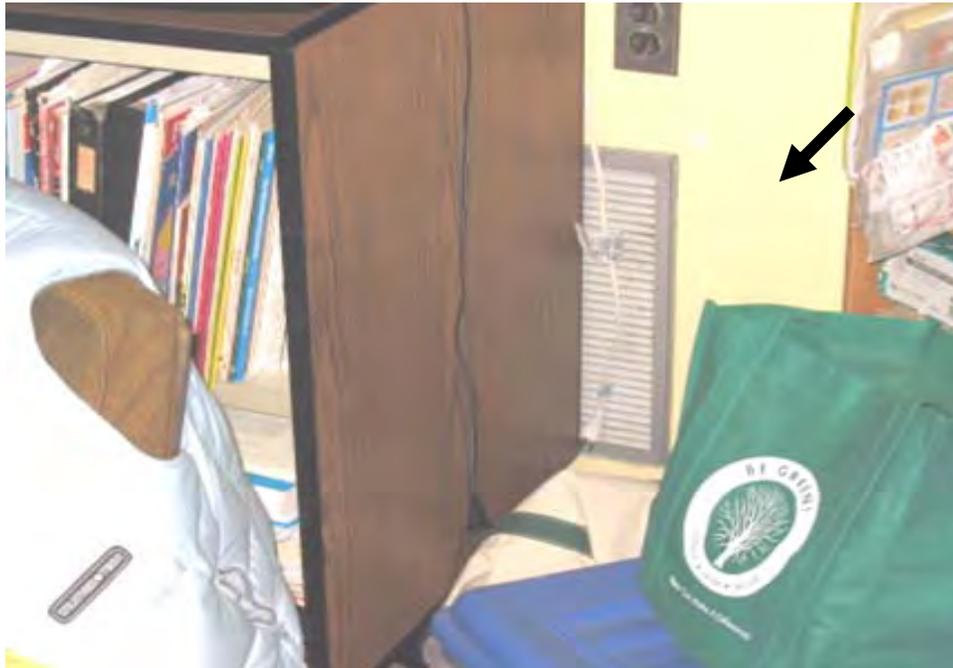
**Picture 7**

A number of classroom exhaust vents were obstructed by furniture and other items, limiting airflow (Picture 7). Some exhaust vents are located behind classroom doors (Table 1). Due to their location, these vents are prone to blockage when the doors are left open (Picture 8). In addition, with the classroom doors open the exhaust vent tends to draw air from the hallway *into* the classroom instead of stale air *out* of the classroom.

**Wall-Mounted Exhaust Vent in Classroom Obstructed by Bookcase**

5. Remove all blockages from exhaust vents to ensure adequate airflow.
6. Use openable windows in conjunction with mechanical ventilation to increase air exchange. Care should be taken to ensure windows are properly closed at night and weekends to avoid the freezing of pipes and potential flooding.

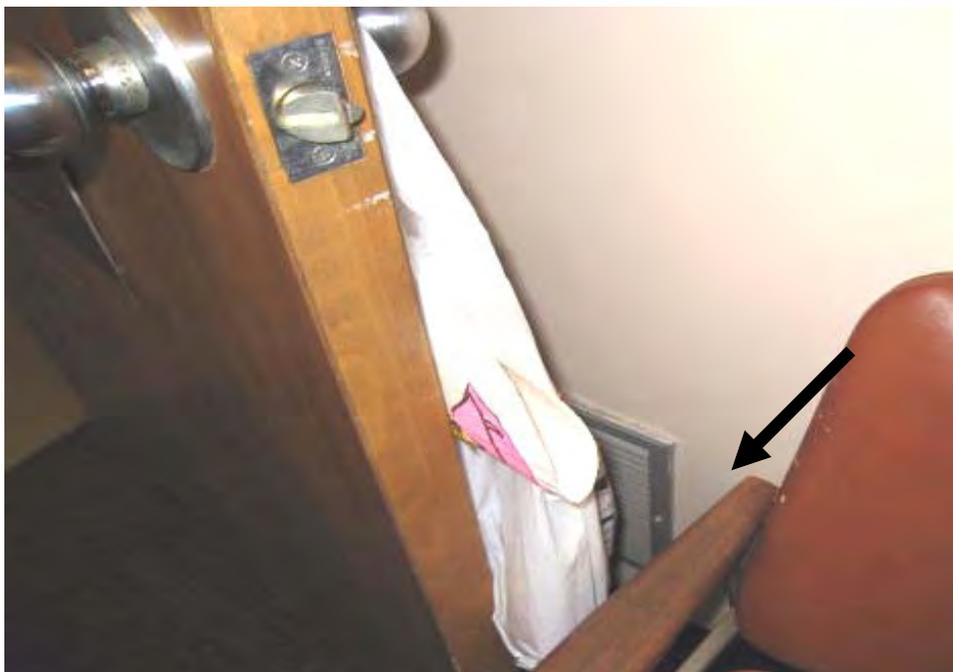
**Picture 8**

**Wall-Mounted Exhaust Vent in Classroom Obstructed by Open Classroom Door**

2. Restore restroom exhaust ventilation.
3. Inspect all exhaust motors and belts periodically for proper function. Repair and replace as necessary.
4. Close classroom doors to maximize air exchange.

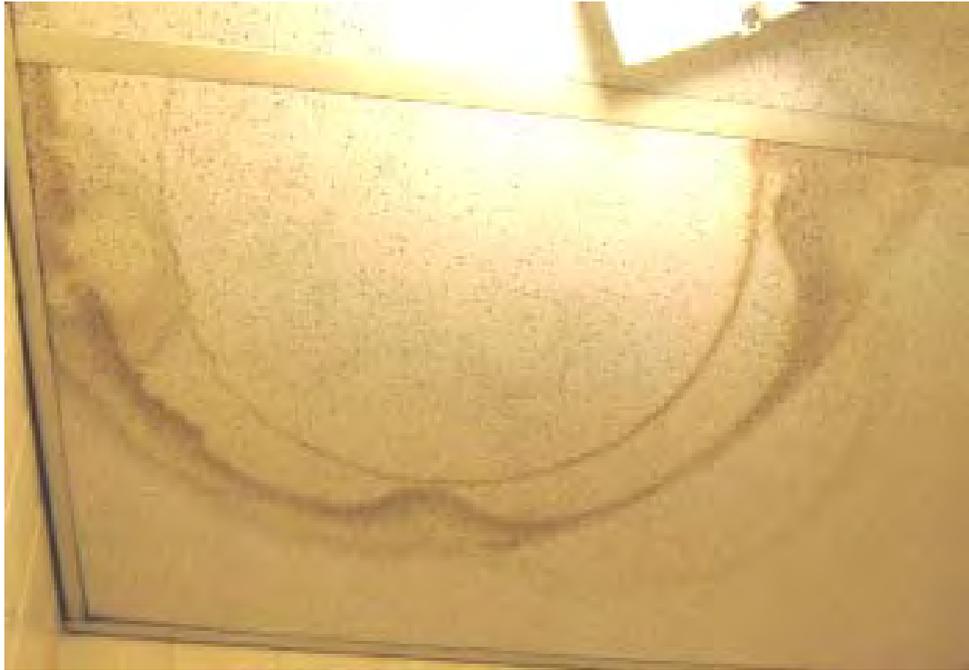
**Picture 9**

Several areas had water-damaged ceiling tiles, which can indicate leaks from the roof or plumbing system (Pictures 9 and 10/Table 1). Water-damaged ceiling tiles can indicate sources of water penetration and provide a source of mold growth. In classroom H-4, dark staining that appeared to be mold was visible on a ceiling tile (Picture 10). However, there was no evidence of further mold growth above the ceiling tiles. Ceiling tiles should be replaced after a water leak is discovered and repaired. At the time of assessment, BEH staff recommended that this ceiling tile be removed.

**Water Damaged Ceiling Tile in Classroom/Restroom**

9. Ensure roof leaks are repaired. Remove/replace any water-damaged ceiling tiles.

10. Encourage staff to monitor their classrooms for active leaks/water damage and report to school maintenance staff for prompt remediation.
11. Seal areas around sinks to prevent water damage to the interior of cabinets and adjacent wallboard.

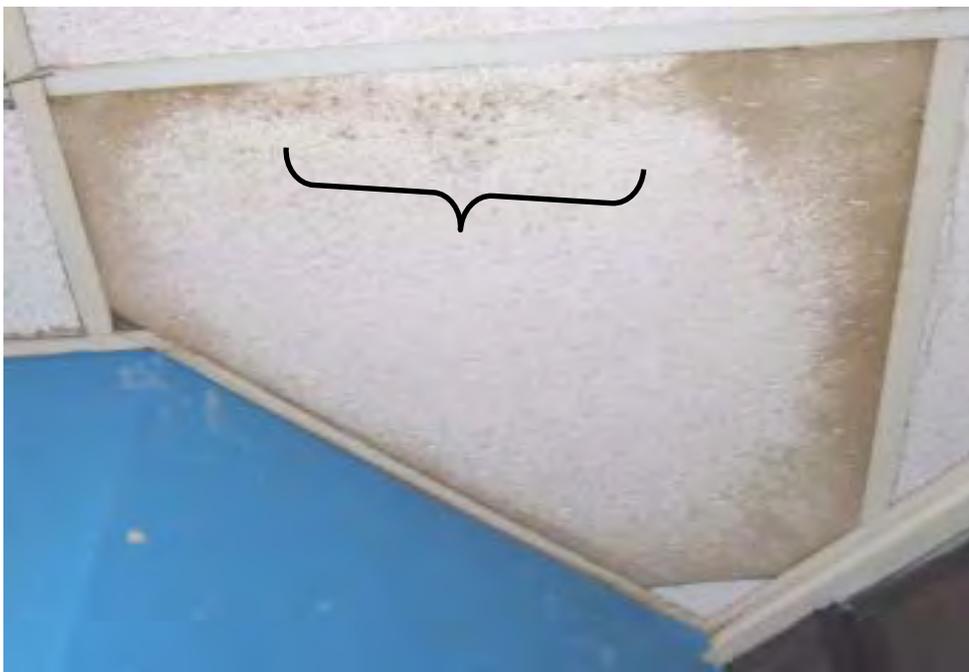
**Picture 10**

**Water Damaged Ceiling Tile in Classroom, Noted Area Indicates Possible Mold Growth**

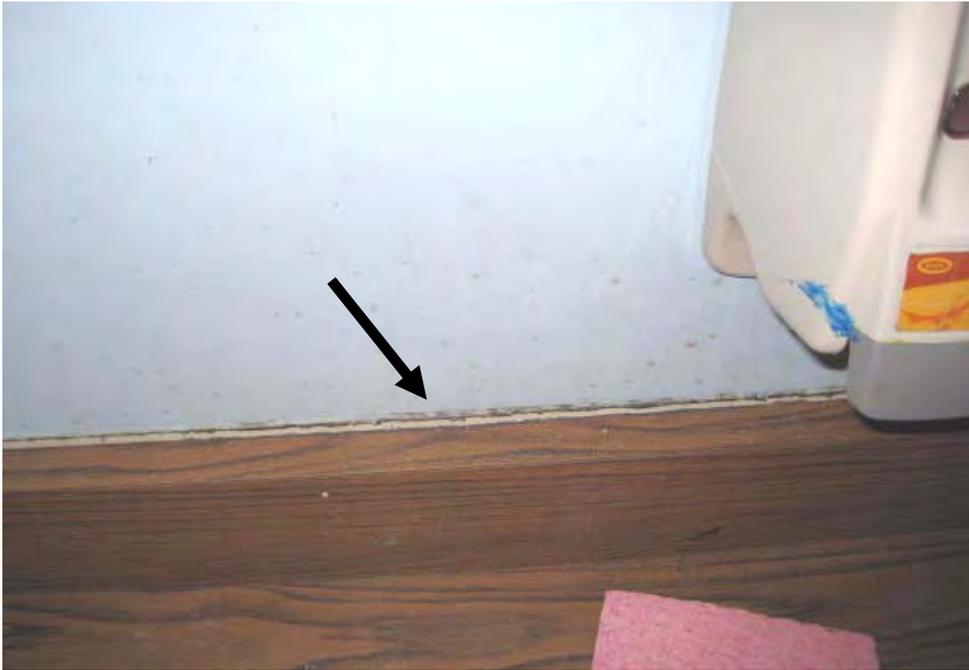
**Picture 11**

Open seams between sink countertops and walls were observed in several rooms (Picture 11/Table 1). Improper drainage or sink overflow can lead to water penetration into the countertop, cabinet interior and areas behind cabinets. If not watertight, moisture can penetrate through the seam, causing water damage and potential mold growth.

**Breach between Sink Countertop and Backsplash**

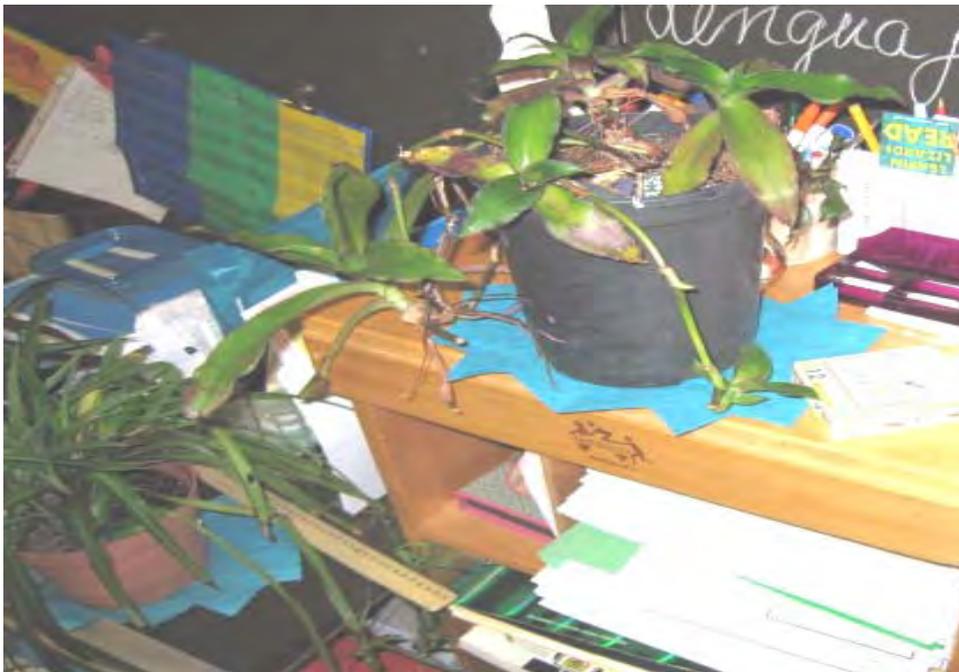
**Picture 12**

Several classrooms had a number of plants. Moistened plant soil and drip pans can be a source of mold growth. Plants in one area were observed on paper (Picture 12), which is a porous material that is susceptible to mold growth if moistened repeatedly. Plants should be equipped with drip pans; the lack of drip pans can lead to water pooling and mold growth on

**Plants on Paper in Classroom**

12. Avoid over-watering plants and examine drip pans periodically for mold growth. Disinfect with an appropriate antimicrobial where necessary.
13. Trim shrubbery/trees back approximately 5-feet to prevent water impingement on exterior brick.

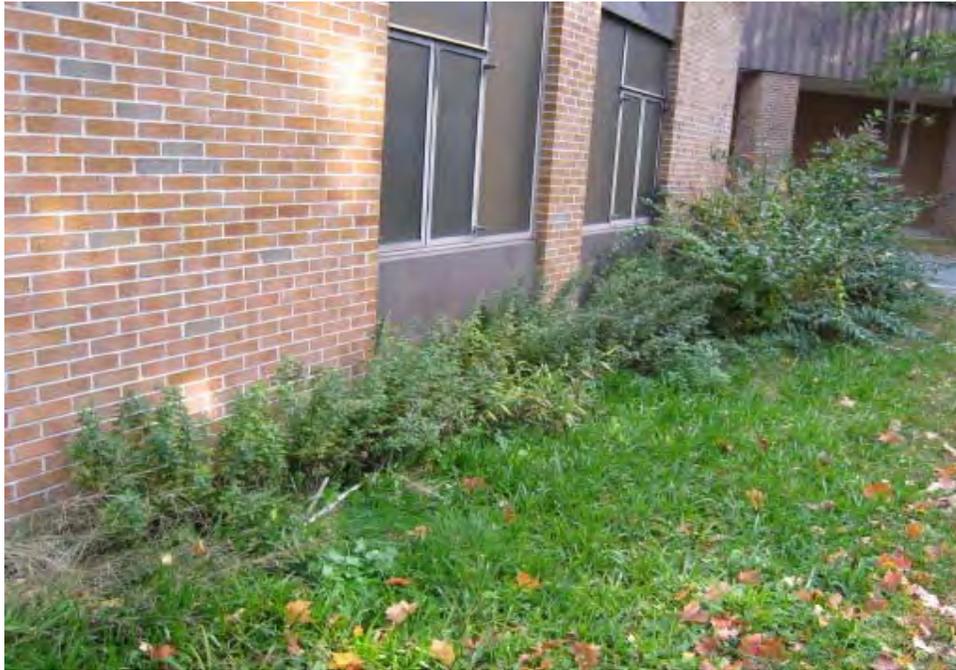
**Picture 13**

Shrubs/trees were observed growing in close proximity to exterior walls (Picture 13 and 14). Accumulated leaves, moss and plant debris was observed on the roof (Pictures 15 and 16). These conditions can hold moisture against exterior brick or on the roof, preventing drying and serving as sources for potential water penetration. Over time, these conditions can undermine the integrity of the building envelope and provide a means of water entry into the building via roof leaks or capillary action through concrete and masonry (Lstiburek & Brennan, 2001).

**Plant Growth against Exterior Brick**

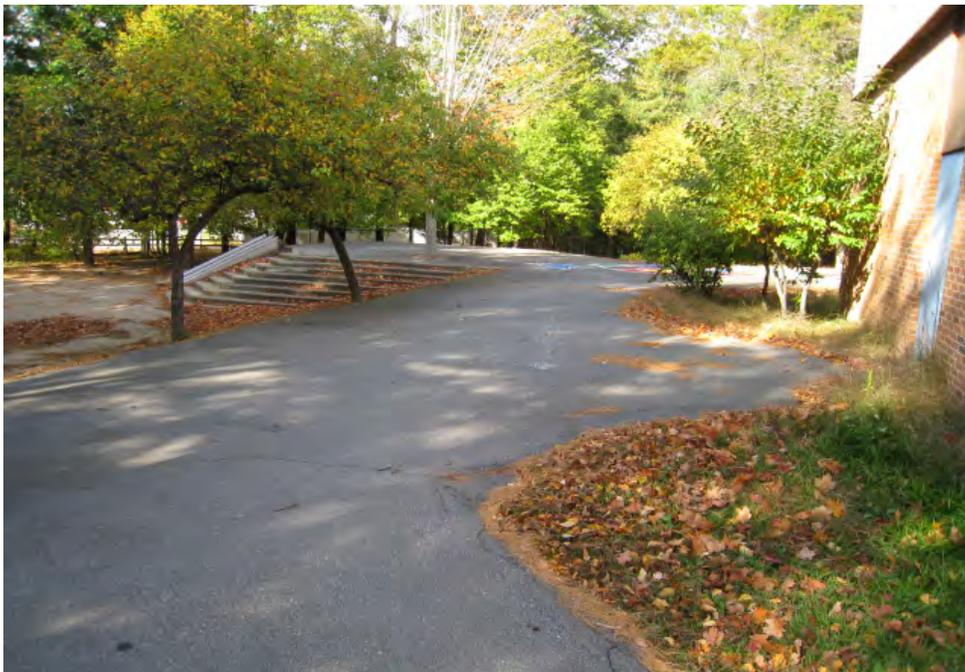
**Picture 14**

**Trees in Close Proximity to Exterior Brick**

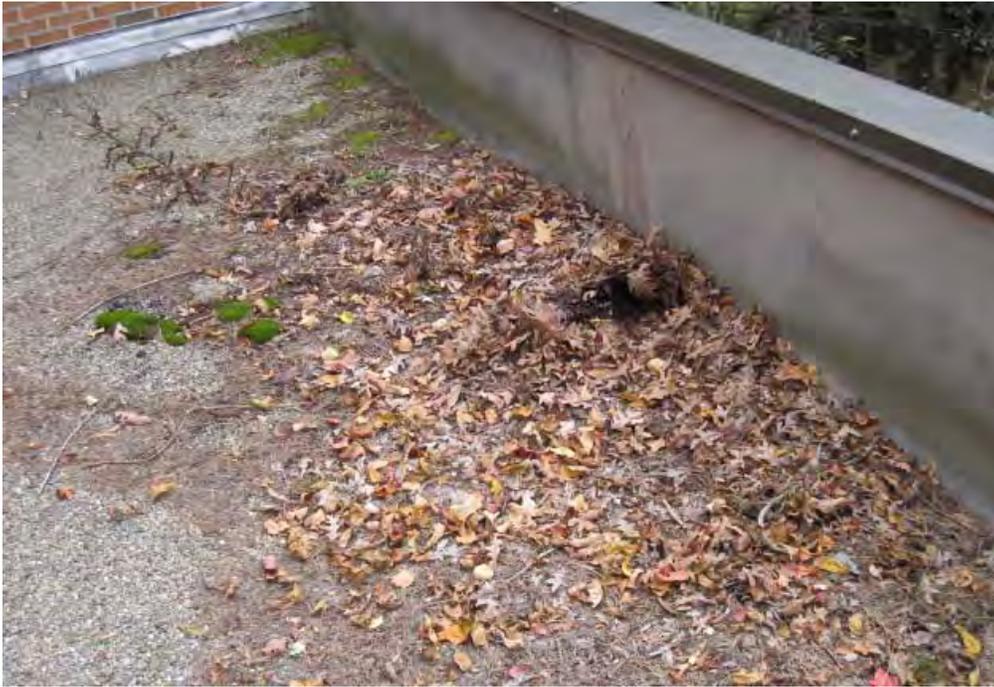
**Picture 15**

**Accumulated Leaves, Moss and Plant Debris on Roof**

14. Remove accumulated plant debris from roof to prevent water pooling.
15. Store cleaning products properly and out of reach of students. Ensure spray bottles are properly labeled.

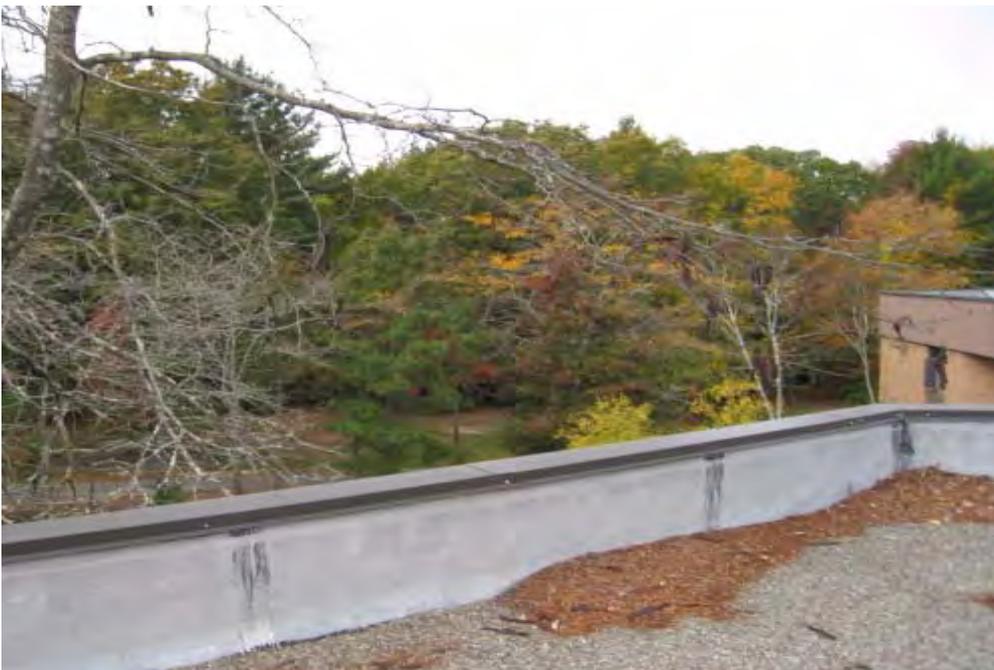
**Picture 16**

**Overhanging Branches and Accumulated Plant Debris on Roof**

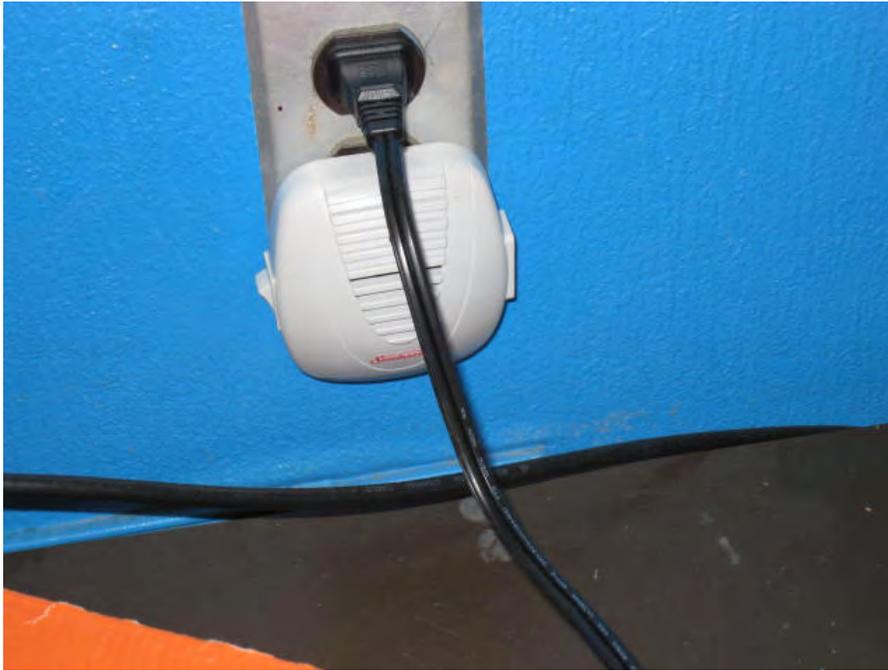
**Picture 17**

Plug-in air fresheners were in use in a few areas (Picture 17). Air fresheners contain chemicals that can be irritating to the eyes, nose and throat of sensitive individuals. Further, air fresheners do not remove materials causing odors, but rather mask odors which may be present in the area.

**Plug-In Air Freshener**

17. Clean personal fans periodically of accumulated dust.
18. Refrain from using strongly scented materials (e.g., plug-in air fresheners).
19. Remove carpeting from nurse's suite. Continue with carpet replacement throughout the building as funds become available.

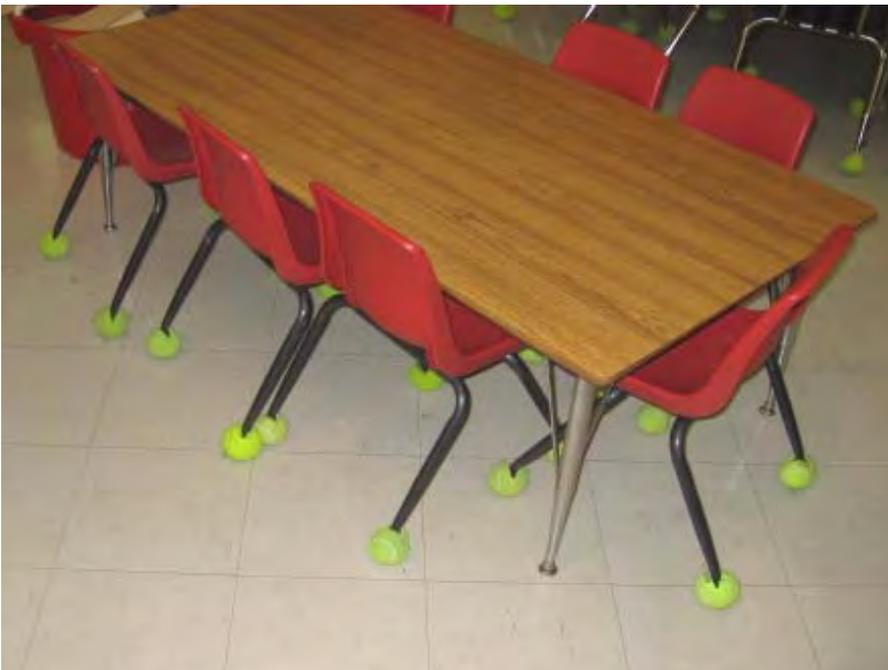
**Picture 18**

In an effort to reduce noise from sliding chairs, tennis balls had been sliced open and placed on chair legs (Picture 18). Tennis balls are made of a number of materials that are a source of respiratory irritants. Constant wearing of tennis balls can produce fibers and cause TVOCs to off-gas. Tennis balls are made with a natural rubber latex bladder, which becomes abraded when used as a chair leg pad. Use of tennis balls in this manner may introduce latex dust into the school environment. Some individuals are highly allergic to latex (e.g., spina bifida patients) (SBAA, 2001). It is recommended that the use of materials containing latex be limited

**Tennis Balls on Chair Legs**

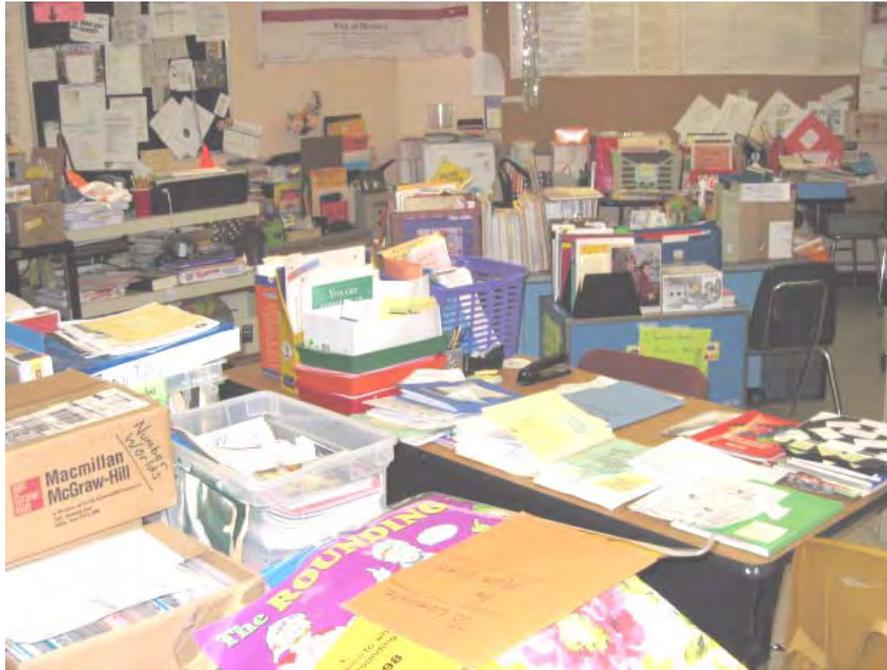
**Picture 19**

Other conditions that can affect indoor air quality were observed during the assessment. In several classrooms, items were observed on windowsills, tabletops, counters, bookcases and desks (Picture 19). The large number of items stored in classrooms provides a source for dusts to accumulate. These items (e.g., papers, folders, boxes) make it difficult for custodial staff to clean. Items should be relocated and/or be cleaned periodically to avoid excessive dust build up. In addition, these materials can accumulate on flat surfaces (e.g., desktops, shelving and carpets) in occupied areas and subsequently be re-aerosolized causing further irritation. A number of personal fans in classrooms were observed to have accumulated dust/debris. Re-activated supply fans can aerosolize dust accumulated on fan blades/housing.

**Accumulated Items on Flat Surfaces in Classroom**

16. Relocate or consider reducing the amount of materials stored in classrooms to allow for more thorough cleaning of classrooms. Clean items regularly with a wet cloth or sponge to prevent excessive dust build-up.
