# **INDOOR AIR QUALITY POST-OCCUPANCY ASSESSMENT**

**Health and Human Services Center  
330 Lynnway  
Lynn, MA**

Prepared by:  
Massachusetts Department of Public Health  
Bureau of Environmental Health  
Indoor Air Quality Program  
November 2011

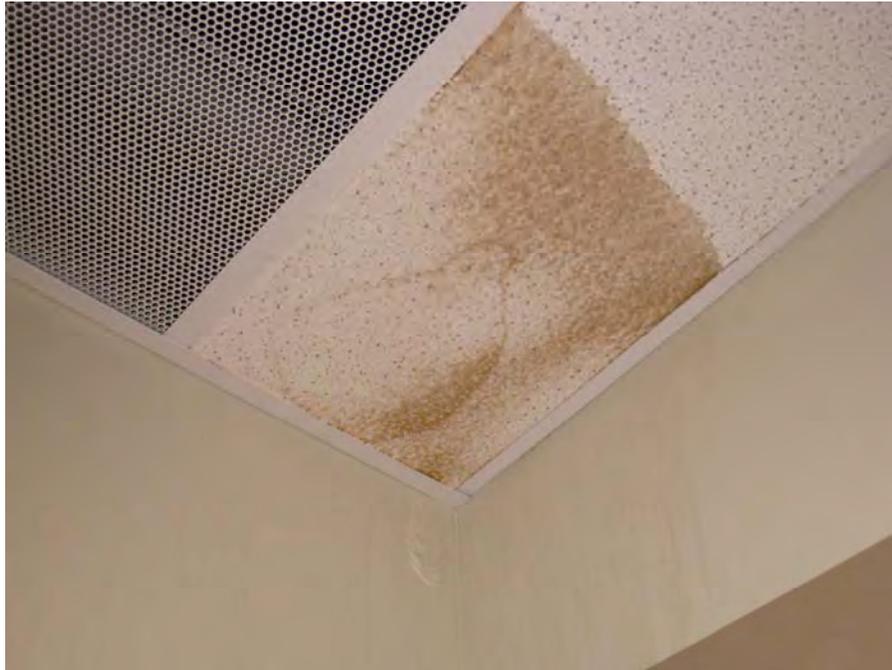
**Picture 1**

In order for building materials to support mold growth, a source of water exposure is necessary. Water-damaged ceiling tiles were observed in two areas of the building, 231 and 243 (Picture 1). Bubbled paint was also observed in room 243 (Picture 1), indicating water had moistened the corner of the wall. Unlike other areas occupied by the HHS Center that have additional floors above them, this is the top most floor of this portion of the building. Ductwork

located above the ceiling tile system penetrates through the roof to the AHU (Picture 2). Given the number of recent severe weather events, it is likely that the leakage experienced in this area is the result of wind-driven rain causing water to enter the building around ductwork.

Neither the ceiling tile nor the gypsum wallboard (GW) was moist at the time of assessment. However, since it is unclear how long the GW had been wet, measures should be taken to exam the GW. If warranted, it should be removed and replaced in accordance with US EPA (2001) recommendations. This area should be monitored for further leakage.

**Water-damaged ceiling tile and bubbled/stained wall paint in area 243**

7. Monitor for signs of water damage following rainstorms around ductwork in area 243. Seal areas around rooftop ductwork as needed to prevent further leakage.
8. Repair/replace water-damaged building materials as necessary to prevent mold growth.
9. Place rubber mats under water dispensers and refrigerators to prevent water from wetting carpet.
10. Providing plants with drip pans and avoid over-watering. Examine drip pans periodically for mold growth. Disinfect with an appropriate antimicrobial where necessary.
11. Refrain from using VOC-containing air deodorizing products.
12. Refer to resource manual and other related indoor air quality documents located on the MDPH's website for further building-wide evaluations and advice on maintaining public buildings. These documents are available at: <http://mass.gov/dph/iaq>.

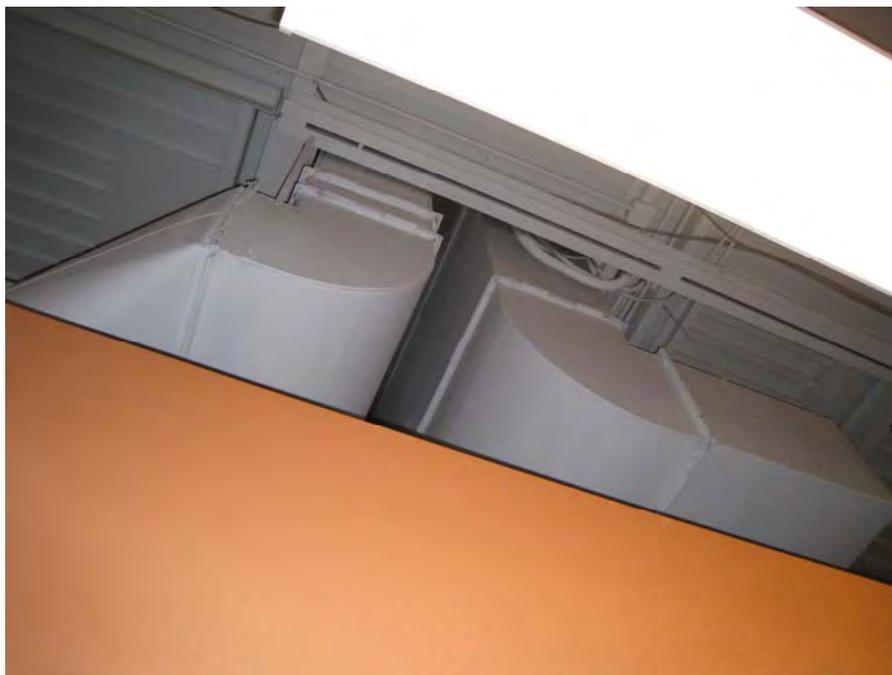
**Picture 2**

**Ductwork above area 243**

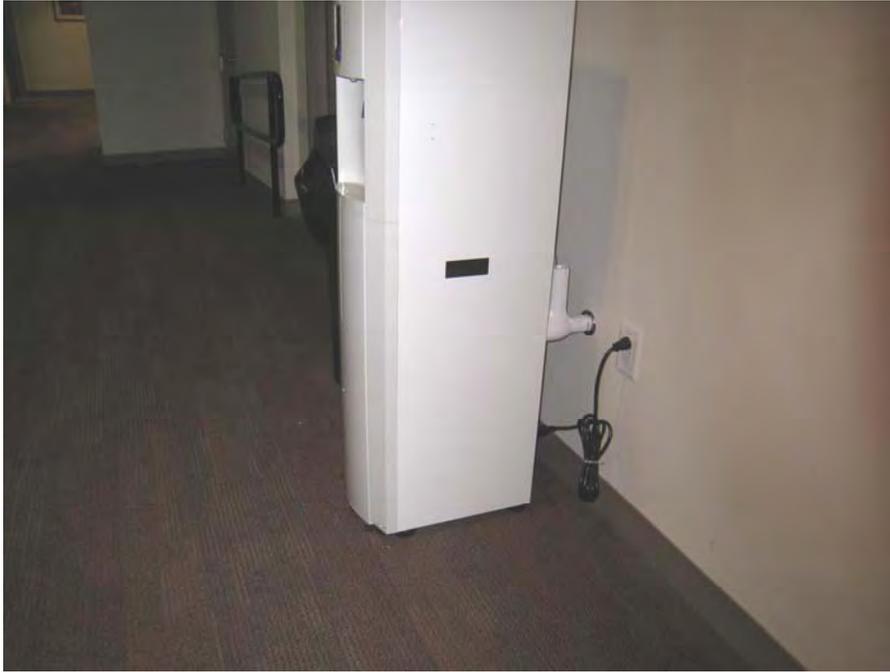
**Picture 3**

In a few areas, water dispensers were located on carpet (Picture 3) as was a refrigerator (Table 1). Spills/condensation from these appliances can be a source of moisture in carpeting that can lead to water damage and mold growth. When possible, these units should be located in tiled areas or placed on a waterproof mat.

**Water cooler on carpeting**
