# **INDOOR AIR QUALITY ASSESSMENT**

**Lynn District Court  
580 Essex Street  
Lynn, Massachusetts**

Prepared by:  
Massachusetts Department of Public Health  
Bureau of Environmental Health  
Indoor Air Quality Program  
May 2013

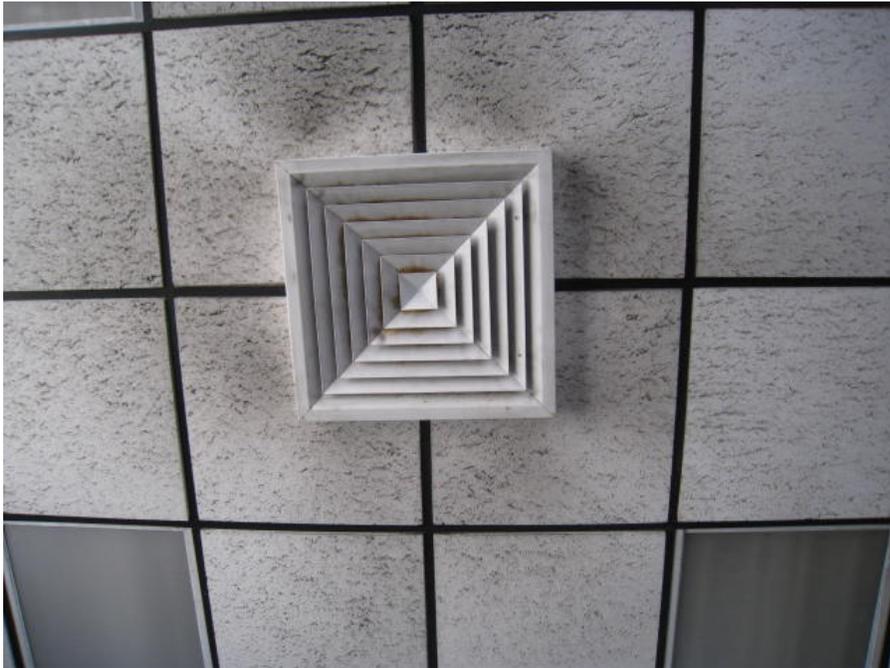
**Picture 1**

Mechanical ventilation for the original building is provided by air-handling units (AHUs) located in an attic mechanical room. Fresh air is drawn into the AHUs through an air intake located in a pit on the exterior of the building and delivered to occupied areas via ceiling-mounted air diffusers (Picture 1). Exhaust air is drawn into ductwork via grilled vents and returned to the mechanical room. These units were operating at the time of assessment.

One concern prompting the investigation was the presence of dark particles/black dust observed around fresh air diffusers of the building (Picture 1). Material accumulated on the diffusers is likely dust. Dust particles in a room can become positively charged when they remain in the air stream. Over time, the charged particles can collect on the air diffuser due to attraction of the dust to the negatively charged diffuser and surround ceiling tiles. PM<sub>2.5</sub> levels were not elevated at the time of assessment, indicating that there is no aerosolization of dust collecting on the diffuser. These particles appears should be removed through regular building cleaning and maintenance activities.

**Ceiling-mounted fresh air diffuser (note black particles around diffuser)**

6. Clean debris from fresh air diffusers and adjacent ceiling tiles regularly.
7. Remove the pipe in the vault area.

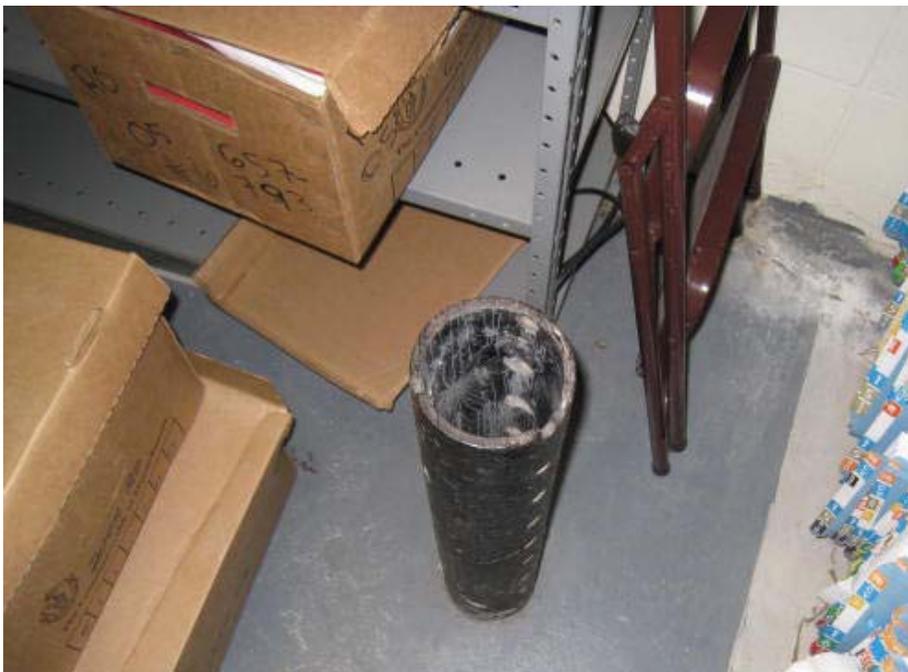
**Picture 2**

An open pipe was noted in the lower vault; the purpose/function of the pipe was unknown to building occupants (Picture 2). Holes observed at regular intervals along the length

of the pipe's length suggest that the pipe was designed to support equipment formerly located in the lower vault rather than used for water supply or drainage. Unnecessary pipes/penetrations should be removed/sealed to prevent pathways for odors entering occupied spaces.

**An open pipe with unknown function in the lower vault**
