INDOOR AIR QUALITY ASSESSMENT ODOR INVESTIGATION

**Westfield High School
Administrative Suite
177 Montgomery Road
Westfield, Massachusetts**

Prepared by:
Massachusetts Department of Public Health
Bureau for Environmental Health
Indoor Air Quality Program
June 2014

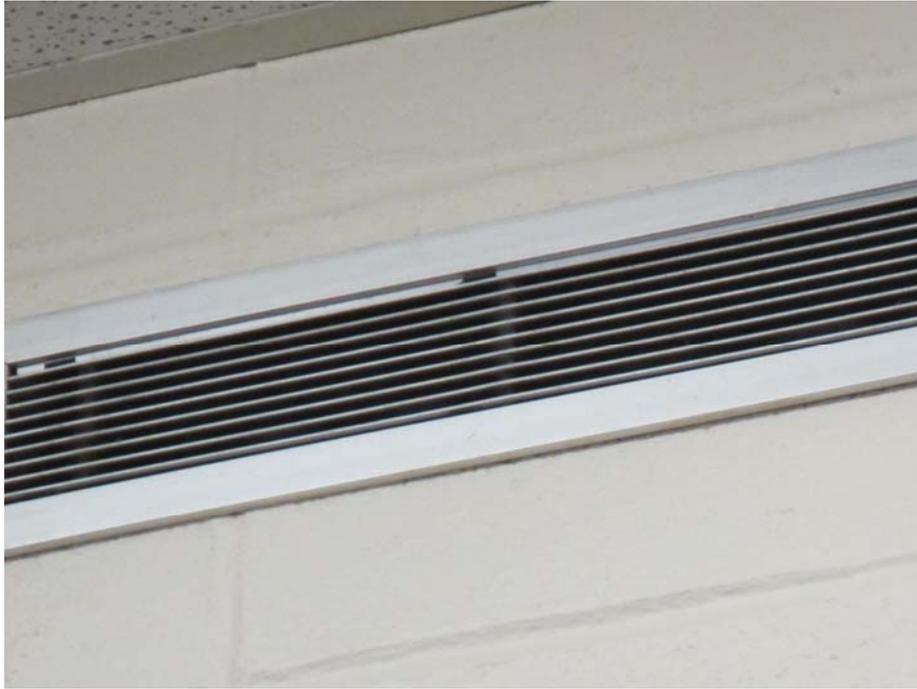
Picture 1

Passive vent located in an office

6. Consult with a HVAC engineering firm to determine the feasibility of providing mechanical supply and exhaust ventilation to the AS.
7. Consider adopting the US EPA (2000) document, “Tools for Schools.” This document is available at: <http://www.epa.gov/iaq/schools/index.html>.

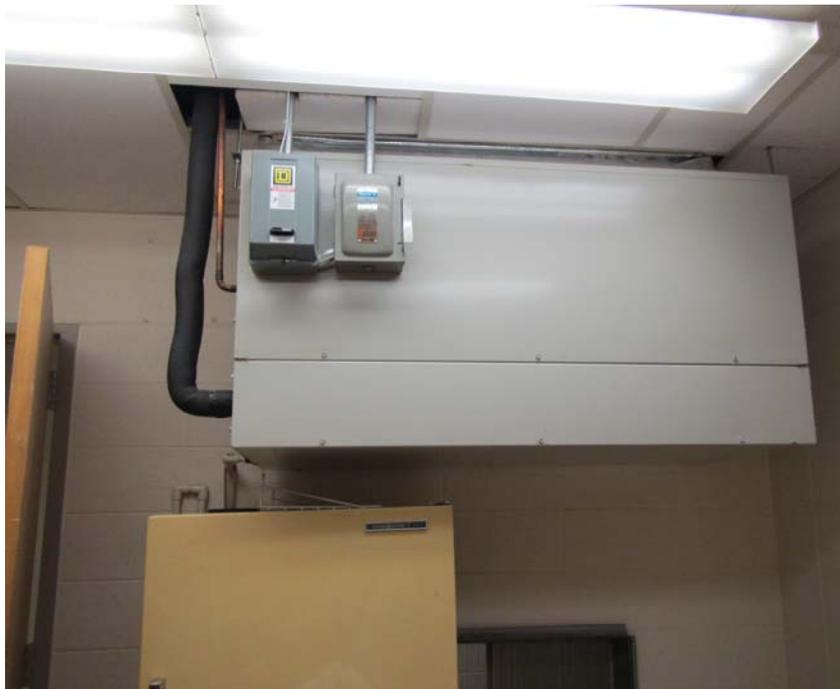
Picture 2

AHU in kitchen

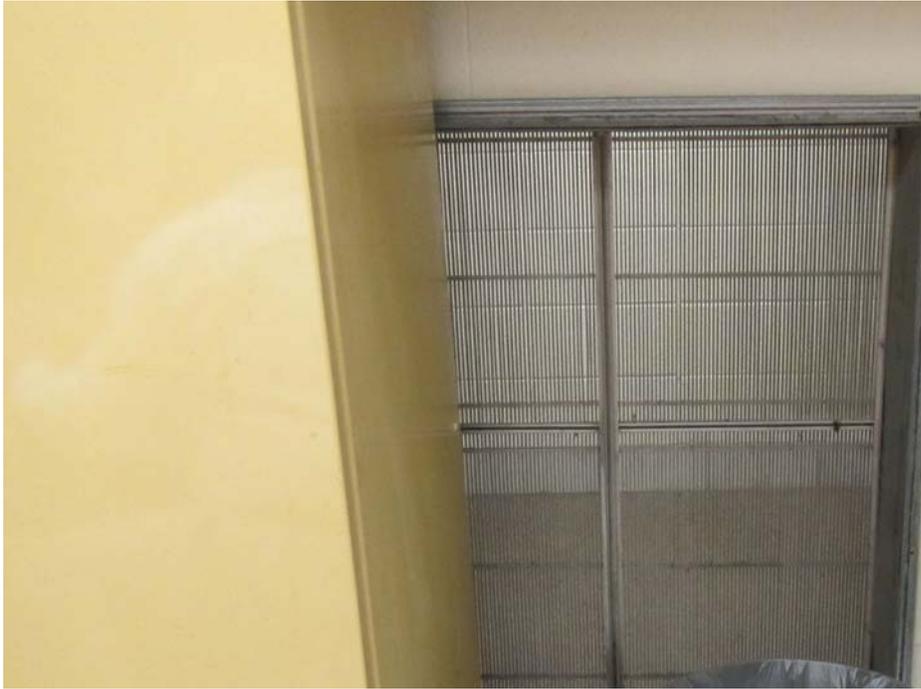
Picture 3

Of note is a large passive vent located in the hallway wall of the kitchen (Picture 3). This vent was likely connected to the original air-conditioning AHU that was replaced by the current ceiling-mounted AHU. BEH/IAQ staff observed different floor tiles in this area which likely indicated that the original AHU was installed on the floor of the kitchen.

Large vent in kitchen

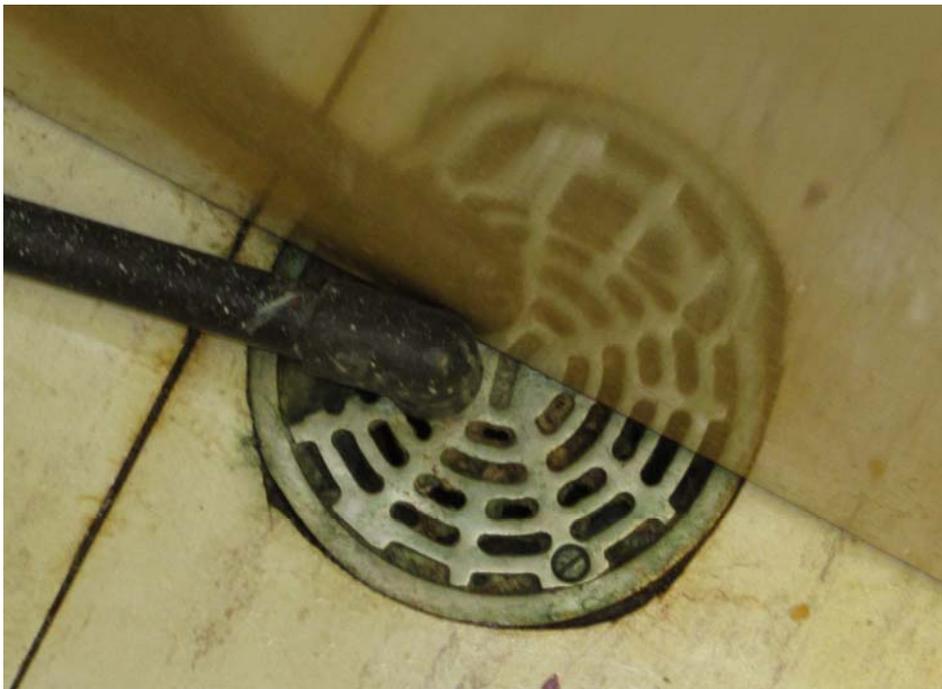
Picture 4

The kitchen contains a floor drain that is the likely source of odors in the AS. A condensation drainpipe for the AHU terminates above the floor drain which is connected to the building drainage system (Picture 4). Drains typically have traps to prevent sewer odors/gases from penetrating into occupied spaces. During air-conditioning operation, moisture (e.g., condensation) will flow into the drain which fills the trap to form a watertight seal. During the

heating season, the drain traps can dry out, which then may allow sewer gas/odors and moisture from the sewer system to enter occupied spaces of the office. In order to maintain the watertight seal, water should be poured down the drain routinely during the heating season to prevent back up of gas/odors into occupied spaces.

Of note is that the kitchen refrigerator partially covers the floor drain (Picture 4). Refrigerators are equipped with a fan to help cool the refrigerant and compressor. When operating, this fan can draw air from the floor. If the sewer/septic system becomes pressurized by increased water drainage after a rainstorm, air from the sewer can be forced up the line through the dry drain trap, which is then drawn and distributed into the AS by the refrigerator fan.

Floor drain in kitchen (note: partially obstructed by the refrigerator)

1. Pour water down the floor drain in the kitchen every 2- 3 days to ensure a water tight seal during the heating season.
2. Open windows (weather permitting) to provide fresh outside air. Care should be taken to ensure windows are properly closed at night and weekends during winter months to avoid the freezing of pipes and potential flooding. In addition, keep windows closed during

4. Move refrigerator away from the floor drain. Replace the condensation drip pan and make repairs to or replace the refrigerator as needed. Clean/disinfect the drip pan on a regular basis.

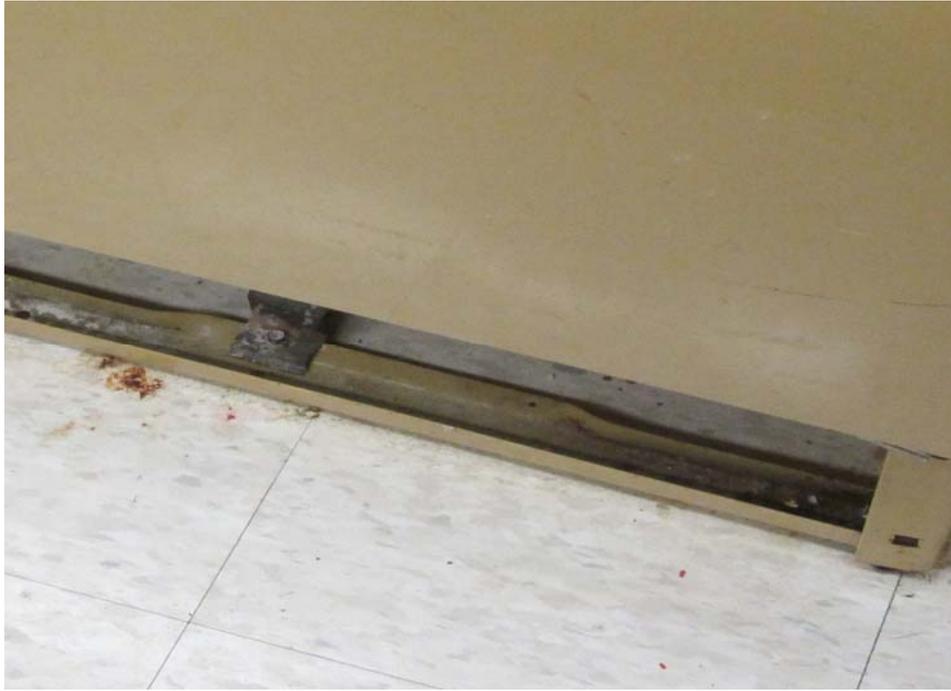
Picture 5

Missing drip pan under the refrigerator

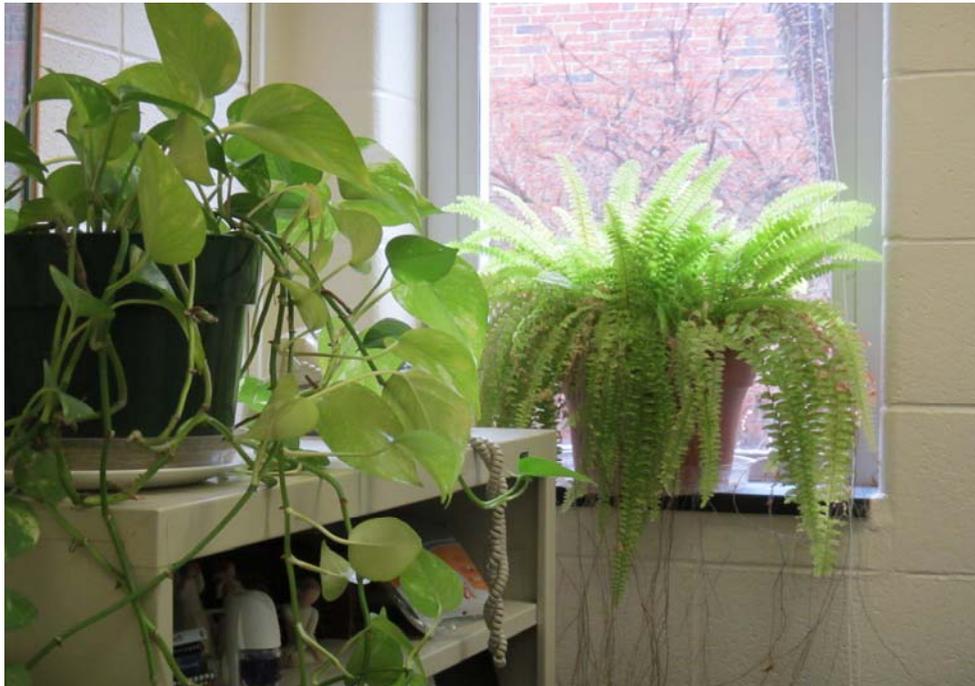
Picture 6

Plants were observed in a few rooms (Table 1, Picture 6). Plants, soil and drip pans can serve as sources of mold growth. Plants can also be a source of pollen. Plants should not be placed on porous materials, since water damage to porous materials may lead to microbial growth.

Plants located in office space

5. Ensure indoor plants are equipped with drip pans. Examine drip pans periodically for mold growth and disinfect with an appropriate antimicrobial, as needed. Move plants away from the air stream of mechanical ventilation equipment.
