# **INDOOR AIR QUALITY POST-OCCUPANCY ASSESSMENT**

**EOHHS Center  
Department of Children and Families (DCF)  
Department of Developmental Services (DDS), and  
Massachusetts Rehabilitation Commission (MRC)  
220 Rear Forbes Street  
Braintree, MA**

Prepared by:  
Massachusetts Department of Public Health  
Bureau of Environmental Health  
Indoor Air Quality Program  
August 2014

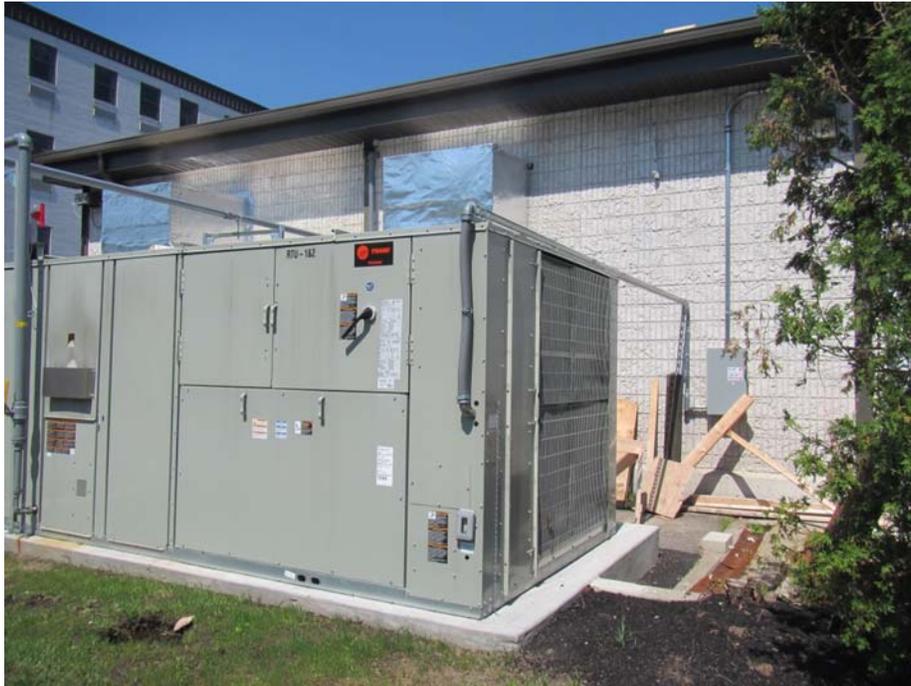
**Picture 1**

BEH/IAQ staff examined the HVAC units, which are located along the side of the building. The units are in close proximity to trees and mulch (Pictures 7 and 8). Mulch is designed to hold moisture; when wet, it can also emit odors. Moisture and odors from the mulch can be drawn into ventilation equipment and subsequently distributed through the building. Trees, shrubs and plants can also be a source of pollen, debris and mold into the AHU, which can penetrate the building or clog the air filters. Consideration should be given to removing landscaping in close proximity to the building so as to maintain a space of 5 feet between shrubbery and the building and/or air intakes.

**Air handling units (AHU) along the side of the building**

13. Remove mulch from areas near the AHUs and consider replacing with crushed stone.
14. Avoid the use of scented products such as air deodorizers and fresheners.

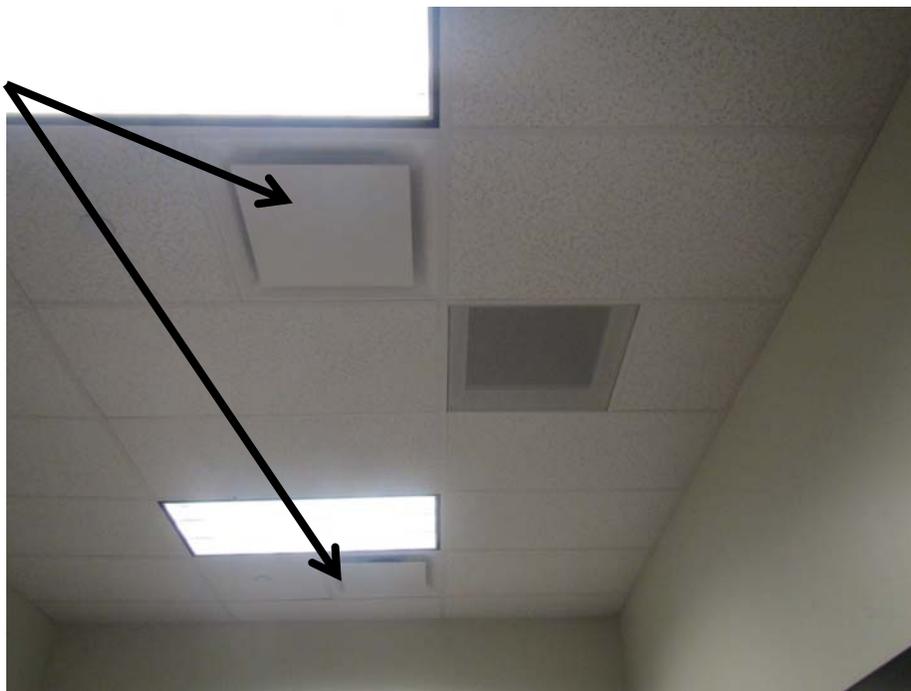
**Picture 2**

It can be seen from Table 1 that carbon dioxide levels were below 800 parts per million (ppm) in all 94 areas tested, indicating adequate air exchange at the time of assessment. The heating, ventilation and air-conditioning system (HVAC) consists of air-handling units (AHUs) located on the side of the building (Picture 1). Each AHU draws fresh, outdoor air into the unit, where it is filtered, heated/cooled and provided to office space via ceiling-mounted supply vents (Picture 2). Return air is drawn into an above-ceiling plenum via ceiling grates (Picture 2) and ducted back to AHUs. Note that in some offices and open areas, layout of supply and return vents do not appear to be optimal. For example, the office shown in Picture 2 has two supply vents in close proximity to one another, with a return vent also very close. This would tend to

lead to short-circuiting of fresh supply air being drawn back into the return vent. Note : MDPH was not asked to do a pre-occupancy assessment of this space, otherwise this would have been noted at that time.

**Supplies (arrows) and return vent in an office**

5. Consideration should be given to moving supply and exhaust vents such as those shown in Picture 2.
6. For buildings in New England, periods of low relative humidity during the winter are often unavoidable. Therefore, scrupulous cleaning practices should be adopted to minimize common indoor air contaminants whose irritant effects can be enhanced when the relative humidity is low. To control for dusts, a high efficiency particulate arrestance (HEPA) filter equipped vacuum cleaner in conjunction with wet wiping of all surfaces is recommended. Avoid the use of feather dusters. Drinking water during the day can help ease some symptoms associated with a dry environment (throat and sinus irritations).

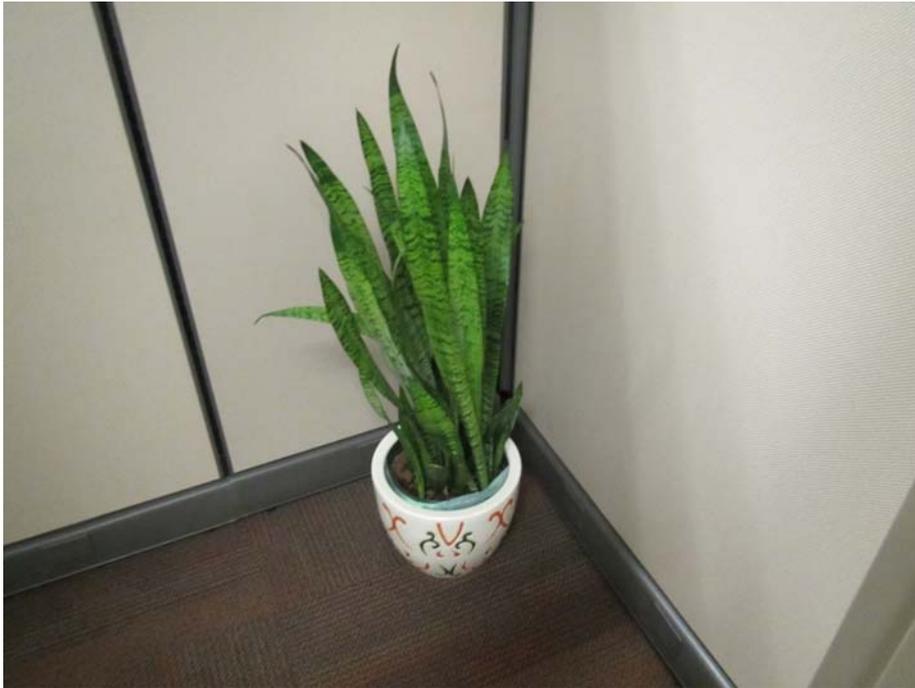
**Picture 3**

Plants were observed in some areas (Table 1; Picture 3). Plants should be properly maintained and equipped with drip pans. Plants should be located away from ventilation sources to prevent aerosolization of dirt, pollen or mold. Plants should not be placed on carpets or other porous materials (Picture 3), since water damage to porous materials may lead to microbial growth.

**Plant on carpeted surface**

8. Ensure plants have drip pans and avoid over-watering. Examine drip pans periodically for mold growth. Disinfect with an appropriate antimicrobial where necessary.

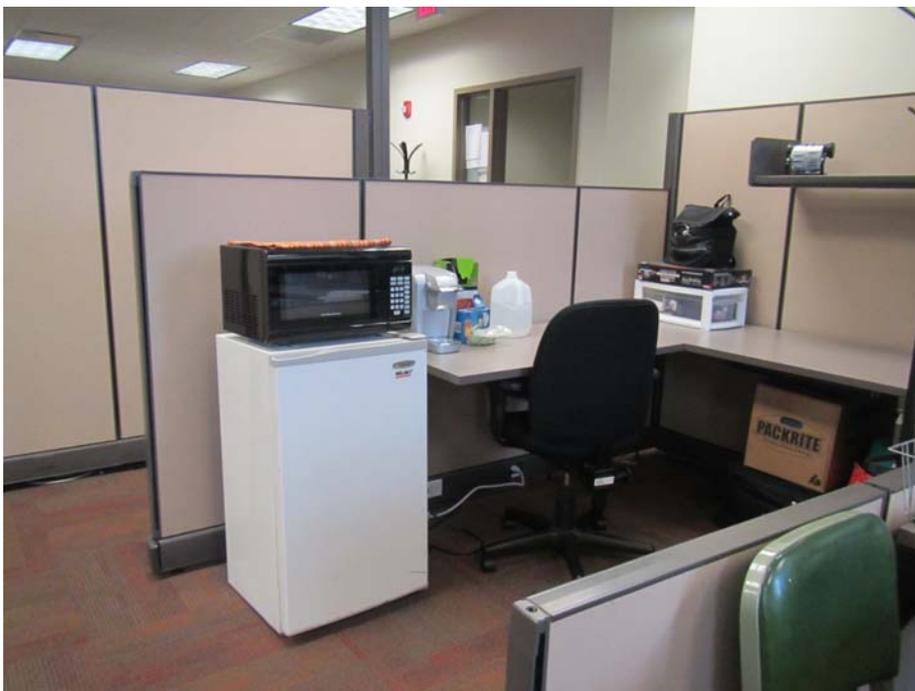
**Picture 4**

BEH/IAQ staff observed refrigerators and water coolers on carpeted surfaces (Picture 4). Spills or leaks from this equipment can moisten carpet and lead to microbial growth and degradation of the carpet. MDPH typically recommends placing rubber mats or non-porous flooring (e.g., vinyl tile) beneath this equipment to protect the porous carpet from leaks and spills.

**Refrigerator on carpet**

9. Place protective rubber mats beneath water coolers and refrigerators or use non-porous flooring to prevent damage to carpeting.
10. Clean refrigerator gaskets with an antimicrobial cleaner and ensure that refrigerators are cleaned out regularly.

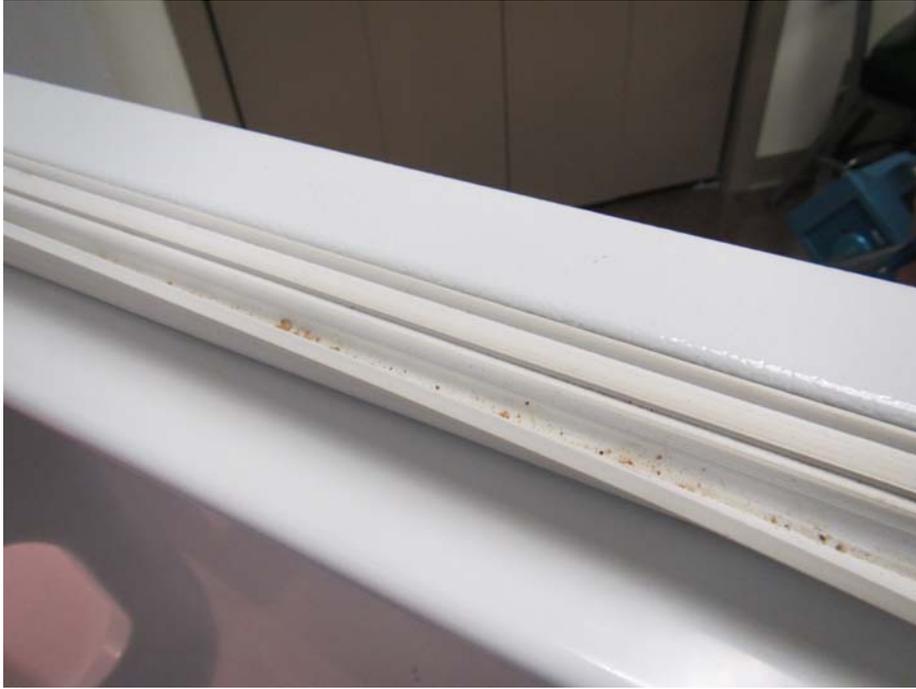
**Picture 5**

There were also several refrigerators located in the kitchen area. The gaskets of one was found to have debris and possible mold staining (Picture 5). Refrigerator gaskets are non-porous surfaces and should be cleaned with an antimicrobial cleaner. Refrigerators should be cleaned out regularly. A fish tank was observed in one office. Fish tanks need to be kept clean or they can become a source of odors.

**Refrigerator gasket with debris and mold staining**

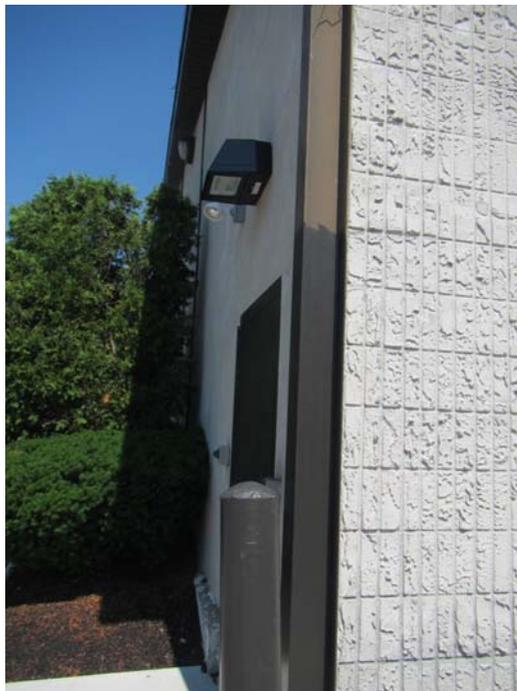
**Picture 6**

BEH/IAQ staff examined the exterior of the building for sources of water penetration. Plants were observed in close proximity to the building's exterior (Picture 6). Plants, shrubs, and trees in close proximity to the building hold moisture against the building exterior. The growth

of roots against exterior walls can bring moisture in contact with the foundation. Plant roots can eventually penetrate the wall, leading to cracks and/or fissures in the foundation. Over time, these conditions can undermine the integrity of the building envelope and provide a means of water entry into the building via capillary action through exterior walls, foundation concrete, and masonry (Lstiburek & Brennan, 2001). The freezing and thawing action of water during the winter months can create cracks and fissures in the foundation that can result in additional penetration points for both water and pests.

**Shrubbery against the side of the building**

11. Maintain fish tanks to prevent odors and microbial growth.
12. Ensure plants, trees and shrubs are located at least five feet away from exterior walls/foundation of the building and the air intakes for the AHUs.

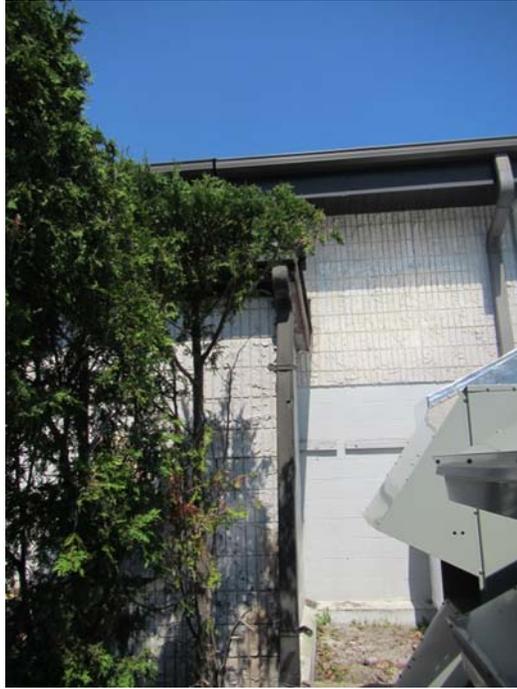
**Picture 7**

**Plants in front of the AHU air intake**

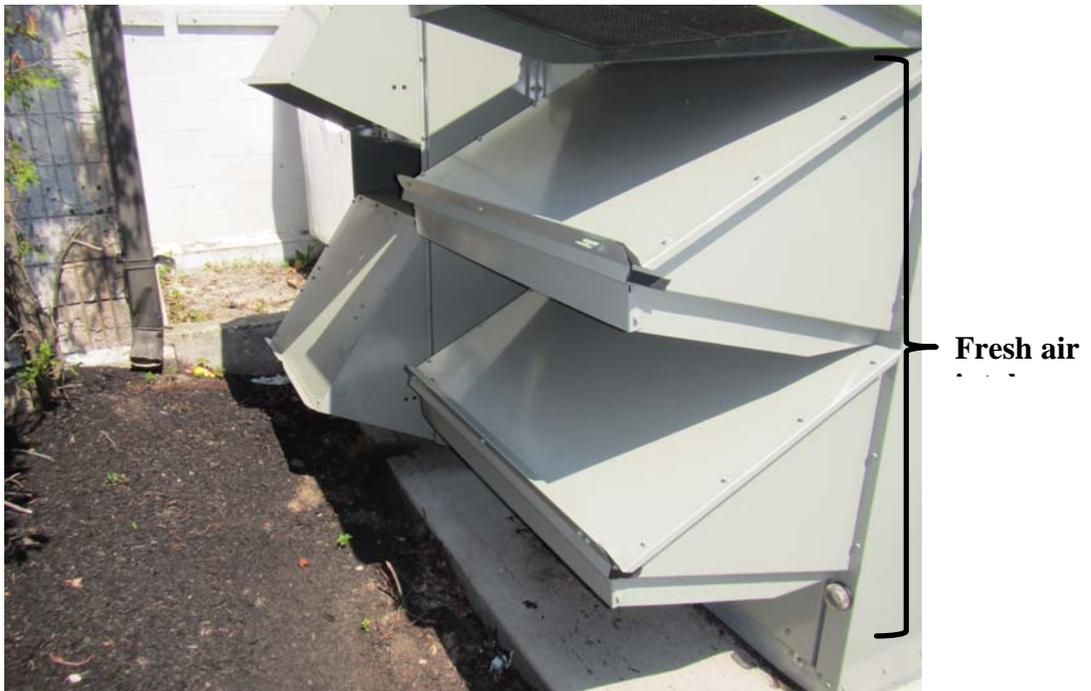
**Picture 8**

**Ventilation fresh air intakes in close proximity to mulch**

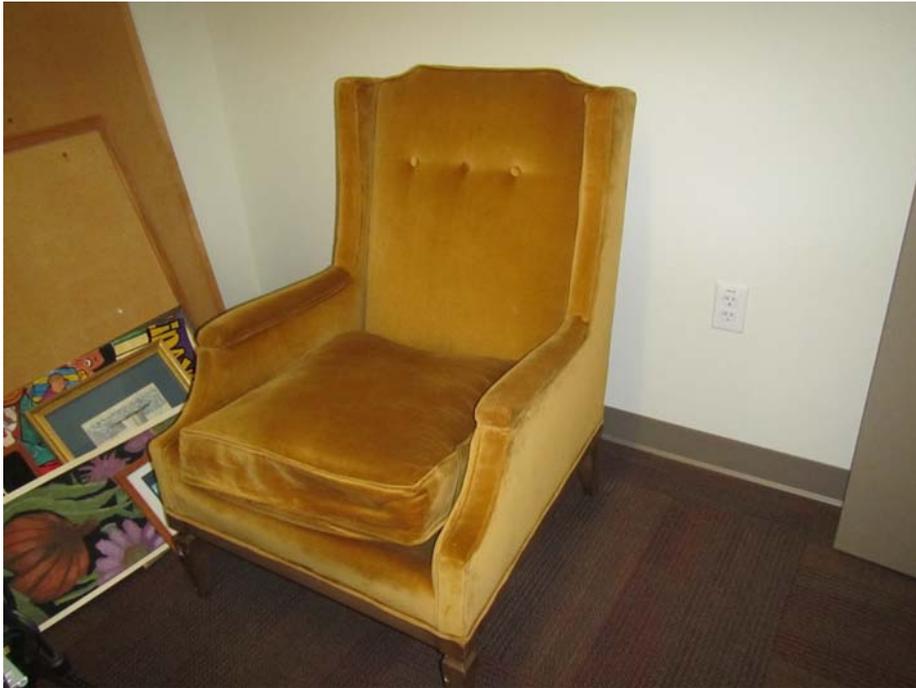
**Picture 9**

Upholstered furniture and plush items were seen in some areas (Table 1; Picture 9). Upholstered furniture is covered with fabric that comes in contact with human skin. This type of contact can leave oils, perspiration, hair and skin cells. Dust mites feed upon human skin cells and excrete waste products that contain allergens. In addition, if relative humidity levels increase above 60 percent, dust mites tend to proliferate (US EPA, 1992). In order to remove dust mites and other pollutants, frequent vacuuming of upholstered furniture is recommended (Berry, 1994). It is also recommended that upholstered furniture, be professionally cleaned on

an annual basis. If outdoor conditions or indoor activities (e.g., renovations) create an excessively dusty environment, cleaning frequency should be increased (every six months) (IICRC, 2000).

**Upholstered chair in office**
