INDOOR AIR QUALITY ASSESSMENT

**North Shore Technical High School
30 Log Bridge Rd
Middleton, MA**

Prepared by:
Massachusetts Department of Public Health
Bureau of Environmental Health
Indoor Air Quality Program
November 2014

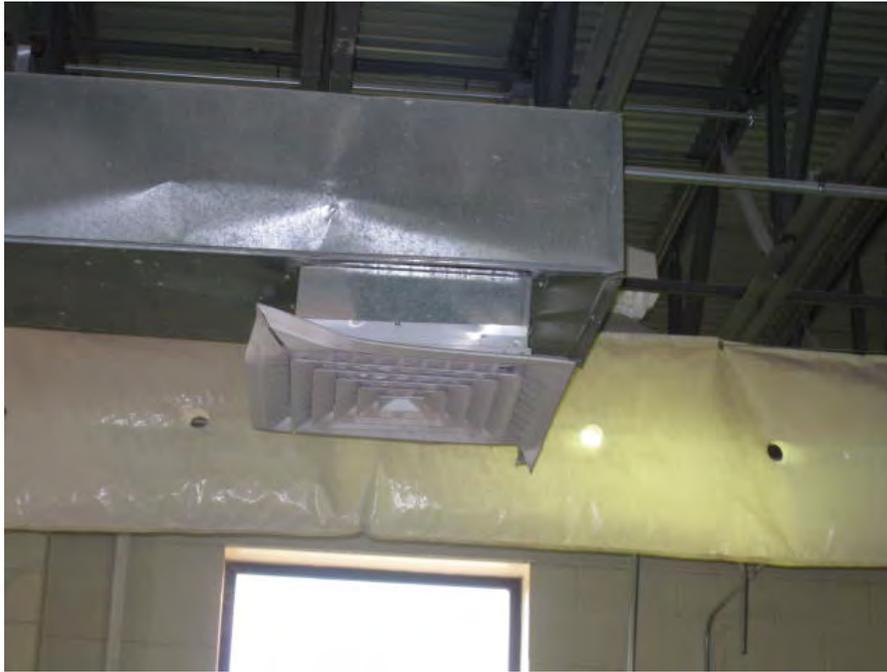
Picture 1

Fresh air to the main building and the gymnasium is supplied by rooftop air-handling units (AHUs) ducted to ceiling-mounted supply vents (Pictures 1 and 2). The AHUs for the main building supplies both heating and cooling. It was reported to BEH/IAQ staff that cooling for some portions of the building was not operational during the day of assessment.

Supply vent in a workshop area

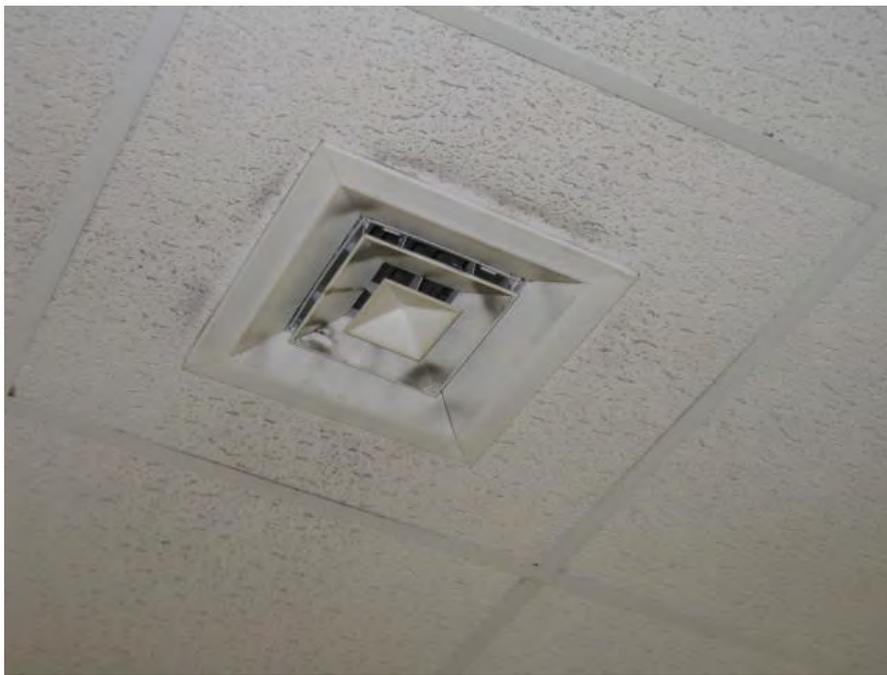
Picture 2

Supply vents, exhaust vents, and personal fans were found to be dusty (Table 1). Re-activated supply vents/fans can aerosolize dust accumulated on fan blades/housing. If exhaust vents are not functioning, backdrafting can occur, which can re-aerosolize dust particles.

Supply vent in a classroom/office area, note dust on louvers

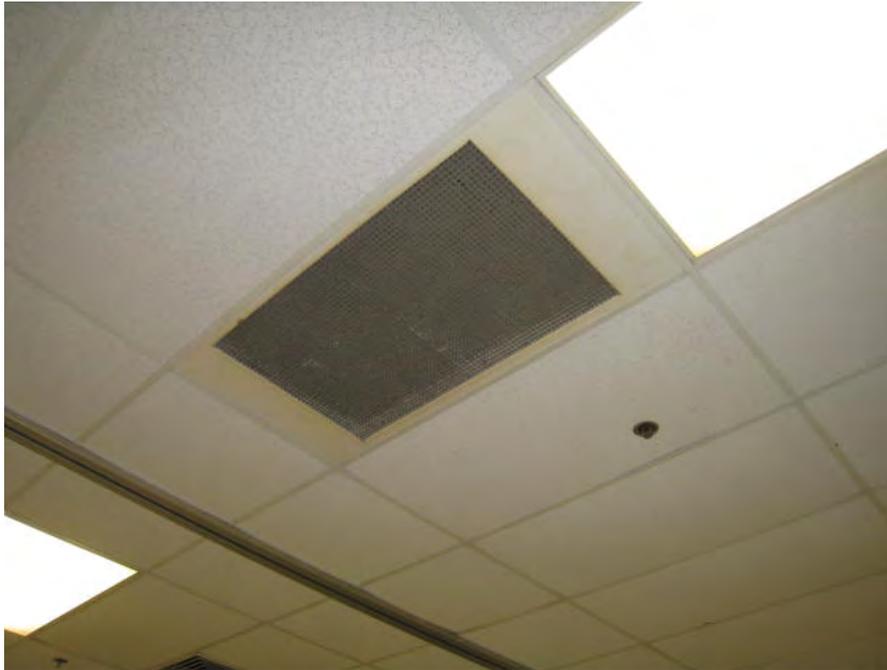
Picture 3

Ceiling-mounted exhaust vent

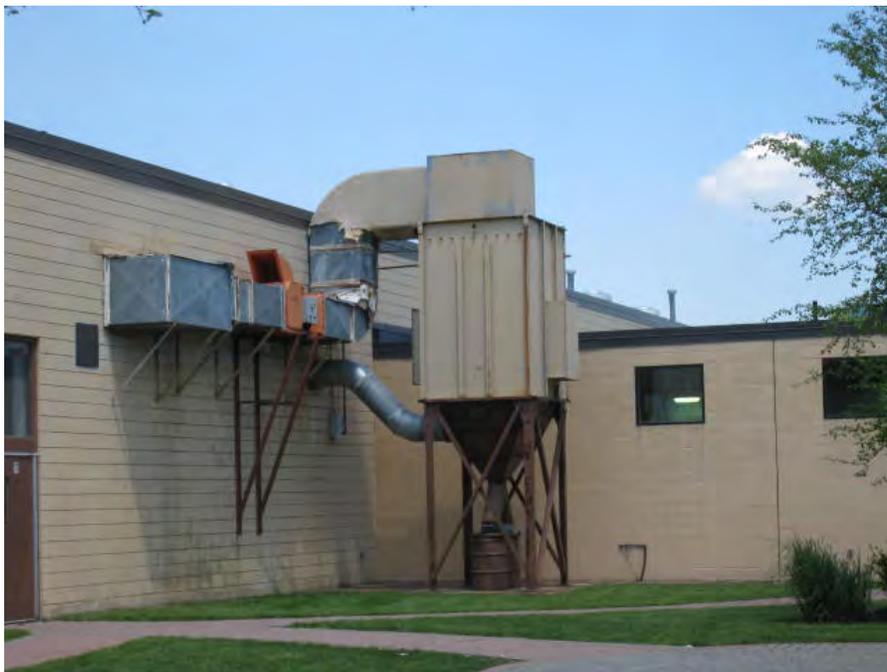
Picture 4

Exhaust system for carpentry area

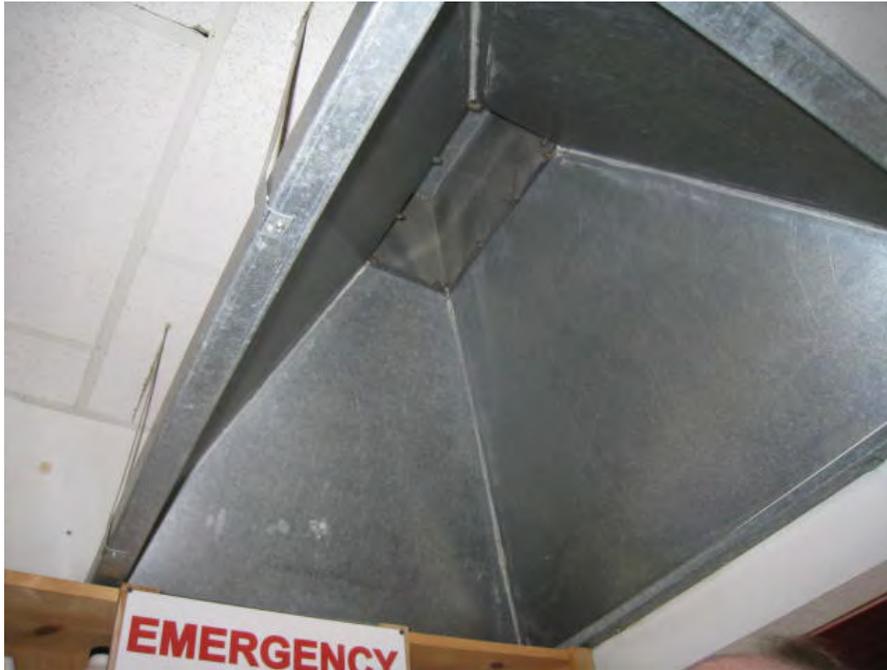
Picture 5

BEH/IAQ staff observed an exhaust hood in the storage/mixing area of the cosmetology classroom, but no means for activating the unit could be identified. The hood unit appeared to be blocked from the inside (Picture 5). School staff could not confirm if the unit had ever been operational. Dedicated exhaust ventilation would facilitate removal of pollutants and odors generated from cosmetic chemicals.

Exhaust hood structure in the cosmetology storage area

3. Consider having the mechanical systems balanced as recommended by ventilation industrial standards (SMACNA, 1994).
4. Examine the exhaust hood noted in the cosmetology storage area to see if this can be made usable. If so, ensure the unit is in use whenever materials that may release TVOCs are used in the storage area.

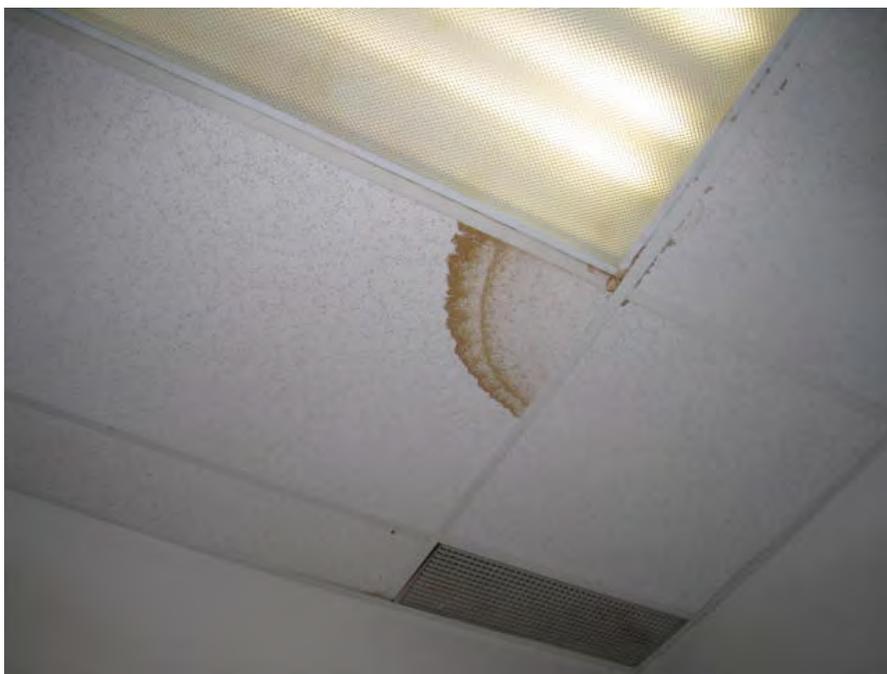
Picture 6

Water-stained ceiling tiles were observed in a few areas (Picture 6; Table 1). Water-damaged ceiling tiles indicate leaks from the building envelope or plumbing and can provide a source for mold. Stain and damaged materials should be replaced after the source of moisture has been addressed.

Water-stained ceiling tile

9. Examine areas of leakage and ensure any water-damaged ceiling tiles and wall materials are repaired and/or replaced. Examine the area above ceiling tiles for mold growth. Disinfect areas of water leaks with an appropriate antimicrobial, as needed.

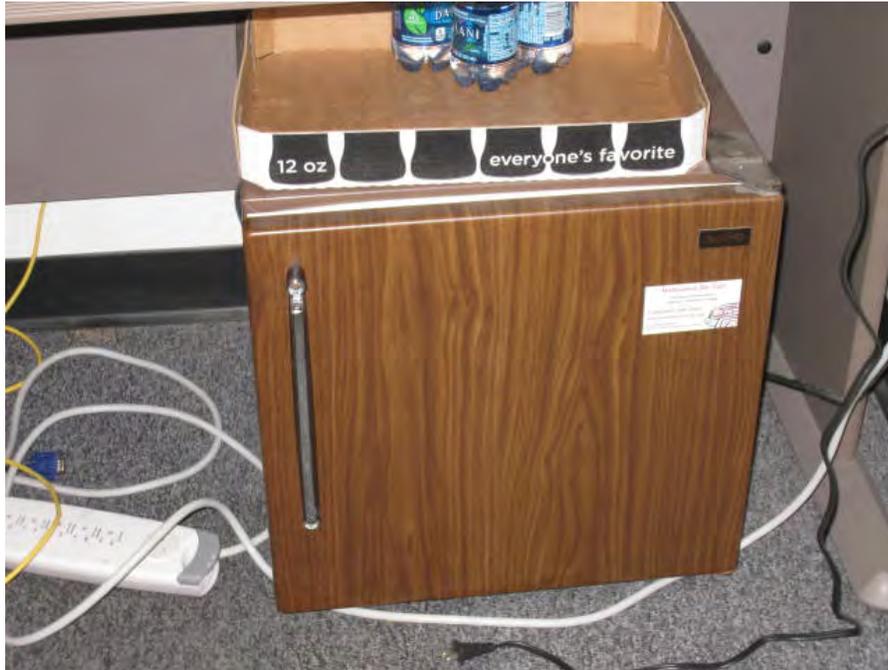
Picture 7

Small refrigerators were observed on top of carpeting (Picture 7). These appliances can leak or spill and moisten the carpet, which can lead to microbial growth; they should be placed on a non-porous surface when possible.

Refrigerator on carpet

11. Consider moving refrigerators to areas with non-porous flooring or using a non-porous mat to collect spills.
12. Trim back shrubbery from the foundation of the building.

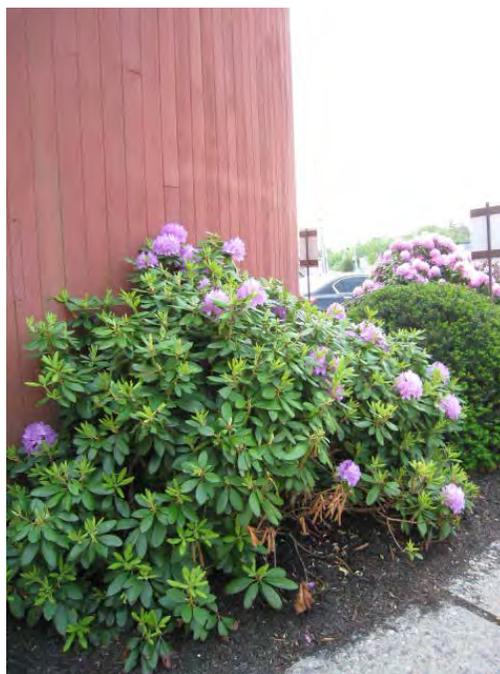
Picture 8

During an examination of the exterior of the building, BEH/IAQ staff observed plants and shrubs in close proximity to the building in some areas (Picture 8). Shrubs/trees in close proximity to the building hold moisture against the building exterior and prevent drying. The growth of roots against exterior walls can bring moisture in contact with the foundation. Plant roots can eventually penetrate the wall, leading to cracks and/or fissures in the sublevel foundation. Over time, these conditions can undermine the integrity of the building envelope and provide a means of water entry into the building via capillary action through exterior walls, foundation concrete, and masonry (Lstiburek & Brennan, 2001). The freezing and thawing action of water during the winter months can create cracks and fissures in the foundation that can result in additional penetration points for both water and pests. Trees and shrubs can also be a source of pollen, debris, and mold into univents and windows. Consideration should be given to removing landscaping in close proximity to the building so as to maintain a space of 5 feet between shrubbery and the building.

Shrubs growing close to the exterior of the building

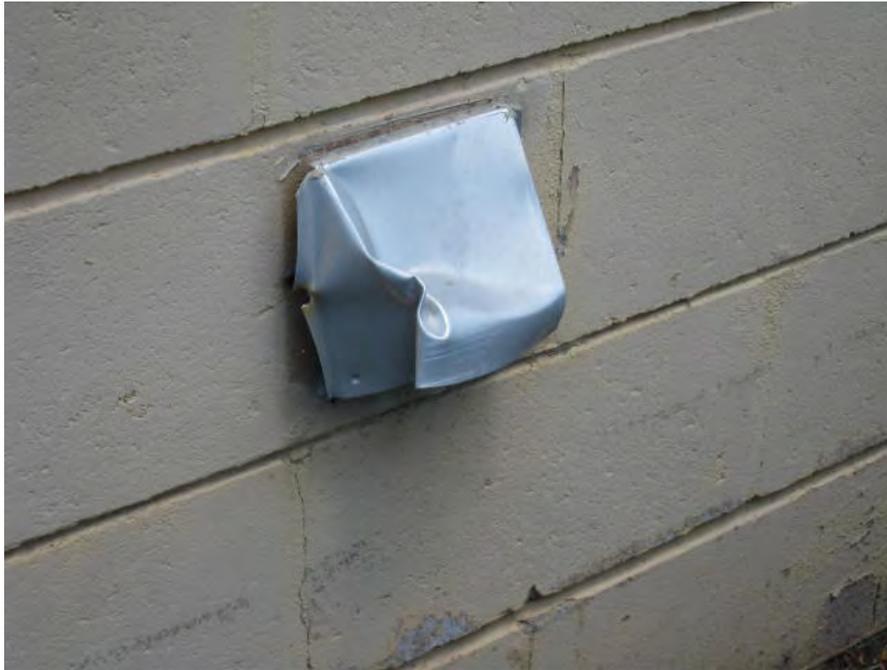
Picture 9

Several holes/penetrations were noted along the exterior of the building, including what appeared to be damaged vents for items such as laundry dryers (Picture 9). If these vents are still in use, the damage observed in the vent could prevent the exhaust from being efficiently vented, which may prevent the attached appliance from working properly or cause moisture and gases to be pushed back into occupied areas. If the vent is no longer in use, it should be properly sealed with an applicable water/air resistant material to prevent the ingress of unconditioned air, dust/debris, moisture, and pests. Other penetrations to the wall, such as holes resulting from missing vents should be also sealed similarly (e.g., Picture 10).

Damaged vent on exterior of building

13. Seal holes/penetrations in the building envelope. Examine vent holes in the side of the building to determine if they are functional vents that should be repaired or disused vents that should be sealed.

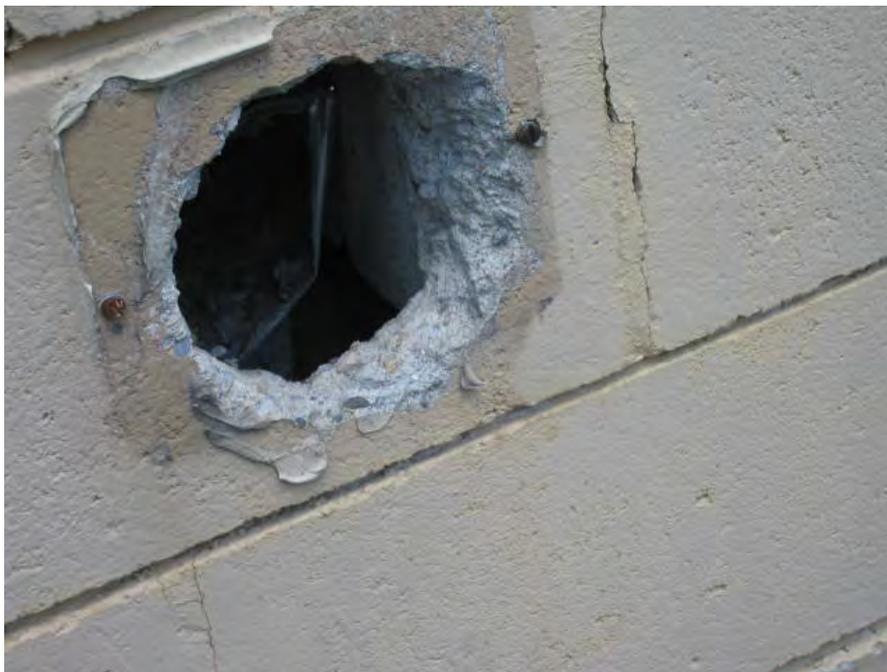
Picture 10

Missing vent cover/hole in exterior wall

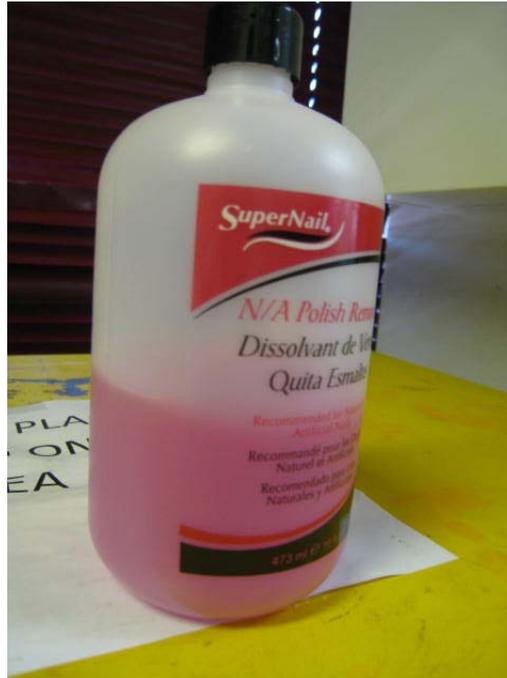
Picture 11

Nail polish remover used in the cosmetology area

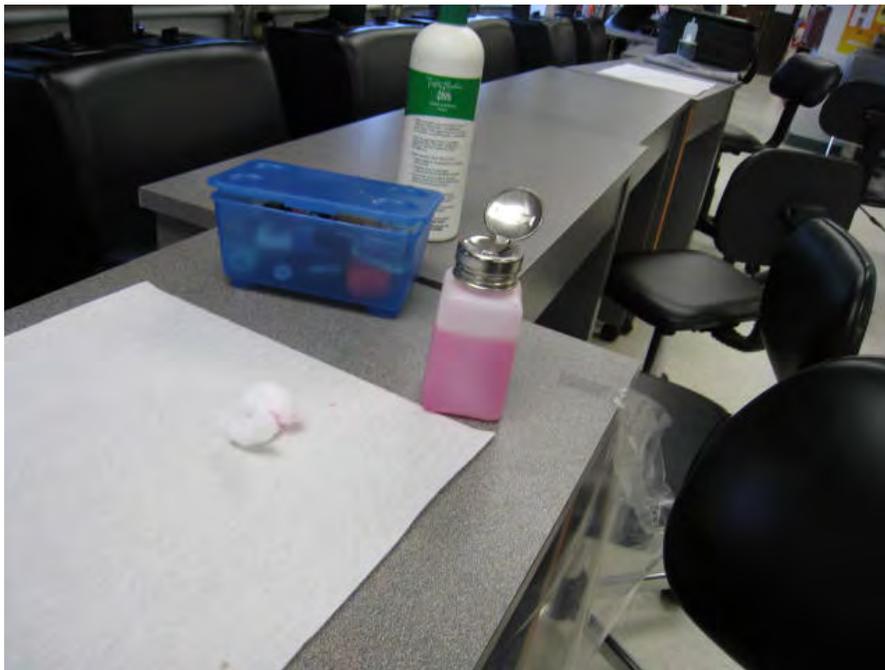
Picture 12

Open container of nail polish remover and moistened cotton ball

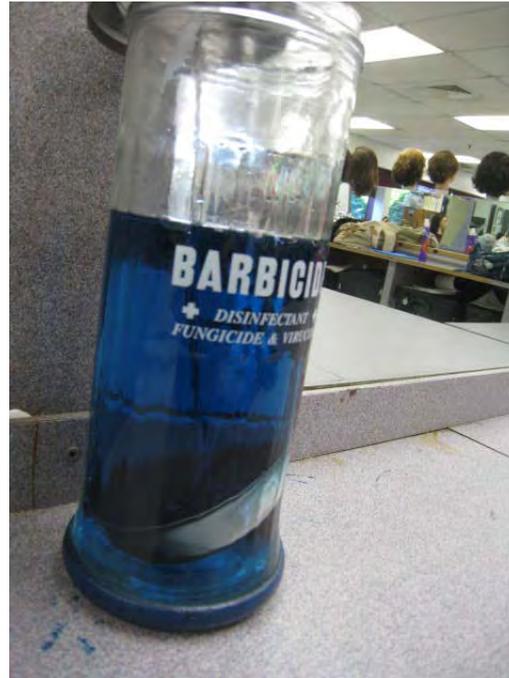
Picture 13

Barbicide container, note cover is ajar

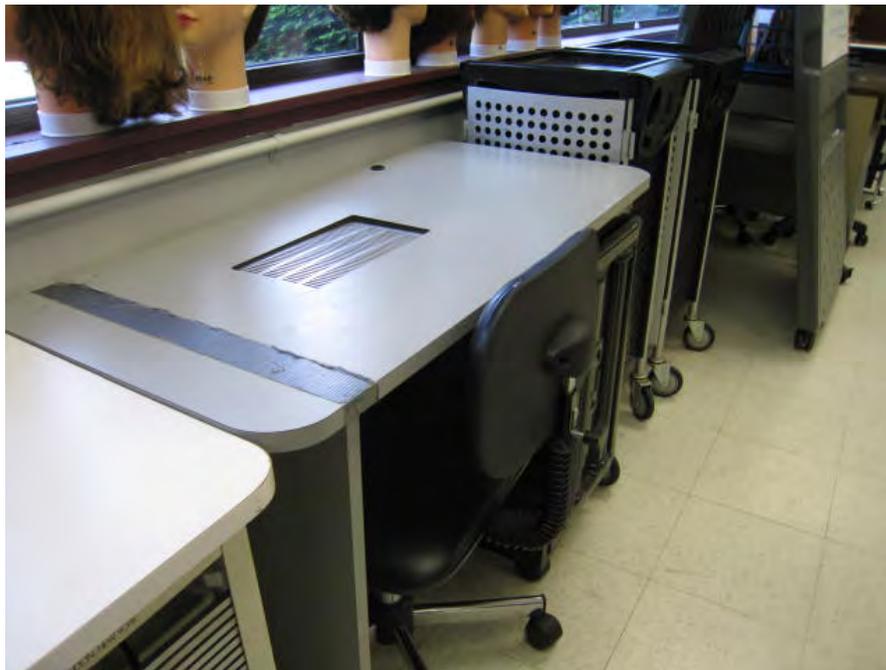
Picture 14

BEH/IAQ staff also noted that there were a number of vented manicure tables in the cosmetology room (Picture 14). These tables are frequently used in nail salons to reduce exposure to VOCs. The tables are equipped with a small exhaust vent at the top near the work surface and fan/blower to remove VOCs from the area of active use of (e.g. where nail lacquer, nail polish removers, and glues are applied). The BEH/IAQ Program recommends the use of these tables to prevent exposure to VOCs. Measures should be taken to ensure exhaust from these tables is properly directed outside, and that the mechanical equipment maintained and serviced regularly for optimal function.

Mechanically-vented manicure table

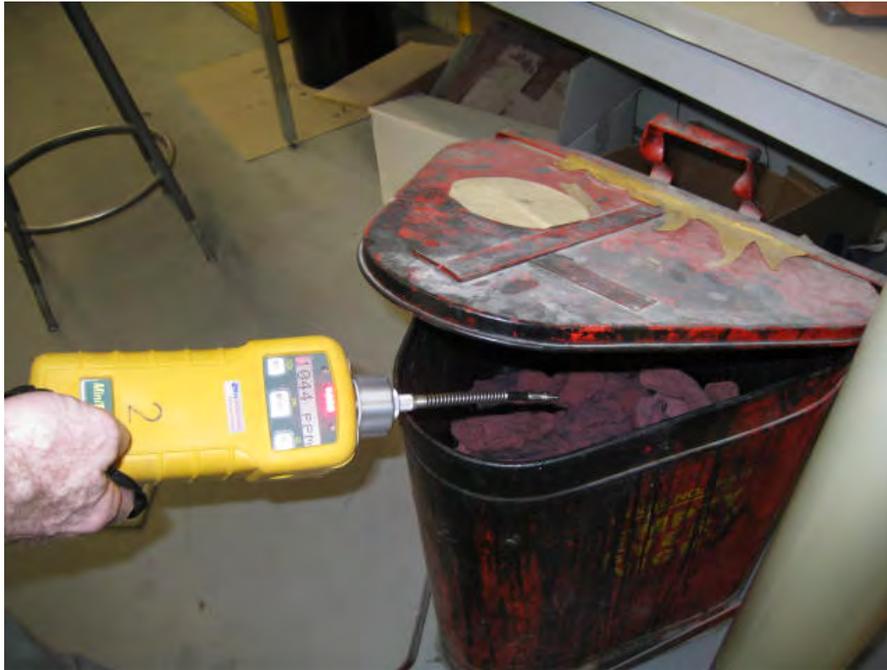
Picture 15

and containers of oils and lubricants in automotive and machine shop areas. The container of rags was found to be tightly sealed, so that TVOCs could only be detected with the lid opened (Picture 15). All chemicals should be kept in tightly sealed and properly labeled containers with applicable MSDSs available. Note that BEH/IAQ staff observed glue in a repurposed food container (Picture 16). Food containers should generally not be reused since food residues may serve as an attractant for pests. Such containers should **never** be reused for potentially hazardous chemicals such as glue to prevent mishandling and potential ingestion.

Oily rag storage container; unit was tightly sealed so VOCs could only be detected with the lid open

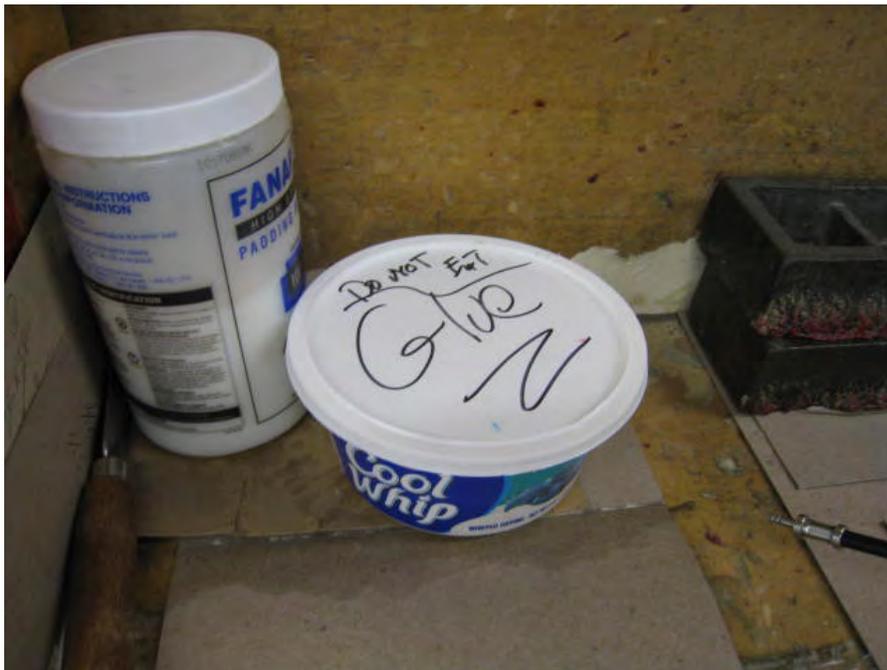
Picture 16

Food container reused for glue
