INDOOR AIR QUALITY ASSESSMENT

**Hanover Middle School
Hanover School District
45 Whiting Street
Hanover, Massachusetts**

Prepared by:
Massachusetts Department of Public Health
Bureau of Environmental Health Assessment
March, 2000

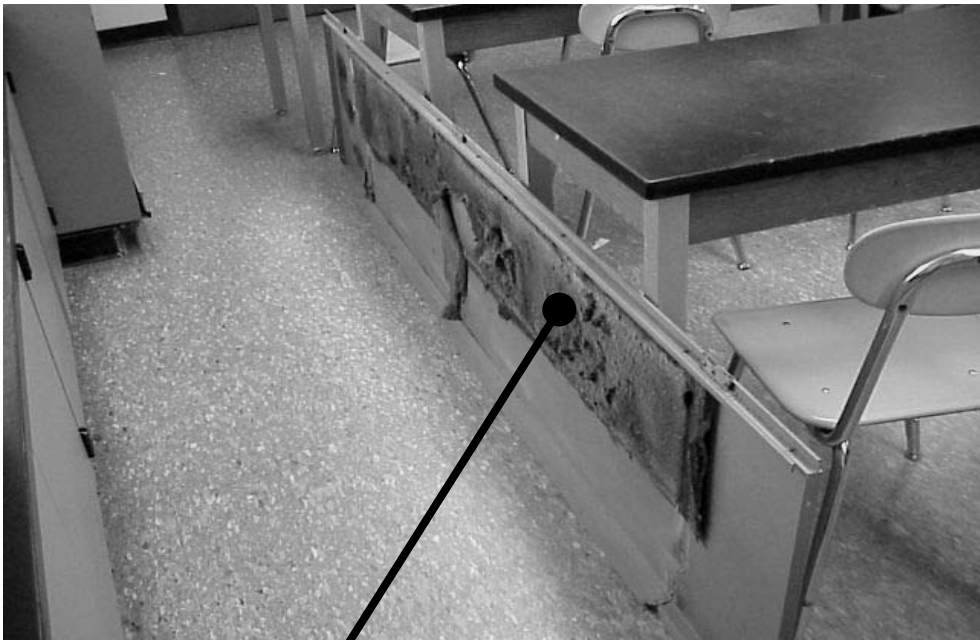
Picture 2

The interior of a univent cabinet was examined. The cabinet cover is insulated with fiberglass insulation that is in a fraying, damaged condition (see Picture 2). Damaged fiberglass can become aerosolized and provide a source of respiratory and skin irritation. School officials report that univents will be replaced as part of the renovations during the summer.

Frayed Fiberglass Insulation on Univent Cover

5. Install new disposable filters in classrooms that fit flush into racks.
6. Continue with plans to replace univents in the old building.
7. Once both the fresh air supply and the exhaust ventilation are functioning, the ventilation system should be balanced by an HVAC engineer.

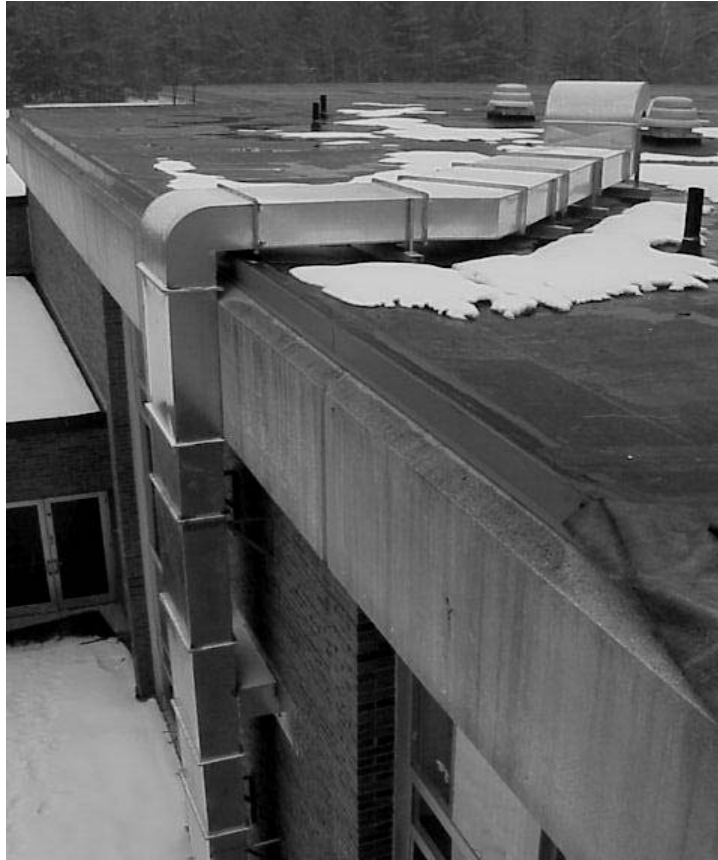
Picture 3

In an effort to prevent renovation generated pollutants from being entrained by univents of classrooms 106, 108, 210 and 212, ductwork was installed over the fresh air intakes (see Pictures 3 and 4). This ductwork extends over the edge of the building and terminates on the roof. While this ductwork will prevent the entrainment of pollutants from the renovation, this

passive ductwork may not be sufficient to provide fresh air for these classrooms. Airflow decreases as the length of ductwork increases from ventilation fans. In addition, airflow is decreased roughly in half by every 90° angle that exists in ductwork. Most univents fans are approximately 3 feet from the fresh air intake. While these univents would be sufficient to draw air from this distance, the installation of ductwork over twenty feet from the univent fans would limit the draw of fresh air into these classrooms. In addition, this ductwork contains over 270° of angles. If the draw of fresh air by the univents at the fresh air intake were 100 percent, the introduction of the angles of this ductwork would reduce that draw to approximately 12.5 percent. Therefore the length of this ductwork combined with the angles within the ductwork would tend to limit the amount of fresh air that can be drawn by univents in these classrooms without some mechanical aid at the rooftop fresh air intake vent.

Ductwork Installed for Fresh Air Intakes of Classrooms 106, 108, 210 and 212

3. Remove all blockages from univents and exhaust vents to ensure adequate airflow.
4. In order to enhance the draw of fresh air by univents in classrooms 106, 108, 210 and 212, consider installing an auxiliary fan in the mouth of the rooftop fresh air intake to force fresh air down the ductwork.

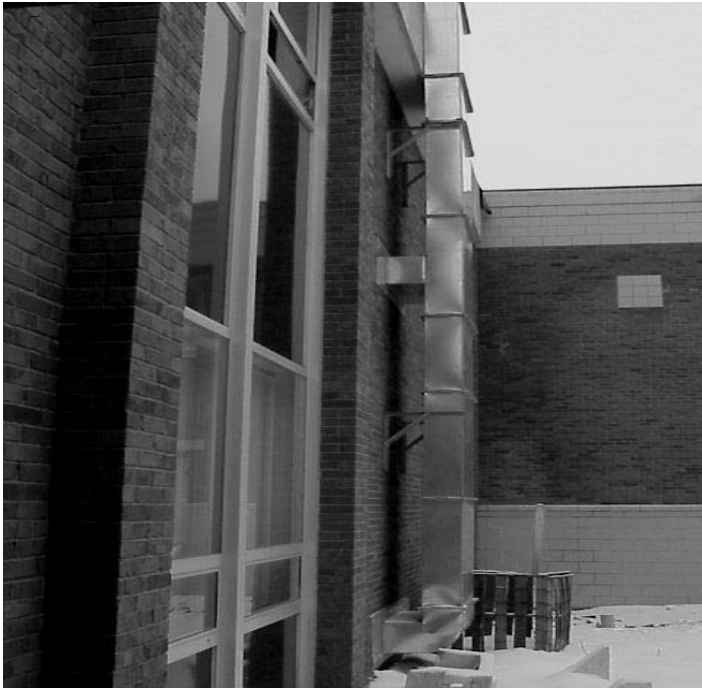
Picture 4

Ground View of Ductwork Installed for Fresh Air Intakes of Classrooms 106, 108, 210 and 212

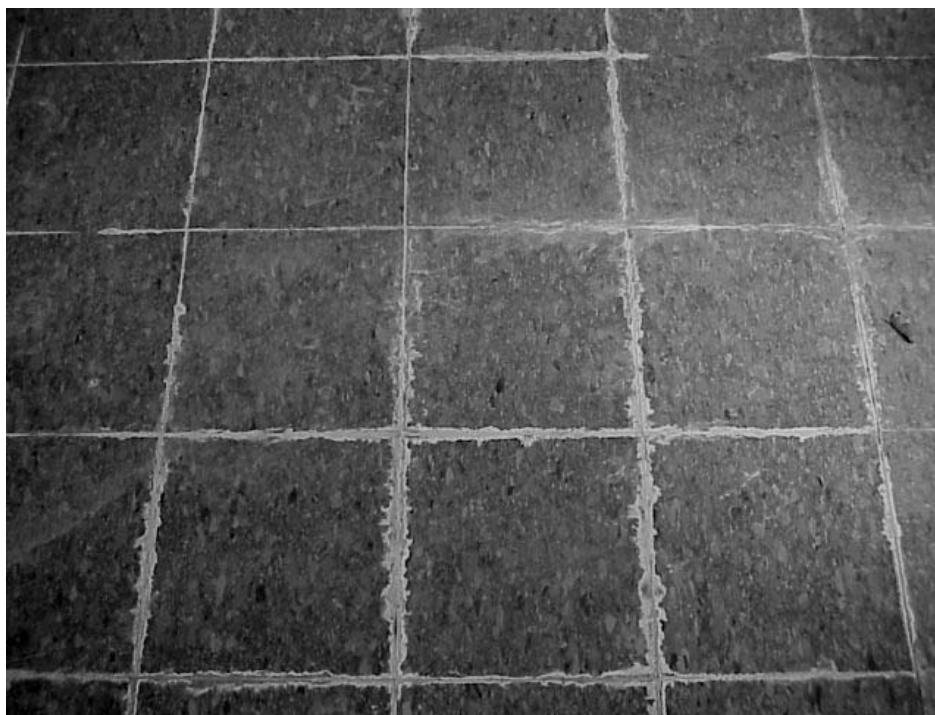
Picture 5

Interviews with building occupants confirm the creation of drafts from the central core areas into exterior classrooms. This cold air penetration results in floor tiles and walls being cooled. With exterior classroom hallway doors open, moist air introduced by the univents and open windows also penetrates into hallways. This can result in the generation of condensation on floors and walls as moist air penetrates into the hallway. A condition noted that would confirm that condensation moistens floor tiles was observed in the hallway between the boy's locker room and classroom 108 (see Pictures 5 and 6). Stains along the seams of floor tiles indicate that moisture accumulates in this hallway. Due to the absence of supply and exhaust ventilation in this area, moistened air tends to linger resulting in the wetting of floor tiles. Introduction of moist air in unconditioned rooms in the building can result in repeated moistening of porous materials. A possible sign of moistening of porous materials is the musty

**Dried Residue in Cracks of Floor Tiles in the Small Hallway between
the Boy's Locker Room and Classroom 108**

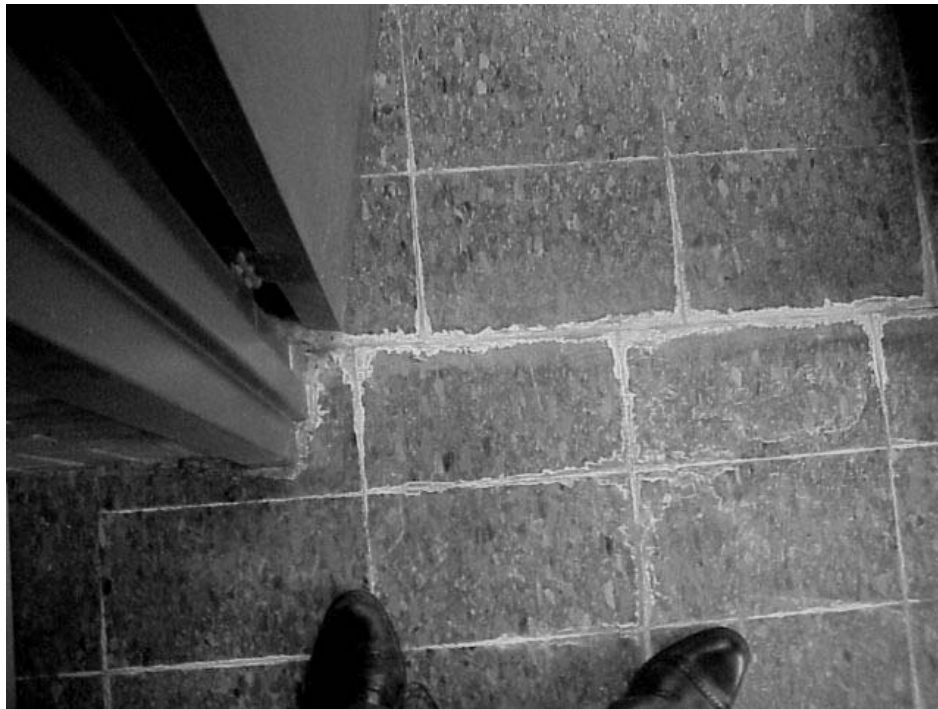
Picture 6

Dried Residue in Cracks of Floor Tiles in the Threshold of Rear Hallway Door of Classroom 108

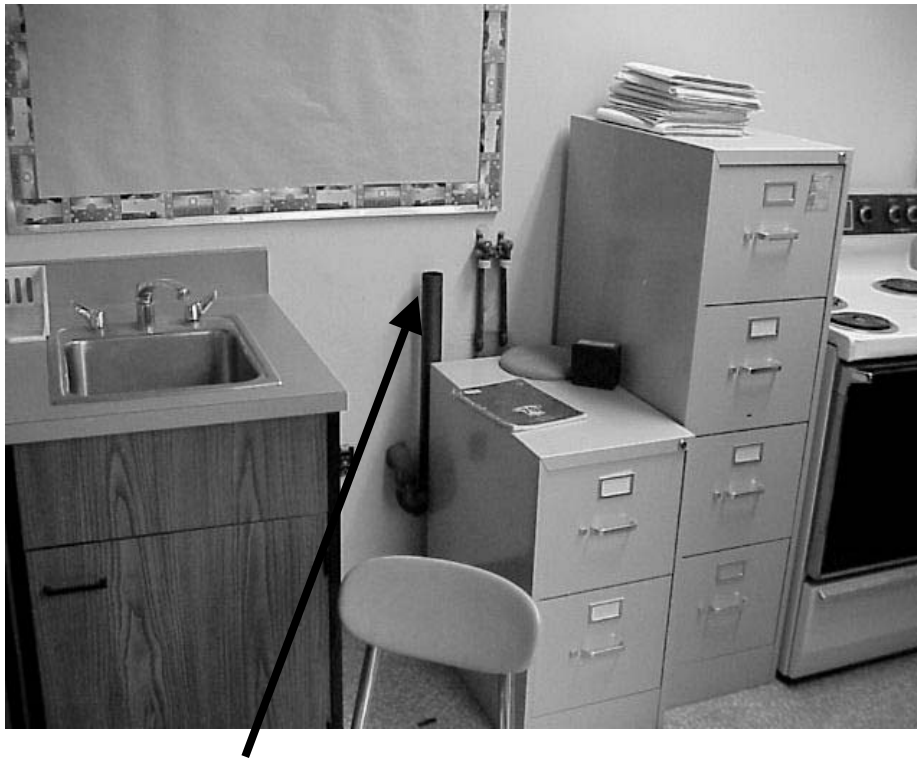
Picture 7

The home arts room 224 was equipped with a clothes washing machine. This equipment was removed, leaving the drainpipe for this equipment open (see Picture 7). Without draining water, the trap of this drain can dry out. This classroom also has a number of unused sinks. Drain traps are designed for a water seal in the pipe to prevent sewer gas from backing up into occupied areas. Sewer gas can contain hydrogen sulfide, which can be irritating to the eyes, nose and throat.

Open Clothes Washer Drainpipe in Classroom 224

13. Seal openings in suspended ceiling to prevent dust and odor penetration into occupied areas.
14. Seal the washing machine drain in classroom 224. Run water into sinks in classroom to prevent drying of drain traps. If these sinks are not to be used, seal drains and disconnect water supply to these sinks.

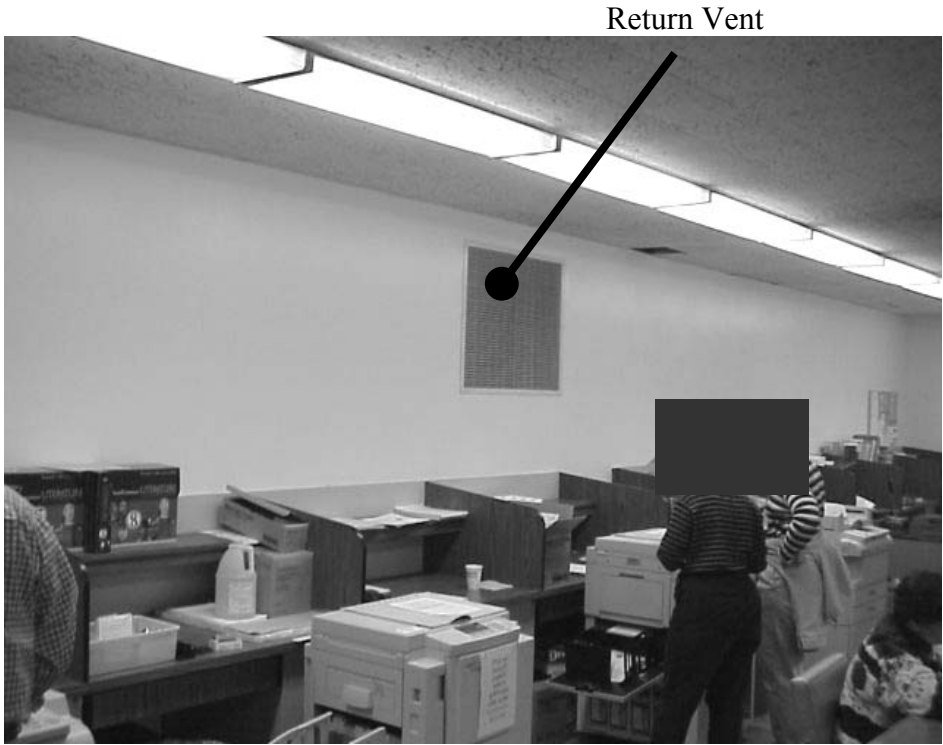
Picture 8

Three photocopiers were noted in the teacher's workroom. The interior wall of this room has a return vent (see Picture 8). Since the teacher's workroom is in the central core, this return vent would be ducted back to the rooftop AHU. VOCs and ozone can be produced by photocopiers, particularly if the equipment is older and in frequent use. Ozone is a respiratory irritant (Schmidt Etkin, D., 1992). Waste heat and other photocopier pollutants can be drawn into this vent and be distributed to other areas serviced by the AHU. Photocopiers should be located in a well-ventilated area and/or be equipped with local exhaust ventilation. Without mechanical exhaust ventilation, pollutants produced by office equipment can build up and in this case, be distributed to other areas of the second floor.

Photocopiers in Teacher's Room

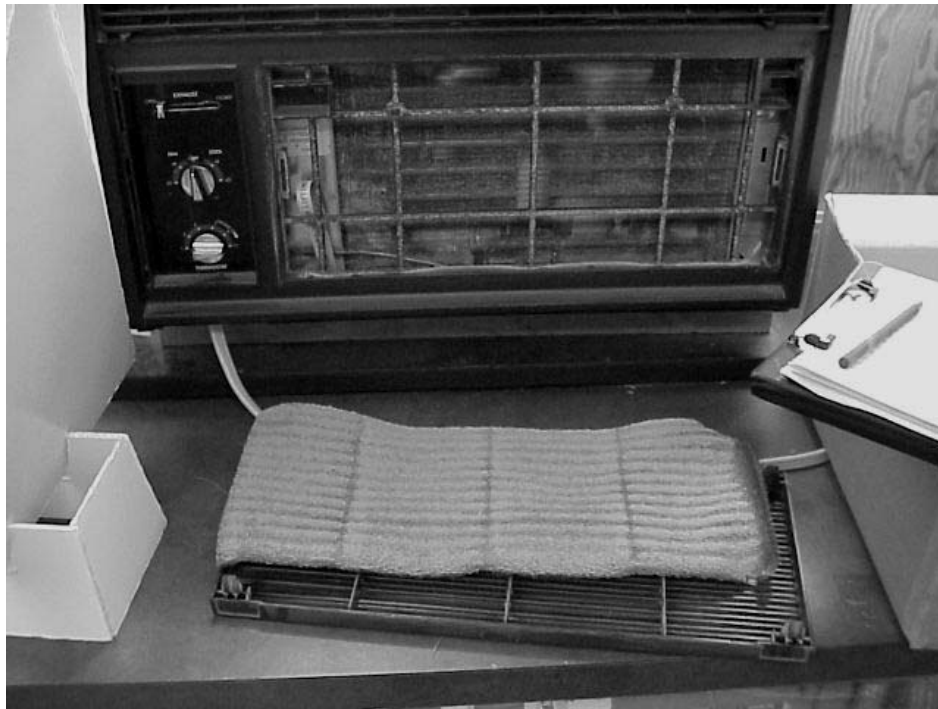
Picture 9

The administrative office contained window-mounted air conditioners (see Picture 9). The filters of this equipment do not appear to have been cleaned. Portable air-conditioning units are normally equipped with filters, which should be cleaned or changed as per the manufacturer's instructions to avoid the build up and re-aerosolization of dirt, dust and particulate matter.

Window-Mounted Air Conditioner, Note Heavy Dust Accumulation on Filter

9. Clean air filters for window-mounted air conditioners in accordance with manufacturer's recommendations.
10. Have a chemical inventory done in all storage areas and classrooms. Discard hazardous materials or empty containers of hazardous materials in a manner consistent with

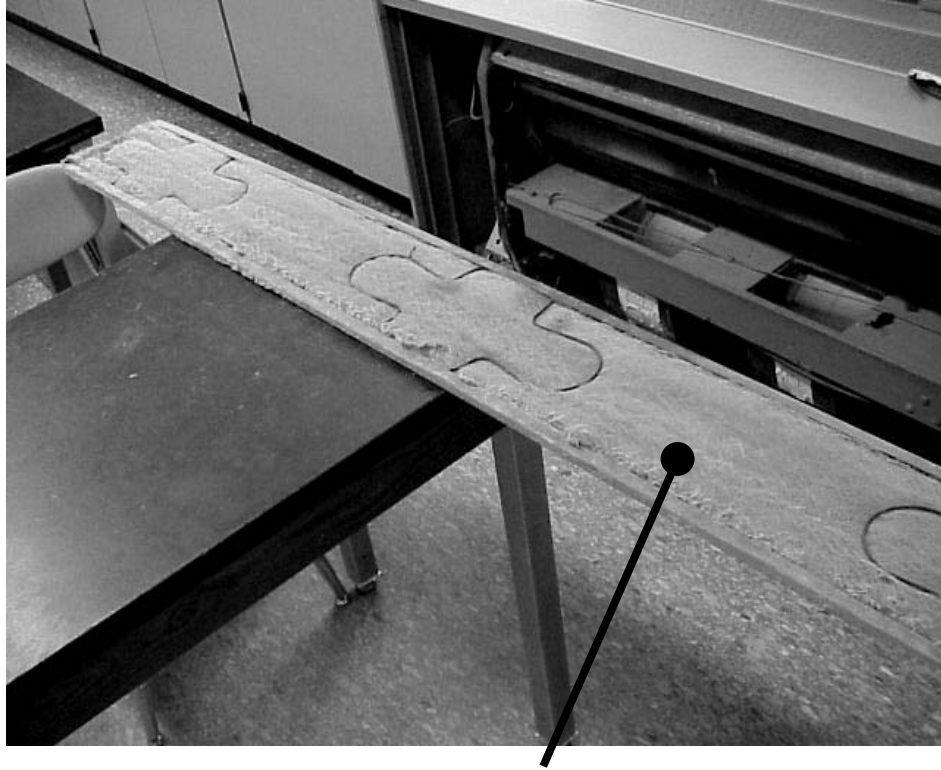
Picture 10

Univents appear to be equipped with filter media that is cut to fit permanent metal racks (see Picture 10). Frequently, cut-to-fit filter media is not installed flush in racks. Air drawn into univents will bypass filters through spaces between filters and racks. This can result in dust, dirt and other debris to be distributed by the ventilation system. Air handling equipment is equipped with filters that strain particulates from airflow. In order to decrease aerosolized particulates, disposable filters with an increased dust spot efficiency can be installed. The dust spot efficiency is the ability of a filter to remove particulates of a certain diameter from air passing through the filter. Filters that have been determined by ASHRAE to meet its standard for a dust spot efficiency of a minimum of 40 percent would be sufficient to reduce airborne particulates (ASHRAE, 1992, MEHRC, 1998). Note that increased filtration can reduce airflow produced by increased resistance. Prior to any increase of filtration, each piece of air-handling equipment (i.e., univents and AHUs) should be evaluated by a ventilation engineer to ascertain whether it can maintain function with more efficient filters.

Metal Rack with Replaceable Filter Media

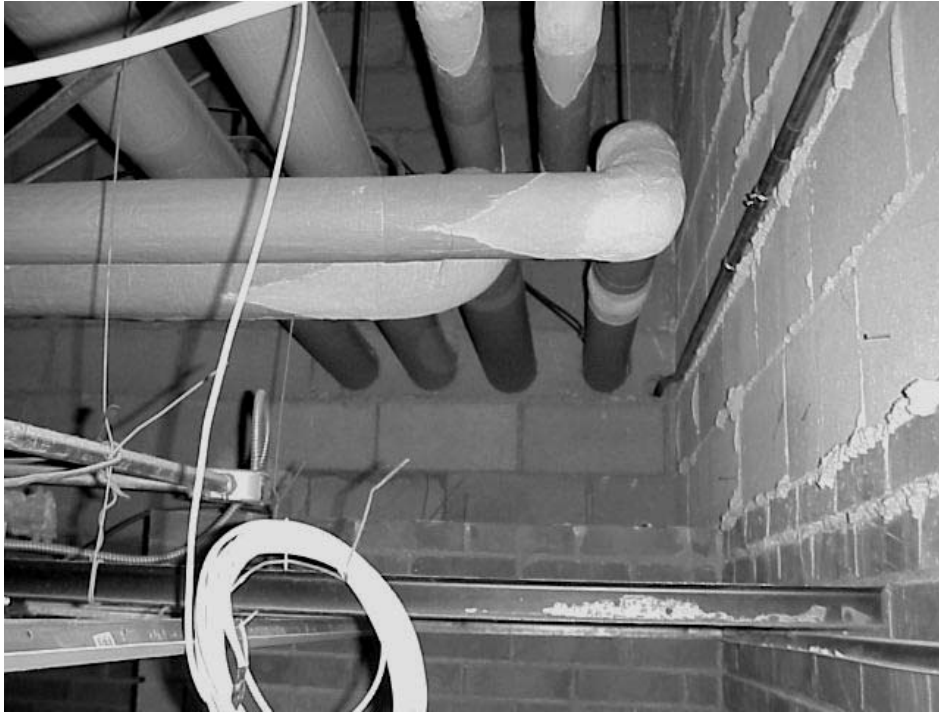
Picture 11

A number of areas have ceiling tiles that are either missing or ajar (see Picture 11). The ceiling plenum is an unconditioned space, which can have a different temperature than the occupied space. This differentiation in temperature can create air movement, which can capture particulate matter in the air stream and distribute this material into occupied areas through open

sections of the suspended ceiling system. Particulate matter can be irritating to the eyes, nose and respiratory system.

Plenum above Suspended Ceiling Pictured through Missing Ceiling Tiles

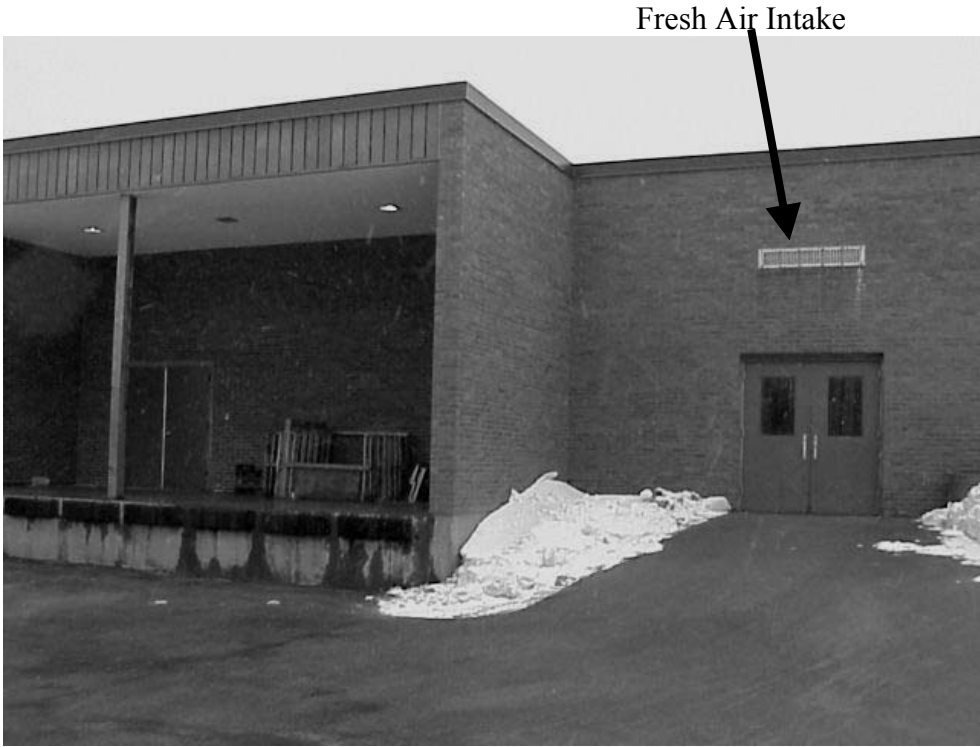
Picture 12

A fresh air intake is located above the loading dock (see Picture 12), which can result in the entrainment of vehicle exhaust into the building. M.G.L. chapter 90 section 16A prohibits the unnecessary operation of the engine of a motor vehicle for a foreseeable time in excess of five minutes (MGL, 1996).

Loading Dock in Close Proximity to Fresh Air Intake

15. Consider posting a sign at the loading dock to inform delivery drivers that engine should be shut off after five minutes as required by Massachusetts General Laws 90:16A.
