INDOOR AIR QUALITY ASSESSMENT

**Wessagusset Primary School
75 Pilgrim Road
Weymouth, Massachusetts**

Prepared by:
Massachusetts Department of Public Health
Bureau of Environmental Health Assessment
Emergency Response/Indoor Air Quality Program
March 2003

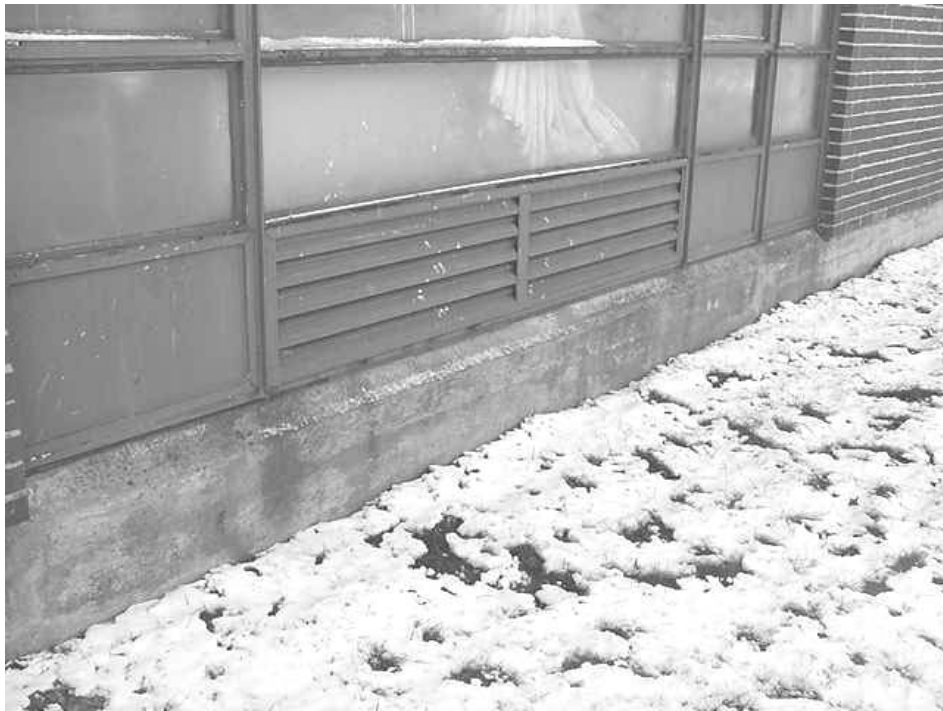
Picture 1

It can be seen from the tables that carbon dioxide levels were elevated above 800 parts per million parts of air (ppm) in eighteen of twenty-eight areas surveyed, indicating inadequate ventilation in these areas of the school. Fresh air in classrooms is supplied by a unit ventilator (univent) system. Univents draw air from outdoors through a fresh air intake located on the exterior walls of the building (see Picture 1) and return air through an air intake located at the base of each unit ([see Figure 1](#)). Fresh air and return air are mixed, filtered, heated and provided to classrooms through a fresh air diffuser located in the top of the unit. School Department officials stated that extensive repair work has been performed over the past two years on the system (e.g. pneumatic controls, actuators and thermostats) to improve ventilation.

Univent Air Intake

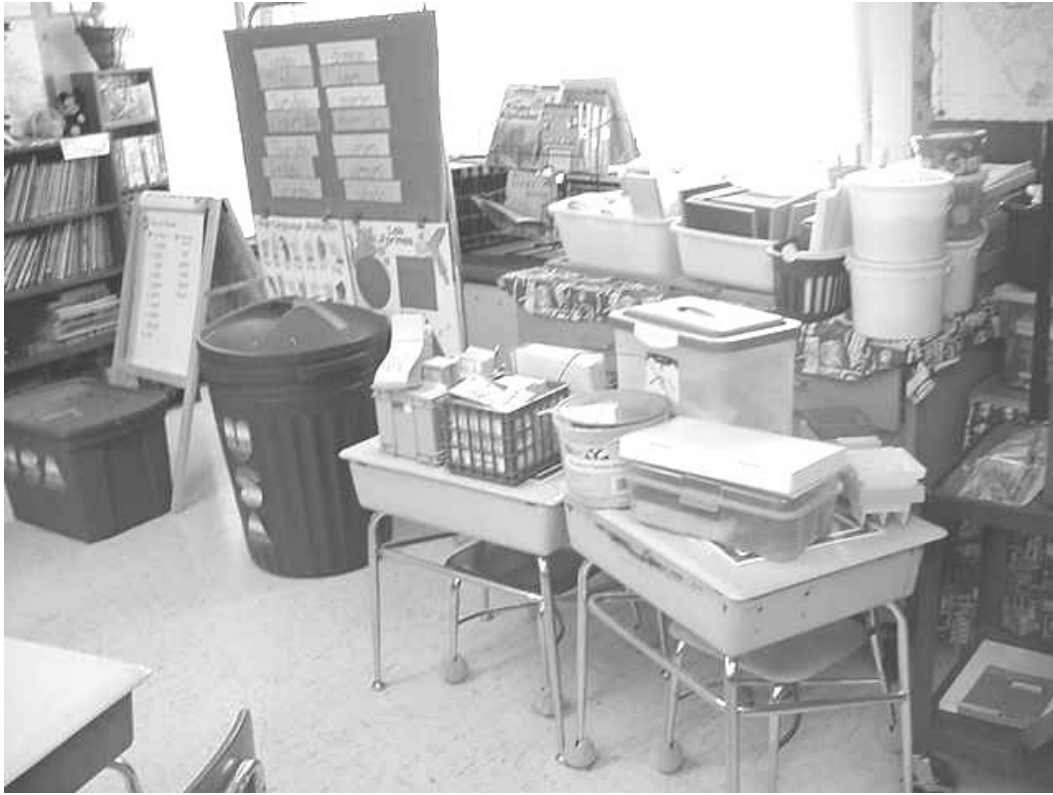
Picture 2

Univents were found deactivated or obstructed in a number of classrooms (see Tables/Pictures 2 & 3), which can prevent airflow and lead to increased carbon dioxide levels. In order for univents to provide fresh air as designed, they must remain free of obstructions and allowed to operate.

Classroom Items on and around Univent Obstructing Airflow

1. To maximize air exchange, the BEHA recommends that both supply and exhaust ventilation *operate continuously* during periods of school occupancy independent of classroom thermostat control.
2. Consider having the ventilation system balanced by an HVAC engineer every five years (SMACNA, 1994).
3. Remove all blockages from univents to ensure adequate airflow. Clean out interiors of univents regularly.
4. For buildings in New England, periods of low relative humidity during the winter are often unavoidable. Therefore, scrupulous cleaning practices should be adopted to minimize common indoor air contaminants whose irritant effects can be enhanced when the relative humidity is low. To control for dusts, a high efficiency particulate arrestance (HEPA) filter equipped vacuum cleaner in

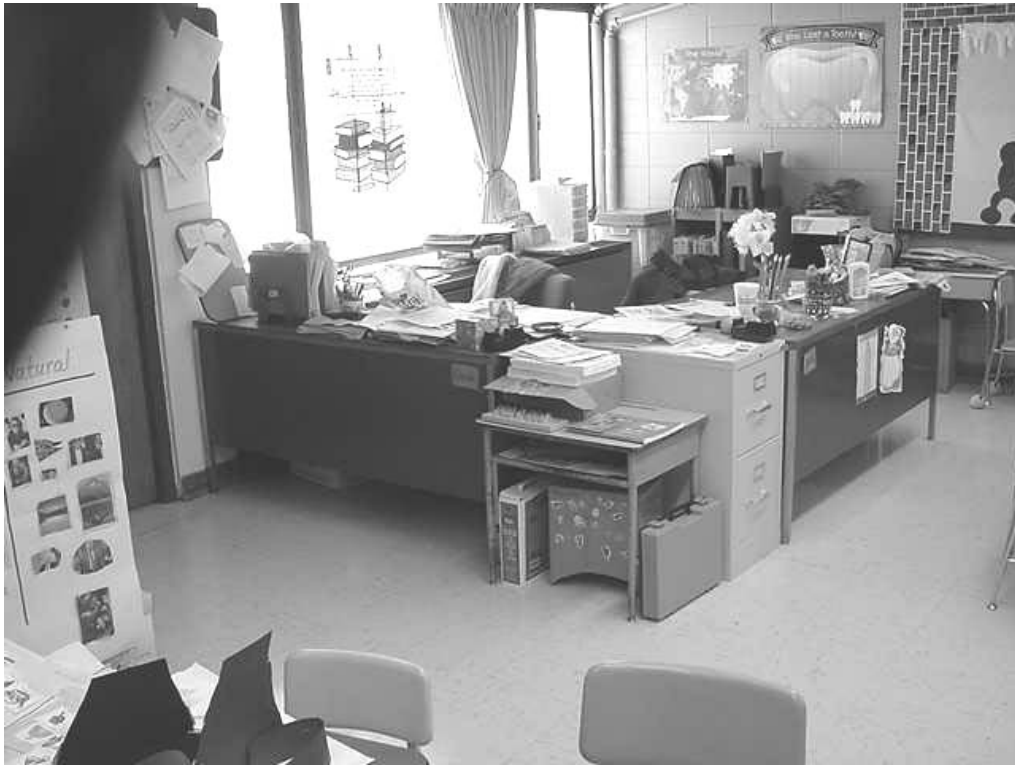
Picture 3

Classroom Furniture set up around Univent Inhibiting Airflow

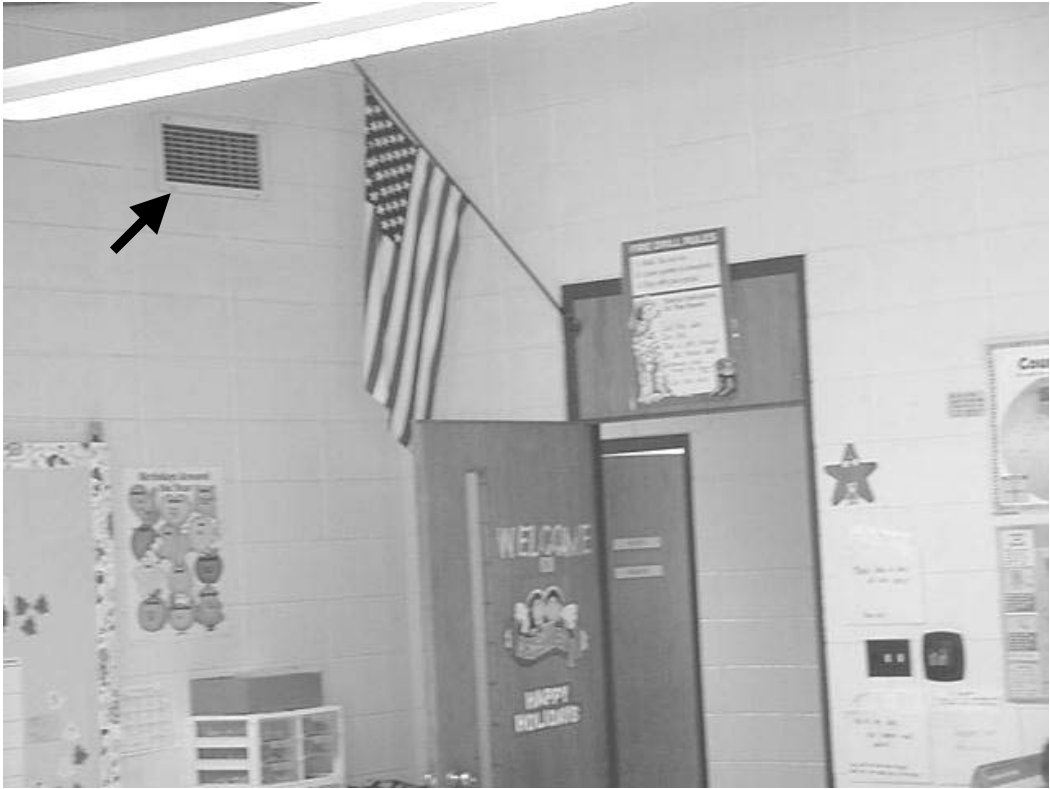
Picture 4

The mechanical exhaust ventilation system in classrooms consists of grated, wall or ceiling-mounted exhaust vents (see Picture 4). Exhaust vents from individual classrooms are drawn into a common duct above the ceiling in hallways. Exhaust air is expelled from the building by a motorized exhaust vent located on the exterior wall above hall way exterior doors (see Picture 5). The location of exhaust vents can limit exhaust efficiency when the classroom hallway door is open. When a classroom door is open,

exhaust vents will tend to draw air from both the hallway and the classroom (see Picture 4). The open hallway door reduces the effectiveness of the exhaust vent to remove common environmental pollutants from classrooms.

Classroom Exhaust Vent Note Open Door

To maximize air exchange, the BEHA recommends that both supply and exhaust ventilation operate continuously during periods of school occupancy. In order to have proper ventilation with a univent and exhaust system, the systems must be balanced to provide an adequate amount of fresh air to the interior of a room while removing stale air from the room. The date of the last balancing of these systems was not available at the time of the assessment. It is recommended that HVAC systems be re-balanced every five years (SMACNA, 1994).

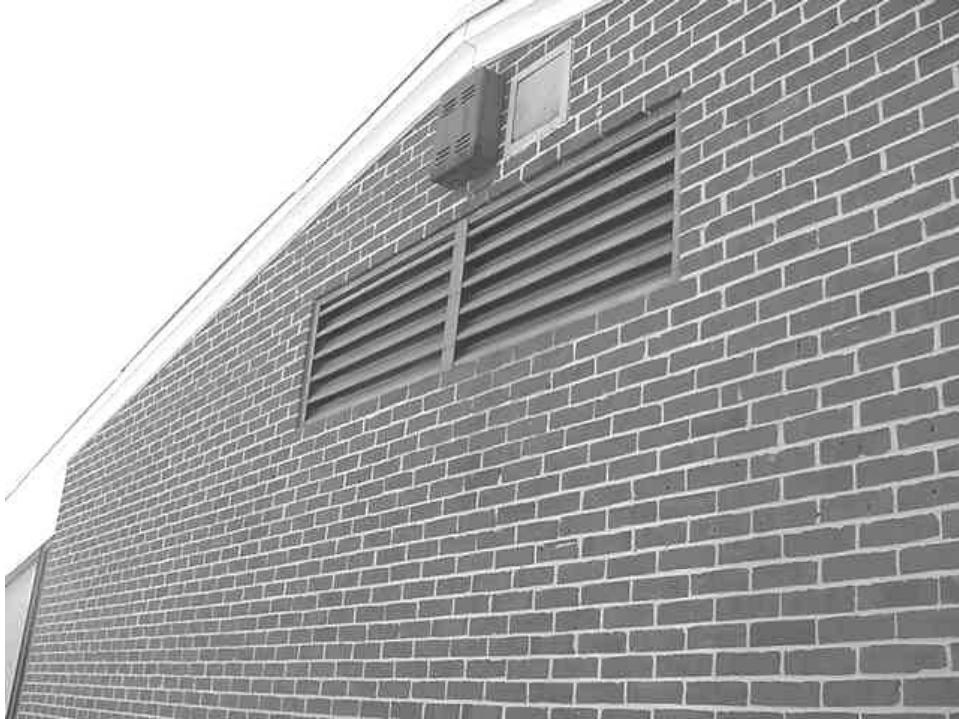
Picture 5

Exhaust Terminus Exterior of Building

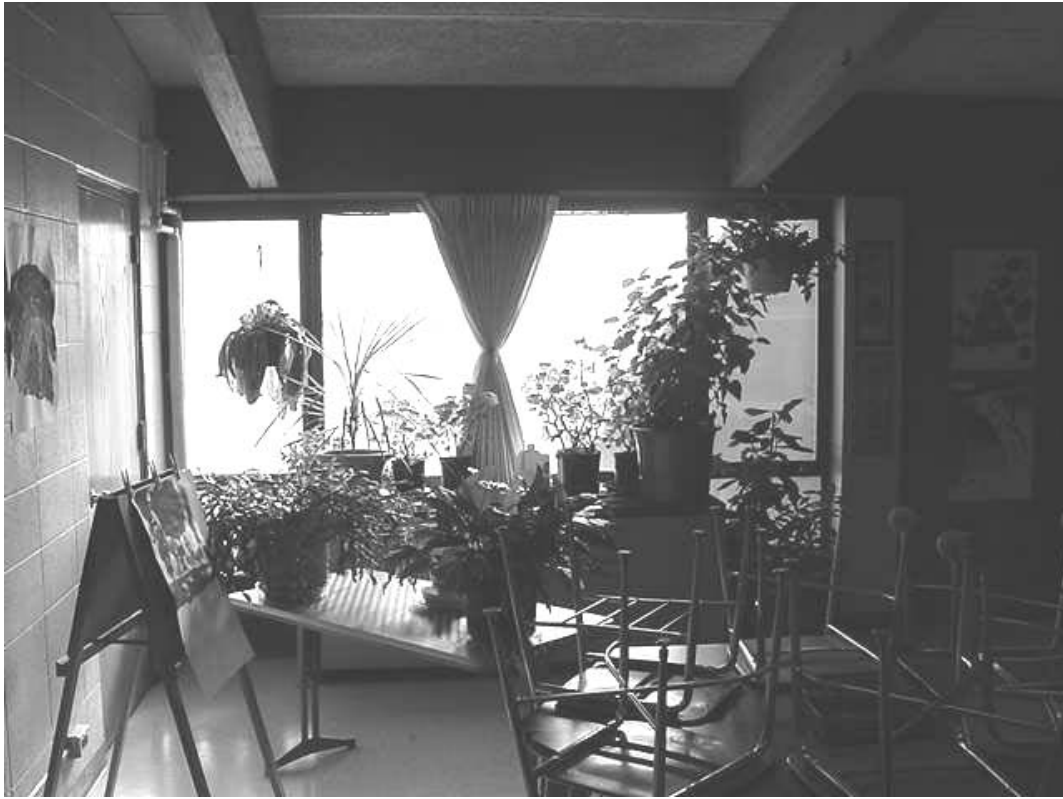
Picture 6

Several classrooms had a number of plants. Moistened plant soil and drip pans can be sources of mold growth. Plants are also a source of pollen. Plants in several classrooms were noted near univent air diffusers (see Picture 6). Plants should be located away from the air stream of ventilation sources to prevent the aerosolization of mold, pollen or particulate matter throughout the classroom.

Plants in Classroom around Univent

5. Remove plants away from univents. Ensure plants have drip pans. Examine drip pans periodically for mold growth and disinfect with an appropriate antimicrobial where necessary.

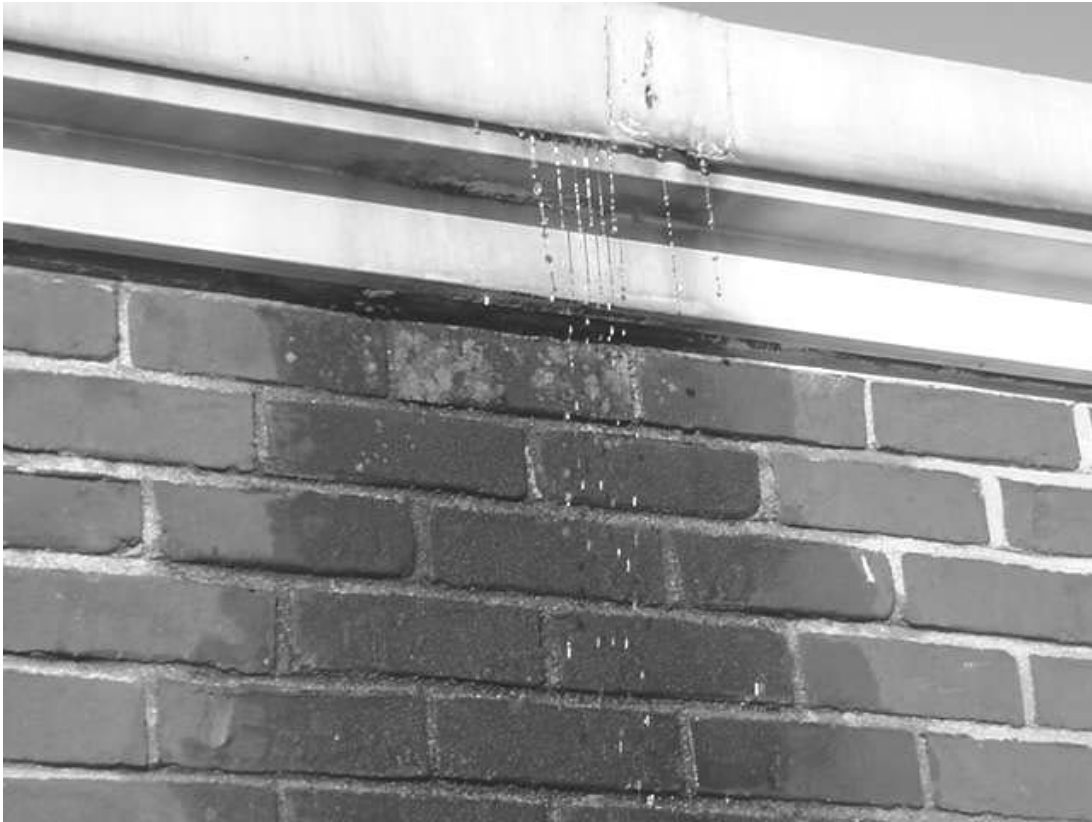
Picture 7

No gutter/downspout system exists along the roof eave to direct rainwater away from the base of the exterior walls (gutters are only installed over exterior doors) in some areas. Sections of the exterior walls appeared to be saturated with moisture and moss growth (see Picture 7). Moss growth on exterior brickwork is an indication of chronic moisture exposure from rainwater. Moss growth holds moisture against brickwork. North-facing corners and walls of this building are particularly vulnerable to moisture for extended periods of time, since the brick is not dried out by exposure to direct sunlight. Excessive exposure to water of exterior brickwork can result in damage over time. During winter weather, the freezing and thawing of moisture in bricks can accelerate the deterioration of brickwork, which can lead to water intrusion into the interior of the building.

Water Staining and Moss Growth on Exterior Brick

6. Continue with plans to replace windows throughout the school.
 7. Consider installing downspouts and gutters to areas of the building without them to direct rainwater away from the building.
