INDOOR AIR QUALITY ASSESSMENT

**John Greenleaf Whittier School
256 Concord St
Haverhill, MA 01830**

Prepared by:
Massachusetts Department of Public Health
Center for Environmental Health
Emergency Response/Indoor Air Quality Program
May 2005

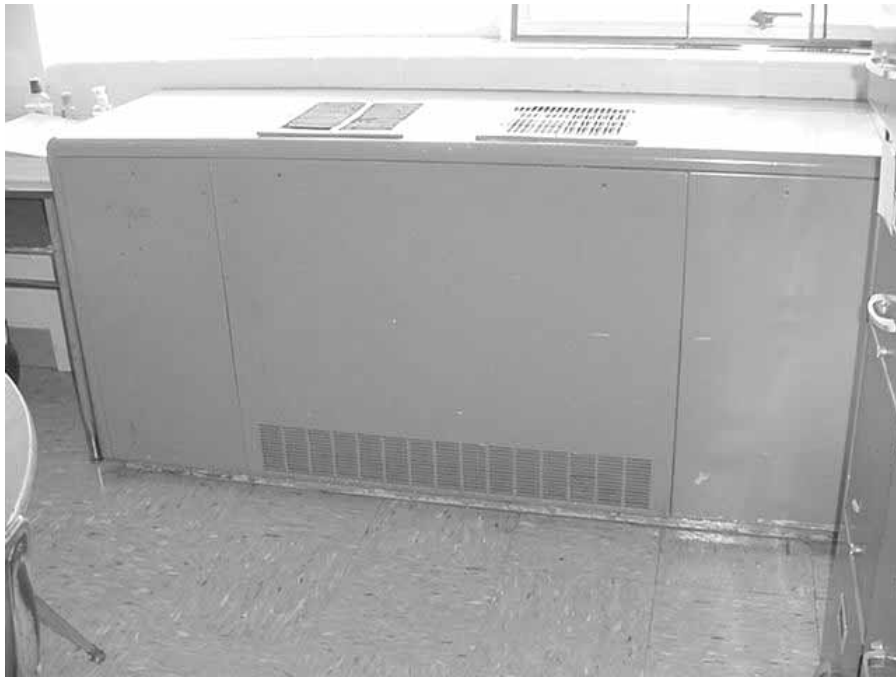
Picture 1

Fresh air in classrooms is mechanically provided by unit ventilator (univent) systems ([Picture 1](#)). A univent draws air from the outdoors through a fresh air intake located on the exterior wall of the building ([Picture 2](#)) and returns air through an air intake located at the base of the unit ([Figure 1](#)). Fresh and return air are mixed, filtered, heated and provided to classrooms through an air diffuser located in the top of the unit. Univents were not operating in many classrooms at the time of the assessment. Obstructions to airflow, such as desks and other items located on or in front of univents, were also observed. To function as designed, univents must be allowed to operate and remain free of obstructions.

Classroom univent

1. Examine each univent for function. Operate univents while classrooms are occupied. Check fresh air intakes for repair and increase the percentage of fresh air intake if necessary.

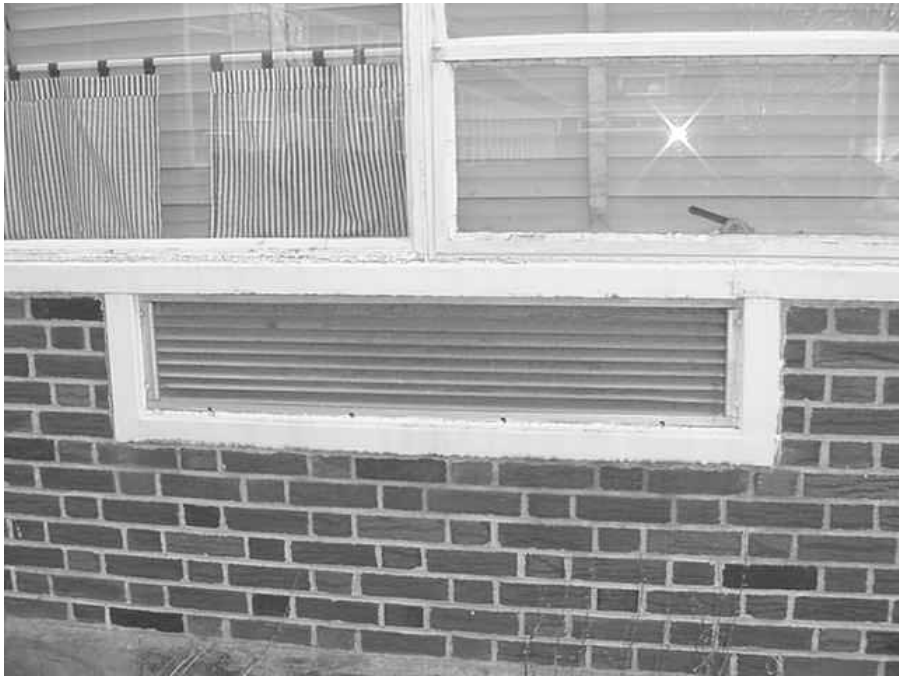
Picture 2

Univent fresh air intake

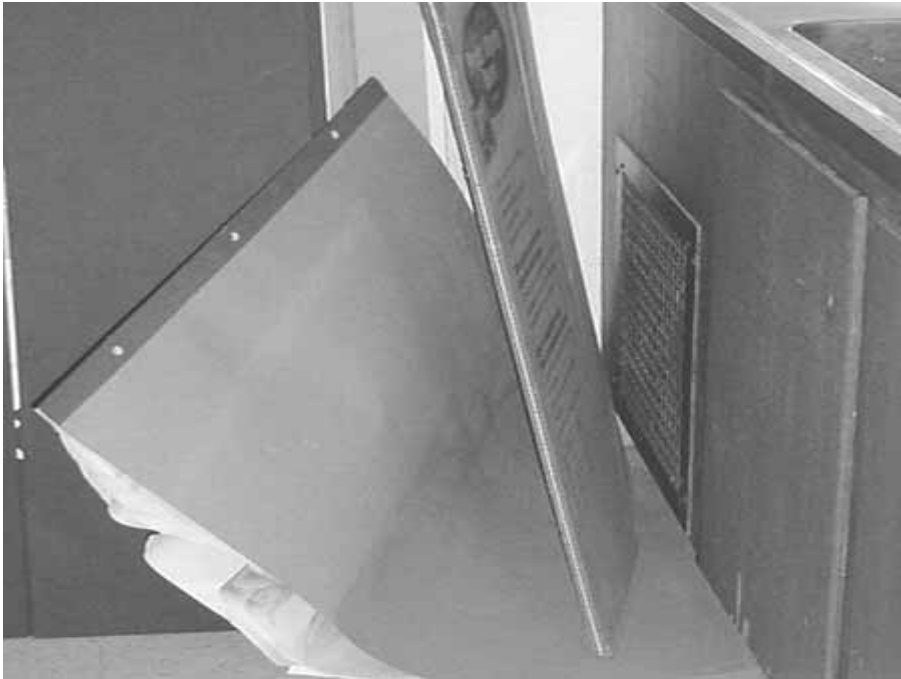
Picture 4

Exhaust ventilation is provided by wall- or cabinet-mounted exhaust vents ([Picture 3](#)), which are ducted to motorized fan units. Exhaust vents were off, drawing weakly, back-drafting and/or blocked with materials in a number of classrooms surveyed ([Picture 4](#)). As with the

Blocked exhaust vent

2. Examine exhaust vents for function and make repairs as necessary.
3. Operate all ventilation systems that are operable throughout the building (e.g., gym, auditorium, classrooms) continuously during periods of school occupancy independent of thermostat control to maximize air exchange.

4. Remove all obstructions from univents and exhaust vents to facilitate airflow. Close classroom doors to improve air exchange.
5. Remove debris and dust accumulated on the ventilation grilles.

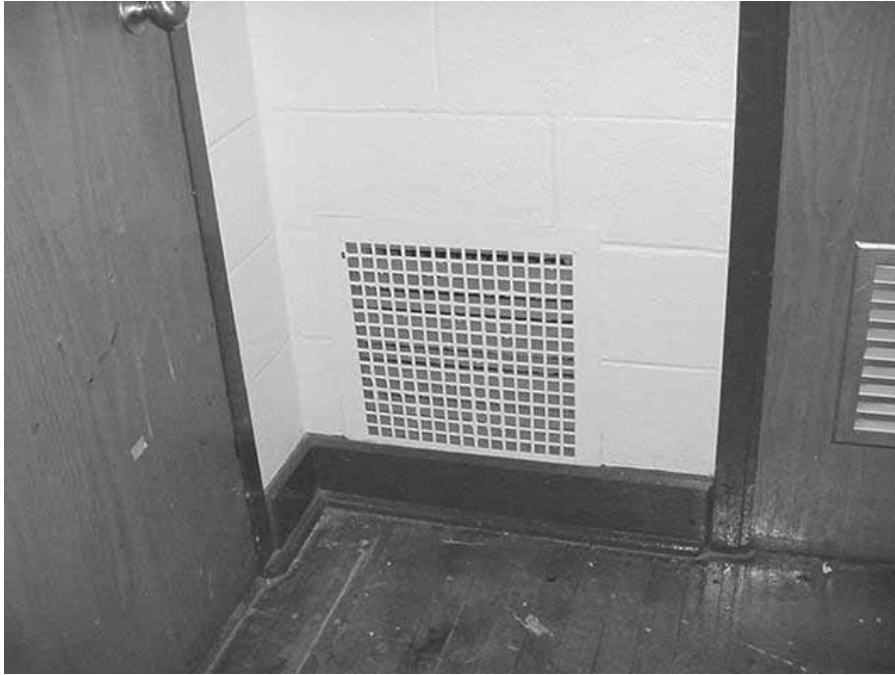
Picture 5

univents, exhaust vents must be allowed to operate and remain free of obstructions. In addition, the location of some exhaust vents near hallway doors can limit exhaust efficiency (Picture 5). When classroom doors are open, exhaust vents will tend to draw air from both the hallway and the classroom reducing the effectiveness of the exhaust vent to remove common environmental pollutants.

Exhaust vent proximity to door

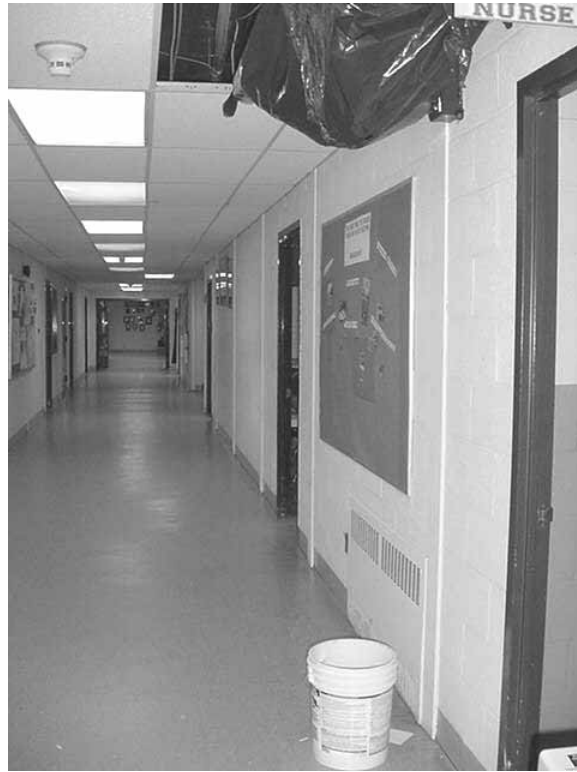
Picture 7

A number of rooms had water-stained ceiling tiles (Picture 6). An active leak was observed in the hallway outside of the nurse's office, where a plastic trash bag was being used to divert water into a trash barrel (Picture 7). Water damaged wood was also observed around skylights. WMS staff indicated leaks are primarily related to roof damage. Water-damaged ceiling tiles can provide a source of mold growth and should be replaced after a water leak is discovered and repaired. Appropriate measures should also be taken to minimize the aerosolization of particulates from tile removal/replacement.

Missing ceiling tile for water drainage to bucket

8. Identify and repair sources of water leaks. Replace water-damaged ceiling tiles. These ceiling tiles can be a source of microbial growth. Examine the non-porous surface beneath the removed ceiling tiles and disinfect with an appropriate antimicrobial. Appropriate measures should also be taken to minimize the aerosolization of particulates from tile removal/replacement.

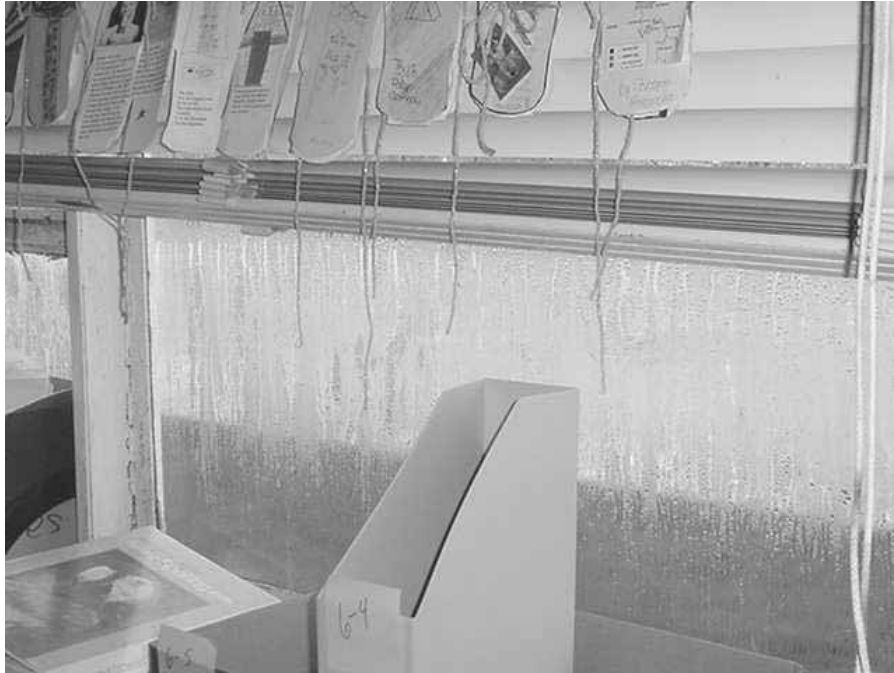
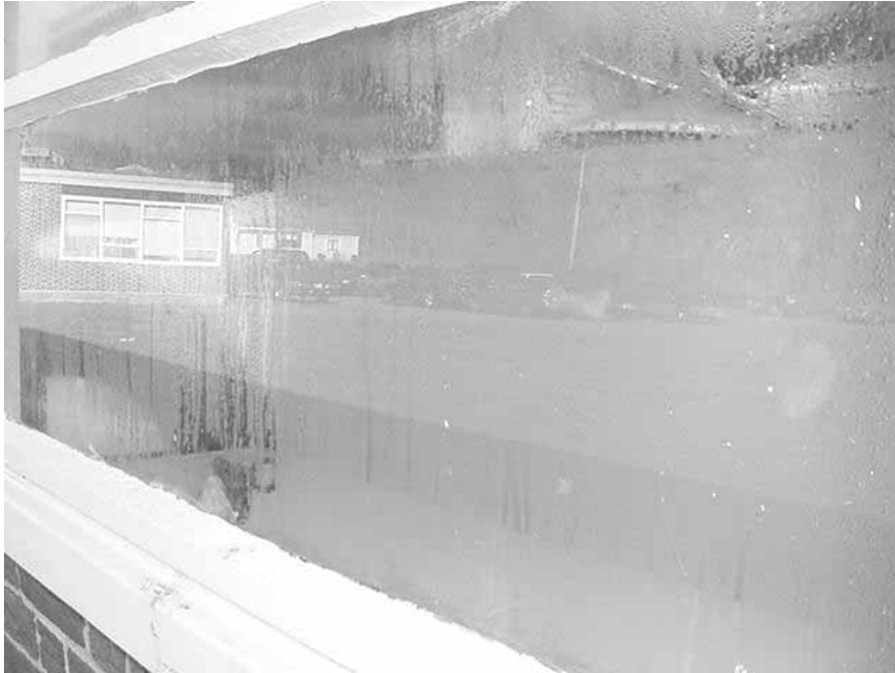
Picture 8

Condensation was noted on windows in classroom 5 (Pictures 8 and 9). These windows consist of single panels of glass framed with metal. One window in this classroom was slightly ajar. As a result, cold air was infiltrating the heated classroom. Since the room is heated by a univent that is located below the metal framed window system, heat generated by the univent is conducted throughout the window system by the metal frame. In addition, sunlight hitting the window also warms the metal frame. When the outdoor air comes in contact with the window, condensation forms. Overtime, chronic condensation formation and subsequent moistening has resulted in damage to the exterior window frame (Picture 10). Materials placed close to such windows were also observed to be water damaged (Picture 11). Water damaged materials should

Interior view of condensation on classroom window

Exterior view of condensation on classroom window

9. Ensure windows are closed during cooler months to prevent condensation generation on windows. Remove porous materials placed near windows to prevent water damage to these items. Discard water-damaged porous materials (e.g. paper).

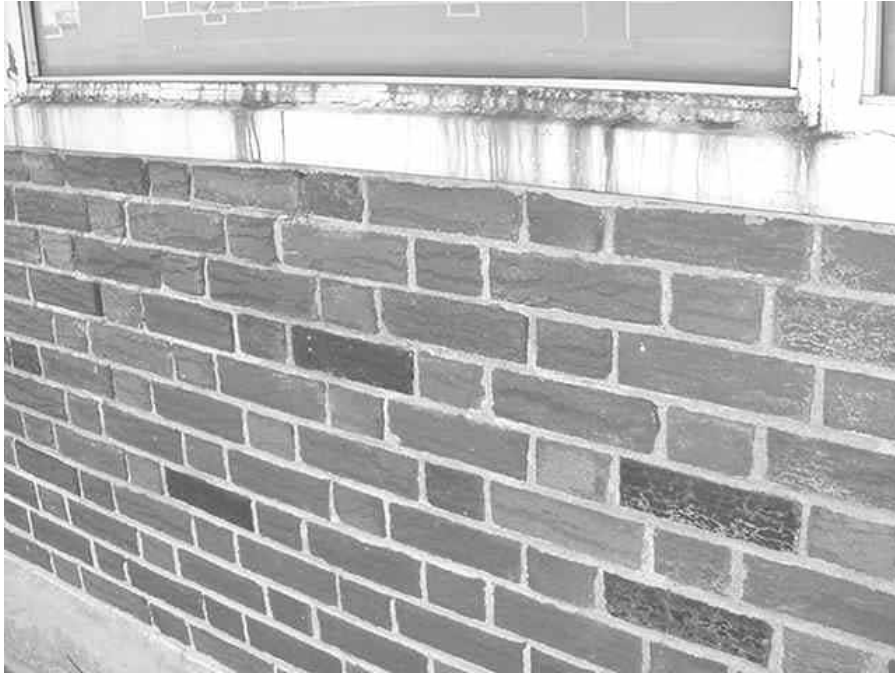
Picture 10

Water damage to exterior of window frame

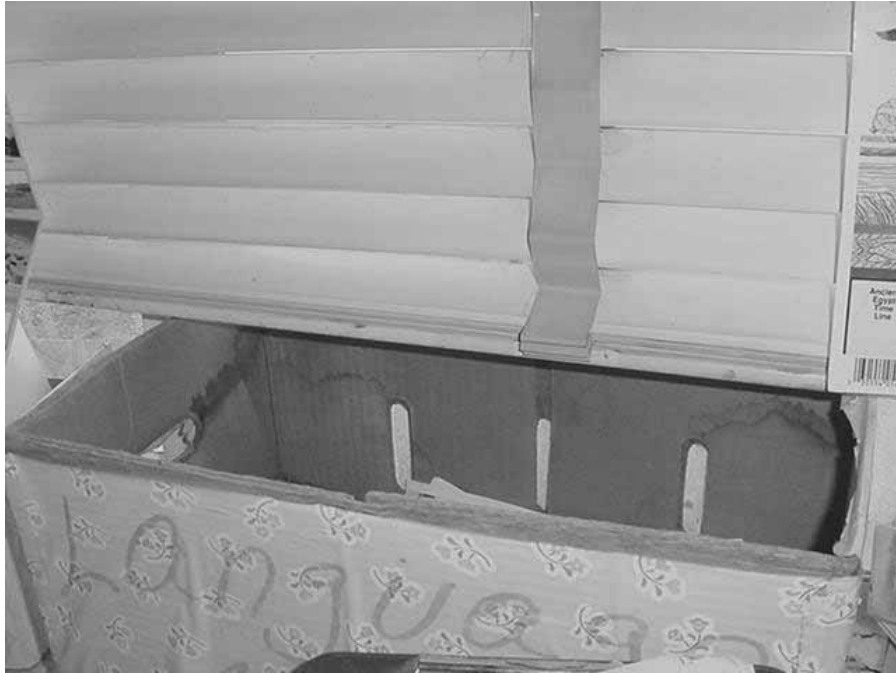
Picture 11

be removed and discarded. Occupants should also refrain from placing porous materials near these windows.

Water damaged materials

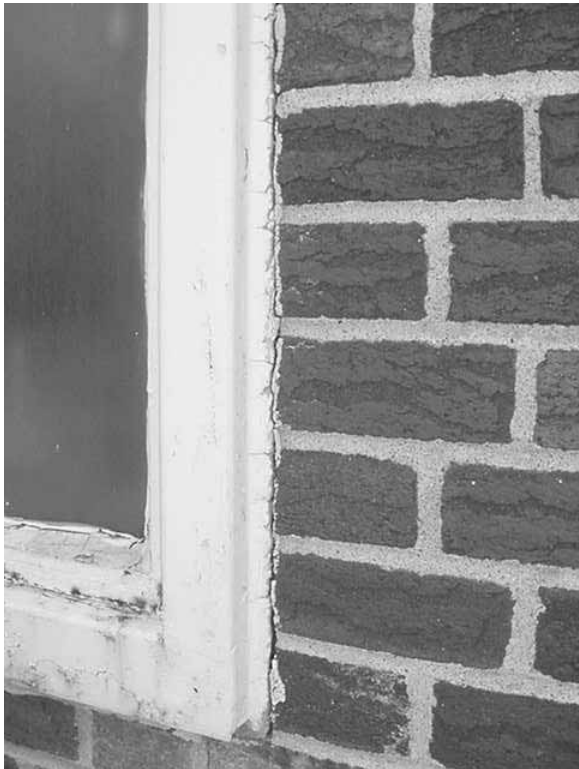
Picture 12

A number of other conditions observed along the building exterior may be conducive to water penetration through the building envelope. Spaces were noted around window frames (Picture 12). These breaches can allow moisture to penetrate the building. Such spaces should be sealed to prevent water damage to the interior of the building.

Spaces around window frame

11. Remove plants growing against building and its foundation to prevent water intrusion through brickwork.
12. Consider repointing or recaulking around windows.

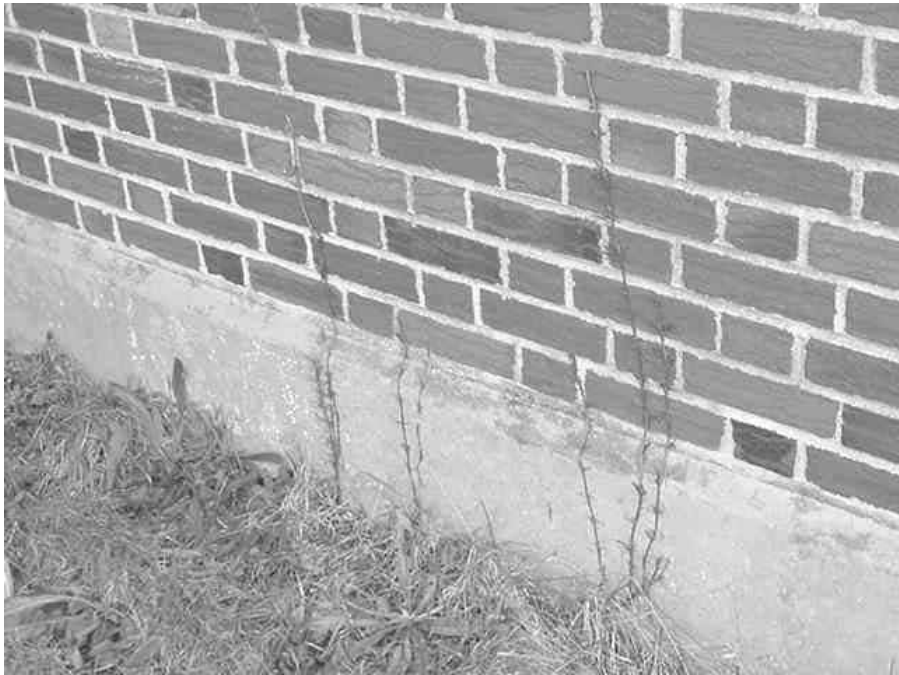
Picture 13

Clinging plant growth was observed on some exterior walls (Picture 13). Clinging plants can cause damage to brickwork through the insertion of tendrils into brick and mortar. Water can penetrate into the brick along the tendrils, which can subsequently freeze and thaw during the winter. This freezing/thawing action can weaken bricks and mortar, resulting in damage. This type of plant growth on brickwork is not recommended.

Clinging plant growth against building

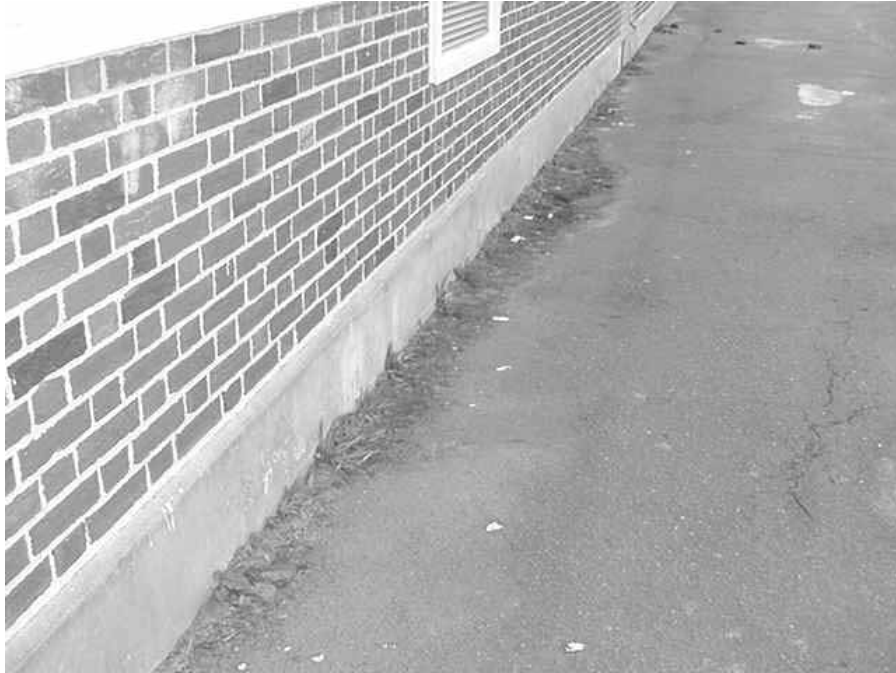
Picture 14

Shrubbery and other plants were also observed to be growing in cracks and crevices in close proximity to the foundation walls (Picture 14). The growth of roots against the exterior walls can bring moisture in contact with wall brick and eventually lead to cracks and/or fissures in the foundation below ground level. Over time, this process can undermine the integrity of the building envelope and provide a means of water entry into the building through capillary action through foundation concrete and masonry (Lstiburek & Brennan, 2001).

Plant growth against building

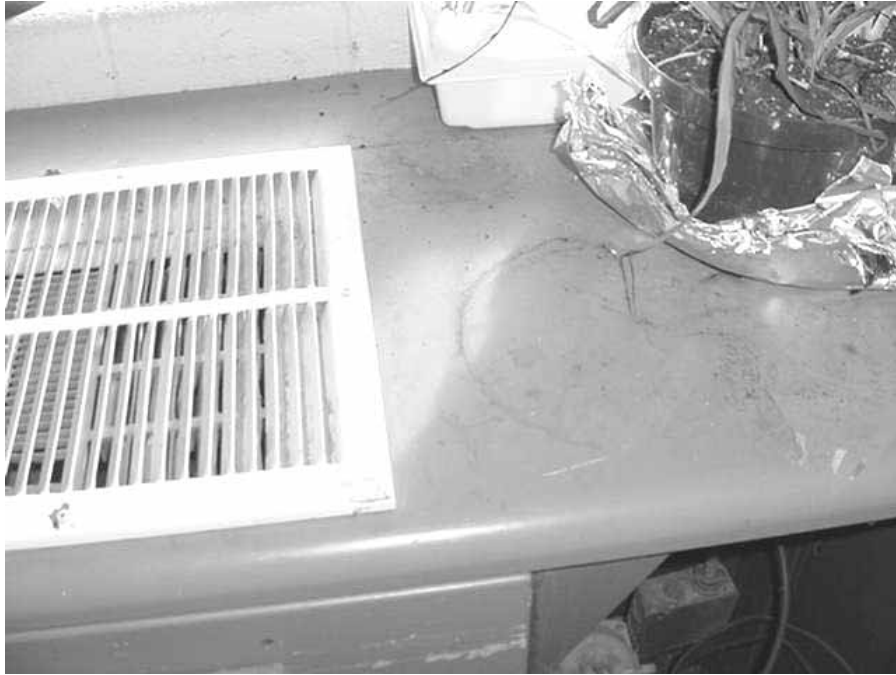
Picture 15

Plants were noted in several classrooms. Plants should be properly maintained and equipped with drip pans. Some plants were placed near ventilation sources (Picture 15), while others were placed on carpeting (Picture 16). Plants can be a source of pollen and mold, which can be respiratory irritants for some individuals. Plants should not be placed directly on carpeting and be located away from univent air diffusers to prevent the aerosolization of dirt, pollen or mold.

Plants placed near ventilation univent, note debris

10. Examine plants in classrooms for mold growth in water catch basins. Disinfect water catch basins if necessary. Remove plants from ventilation sources and carpeted areas.

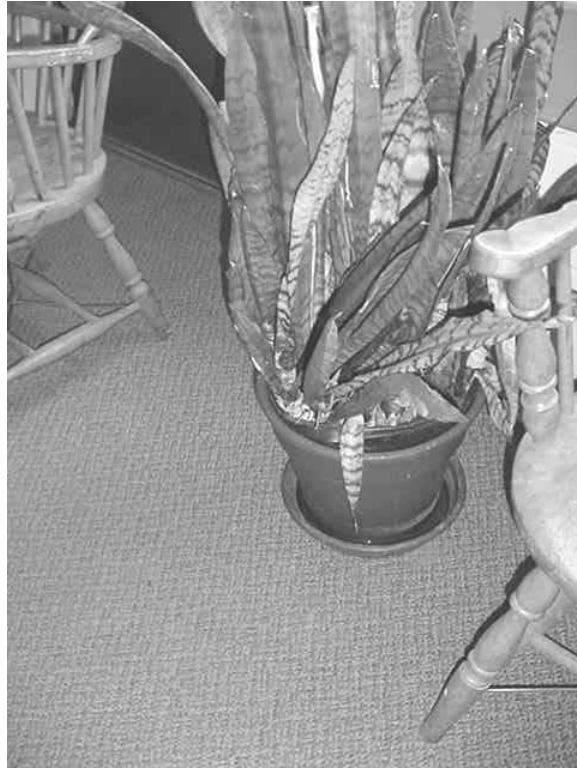
Picture 16

Plant placed on carpeting

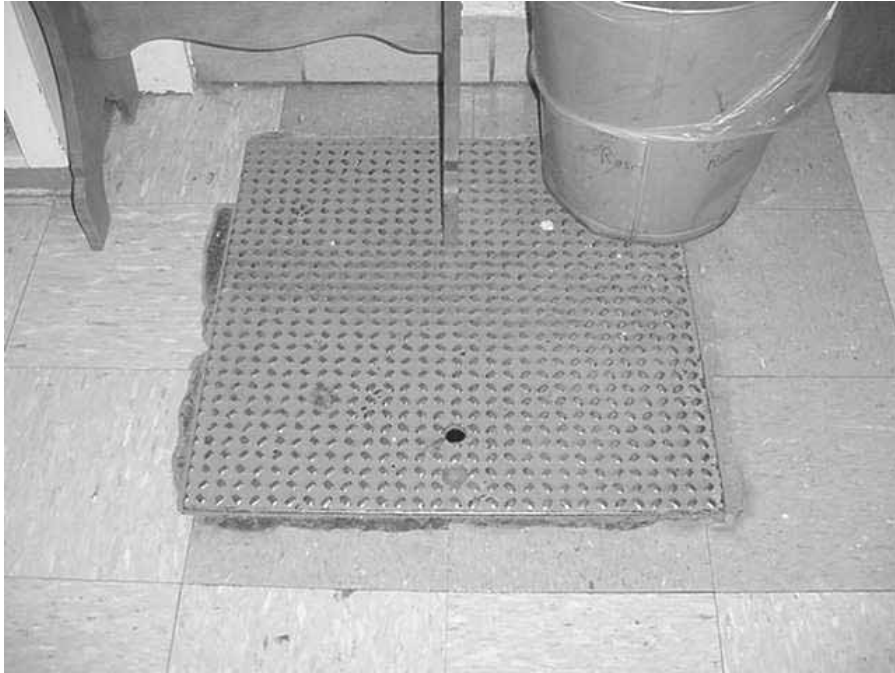
Picture 17

Several other conditions that can affect indoor air quality were noted during the assessment. Crawlspace function as chaseways for pipes to traverse a building. At the time of the assessment, occupants from the music/drama room reported odors from the crawlspace below. A crawlspace access door with an opening was observed in the room (Picture 17). This opening can allow for crawlspace odors to migrate to occupied areas. MDPH staff randomly examined some univents, since pipes running through the crawlspace connect the boiler to classroom univents. Spaces and holes were observed around pipes and within the air handling cabinet (Picture 18). Breaches were also noted around other pipes that also run into the crawlspace (Picture 19). Heated air from HVAC system pipes can create drafts that rise from the crawlspace into classrooms. These drafts can also draw crawlspace-associated odors and particles into occupied areas.

Crawlspace access door

13. Ensure doors leading crawlspace remain closed to prevent the movement of odors and materials into occupied areas. Consider using a rubber stopper to plug the hole in the crawlspace access door.

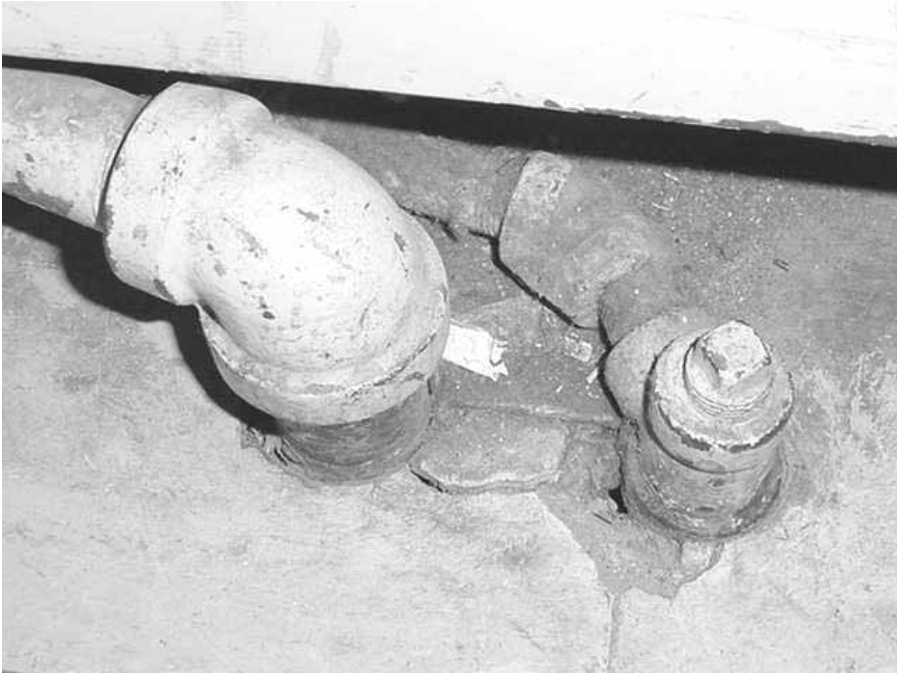
Picture 19

Spaces around pipes

14. Seal breaches around pipes and other spaces leading to the crawlspace to prevent movement of crawlspace odors and particles.
15. Relocate or consider reducing the amount of materials stored in classrooms to allow for more thorough cleaning of classrooms. Clean items regularly with a wet cloth or sponge to prevent excessive dust build-up.
16. Consider adopting the US EPA document, *Tools for Schools* (US EPA, 2000b), as a means to maintaining a good indoor air quality environment in the building. This document can be downloaded from the Internet at <http://www.epa.gov/iaq/schools/index.html>.
17. Refer to resource manuals and other related indoor air quality documents for further building-wide evaluations and advice on maintaining public buildings. Copies of these materials are located on the MDPH's website: <http://www.state.ma.us/dph/beha/iaq/iaqhoFtme.htm>.

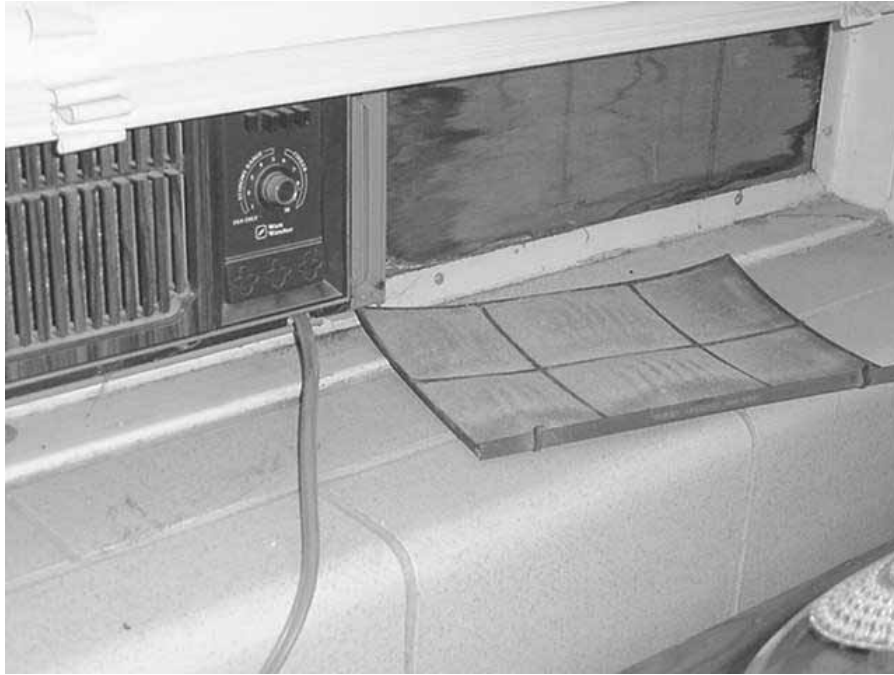
Picture 20

Several window-mounted air conditioners (ACs) were installed in offices. These units are normally equipped with filters, which should be cleaned or changed as per the manufacturer's instructions. MDPH staff removed the covers of several ACs to examine the interior of the units and found filters and the cooling fins occluded with dust and debris (Picture 20). In order to prevent the equipment from serving as a source of aerosolized particulates, MDPH staff recommended changing/installing filters and cleaning the air handling sections of the ACs *prior to re-activation*.

Air conditioner filter occluded with debris

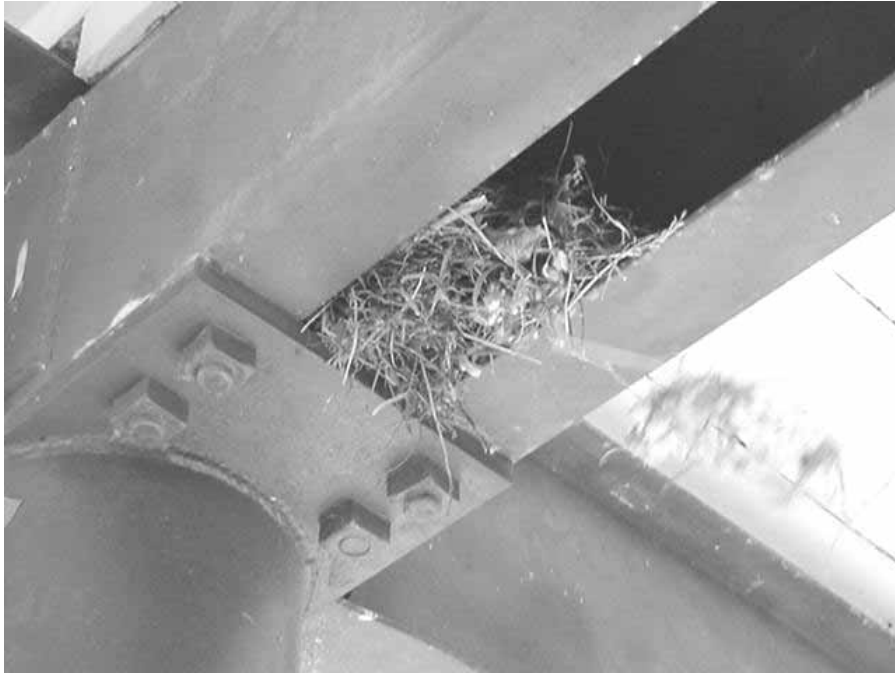
Picture 21

Lastly, a bird's nest was noted near a column supporting the entryway roof (Picture 21). Signs of bird roosting was also noted in recessed areas around the exterior of the building. Birds can be a source of disease, and bird wastes and feathers can contain mold, which can be irritating to the respiratory system. Certain molds are associated with bird waste and are of concern for immune-compromised individuals. Other diseases of the respiratory tract may also result from chronic exposure to bird waste. Exposure to bird wastes is thought to be associated with the development of hypersensitivity pneumonitis in some individuals. Psittacosis (bird fancier's disease) is another condition closely associated with exposure to bird wastes in either the occupational or bird rearing setting. While immune-compromised individuals have an increased risk of health impacts following exposure to the materials in bird wastes, these impacts may also occur in healthy individuals exposed to these materials.

Bird's nest in support beam

The methods employed for cleaning of a bird waste problem depend on the amount of waste and the types of materials contaminated. The MDPH has been involved in several indoor air investigations where bird waste has accumulated within ventilation ductwork (MDPH, 1999). Accumulation of bird wastes have required the clean up of such buildings by a professional cleaning contractor. In less severe cases, the cleaning of the contaminated material with a

solution of sodium hypochlorite has been an effective disinfectant (CDC, 1998). Disinfection of non-porous materials can be readily accomplished with this material. Porous materials contaminated with bird waste should be examined by a professional restoration contractor to determine whether the material is salvageable. Where a porous material has been colonized with mold, it is recommended that the material be discarded (ACGIH, 1989).
