# **INDOOR AIR QUALITY ASSESSMENT**

**Central Tree Middle School  
281 Main Street  
Rutland, Massachusetts**

Prepared by:  
Massachusetts Department of Public Health  
Center for Environmental Health  
Emergency Response/Indoor Air Quality Program  
September 2005

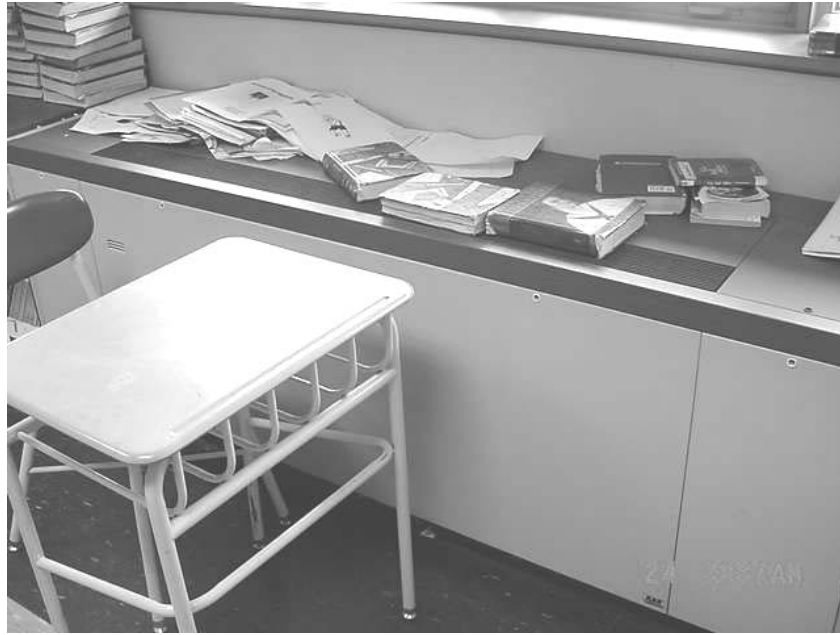
**Picture 1**

It can be seen from Table 1 that carbon dioxide levels were above 800 parts per million (ppm) in seven of thirty-three areas surveyed, indicating adequate air exchange in the majority of areas surveyed. Fresh air in classrooms is mechanically supplied by a computer-programmed unit ventilator (univent) system (Picture 1). A univent draws air from outdoors through a fresh air intake located on the exterior wall of the building (Picture 2) and returns air through an air intake located at the base of the unit. Fresh and return air are mixed, filtered, heated and provided to classrooms through an air diffuser located in the top of the unit ([Figure 1](#)). Univents were found activated in all classroom surveyed. Obstructions to airflow, such as papers and books stored on univents and bookcases, carts and desks located in front of univent returns, were seen in a few classrooms (Pictures 1 and 3). In order for univents to provide fresh air as designed, units must be allowed to operate and remain free of obstructions.

**Classroom Univent, Note Books on Air Diffuser**

2. Close classroom doors to maximize exhaust function.
3. Use openable windows to facilitate air exchange.
4. Remove all blockages from univents and exhaust vents to ensure adequate airflow.

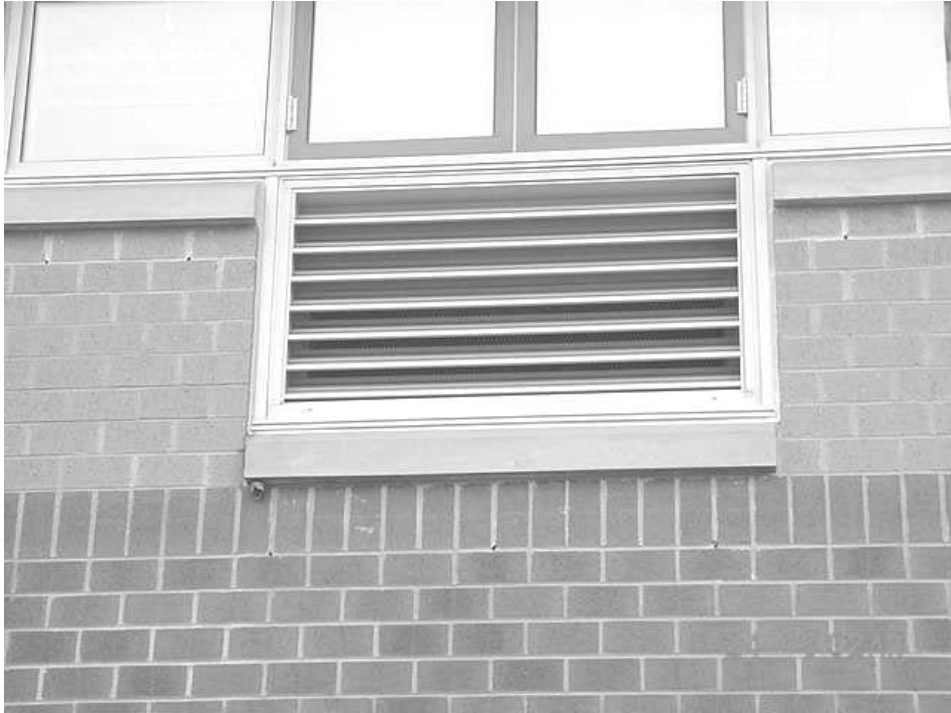
**Picture 2**

**Univent Fresh Air Intake**

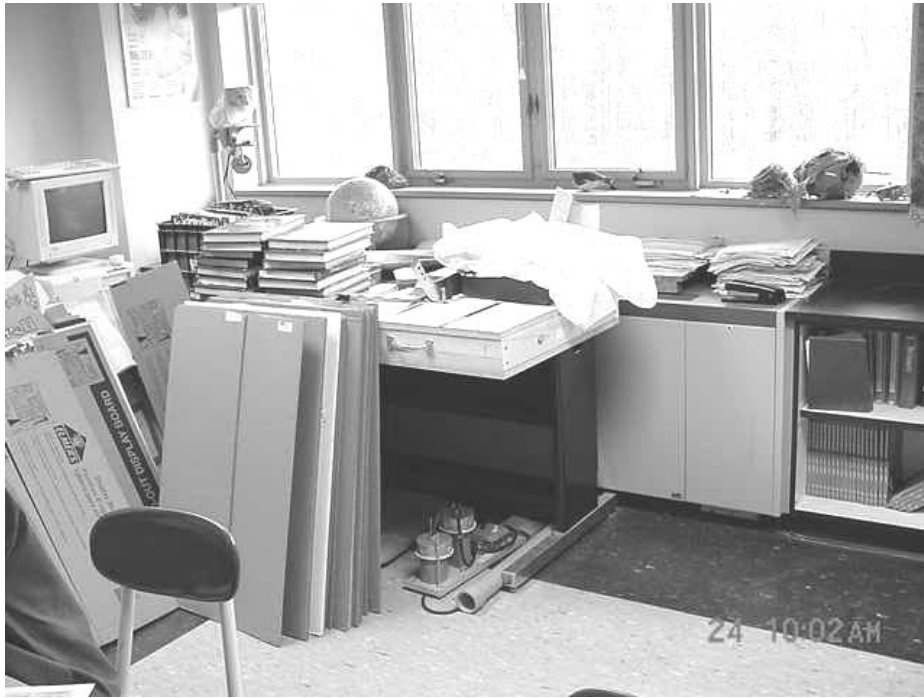
**Picture 3**

**Classroom Unit Obstructed by Various Materials on and in front of Unit**

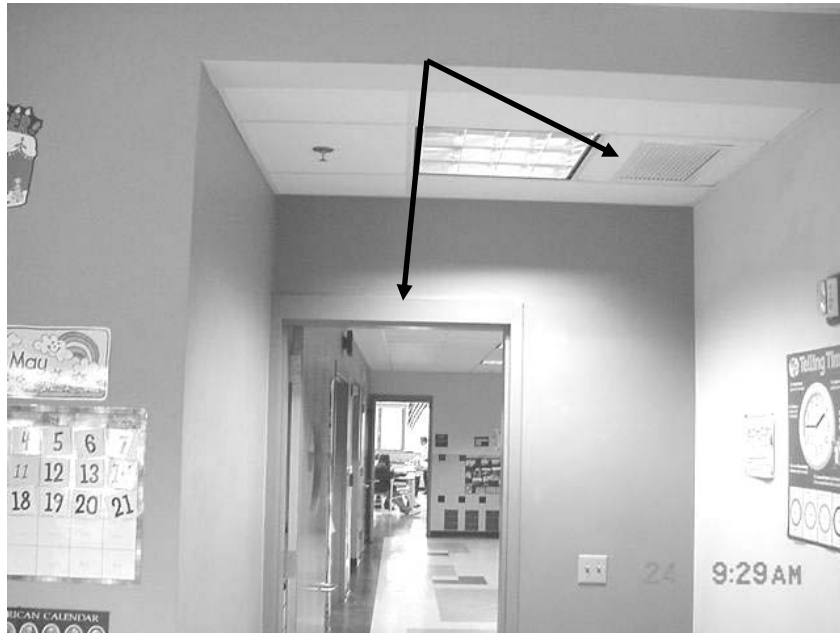
**Picture 4**

Exhaust ventilation in most classrooms is provided by ducted, grated wall or ceiling vents powered by rooftop motors (Pictures 4 and 5). These vents were also operating during the assessment. However, the location of some vents can limit exhaust efficiency. In several rooms, exhaust vents are located near hallway doors (Picture 4). Exhaust vents

in these rooms will tend to draw air from both the hallway and the classroom, reducing the effectiveness of the exhaust vent to remove common environmental pollutants.

**Ceiling-Mounted Exhaust Vent in Classroom, Note Proximity to Open Hallway Door**

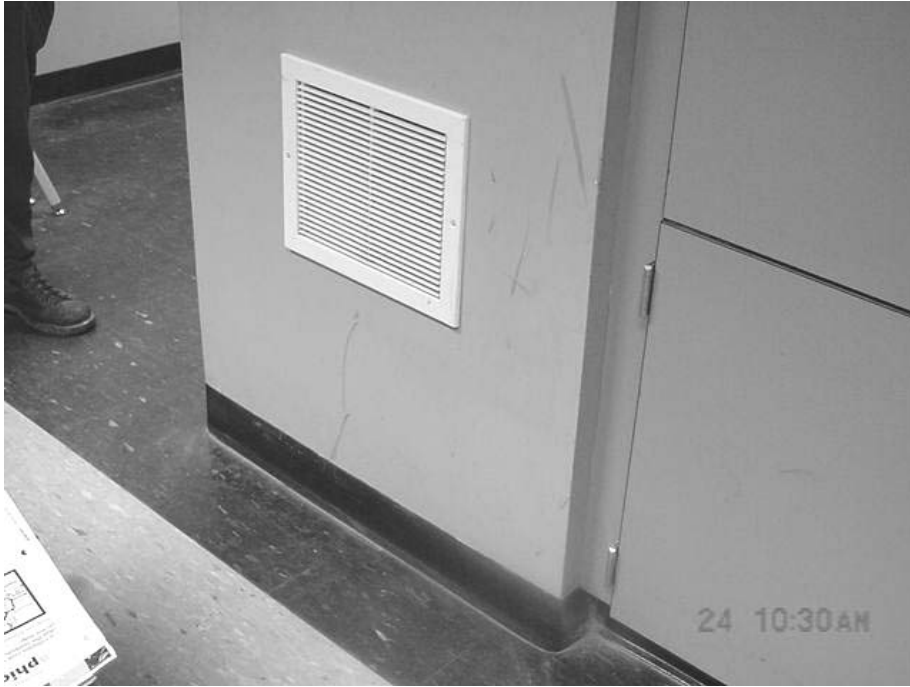
**Picture 5**

**Wall-Mounted Exhaust Vent**

16. Clean exhaust/return vents periodically to prevent excessive dust build-up.
17. Store cleaning products properly and out of reach of students. Ensure spray bottles are properly labeled in case of emergency.

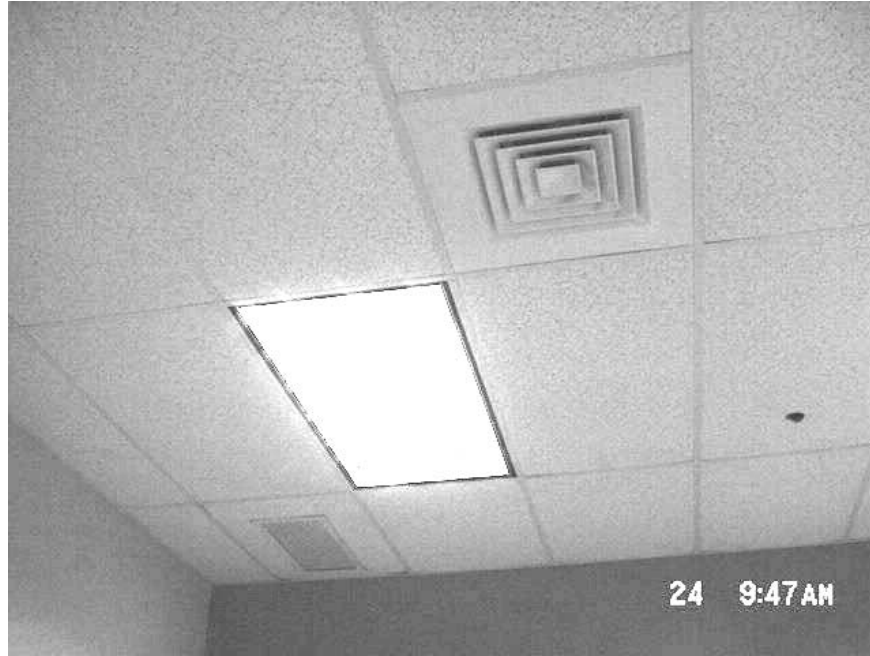
**Picture 6**

Mechanical ventilation in some interior rooms, office space and common areas such as the gymnasium, media center and cafeteria is provided by rooftop air-handling units (AHUs) connected to ceiling or wall-mounted air diffusers via ductwork. Return air is drawn into wall or ceiling exhaust vents and ducted back to the AHUs (Pictures 6 and 7). These systems were all operating during the assessment.

**Supply and Return Vent Ducted to Rooftop AHU**

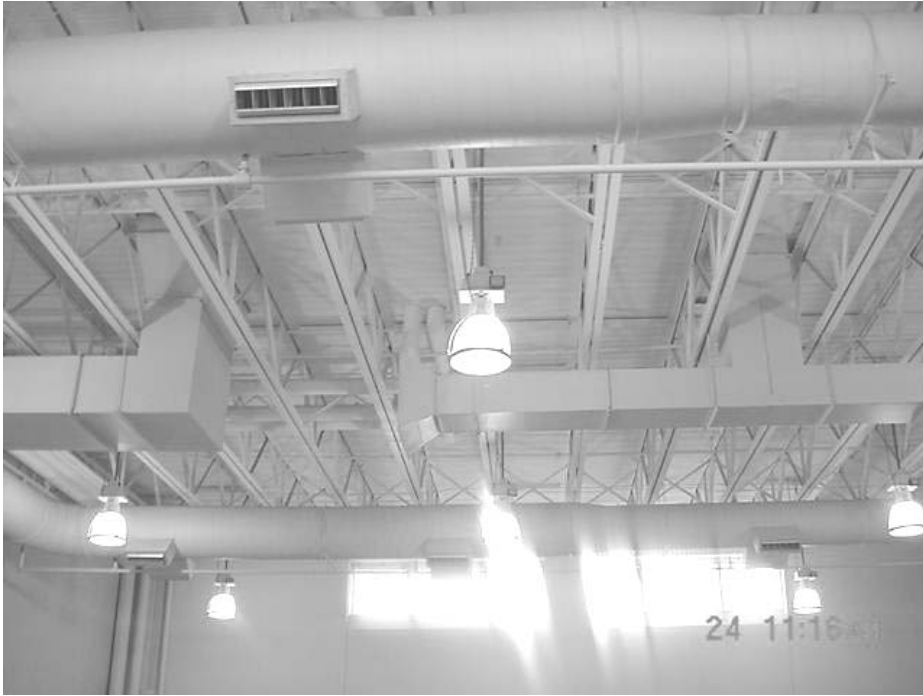
**Picture 7**

**Ducted Supply and Return Vents in Gymnasium**

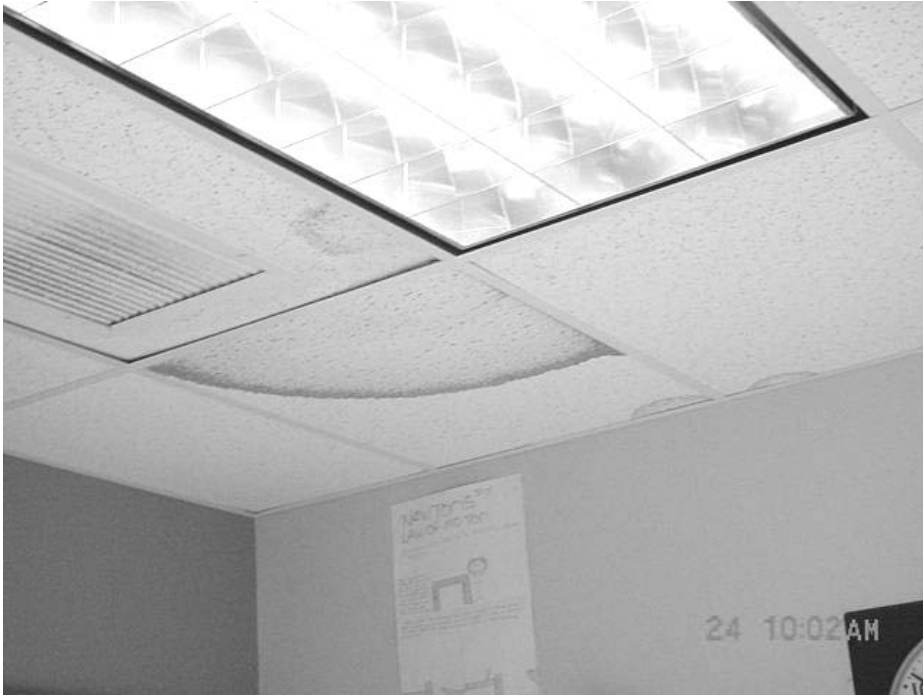
**Picture 8**

Several areas had water-damaged ceiling tiles, which can indicate leaks from the roof or plumbing system (Picture 8/Table 1). Water-damaged ceiling tiles can provide a source of mold and should be replaced after a water leak is discovered and repaired. Repeated water damage to porous building materials (e.g., wallboard, ceiling tiles, carpet) can result in microbial growth. The US Environmental Protection Agency (US EPA) and the American Conference of Governmental Industrial Hygienists (ACGIH) recommend that porous materials be dried with fans and heating within 24 to 48 hours of becoming wet (US EPA, 2001; ACGIH, 1989). If porous materials are not dried within this time frame, mold growth may occur.

**Water Damaged Ceiling Tiles in Classroom**

9. Ensure roof/plumbing leaks are repaired. Once leaks are repaired, replace water damaged ceiling tiles. Examine the area above and around these areas for mold growth. Disinfect areas of water leaks with an appropriate antimicrobial.

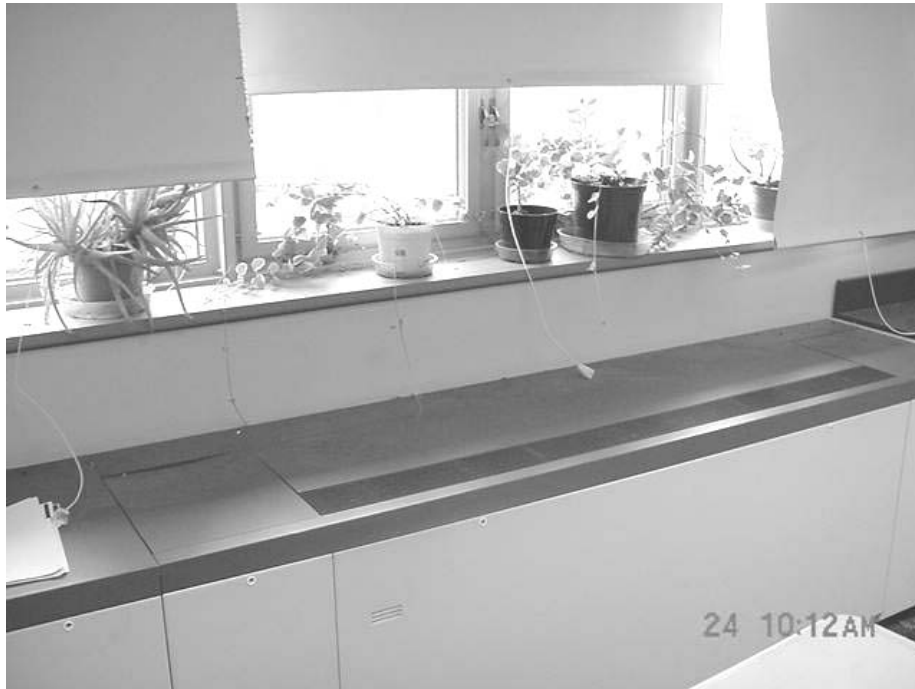
**Picture 9**

Several classrooms contained a number of plants. In several classrooms, plants were found near the air stream of univents (Picture 9). Plants, soil and drip pans can serve as sources of mold growth, and thus should be properly maintained. Plants should have drip pans to prevent wetting and subsequent mold colonization of window frames. Plants should also be located away from univents and ventilation sources to prevent aerosolization of dirt, pollen or mold.

**Plants Near the Air Stream of Univents**

12. Clean and disinfect univent fresh air intake louvers with an appropriate antimicrobial. Ensure univents are *deactivated* prior to cleaning.
13. Ensure plants have drip pans. Examine drip pans periodically for mold growth and disinfect with an appropriate antimicrobial where necessary. Keep plants away from the air stream of univents.

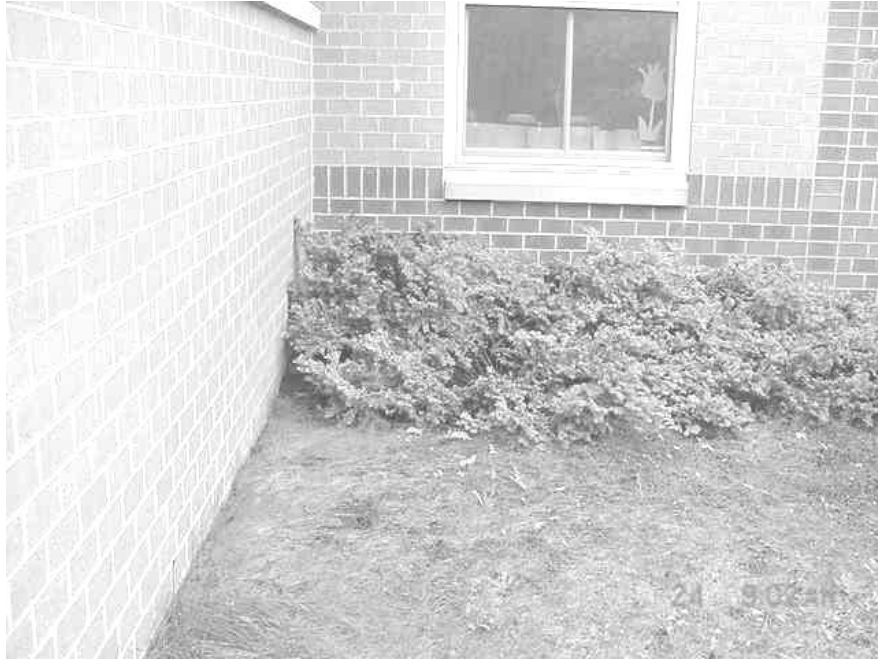
**Picture 10**

Plants were observed growing against exterior walls and in front of univent air intakes (Picture 10). A green film of plant debris and/or mold was observed on several of these air intakes (Picture 11). The close proximity of the shrubbery to the air intakes can allow plant debris, pollen, moisture and/or mold to be drawn in to the ventilation system and distributed by the univent. In addition, the growth of roots against exterior walls can

bring moisture in contact with the foundation. Plant roots can eventually penetrate, leading to cracks and/or fissures in the sublevel foundation. Over time, this process can undermine the integrity of the building envelope, providing a means of water entry into the building via capillary action through foundation concrete and masonry (Lstiburek & Brennan, 2001).

**Plants/Shrubbery Growing against Exterior Walls**

10. Clean and maintain aquariums and terrariums to prevent mold growth and associated odors.
11. Remove plants from the wall/tarmac junction around the perimeter of the building.

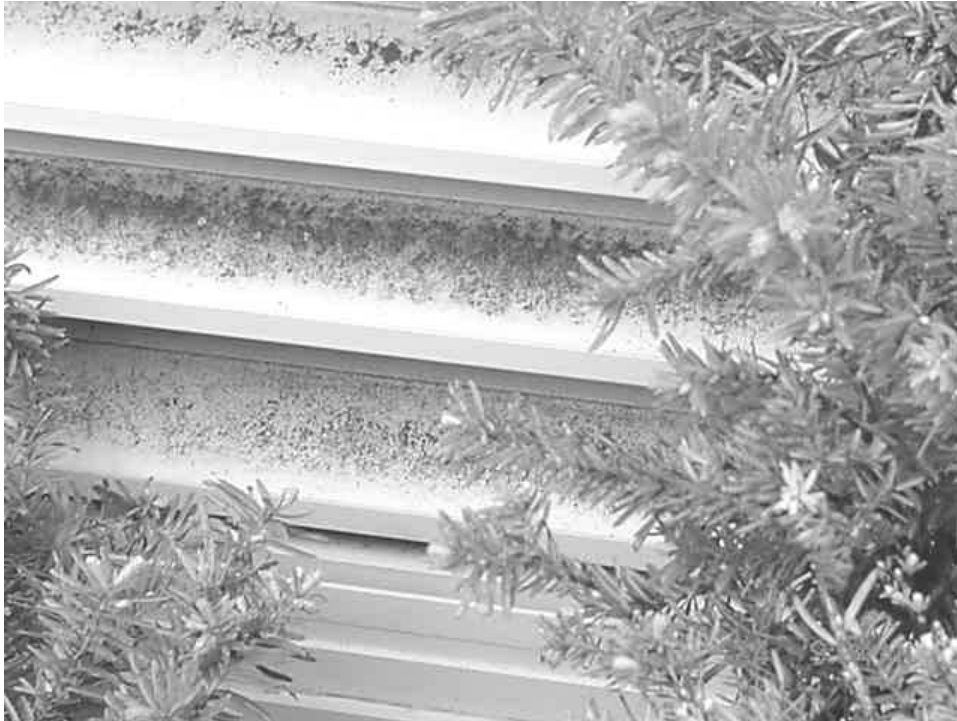
**Picture 11**

**Plant Debris/Mold on Univent Fresh Air Intakes Louvers**

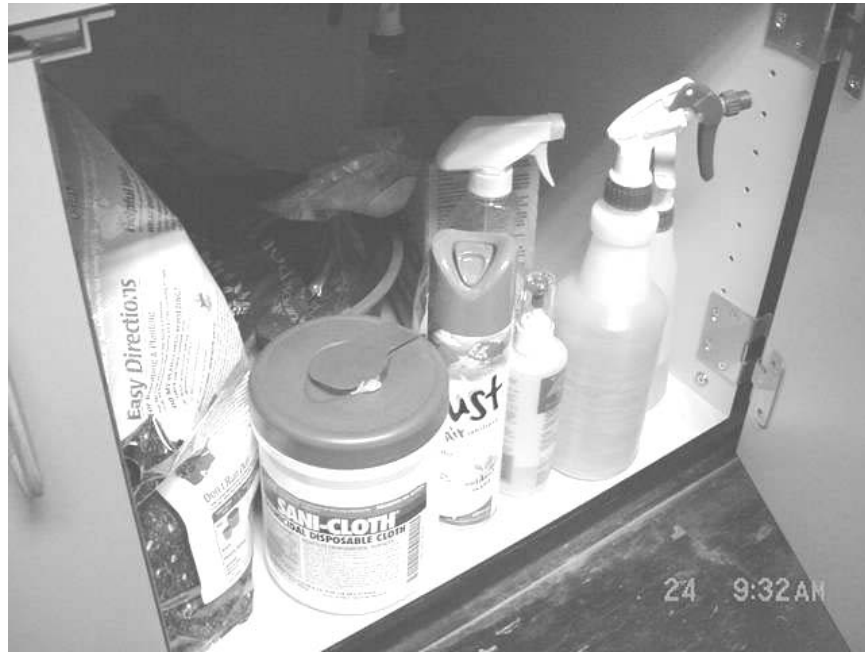
**Picture 13**

Please note, TVOC air measurements are only reflective of the indoor air concentrations present at the time of sampling. Indoor air concentrations can be greatly impacted by the use TVOC containing products (i.e., the concentration of TVOCs within a classroom when the products are actually in use). While no TVOC levels were measured, materials containing VOCs were present in the school. Several classrooms contained dry erase boards and dry erase markers. Materials such as dry erase markers and dry erase board cleaners may contain volatile organic compounds (VOCs), (e.g., methyl isobutyl ketone, n-butyl acetate and butyl-cellusolve) (Sanford, 1999), which can be irritating to the eyes, nose and throat. Cleaning products were found in unlocked cabinets below sinks and on countertops in a number of classrooms (Picture 13). Cleaning products also contain chemicals that can be irritating to the eyes, nose and throat and should be kept out of reach of students.

**Aerosol Cans and Spray Bottles of Cleaning Products under Classroom Sink**

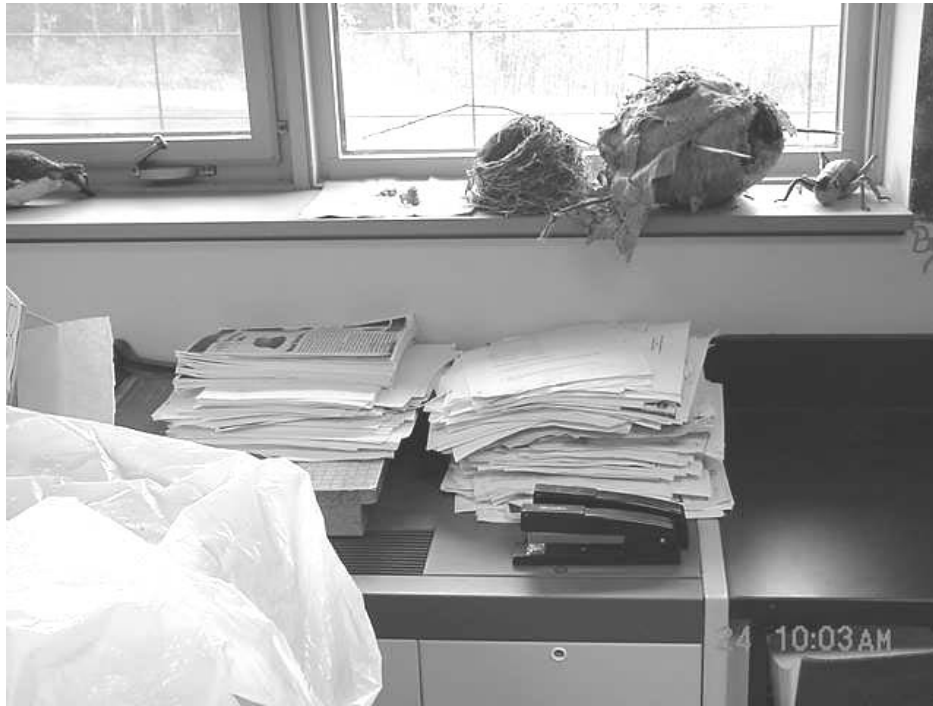
**Picture 14**

Bird's and wasp's nests were seen on a classroom windowsill near the air stream of a univent (Picture 14). Nests can contain bacteria and may also be a source of allergenic material. Nests should be placed in re-sealable bags to prevent aerosolization of allergenic material.

**Birds' and Wasps' Nests near Univent Air Diffuser**

18. Store nests in re-sealable bags to prevent aerosolization of irritants, or bring in on an as-needed basis.

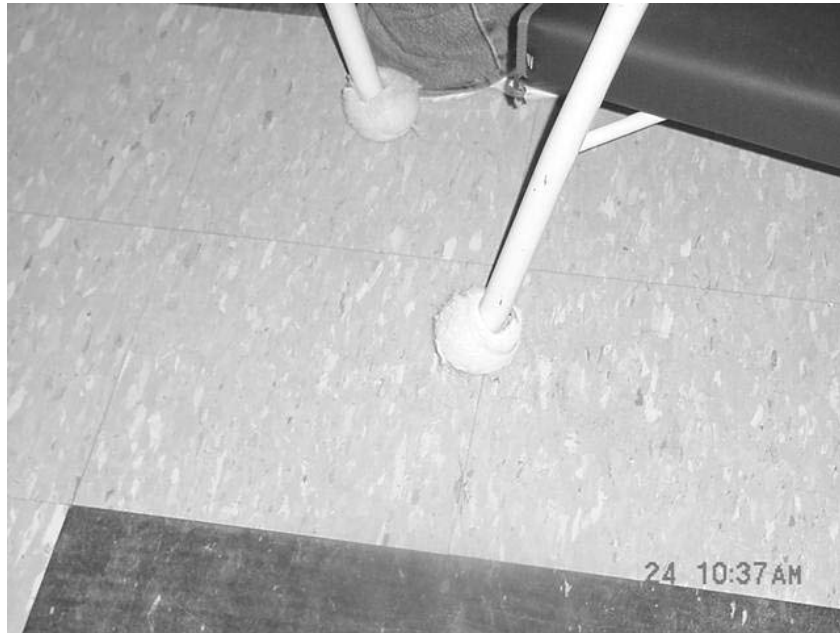
**Picture 16**

Lastly, in an effort to reduce noise from sliding chairs, tennis balls had been sliced open and placed on chair legs (Picture 16). Tennis balls are made of a number of materials that are a source of respiratory irritants. Constant wearing of tennis balls can produce fibers and off gas VOCs. Tennis balls are made with a natural rubber latex bladder, which becomes abraded when used as a chair leg pad. Use of tennis balls in this manner may introduce latex dust into the school environment. Some individuals are highly allergic to latex (e.g., spina bifida patients) (SBAA, 2001). It is recommended that the use of

materials containing latex be limited in buildings to reduce the likelihood of symptoms in sensitive individuals (NIOSH, 1997). A question and answer sheet concerning latex allergy is attached as Appendix B (NIOSH, 1998). Consider replacing tennis balls with alternative glides (Picture 17).

**Tennis Balls on Chair Legs in Classroom**

19. Consider discontinuing the use of tennis balls on furniture and replacing tennis balls with alternative “glides” (Picture 17).
20. Consider adopting the US EPA (2000b) document, *Tools for Schools*, in order to provide self-assessment and maintain a good indoor air quality environment. The document can be downloaded from the Internet at <http://www.epa.gov/iaq/schools/index.html>.
21. Refer to resource manuals and other related indoor air quality documents for further building-wide evaluations and advice on maintaining public buildings. Copies of these materials are located on the MDPH’s website: [http://mass.gov/dph/indoor\\_air](http://mass.gov/dph/indoor_air)
