INDOOR AIR QUALITY ASSESSMENT

**Lynnfield High School
275 Essex Street
Lynnfield, Massachusetts 01940**

Prepared by:
Massachusetts Department of Public Health
Center for Environmental Health
Emergency Response/Indoor Air Quality Program
February 2007

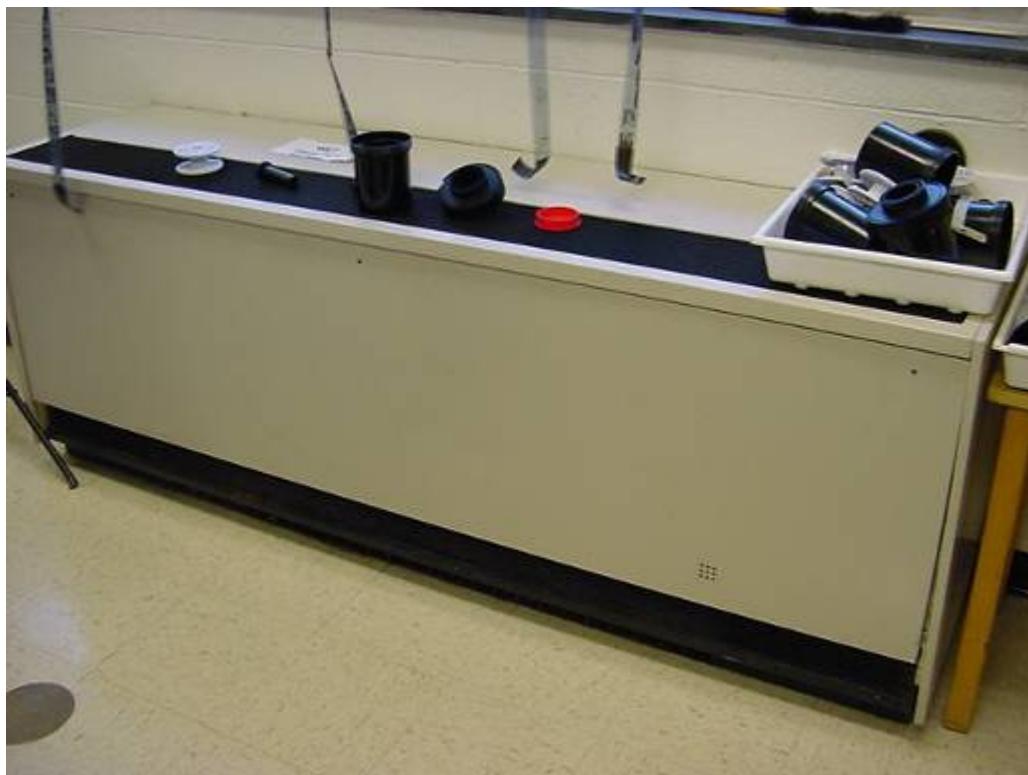
Picture 1

Fresh air in classrooms is supplied by a unit ventilator (univent) system (Picture 1). A univent draws air from the outdoors through a fresh air intake located on the exterior wall of the building (Picture 2) and returns air through an air intake located at the base of the unit. Fresh and return air are mixed, filtered, heated and provided to classrooms through an air diffuser located in the top of the unit. Adjustable louvers control the ratio of outside to recirculated air ([Figure 1](#)). Univents were found deactivated in a number of areas (Table 1). Obstructions to airflow, such as items stored on or in front of univents were seen in some areas. In order for univents to provide fresh air as designed, units must be activated while rooms are occupied and air diffusers should remain free of obstructions.

Classroom Univent

1. Operate all ventilation systems throughout the building (e.g., gym/locker rooms, auditorium, classrooms) continuously during periods of school occupancy independent of thermostat control to maximize air exchange. To increase airflow in classrooms, set univent controls to “high”. This is of particular importance given the high carbon dioxide measurements taken in a number of areas in the school.

4. Work with town/school officials to develop a preventative maintenance program for all HVAC equipment system-wide.
5. Remove all blockages from univents to ensure adequate airflow.

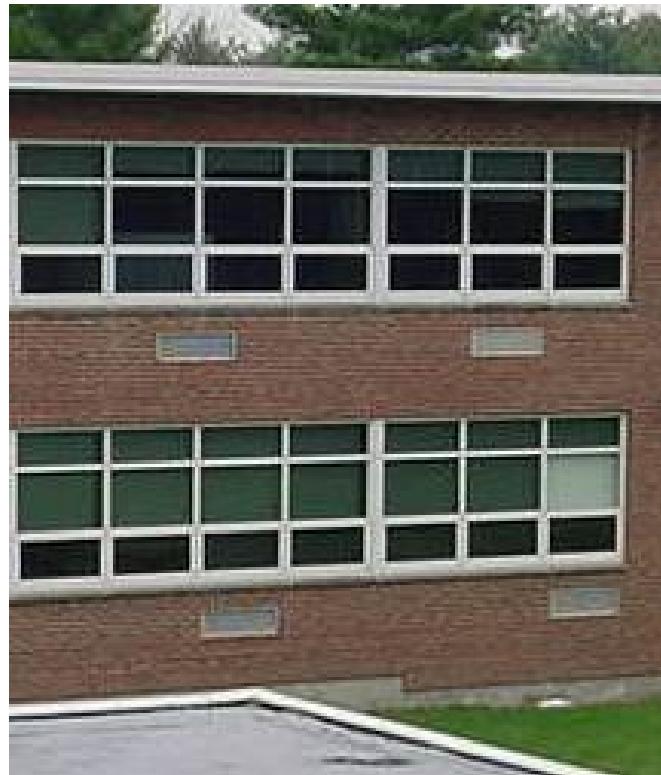
Picture 2

Supply and Exhaust Vents for Univents and Unit Exhaust Ventilators

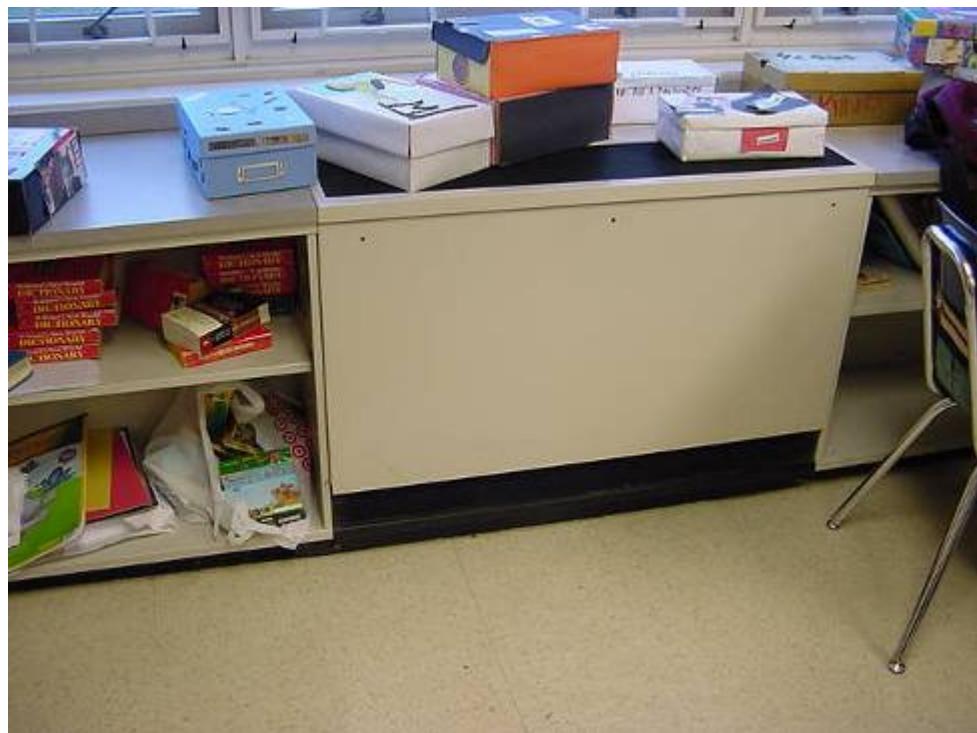
Picture 3

Exhaust ventilation in classrooms is provided by unit exhaust ventilators (Picture 3). These exhaust ventilators were not operating in some of the areas surveyed at the time of the assessment. As with the univents, in order for exhaust ventilation to function as designed, unit exhaust ventilators must be activated. Without sufficient supply and exhaust ventilation, environmental pollutants can build up and lead to indoor air quality/comfort complaints.

Unit Exhaust Ventilator

2. Examine univent in rooms 203 and 301 due to excess heat reports and in room 103 due to noise.
3. Inspect exhaust motors and belts for proper function, particularly in chemical prep rooms. Repair and replace as necessary.

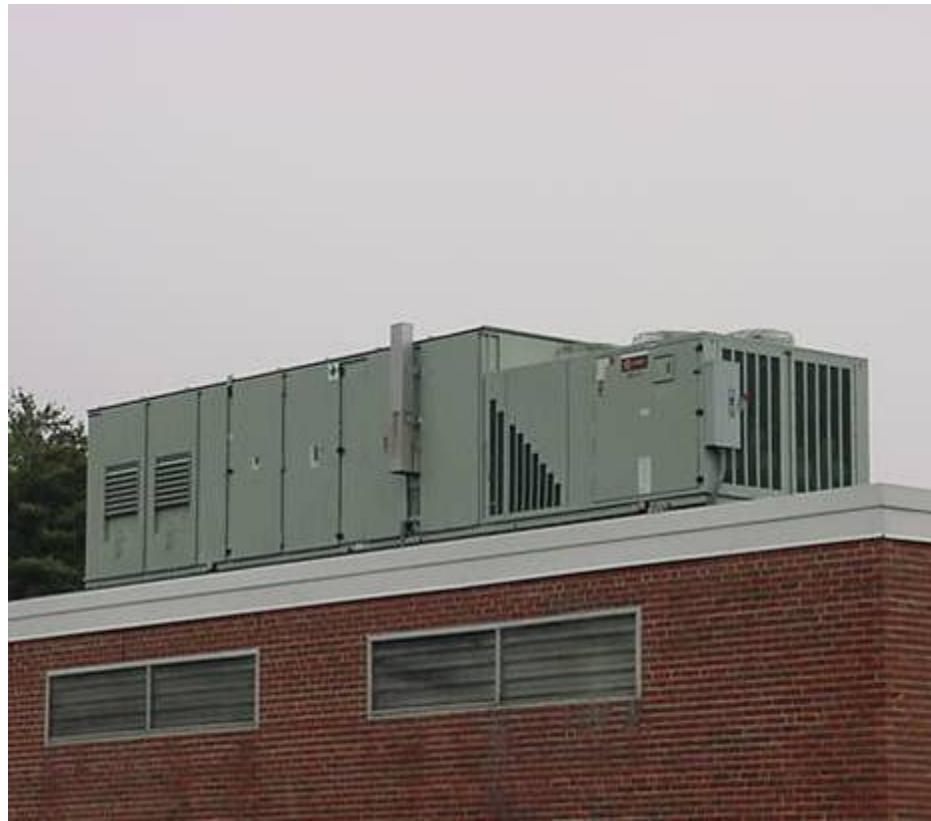
Picture 4

Mechanical ventilation in common areas and interior rooms (e.g., gym, cafeteria, media center) is provided by air handling units (AHUs) located on the roof (Picture 4). Outside air is heated or cooled and distributed to occupied areas via ceiling-mounted air diffusers (Picture 5) and exhausted out of the building via ceiling or wall-mounted vents powered by rooftop motors (Picture 6). Mechanical ventilation did not appear to be operating in a number of common areas such as locker rooms, the athletic storage room and science prep rooms during the assessment (Table 1). Slight chemical odors were detected in prep room 101-A and musty odors were detected in the athletic storage room, most likely due to the mechanical ventilation system not operating.

Rooftop AHU

8. Change filters for air-handling equipment as per the manufacturer's instructions or more frequently if needed. Vacuum interior of units prior to activation to prevent the aerosolization of dirt, dust and particulates. Ensure filters fit flush in their racks with no spaces in between allowing bypass of unfiltered air into the unit.

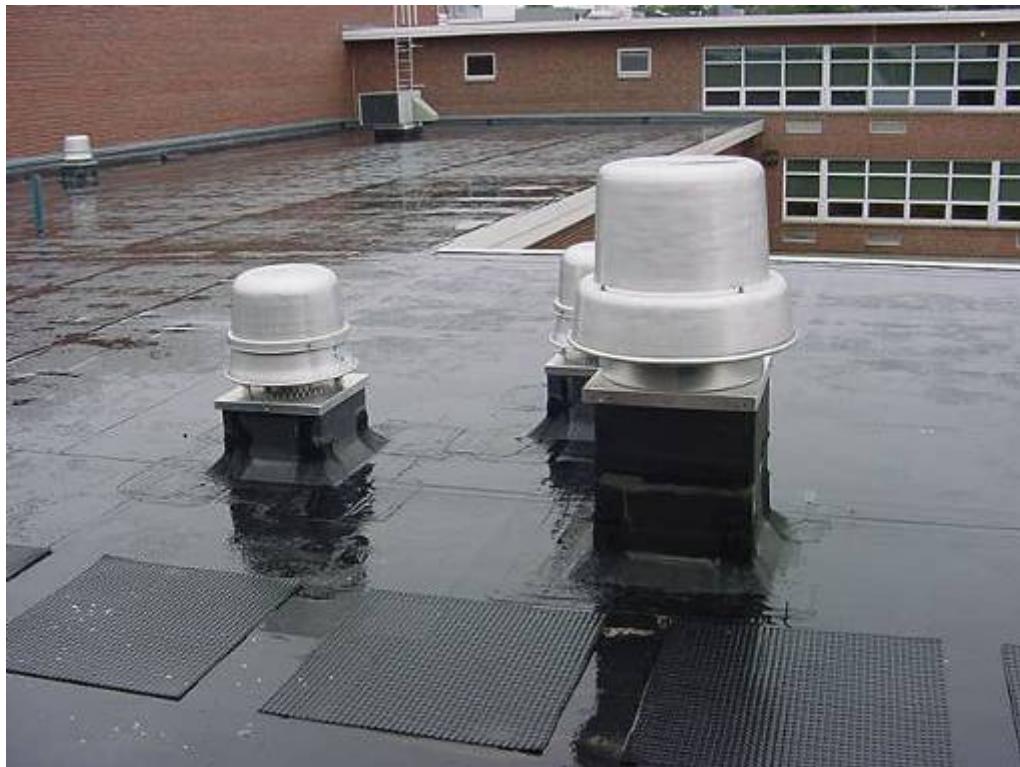
Picture 5

Rooftop Exhaust Motors

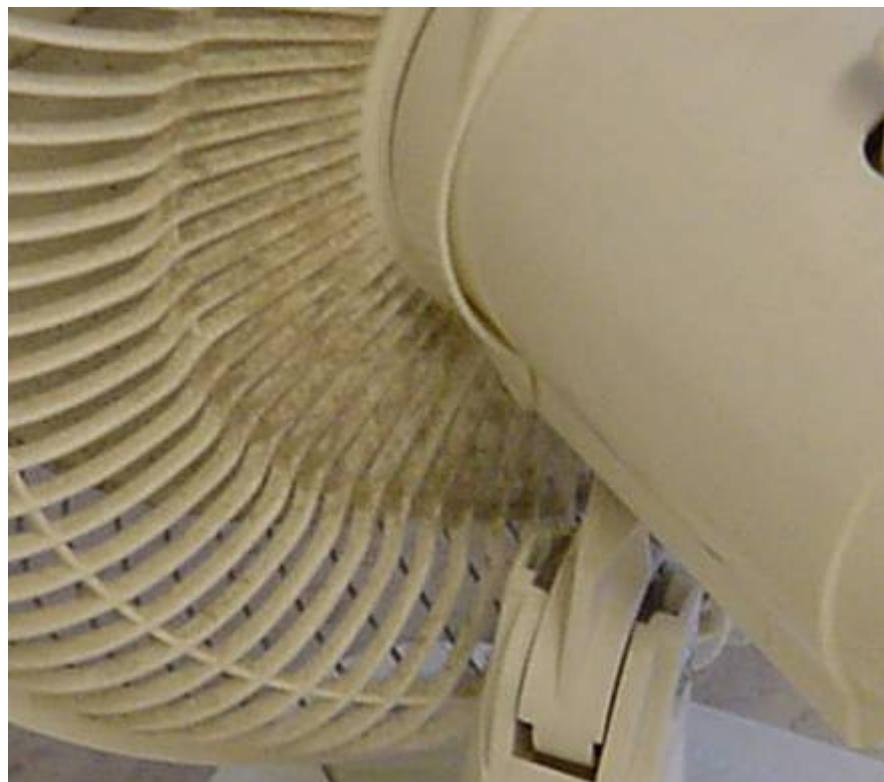
Picture 8

A number of vents and personal fans had accumulated dust (Pictures 7 and 8). If vents are not functioning, backdrafting can occur, which can re-aerosolize dust particles and reduce the efficiency of the vent to draw air. In addition, these materials can accumulate on flat surfaces (e.g., desktops, shelving and carpets) in occupied areas and subsequently be re-aerosolized causing further irritation.

Accumulated Dust/Debris on Fan

13. Clean fans blades, exhaust and supply vents periodically to prevent excessive dust build-up.
