INDOOR AIR QUALITY ASSESSMENT

**Whitman Department of Public Works Administration Office
100 Essex Street
Whitman, Massachusetts**

Prepared by:
Massachusetts Department of Public Health
Bureau for Environmental Health
Indoor Air Quality Program
February 2008

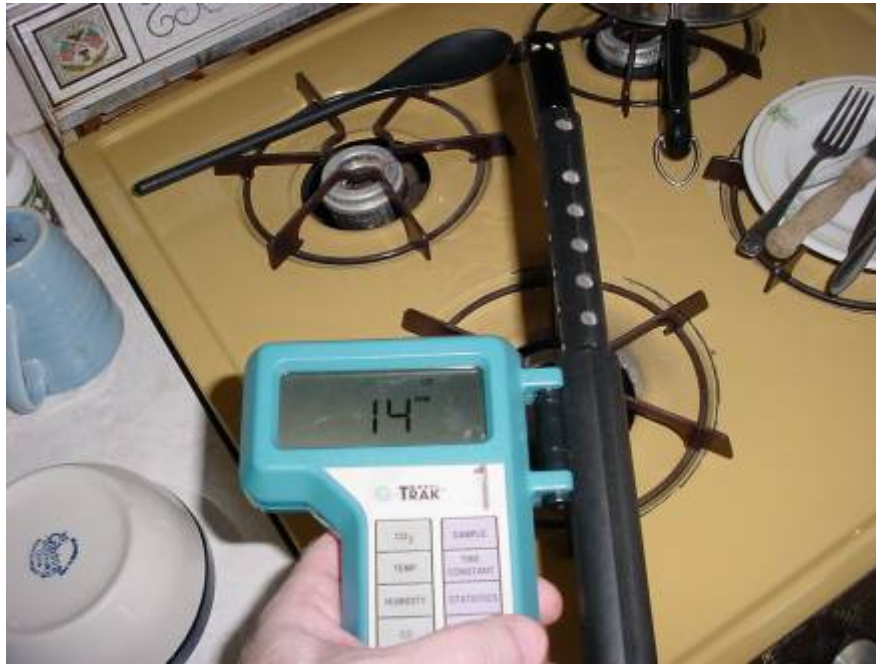
Picture 1

The first floor contains a gas stove. Non-detectable levels of carbon monoxide were detected in the WDPW offices prior to ignition of the stove. After lighting three of the burners on the top of the stove, levels of carbon monoxide were elevated on the first floor. At the burner level, carbon monoxide levels measured in a range of 9 to 14 parts per

million (ppm) (Picture 1). After five minutes of continuous burner activation, carbon monoxide levels measured 4 ppm on the counter approximately 8 feet from the activated gas stove. The gas stove has a local exhaust vent to eject products of combustion outdoors. It is recommended that all gas cook tops and ovens be vented to the outdoors to prevent exposure to products of combustion (Lstiburek and Brennan, 2001).

Carbon Monoxide Measurement in Kitchen with Gas Stove Combusting Fuel

2. Consider replacing the gas stove with an electric model.
3. Install a carbon monoxide digital readout in the basement stairwell. CO levels should be checked daily after the boiler is fired up during the heating season.

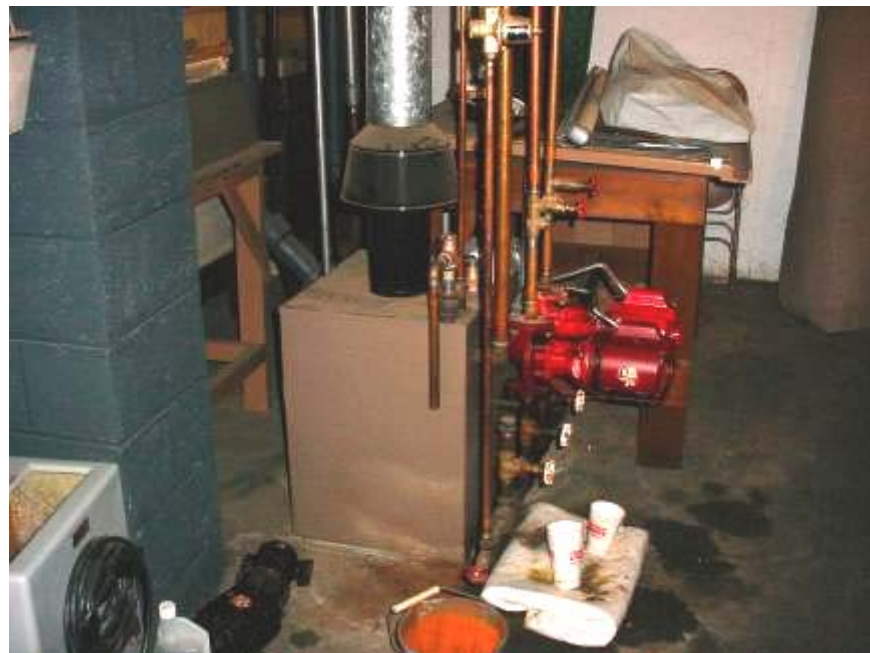
Picture 2

A gas fired furnace (Picture 2) and water heater (Picture 3) were located in the basement. Due to the configuration of the water heater and its exhaust vent, carbon monoxide (CO) measurements were taken in the basement prior to and after activation of the hot water heater. No detectable levels of CO were measured in the basement at anytime during the assessment. In order to provide efficient combustion for the gas jet in the water heater and space heater that minimizes the production of CO, an adequate supply of combustion air is needed to provide oxygen. A combustion air vent is usually located in an area near the furnace. No observable combustion air vent could be identified in the basement.

Gas Fired Furnace

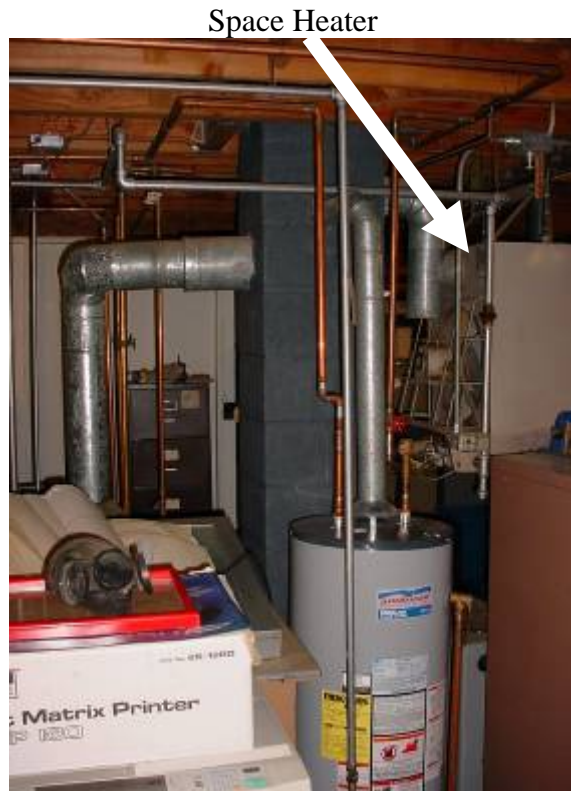
Picture 3

Gas Fired Water Heater, Note Space Heater Fan Location

4. Disconnect the space heater if heat from this unit is not needed.
5. Seal abandoned drain pipe in a proper manner.
6. Adequate combustion air needs to be provided for the water heater and space heater. A ground level fresh air intake may be necessary. Consult with the local fire prevention officer/building code officials to determine an appropriate method to provide combustion air for the water heater. If not feasible, consider replacing current gas water heater with electric model.

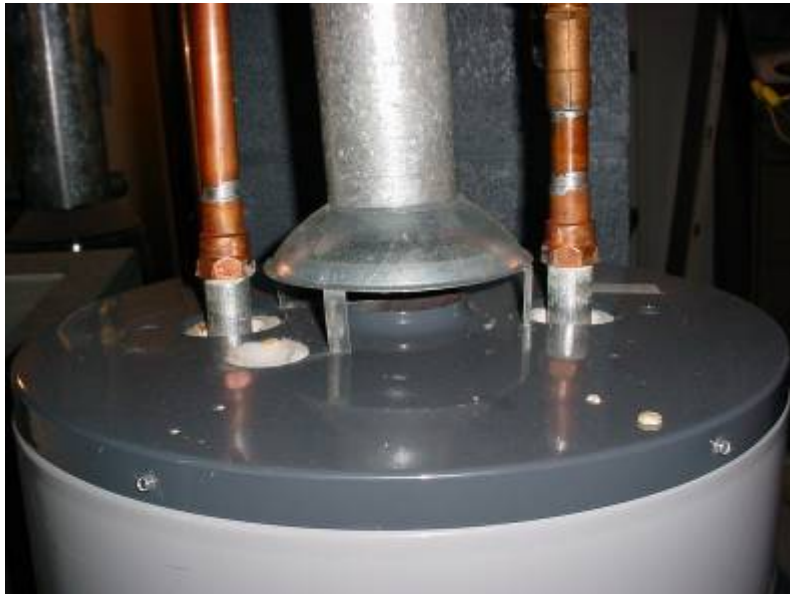
Picture 4

Please note the position of the space heater relative to the water heater. The exhaust vent for the water heater is not continuous (Picture 4). Due to this configuration, products of combustion produced by the water heater can be drawn away from the vent system and directed into the basement when the space heater fan (Picture 5) is operating.

Water Heater Vent

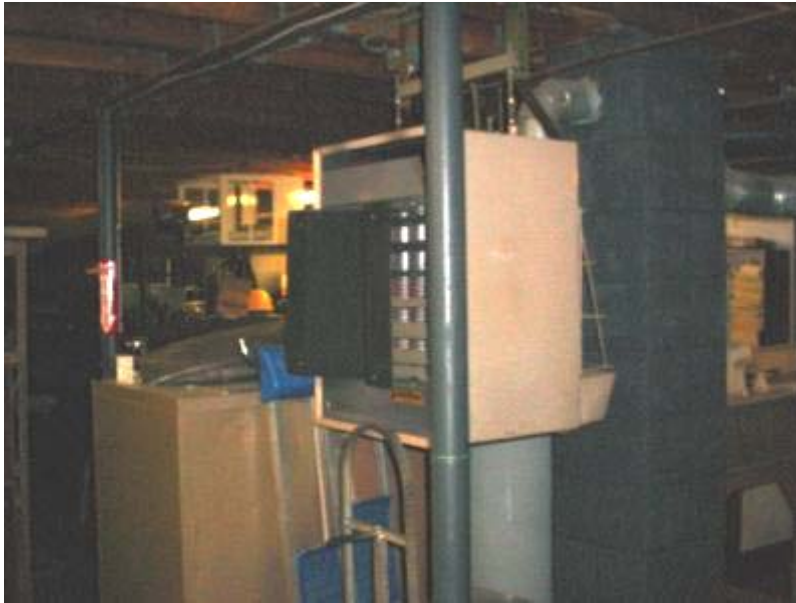
Picture 5

Space Heater near Furnace and Water Heater

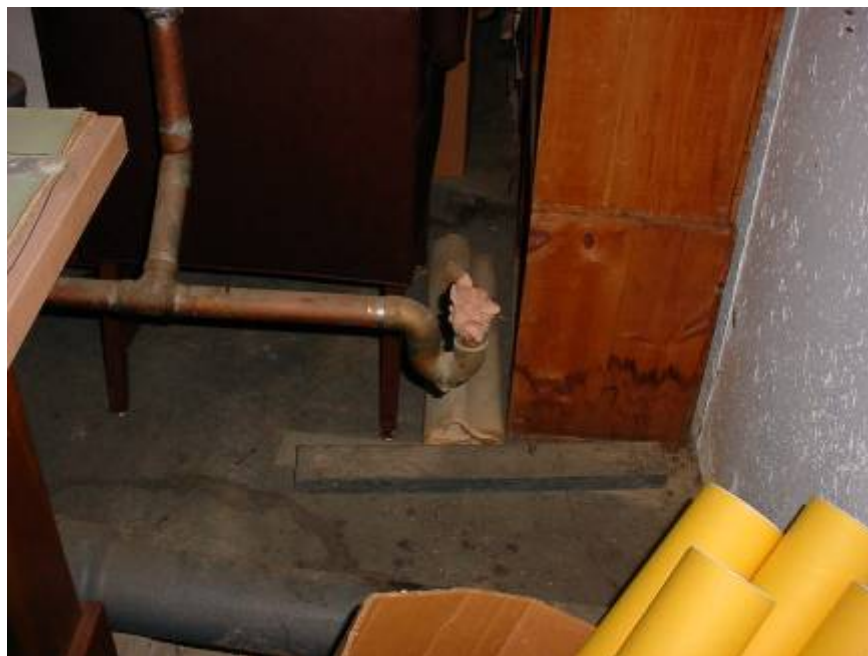
Picture 6

A drainpipe exists in the basement that is sealed with crumpled paper (Picture 6). Drain pipes should be properly sealed to prevent sewer odor penetration into the building. The two likely pathways for migration of basement odors upstairs are the stairwell and holes in the floor. In order to prevent basement odor migration, the basement door should

be closed during working hours and all holes in the basement ceiling and foundation should be sealed.

Drain Pipe Opening Sealed With Crumpled Paper
