INDOOR AIR QUALITY ASSESSMENT

**JFK Elementary School
339 Plymouth Street
Holbrook, MA 02343**

Prepared by:
Massachusetts Department of Public Health
Bureau of Environmental Health
Indoor Air Quality Program
March 2008

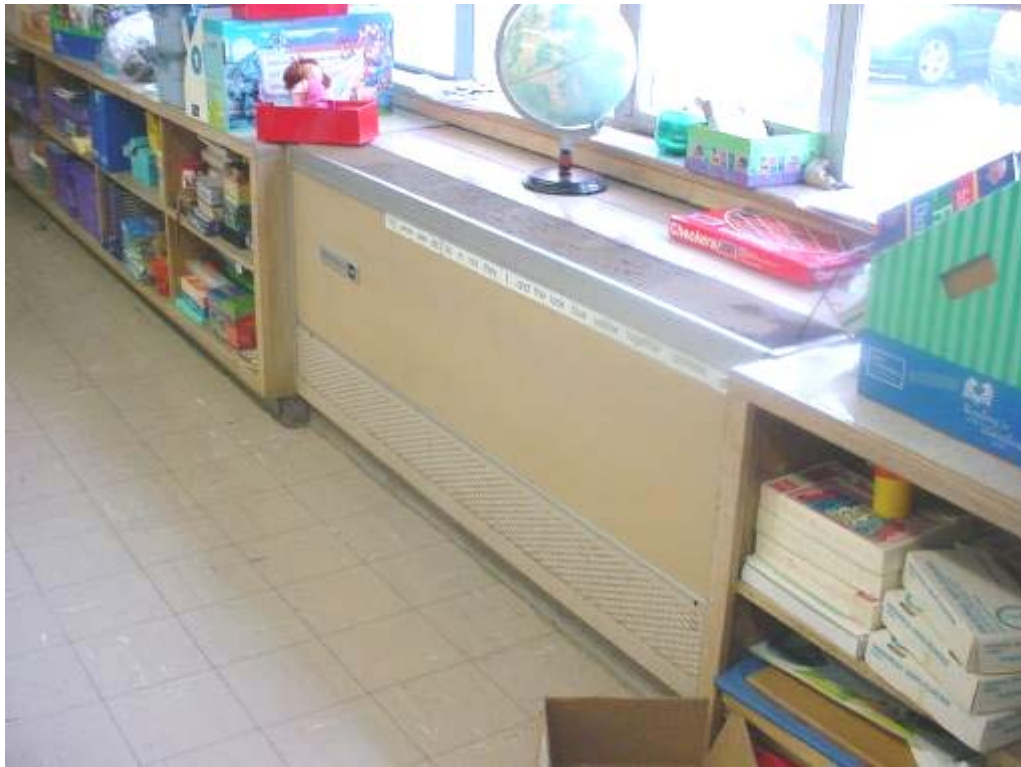
Picture 1

Fresh air is supplied to classrooms by unit ventilator (univent) systems (Picture 1). A univent draws air from the outdoors through a fresh air intake located on the exterior wall of the building (Picture 2) and returns air through an air intake located at the base of the unit ([Figure 1](#)). Fresh and return air are mixed, filtered, heated and provided to classrooms through an air diffuser located in the top of the unit. Univents were found

Classroom Univent

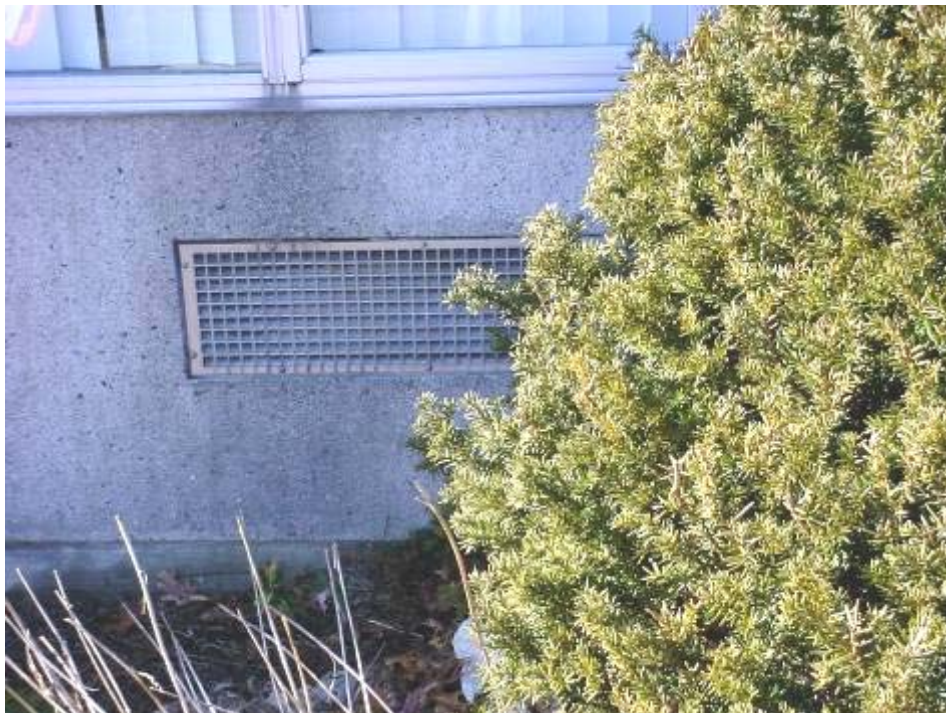
Picture 2

Plants were observed growing in close proximity to a univent fresh air intake along the exterior (Picture 2). Shrubbery and flowering plants can be a source of mold and pollen, and should be located away from fresh air intakes to prevent the aerosolization of mold, pollen or particulate matter throughout the building.

Fresh Air Intake, Note Bush Growing in Front of Intake

9. Remove/replace water damaged ceiling tiles.
10. Move plants away from univents in classrooms. Avoid over-watering and examine drip pans periodically for mold growth. Disinfect with an appropriate antimicrobial where necessary.

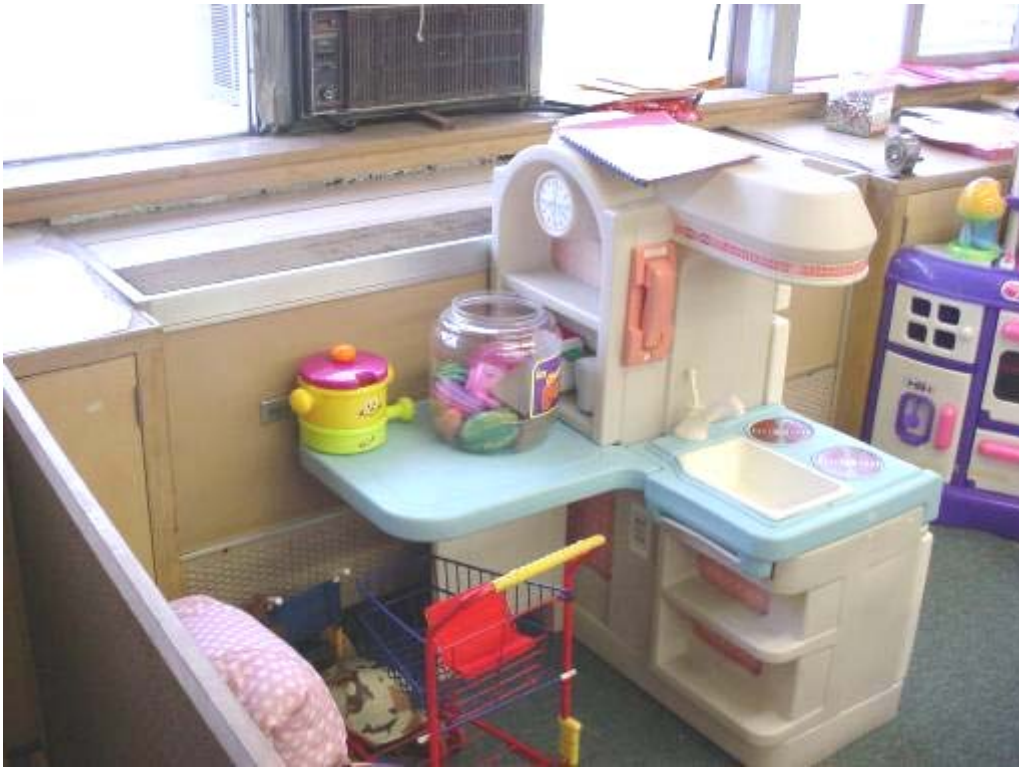
Picture 3

obstructed by furniture, books and other materials (Picture 3). In order for univents to provide fresh air as designed, air diffusers, intakes and return vents must remain free of obstructions. Importantly, these units must remain “on” and be allowed to operate while rooms are occupied. Univents are also original 1960s era equipment, making them approximately 40+ years old. Efficient function of such equipment can be difficult to maintain since compatible replacement parts are often unavailable.

Items Obstructing Univent Return Vent (bottom front of unit)

2. Remove all blockages from univents and exhaust vents to ensure adequate airflow (e.g., beneath wall panels Picture 4). Remove coat hooks directly in front of exhaust vents. Consider reconfiguring the layout of some classrooms to facilitate airflow.

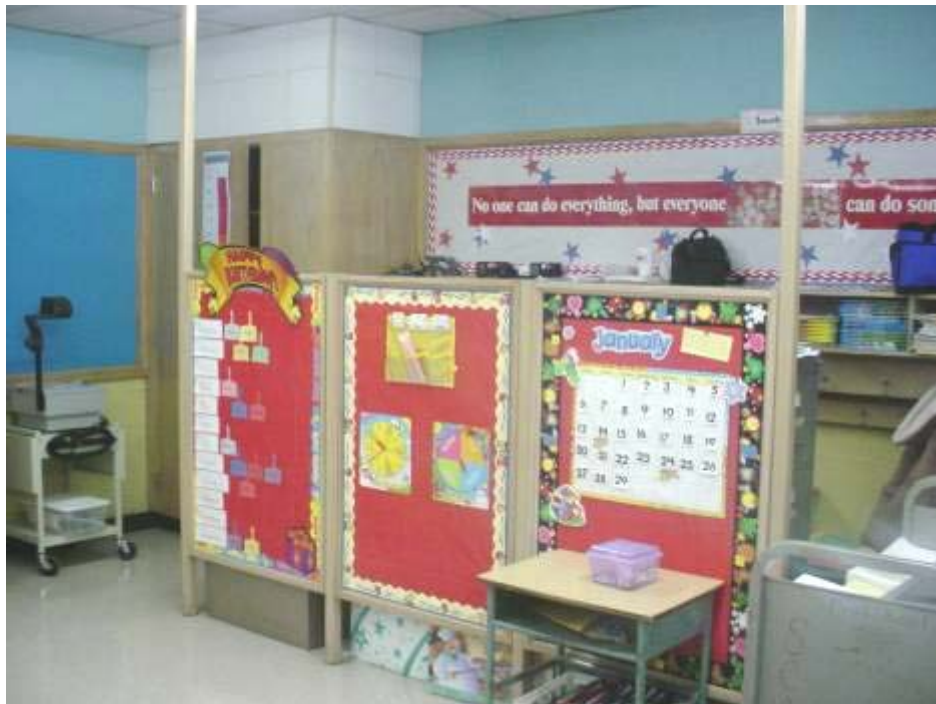
Picture 4

Three Panel Partition, Note Boxes on Floor Obstructing Airflow

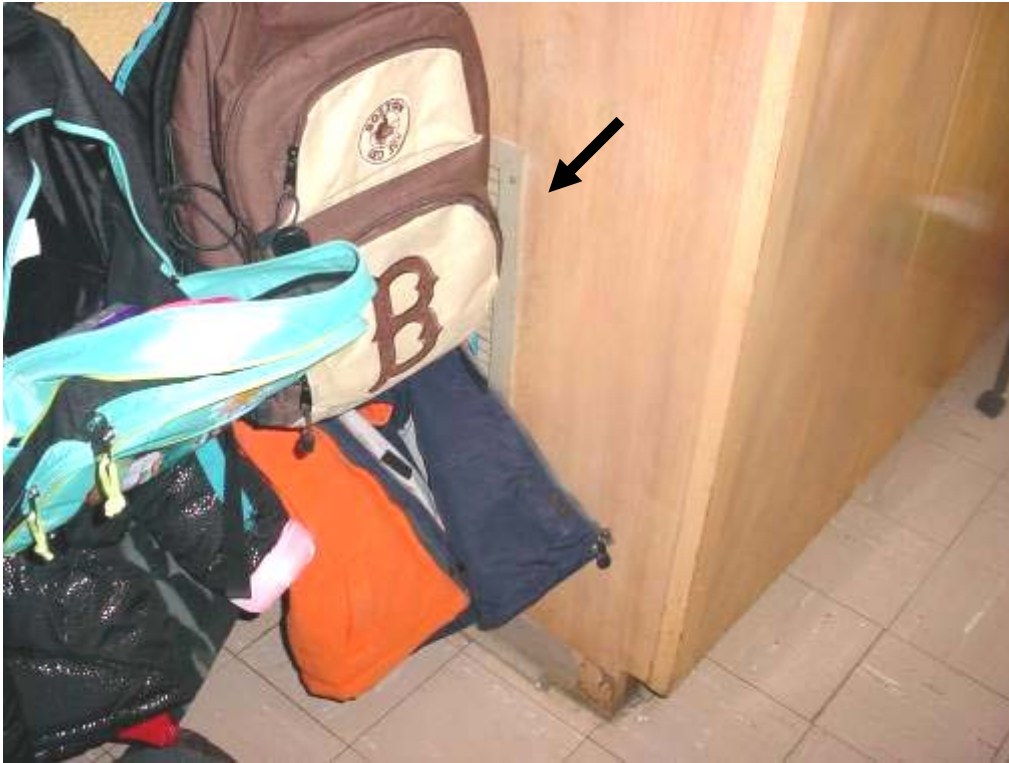
Picture 5

Exhaust ventilation in classrooms is provided by wall vents ducted to rooftop motors, which were deactivated at the time of the assessment. Exhaust vents are located in an area partitioned by three panels, which serves as the designated coat area (Picture 4). The panels are undercut to allow air to move freely, however, airflow underneath the panels was blocked by file cabinets and stored materials (Picture 4). Moreover, a number of exhaust vents were obstructed by furniture, coats and bags (Picture 5). As with univents, in order to function properly, exhaust vents must be activated and allowed to operate while rooms are occupied. Without adequate supply and exhaust ventilation, excess heat and environmental pollutants can build up leading to indoor air/comfort complaints.

Exhaust Vent Obstructed by Coats and Bags

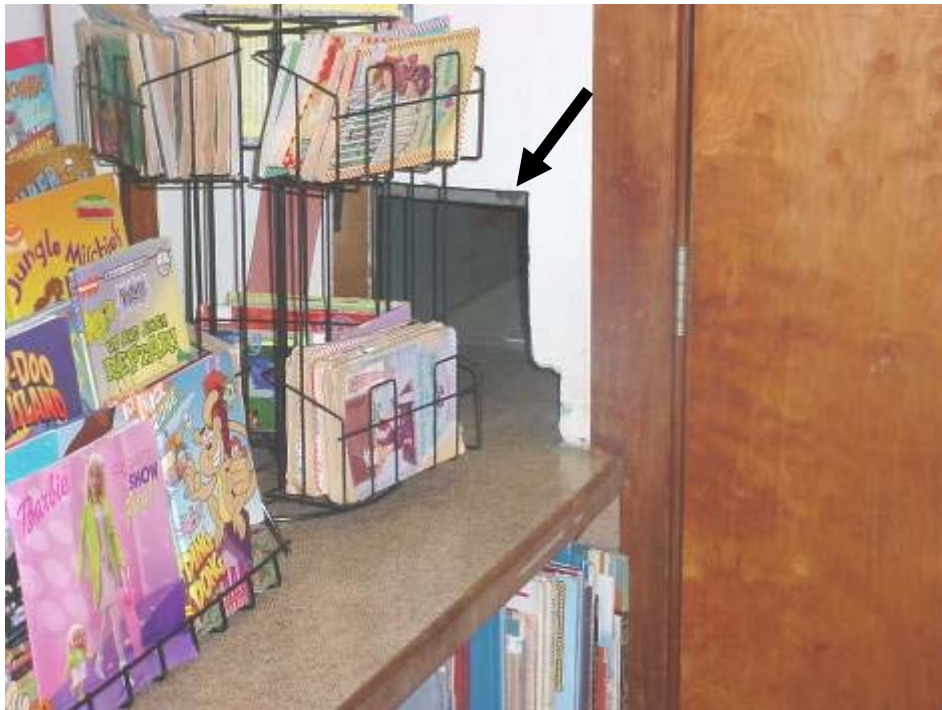
Picture 6

A wall divides the library and speech rooms, placing the univent in the speech room and the exhaust vent in the library. In order to provide air to the library, a duct extends from the air diffusers atop the univent through a wall to the library (Pictures 6 and 7). Air is exhausted from the speech room by a passive door vent and the undercut of the door from the library. Although this provides *some* supply air to the library it compromises make-up air capacity to both the speech and library by approximately 50 %.

Air Supply Ducted into Library from Speech Room

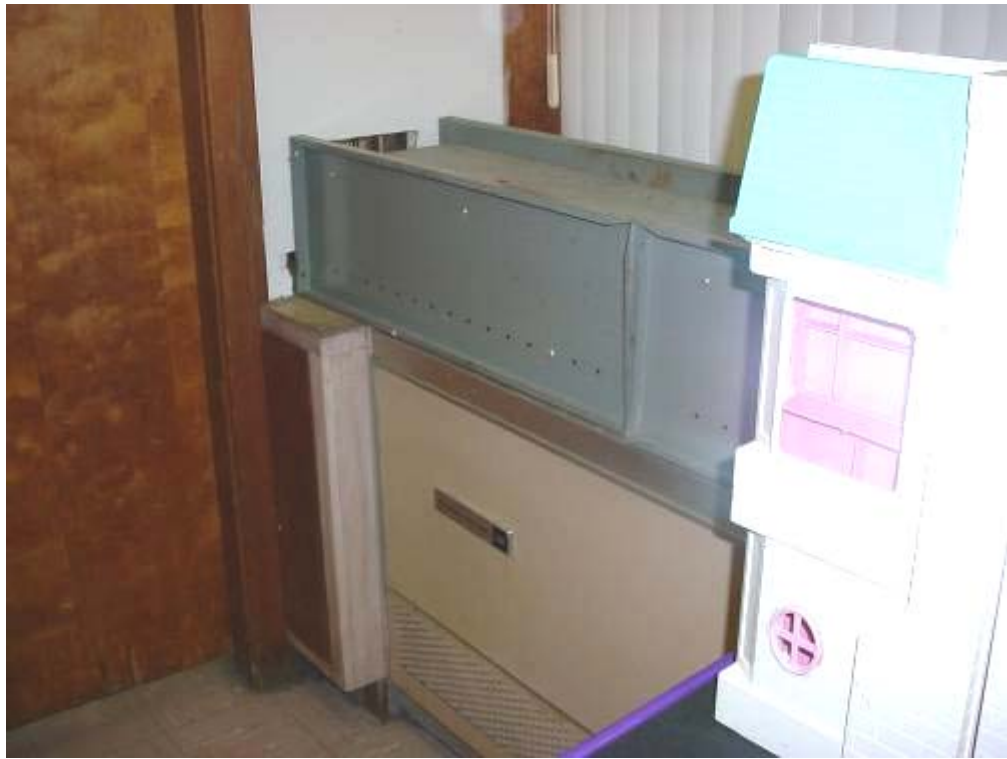
Picture 7

Ducted Univent Leading to Library (From Speech Room)

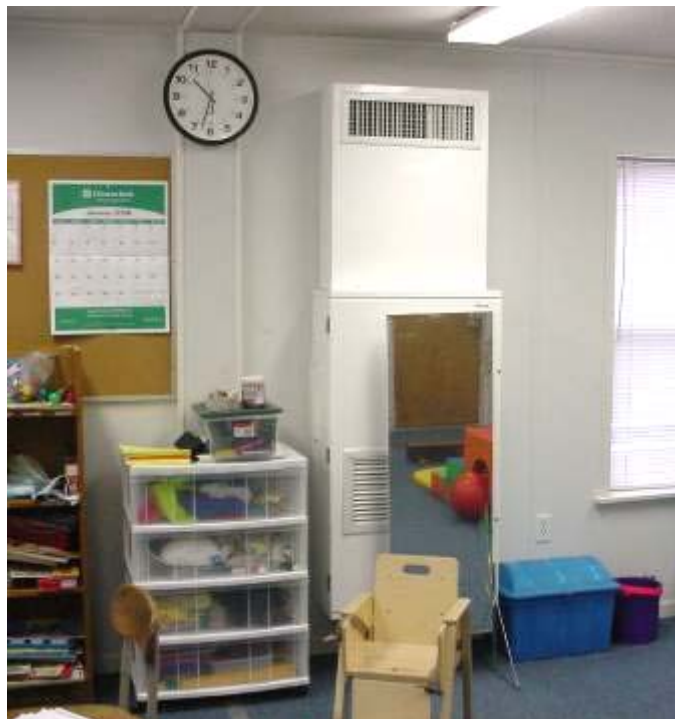
Picture 8

Ventilation for modular classrooms is provided by wall-mounted AHUs (Picture 8). Fresh air is drawn in through an air intake on the exterior of the building and distributed to classrooms via an air diffuser and drawn back to the AHUs through a return grill. Thermostats control each AHU. All AHUs for modular classrooms were found deactivated (Picture 9) and windows were shut at the time of the assessment, explaining the elevated carbon dioxide levels and lack of air exchange. In one particular modular classroom, carbon dioxide levels were elevated to 2,620 ppm (Table 1). The AHUs were subsequently reactivated by Mr. Quimby, significantly reducing the carbon dioxide level to 754 ppm (Table 1). Furthermore, thermostats for AHUs were set to an “automatic” setting which deactivates the HVAC system at a preset temperature. Therefore, no mechanical ventilation is provided until the thermostat re-activates the system.

Wall-mounted Air Handling Unit, Note Mirror Blocking Vent

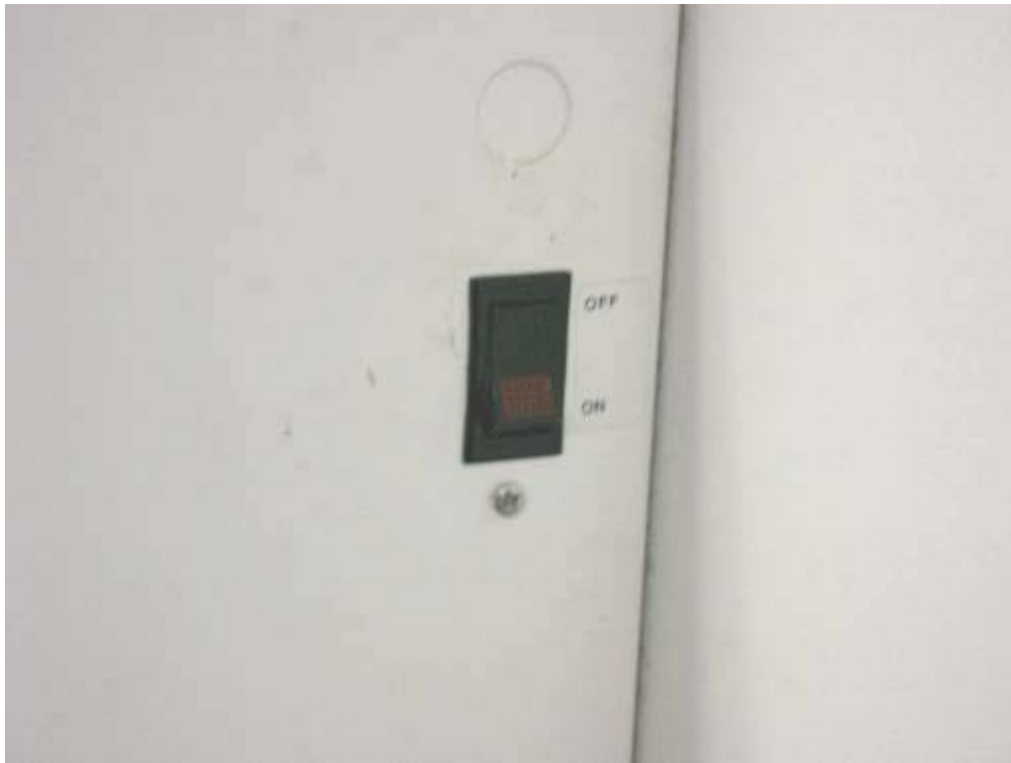
Picture 9

Air Handling Unit for Modular Classroom Switched to “Off”

1. Operate both supply and exhaust ventilation continuously during periods of school occupancy, independent of classroom thermostat control to maximize air exchange.

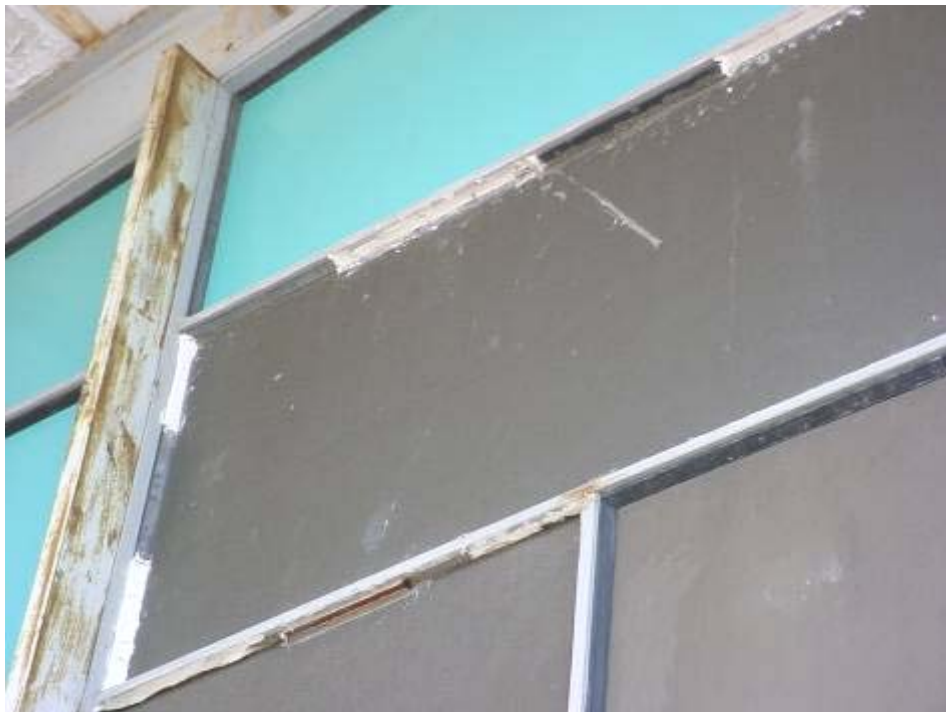
Picture 10

Several potential sources of water damage/water infiltration were observed in the building. Throughout the school, caulking around the interior and exterior windowpanes was crumbling, missing or damaged (Pictures 10 and 11). As previously mentioned, air infiltration was noted around windows, which has resulted in chronic water penetration illustrated by water damaged ceiling tiles along window frames throughout the building (Pictures 12 and 13). Water penetration through window frames can lead to mold growth under certain conditions. Repairs of window leaks are necessary to prevent further water

Loose/Damaged Caulking

2. Consider having exterior walls re-pointed and waterproofed to prevent water intrusion. This measure should include a full building envelope evaluation.
3. Consider replacing window systems to prevent air infiltration and water penetration.

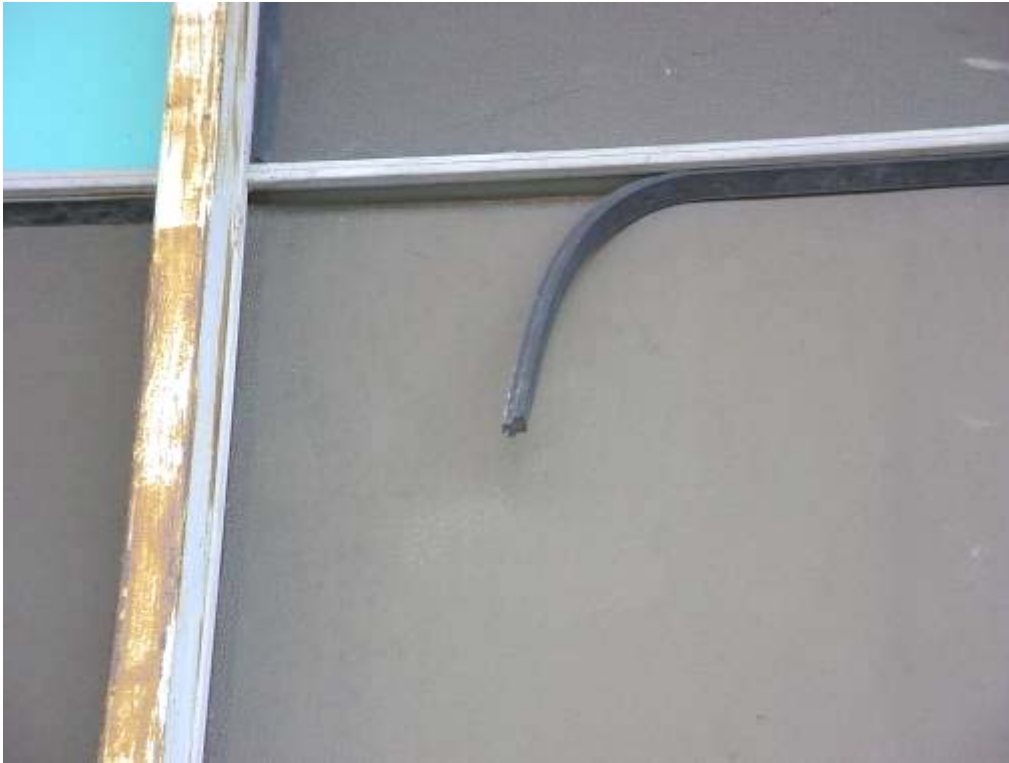
Picture 11

Loose/Damaged Strip Caulking

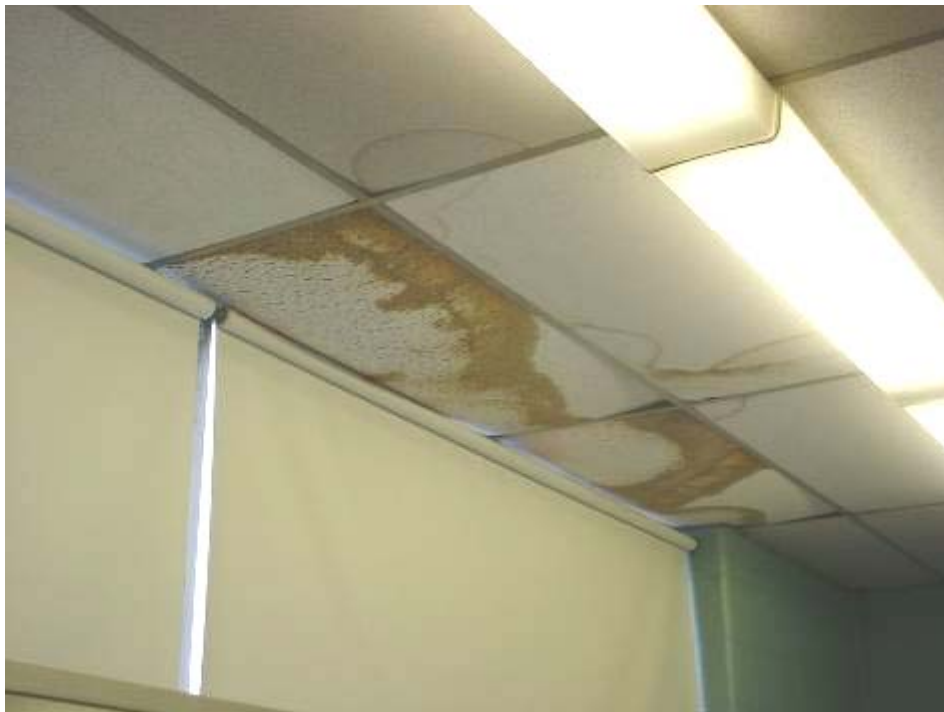
Picture 12

penetration. Water-damaged ceiling tiles can provide a source of mold and should be replaced after a water leak is discovered and repaired.

Water-damage to Ceiling Tiles along Windows

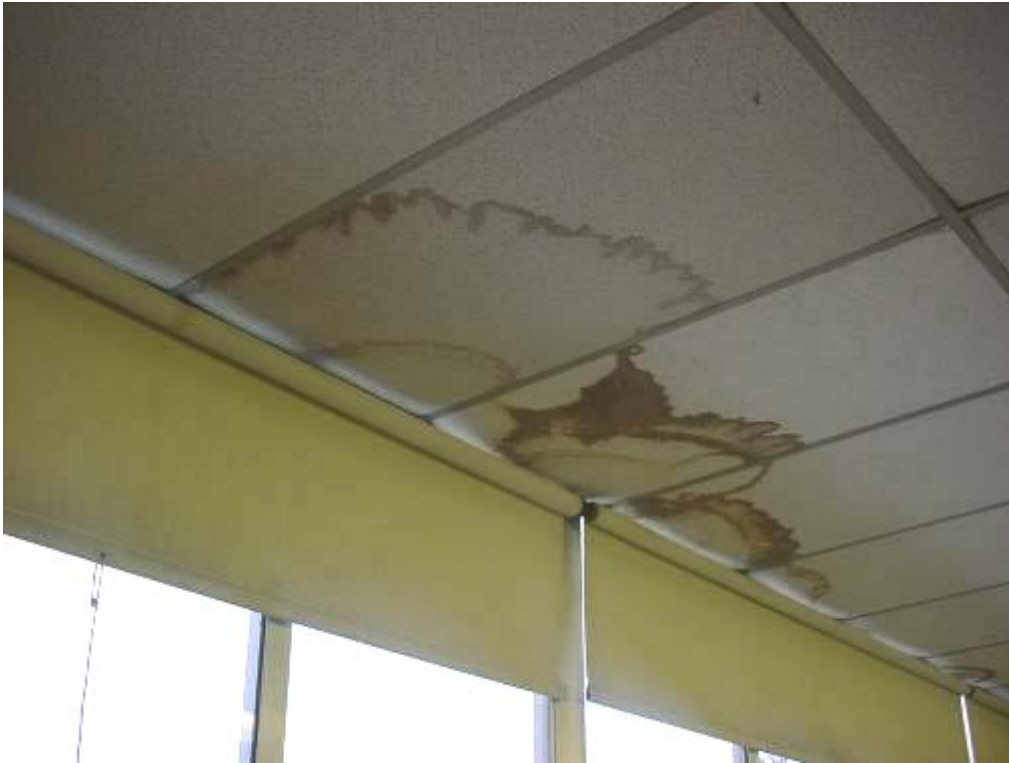
Picture 13

Water-damage to Ceiling Tiles along Window

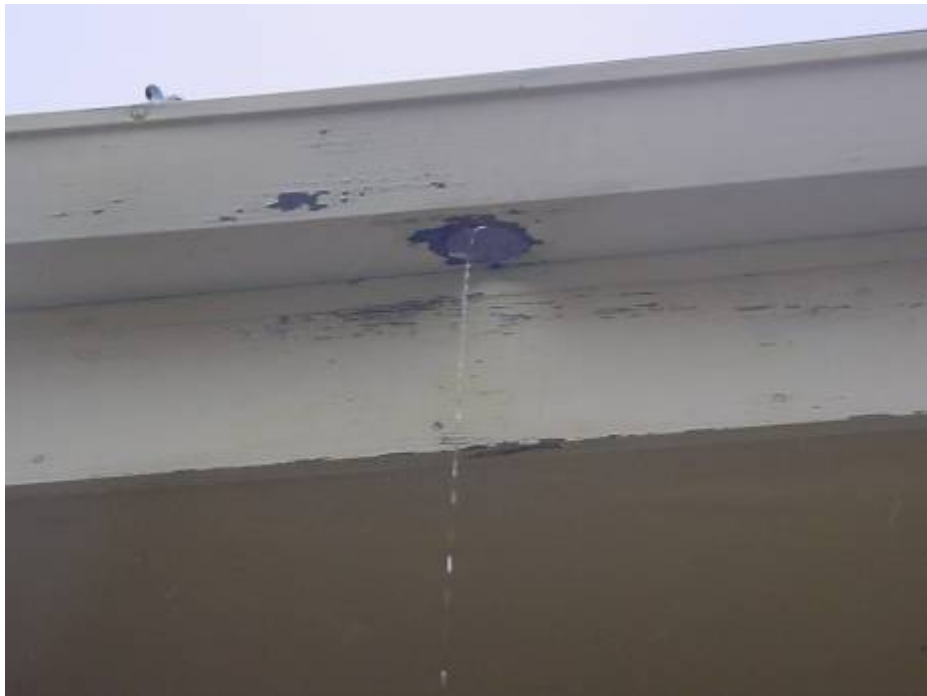
Picture 14

- Gutters/downspouts were damaged and emptying against the exterior of the building, allowing rainwater to pool on the ground at the base of the building (Pictures 14 through 17);
- Open utility holes (Picture 18);
- Interior and exterior wall cracks (Picture 19); and
- A tree growing at the base of the exterior wall on the southwest corner of the building (Picture 20).

The conditions listed above can undermine the integrity of the building envelope and create/provide a means of water entry by capillary action into the building through exterior walls, foundation concrete and masonry (Lstiburek & Brennan, 2001). The freezing and thawing action of water during the winter months can create cracks and fissures in the foundation. In addition, they can serve as pathways for insects, rodents and other pests into the building.

Water Emptying Against Building Hole in Gutter/Missing Downspout

11. Repair/replace damaged/missing gutters and downspouts to collect and drain water away from the building.
12. Seal open utility holes to prevent water penetration and block insect and rodent pathways into the building.

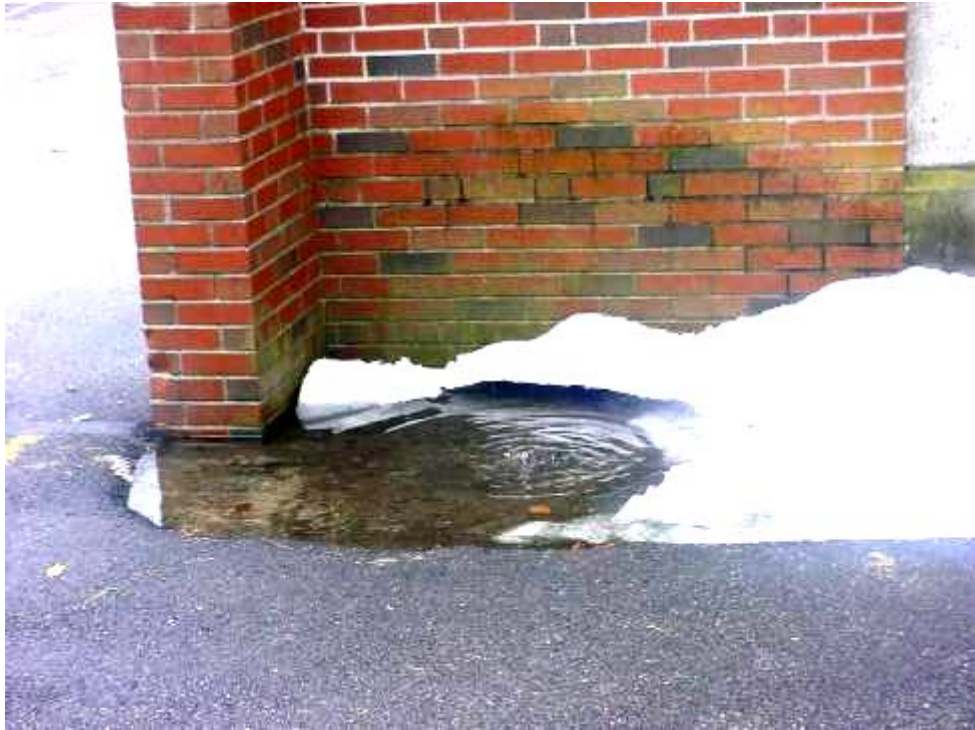
Picture 15

Exterior brickwork in several areas was visibly moist and had moss growth on the surface (Pictures 15 and 16). The building has been exposed to a substantial amount of water as a result of damaged gutters/downspouts. Moss growth is a sign of heavy/continuous water exposure which can undermine the structural integrity of the brick and mortar by holding moisture against the building.

Water Pooling at Base of Building, Note Moss Growth on Exterior Wall (as Indicated by Dark Staining)

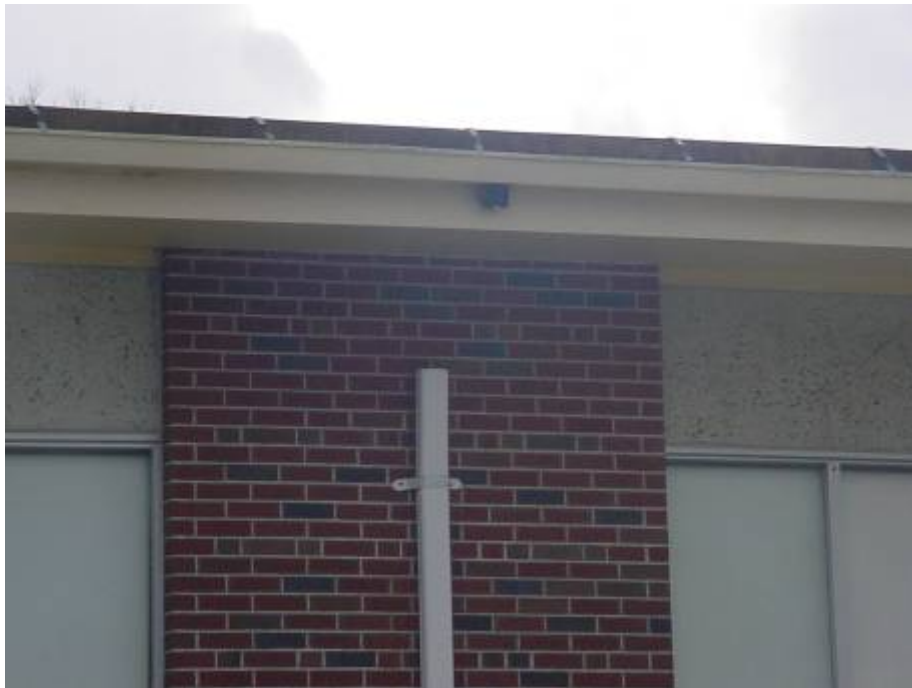
Picture 16

Missing/Damaged Downspout

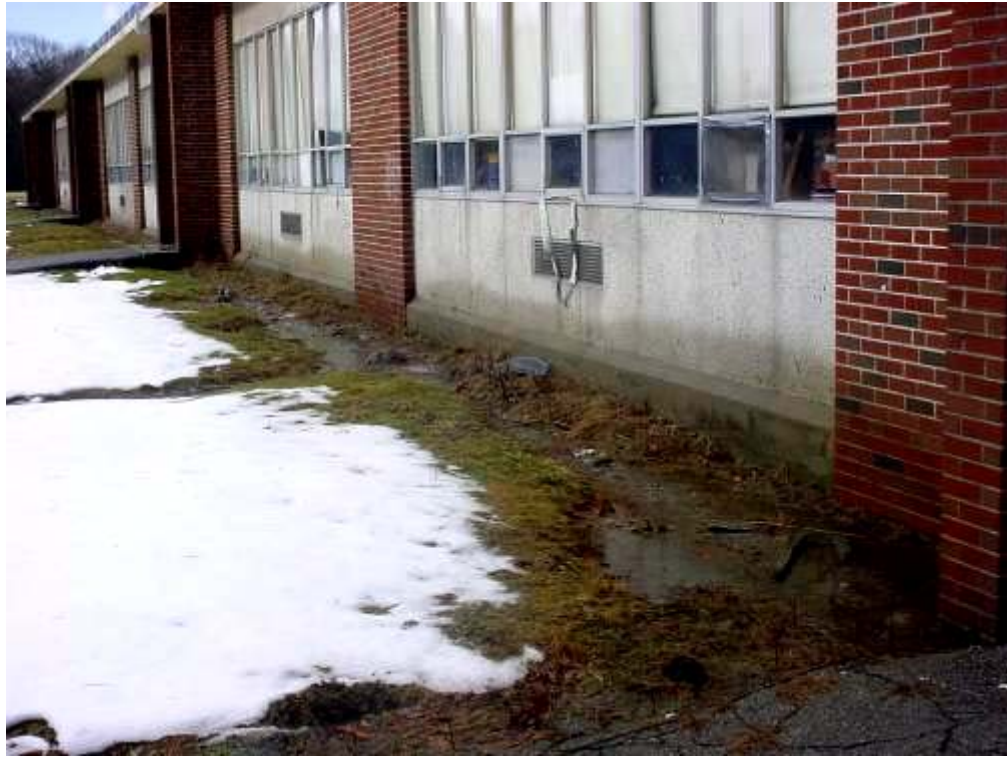
Picture 17

Water Pooling at the Base of Building against Exterior Wall Note Backsplash on Exterior Wall (as Indicated by Dark Staining)

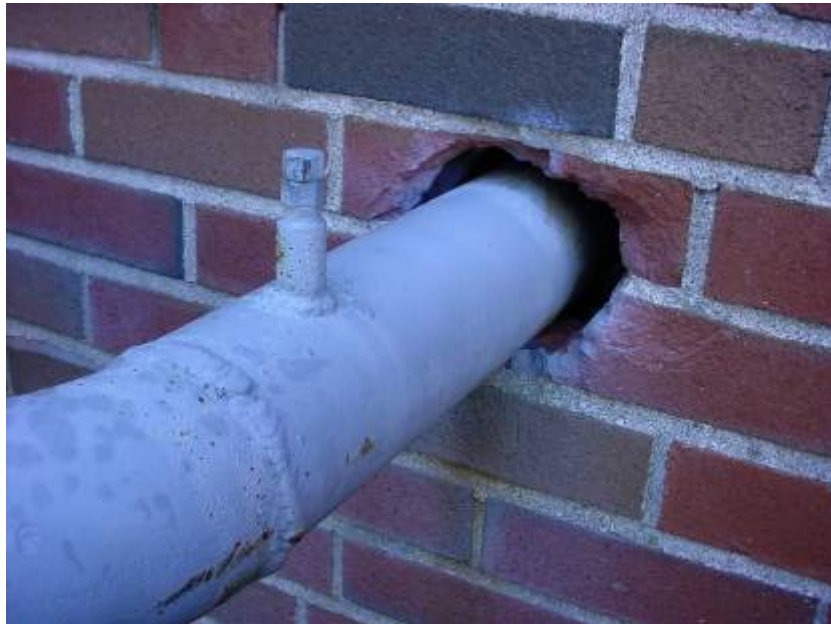
Picture 18

Open Utility Hole

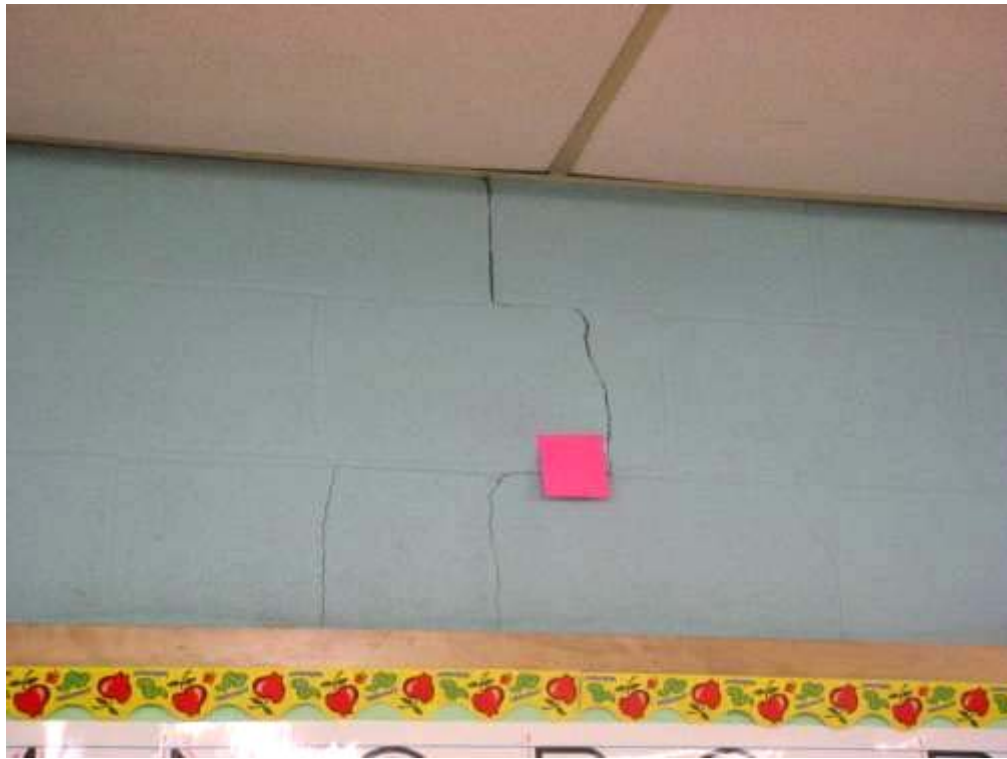
Picture 19

Interior Wall Crack

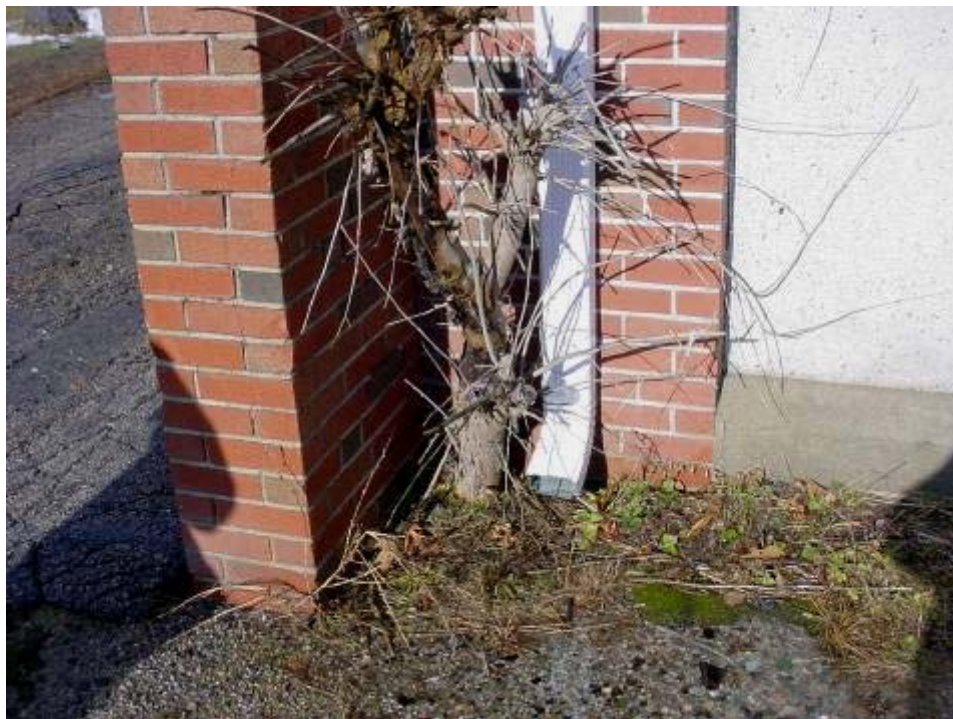
Picture 20

Tree Growing against Foundation/Exterior Walls

13. Remove tree growing at base of exterior wall on southwest corner of building. Ensure roots did not undermine structural integrity of brick and mortar.

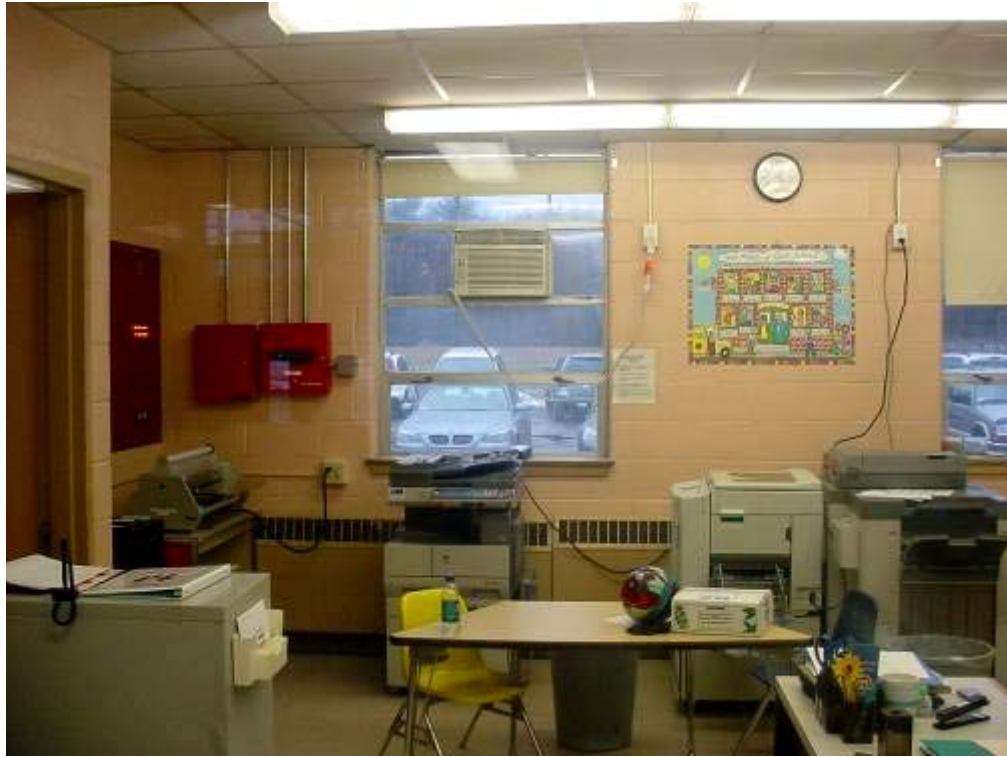
Picture 21

The main office contains photocopiers and a laminator (Picture 21). This area is not equipped with local exhaust ventilation to help reduce excess heat and odors. VOCs and ozone can be produced by photocopiers, particularly if the equipment is older and in frequent use. Ozone is a respiratory irritant (Schmidt Etkin, 1992).

Photocopiers and Laminator in Main Office

14. Consider installing local exhaust ventilation for photocopiers and laminator in main office.

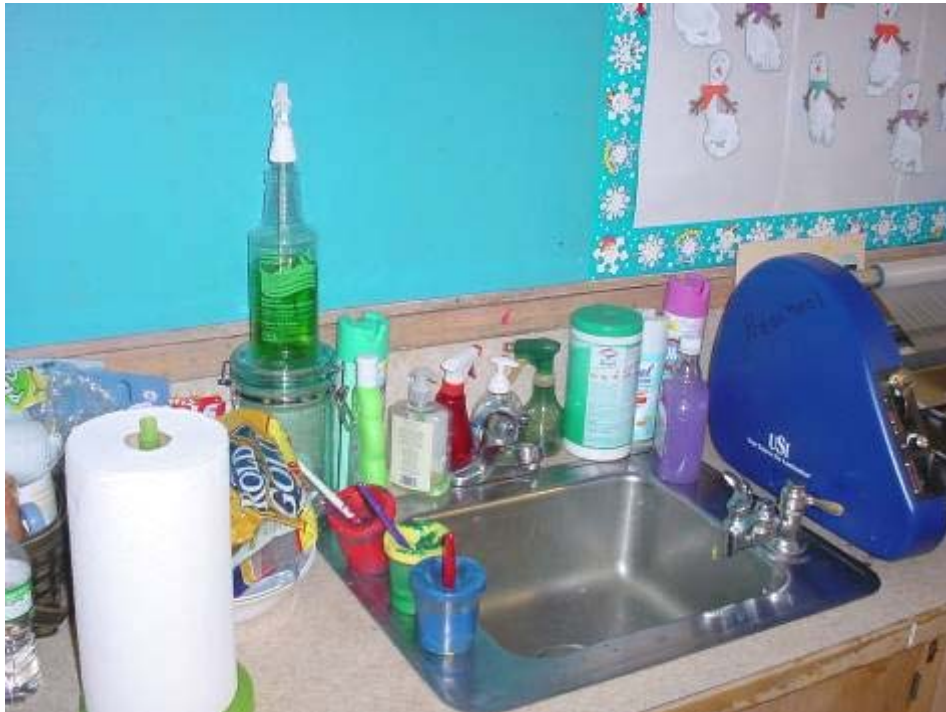
Picture 22

Cleaning products were found on countertops and in unlocked cabinets beneath sinks in a number of classrooms. Like dry erase materials, cleaning products contain VOCs and other chemicals (Picture 22). These chemicals can be irritating to the eyes, nose and throat and should be kept out of reach of students.

Cleaning Products on Classroom Countertop

15. Store cleaning products properly and out of reach of students. Ensure spray bottles are properly labeled. *All* cleaning products used at the facility should be approved by the school department with MSDS' available at a central location.

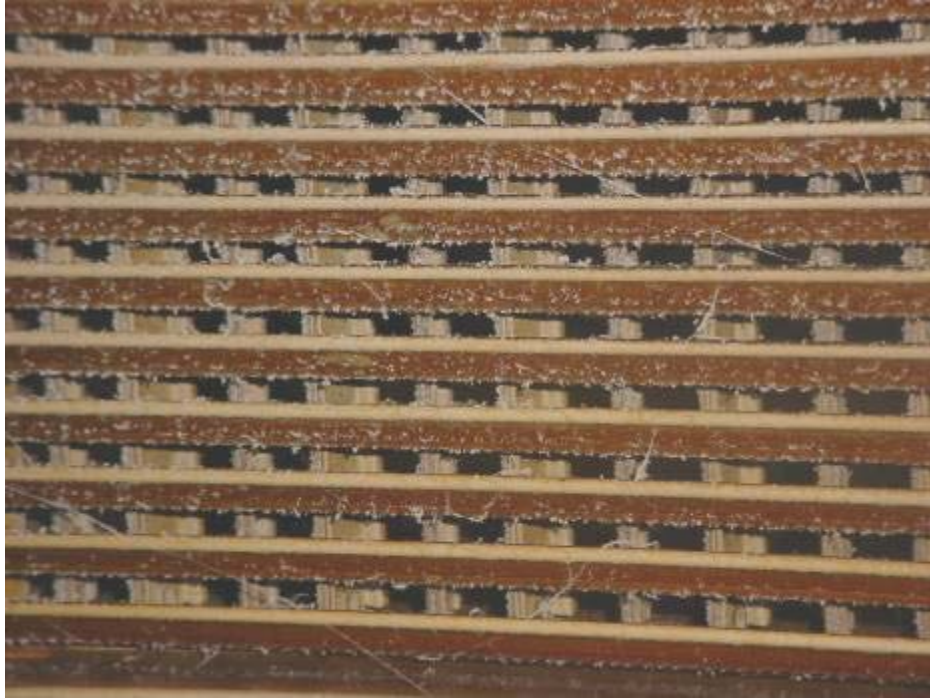
Picture 23

A number of exhaust/return vents, univent air diffusers and personal fans (Pictures 23 and 24) were observed to have accumulated dust. If exhaust vents are not functioning, backdrafting can occur, which can re-aerosolize accumulated dust particles. Re-activated univents and fans can also aerosolize dust accumulated on vents/fan blades.

Dirty Exhaust Vent

17. Clean personal fans, univent air diffusers, return vents and exhaust vents periodically of accumulated dust.
18. Clean chalk and dry erase trays to prevent accumulation of materials.

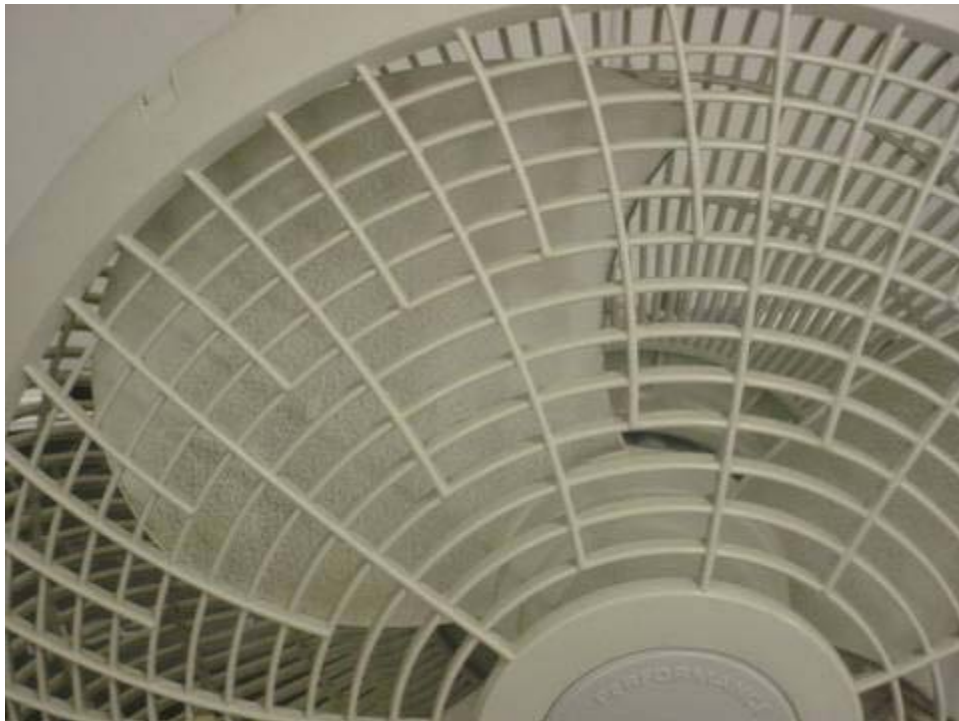
Picture 24

Personal Fan with Dust on Blades

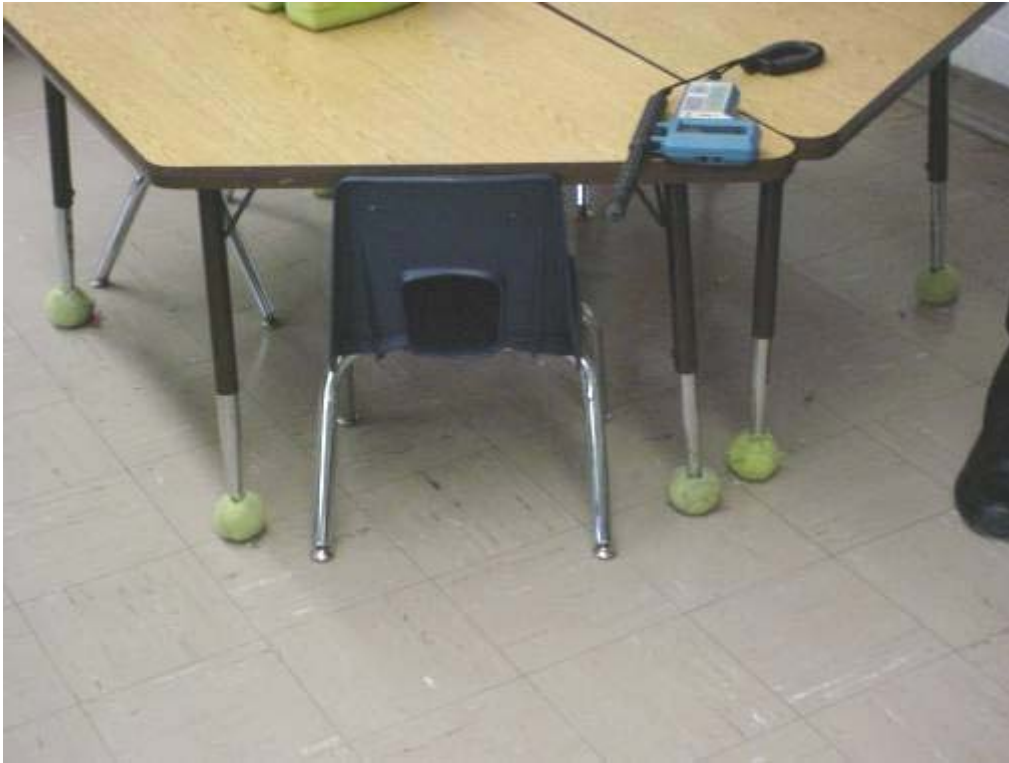
Picture 25

In an effort to prevent scratching from sliding tables, tennis balls had been sliced open and placed on the table legs (Picture 25). Tennis balls are made of a number of materials that are a source of respiratory irritants. Constant wearing of tennis balls can produce fibers and cause TVOCs to off-gas. Tennis balls are made with a natural rubber latex bladder, which becomes abraded when used as a chair leg pad. Use of tennis balls

in this manner may introduce latex dust into the school environment. Some individuals are highly allergic to latex (e.g., spina bifida patients) (SBAA, 2001). It is recommended that the use of materials containing latex be limited in buildings to reduce the likelihood of symptoms in sensitive individuals (NIOSH, 1997).

Tennis Balls on Table Legs

19. Clean and maintain aquariums and terrariums to prevent mold growth and associated odors.
20. Replace latex-based tennis balls with latex-free tennis balls or glides.

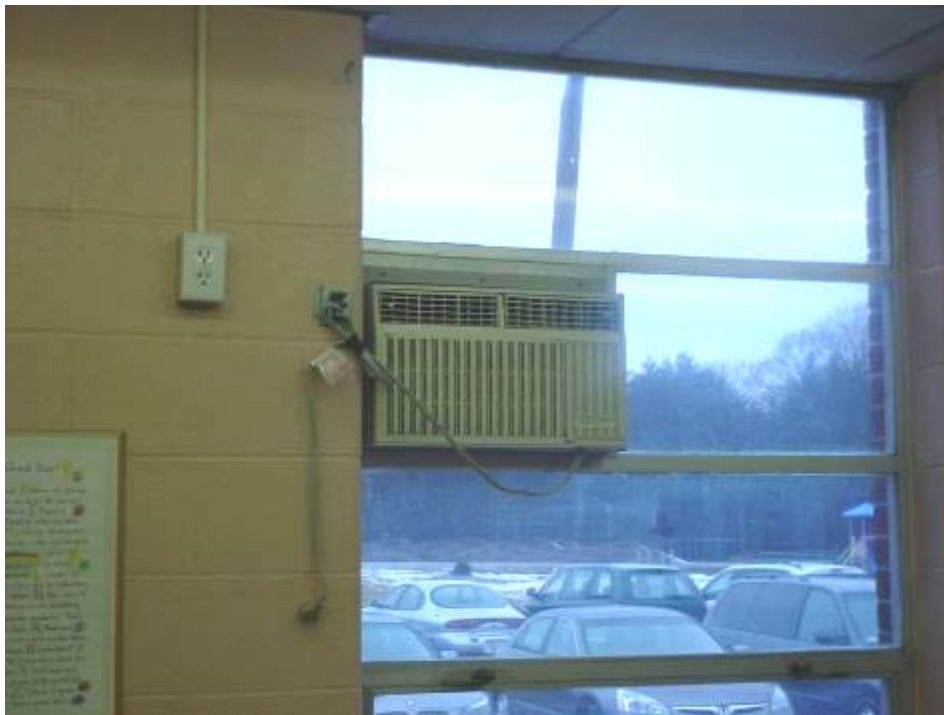
Picture 26

Finally, a number of classrooms had window-mounted air conditioners (ACs) or wall-mounted units (Picture 26). ACs are normally equipped with filters, which should be cleaned or changed as per manufacturer's instructions to avoid the build-up and re-aerosolization of dirt, dust and particulate matter.

Air Conditioner in Window

6. Change filters for air-handling equipment (e.g., univents, AHUs and ACs) as per the manufacturer's instructions or more frequently if needed. Vacuum interior of units prior to activation to prevent the aerosolization of dirt, dust and particulates. Ensure filters fit flush in their racks with no spaces in between allowing bypass of unfiltered air into the unit.
