INDOOR AIR QUALITY ASSESSMENT

**Jordan/Jackson Elementary School
255 East Street
Mansfield, MA 02048**

Prepared by:
Massachusetts Department of Public Health
Bureau of Environmental Health
Indoor Air Quality Program
April 2008

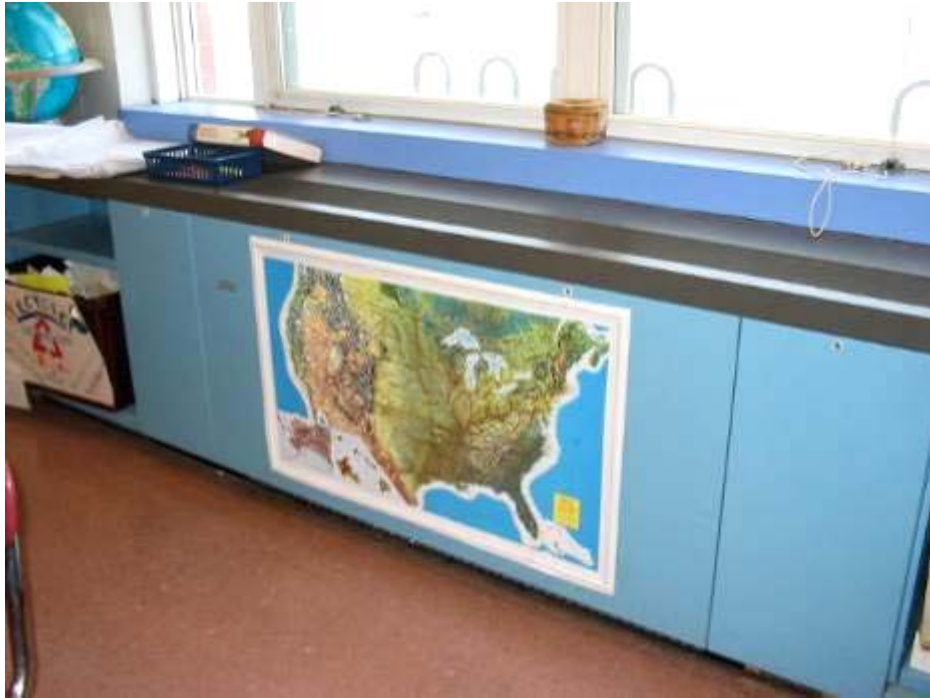
Picture 1

Fresh air is supplied to classrooms by unit ventilator (univent) systems (Picture 1). A univent draws air from the outdoors through a fresh air intake located on the exterior wall of the building (Picture 2) and returns air through an air intake located at the base of the unit ([Figure 1](#)). Fresh and return air are mixed, filtered, heated and provided to classrooms through an air diffuser located in the top of the unit. Univents were found obstructed by furniture, books and other stored materials (Picture 3). Further, a heavy buildup of dust and debris was observed in

Classroom Unit

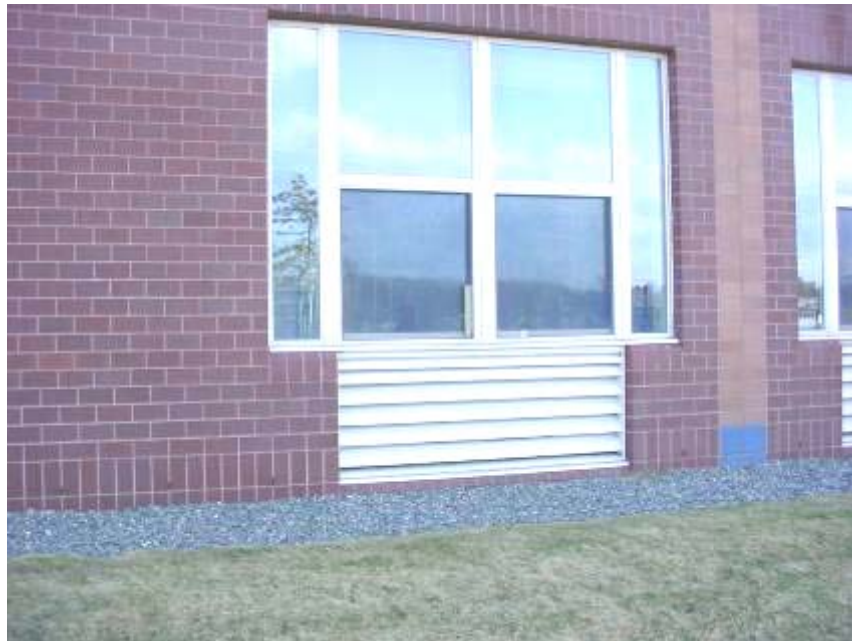
Picture 2

Fresh Air Intake

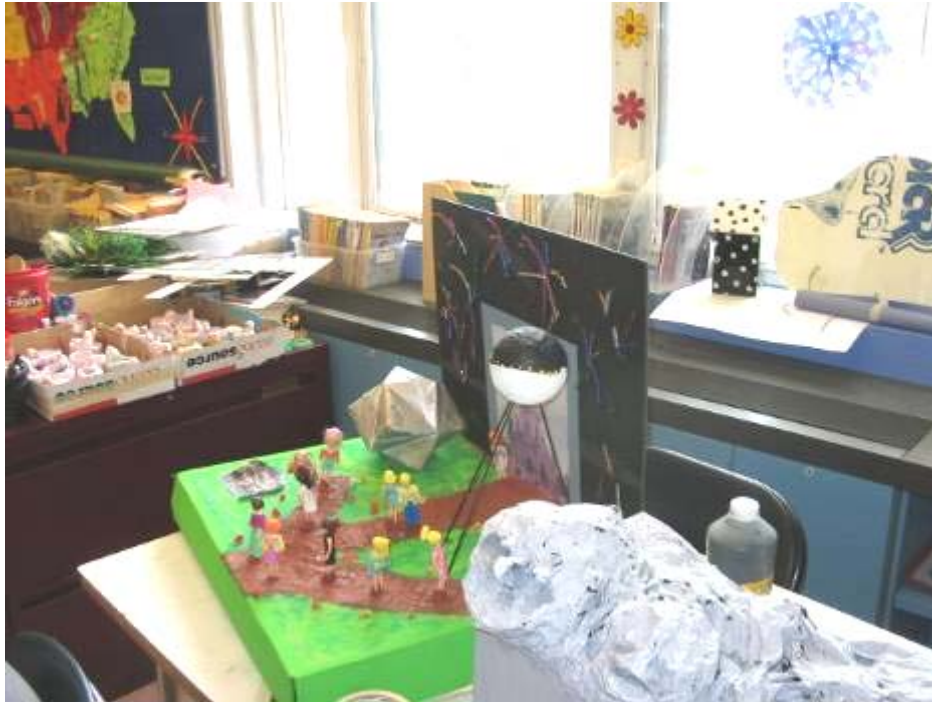
Picture 3

Univent Blocked by Furniture and Store Materials

2. Inspect exhaust motors and belts for proper function. Repair and replace as necessary.
3. Remove all blockages from univents and exhaust vents to ensure adequate airflow.

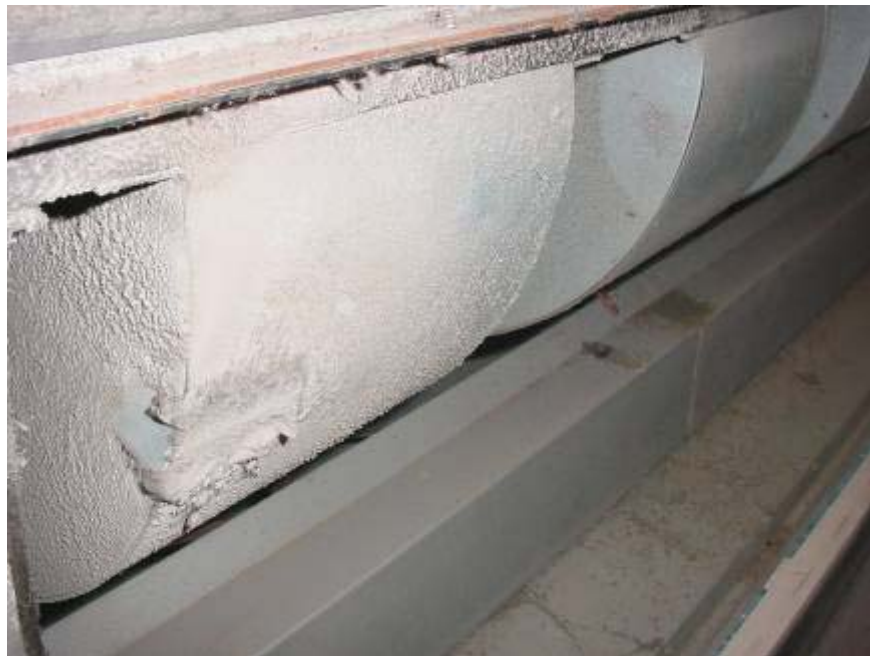
Picture 4

the air diffusers of several univents. In one particular room, BEH staff opened the univent to find a buildup of dirt, dust and debris as well as disintegrating fiberglass insulation (Pictures 4 and 5/Table 1). In order for univents to provide fresh air as designed, air diffusers, intakes and returns must remain free of obstructions. Importantly, these units must remain “on” and be allowed to operate while rooms are occupied.

Dirt, Dust, Debris Buildup in Univent

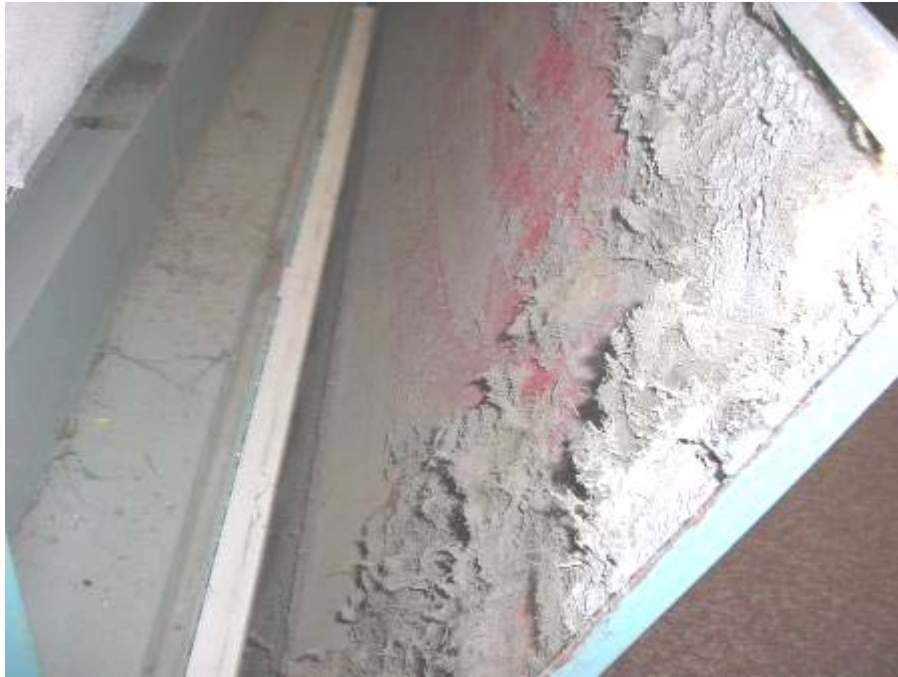
Picture 5

Disintegrating Fiberglass Insulation in Univent

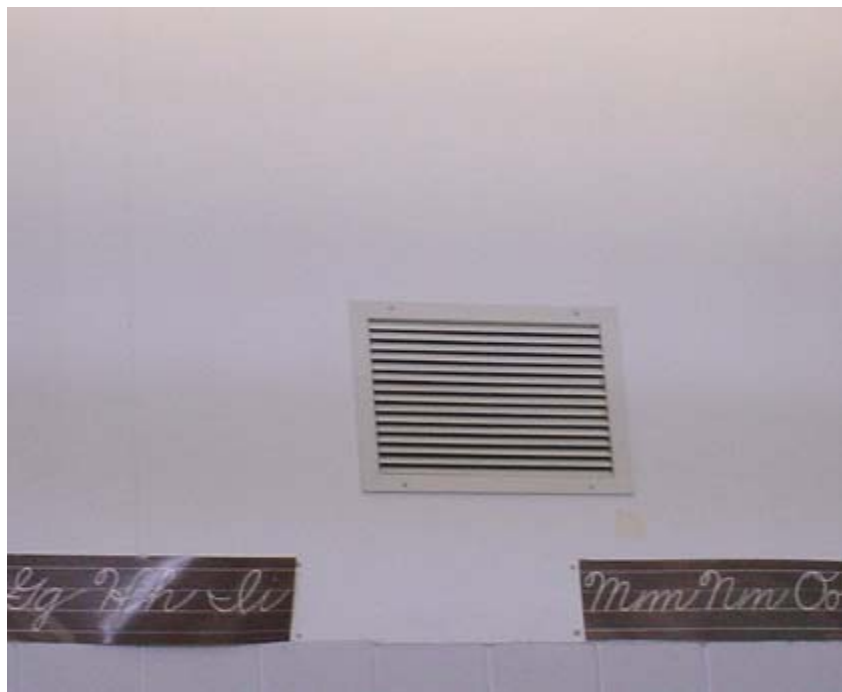
Picture 6

Exhaust ventilation in classrooms is provided by ceiling and wall-mounted vents (Picture 6) ducted to rooftop motors. Exhaust ventilation was deactivated in a number of areas during the assessment (Table 1). As with univents, in order to function properly, exhaust vents must be activated and allowed to operate while rooms are occupied. Without adequate supply and exhaust ventilation, excess heat and environmental pollutants can build up leading to indoor air/comfort complaints. Also of note was a breach in the ductwork in classroom A-214 (Picture 7), which can reduce the efficiency of the exhaust system.

Wall-Mounted Exhaust Vent

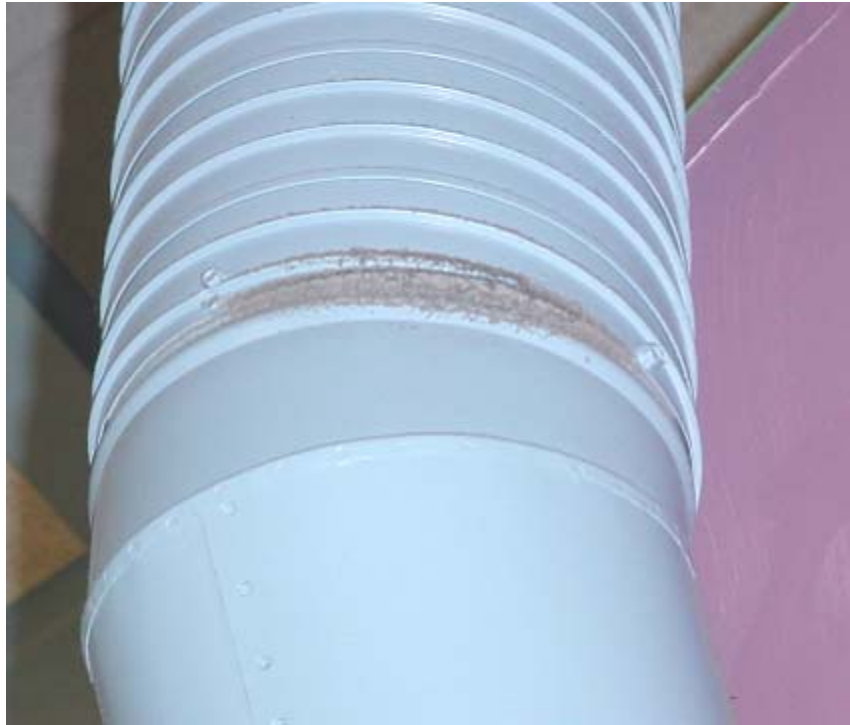
Picture 7

Breach in Exhaust Duct, Note Dust/Debris Accumulation

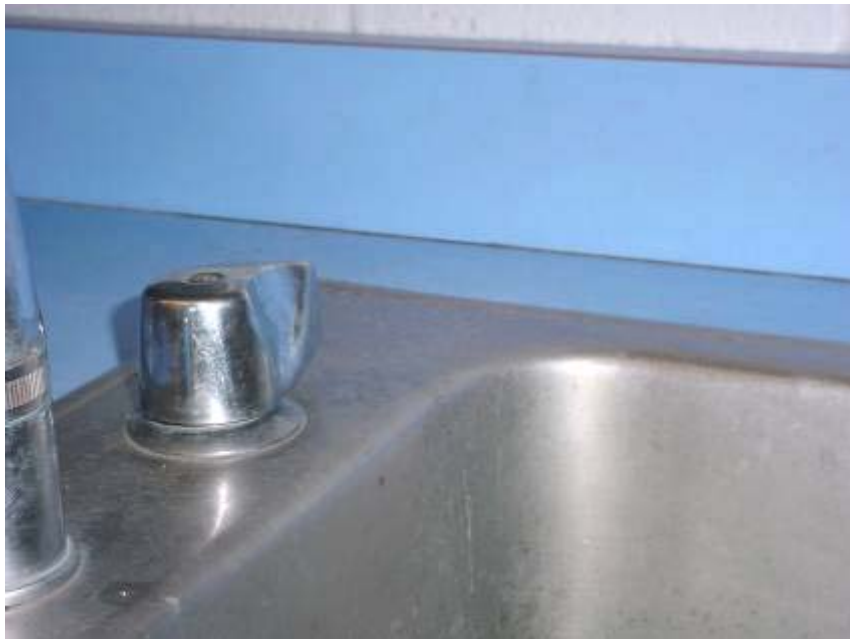
Picture 8

Open seams between sink countertops and walls were observed in several rooms (Picture 8). If not watertight, moisture can penetrate through the seam, causing water damage. Improper drainage or sink overflow can lead to water penetration into the countertop, cabinet interior and areas behind cabinets. Water penetration and chronic exposure of porous and wood-based materials can cause these materials to swell and show signs of water damage.

Open Seam between Sink Countertop and Backsplash

8. Install weather stripping around exterior doors to prevent drafts, water penetration and pest entry.
9. Seal areas around sinks to prevent water damage to the interior of cabinets and adjacent wallboard. Inspect wallboard for water damage and mold growth, repair/replace as necessary. Disinfect areas with an appropriate antimicrobial, as needed.

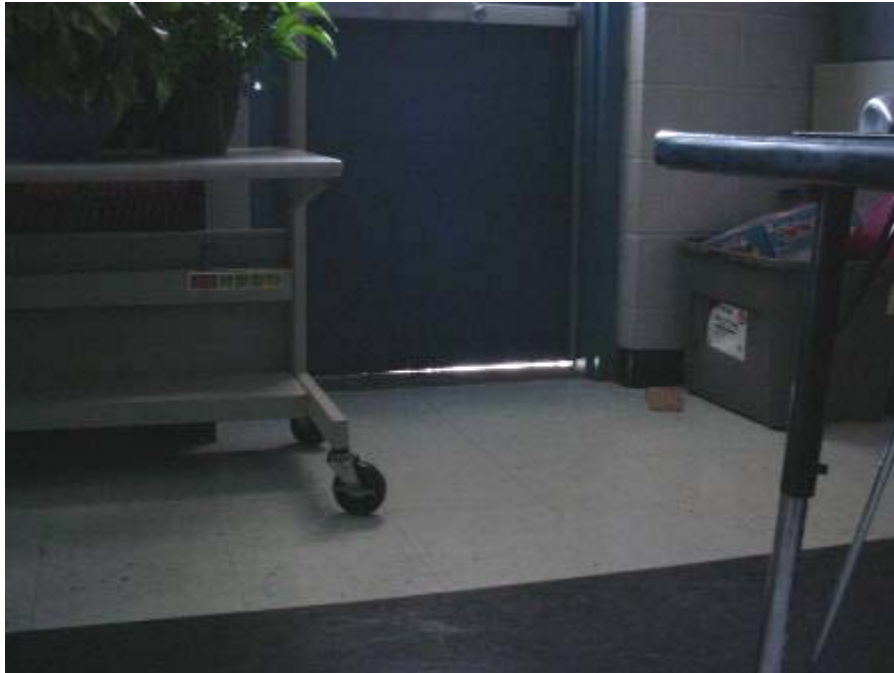
Picture 9

Some classrooms were equipped with exterior doors. Several of these doors had damaged weather stripping, and light could be seen penetrating through the spaces underneath the door from the outdoors (Picture 9). Spaces beneath exterior doors can serve as a source of water entry into the building, causing water damage and potentially leading to mold growth. In addition, these spaces can serve as pathways for insects, rodents and other pests into the building.

Space underneath Exterior Door

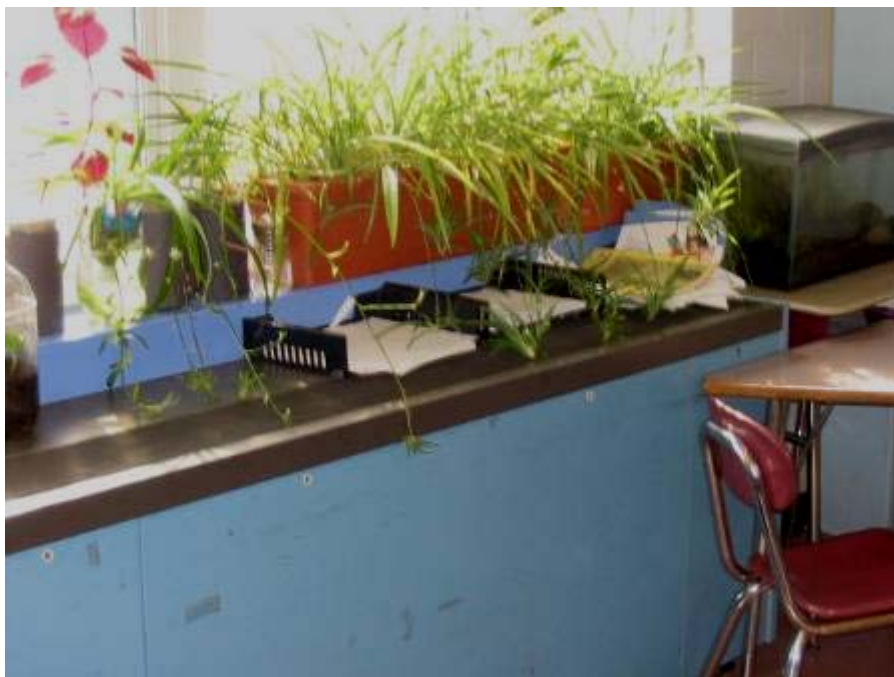
Picture 10

Several classrooms had a number of plants (Picture 10). Moistened plant soil and drip pans can be a source of mold growth. Plants should be equipped with drip pans; the lack of drip pans can lead to water pooling and mold growth on windowsills. Plants are also a source of pollen. Terrariums were observed in some classrooms in close proximity to classroom univents (Picture 10). Terrariums should be properly maintained to ensure soil does not become a source for mold growth. Plants and terrariums should also be located away from univents to prevent the aerosolization of dirt, mold, pollen, odors or particulate matter throughout the classroom.

Plants and Terrarium near Univent

13. Make repairs to missing/damaged gutter/downspout system.
14. Clear plants/debris away from the exterior of univent fresh air intakes.
15. Clean and maintain aquariums and terrariums to prevent mold growth and associated odors.

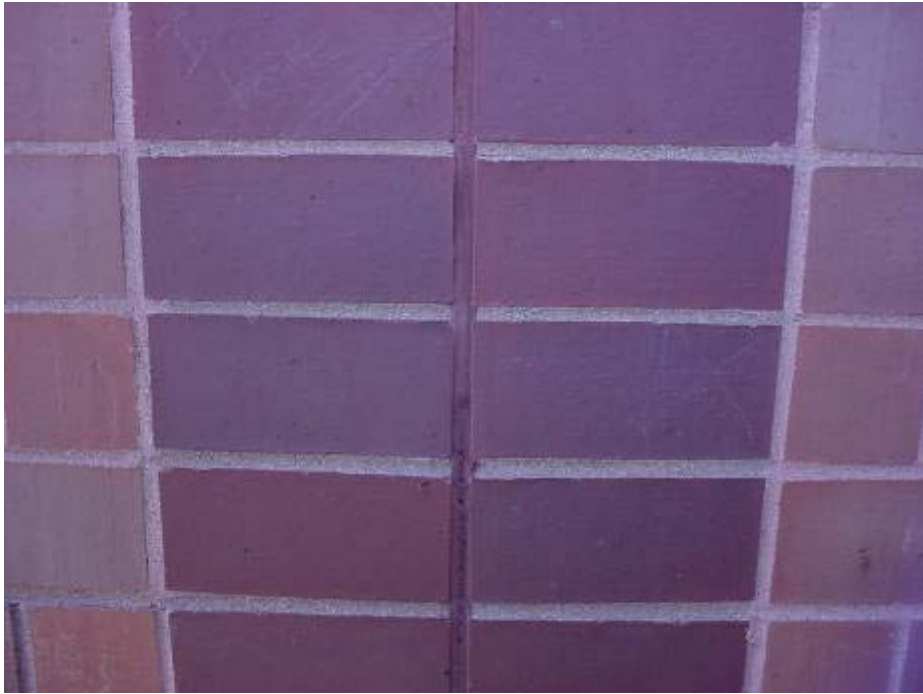
Picture 11

- Missing/damaged sealant between expansion joints (Pictures 11 and 12);
- Gutters/downspouts were damaged and emptying against the exterior of the building, allowing rainwater to pool on the ground at the base of the building (Picture 13);
- Open utility holes (Picture 14); and

Sealed Expansion Joint

11. Examine all expansion joint seals on the exterior wall system. Reseal all expansion joints with damaged, missing or eroded sealant.
12. Seal spaces around exterior utility holes.

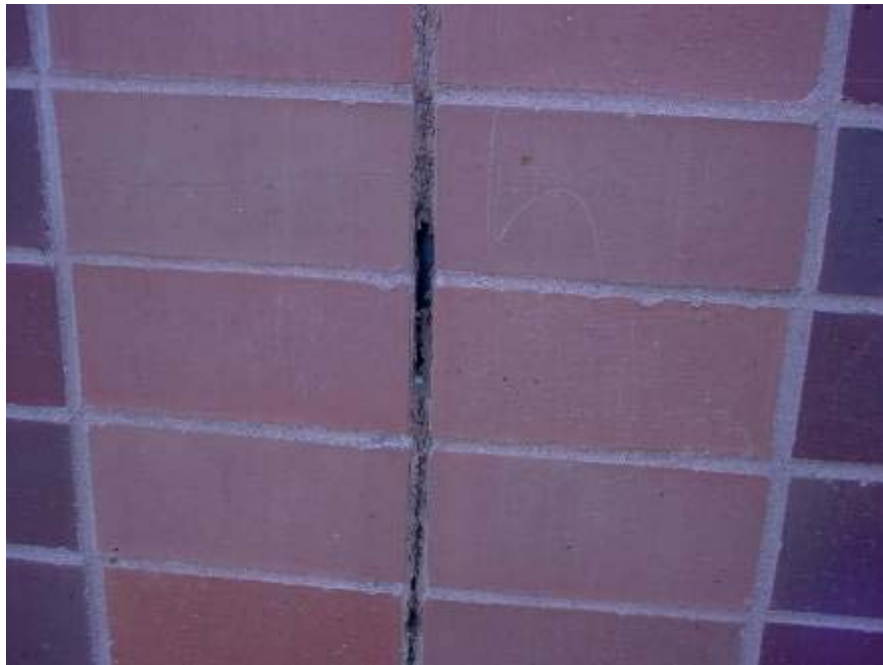
Picture 12

The conditions listed above can undermine the integrity of the building envelope and create/provide a means of water entry by capillary action into the building through exterior walls, foundation concrete and masonry (Lstiburek & Brennan, 2001). The freezing and thawing action of water during the winter months can create cracks and fissures in the foundation. In addition, they can serve as pathways for insects, rodents and other pests into the building.

Expansion Joint with Missing/Damaged Sealant

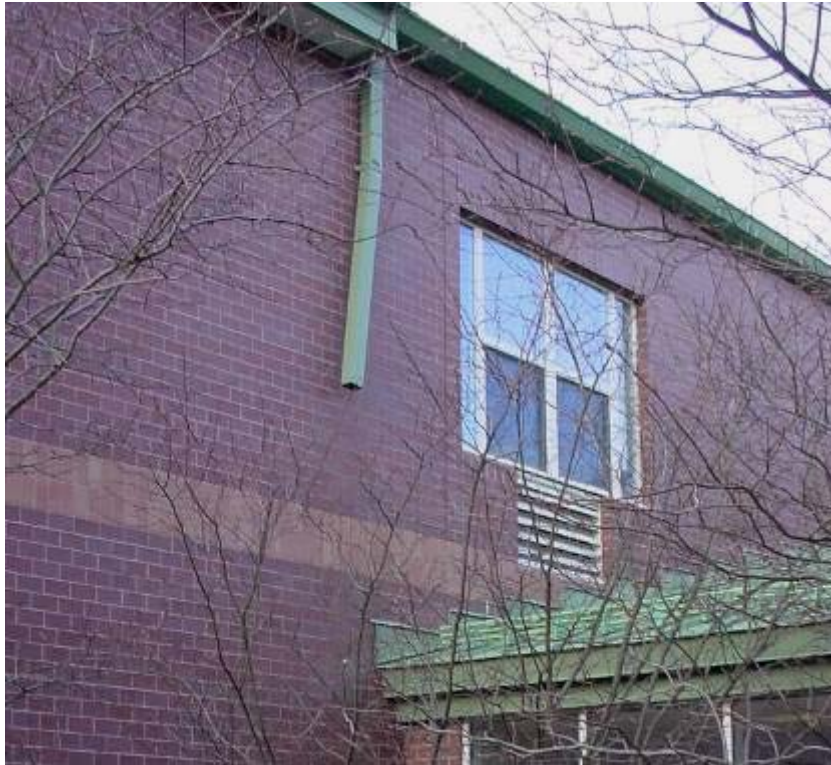
Picture 13

Missing/Damaged Downspout

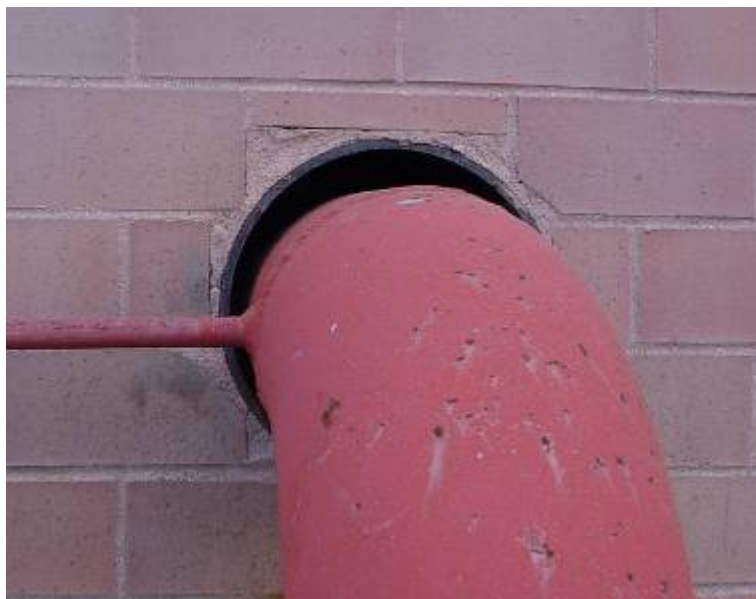
Picture 14

Spaces around Utility Hole

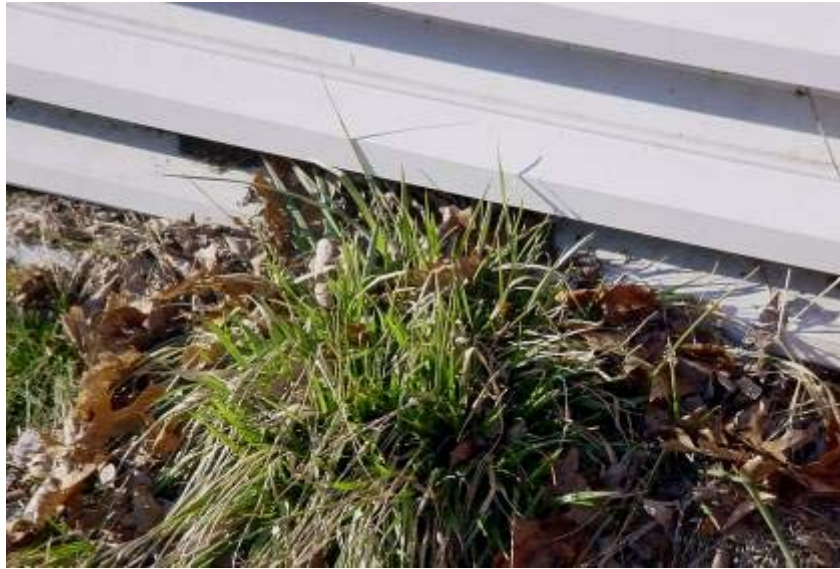
Picture 15

- Plants/debris in/near univent fresh air intakes (Picture 15).

Plants/Leaves/Debris in/near Univent Air Intake

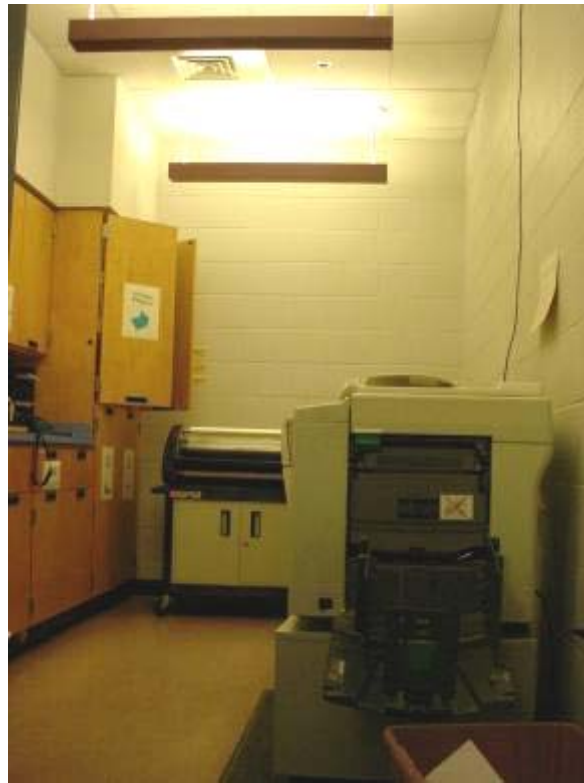
Picture 16

Work Room with Photocopier and Laminator

21. Clean upholstered furniture/cushions/pillows on the schedule recommended in this report.
If not possible/practical consider removal.
22. Ensure local exhaust ventilation is operating in teacher work rooms during use.

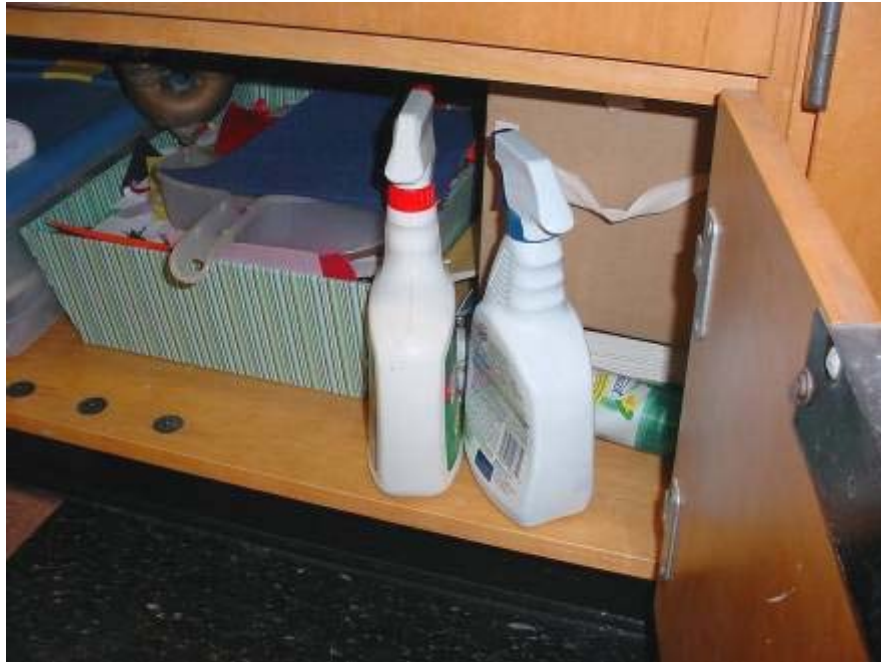
Picture 17

Cleaning products, spray paint and plastic primer spray were found on countertops and in unlocked cabinets beneath sinks in a number of classrooms (Pictures 17 and 18). These products contain VOCs and petroleum distillates, which can be irritating to the eyes, nose and throat. Further, the plastic primer is an extremely flammable liquid and vapor. It is important that cleaning products, spray paint and plastic primer spray be kept out of reach of children. Unlabeled/poorly labeled spray bottles were also observed in some classrooms. Products should be kept in their original containers, or should be clearly labeled as to their contents, for identification purposes in the event of an emergency. Further, material safety data sheets (MSDS) for all cleaning products must be available at a central location.

Cleaners under Sink

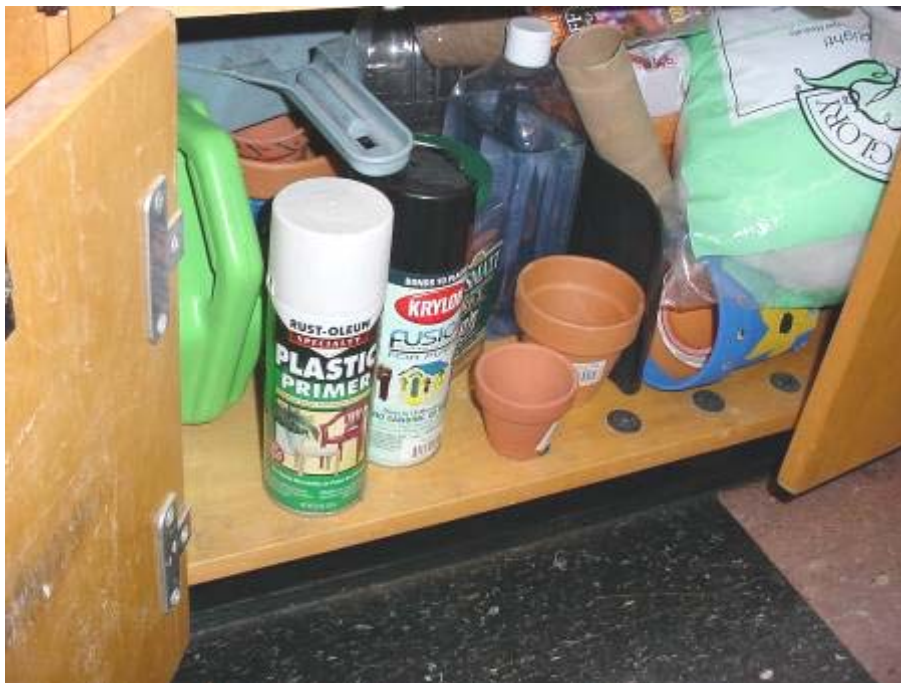
Picture 18

Spray Paint and Plastic Primer under Sink

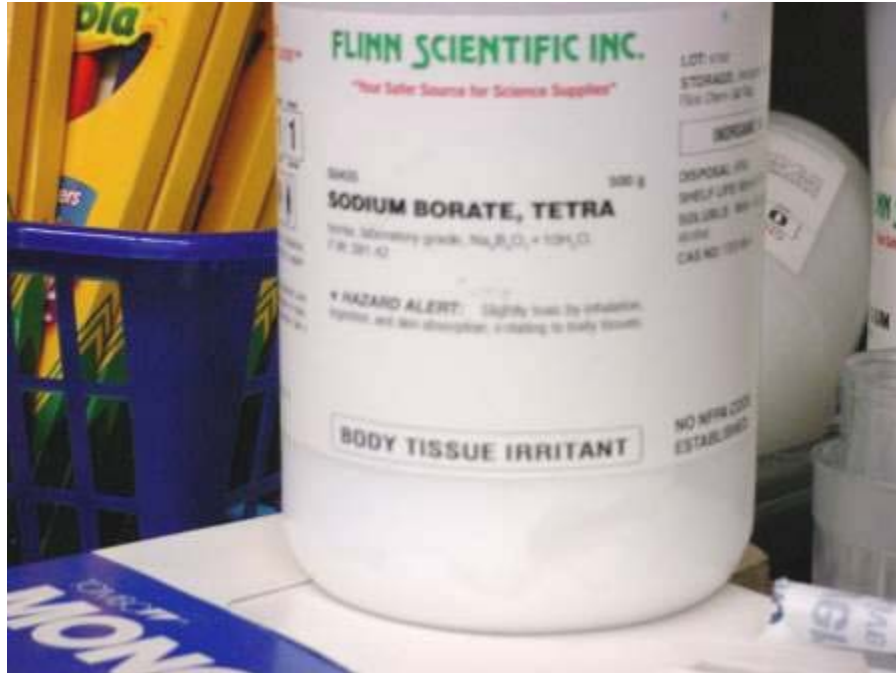
Picture 19

In one classroom, bottles of sodium borate, an industrial cleaner, were observed on the countertop next to the sink (Picture 19). Sodium Borate is slightly toxic by inhalation, ingestion and skin absorption. It is irritating to the eyes, skin and respiratory tract; avoid contact with body tissue (NIOSH, 2008). Therefore, it is important that sodium borate be kept out of reach of children.

Sodium Borate on Countertop in Classroom

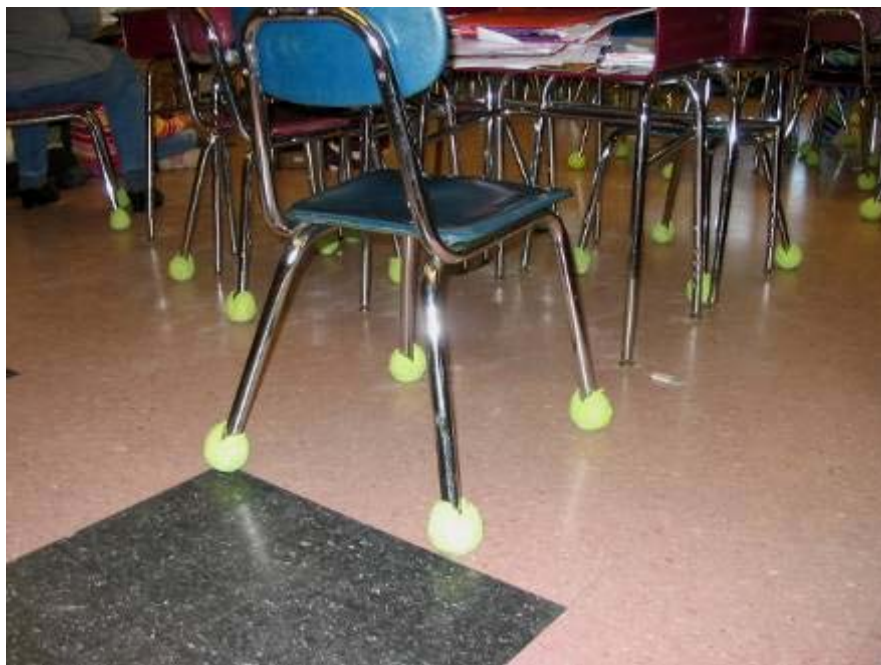
Picture 20

In an effort to reduce noise from sliding tables/chairs, tennis balls had been sliced open and placed on the base of the legs (Picture 20). Tennis balls are made of a number of materials that are a source of respiratory irritants. Constant wearing of tennis balls can produce fibers and cause VOCs to off-gas. Tennis balls are made with a natural rubber latex bladder, which becomes abraded when used as a chair leg pad. Use of tennis balls in this manner may introduce latex dust into the school environment. Some individuals are highly allergic to latex (e.g., spina bifida patients) (SBAA, 2001). It is recommended that the use of materials containing latex be limited in buildings to reduce the likelihood of symptoms in sensitive individuals (NIOSH, 1997).

Tennis Balls on Chair Legs

19. Clean chalk and dry erase trays to prevent accumulation of materials.
20. Replace latex-based tennis balls with latex-free tennis balls or alternative “glides”.

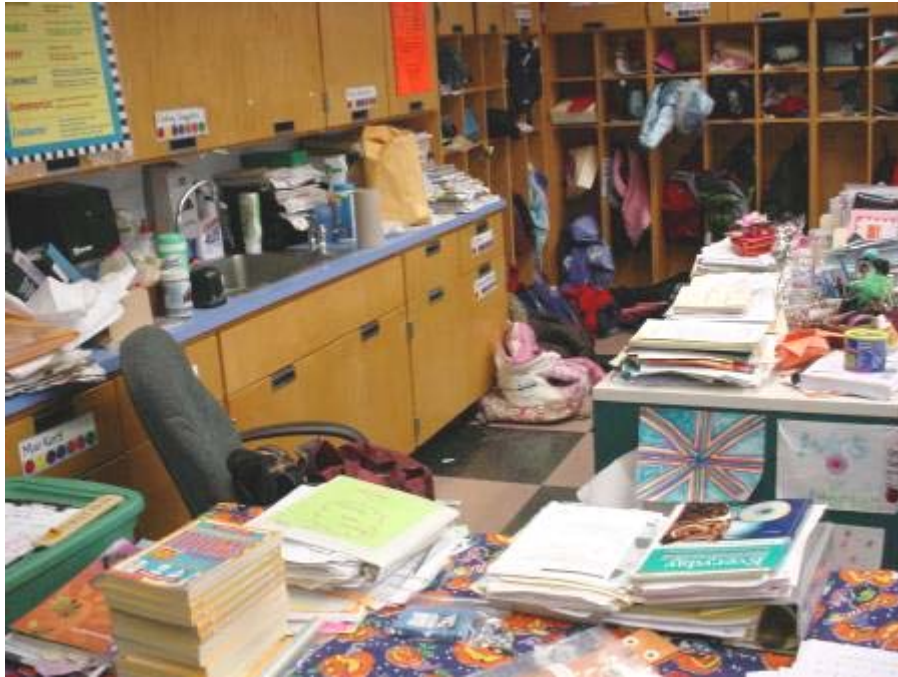
Picture 21

Other conditions that can affect indoor air quality were observed during the assessment. In several classrooms, items were observed on the floor, windowsills, tabletops, counters, bookcases and desks (Picture 21). The large number of items stored in classrooms provides a source for dusts to accumulate. These items (e.g., papers, folders, boxes) make it difficult for custodial staff to clean. Items should be relocated and/or be cleaned periodically to avoid excessive dust build up. In addition, these materials can accumulate on flat surfaces (e.g., desktops, shelving and carpets) in occupied areas and subsequently be re-aerosolized causing further irritation.

Accumulated Items in Classroom

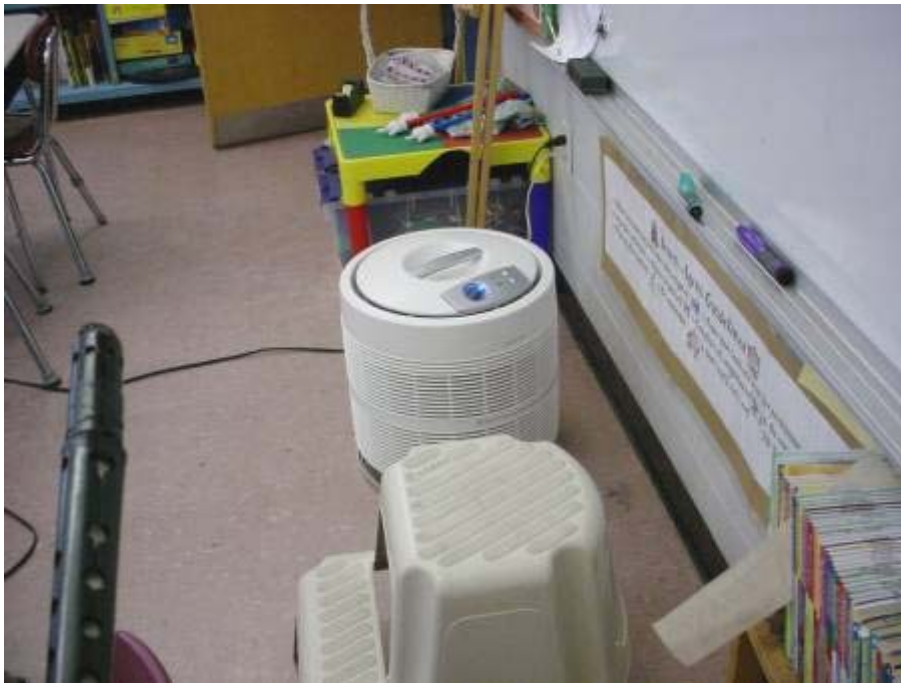
Picture 22

A high efficiency particulate air (HEPA) purifier was observed on the floor of a classroom (Picture 22). Air purifiers should be placed within the breathing zone rather than at floor level. In addition, this equipment is normally equipped with filters that should be cleaned or changed as per manufacturer's instructions to prevent build up and re-aerosolization of dirt, dust and particulate matter.

Air Purifier on Floor

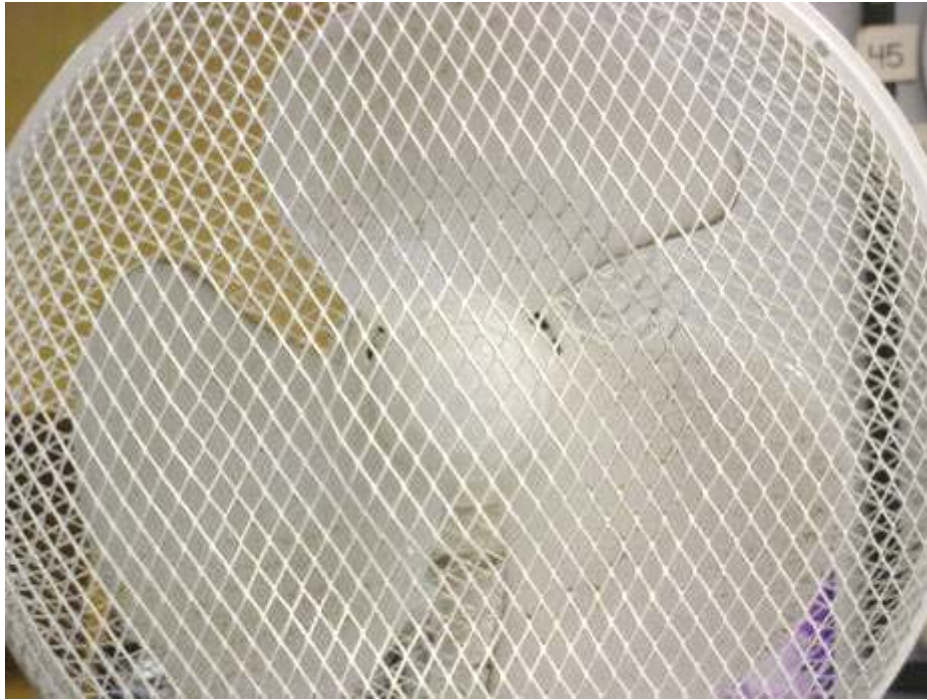
Picture 23

A number of exhaust/return vents, univent air diffusers and personal fans (Pictures 23 and 24) were observed to have accumulated dirt, dust and debris. If exhaust vents are not functioning, backdrafting can occur, which can re-aerosolize accumulated dirt and dust particles. Re-activated univents and fans can also aerosolize dirt and dust accumulated on vents/fan blades.

Dirt and Dust on Personal Fan

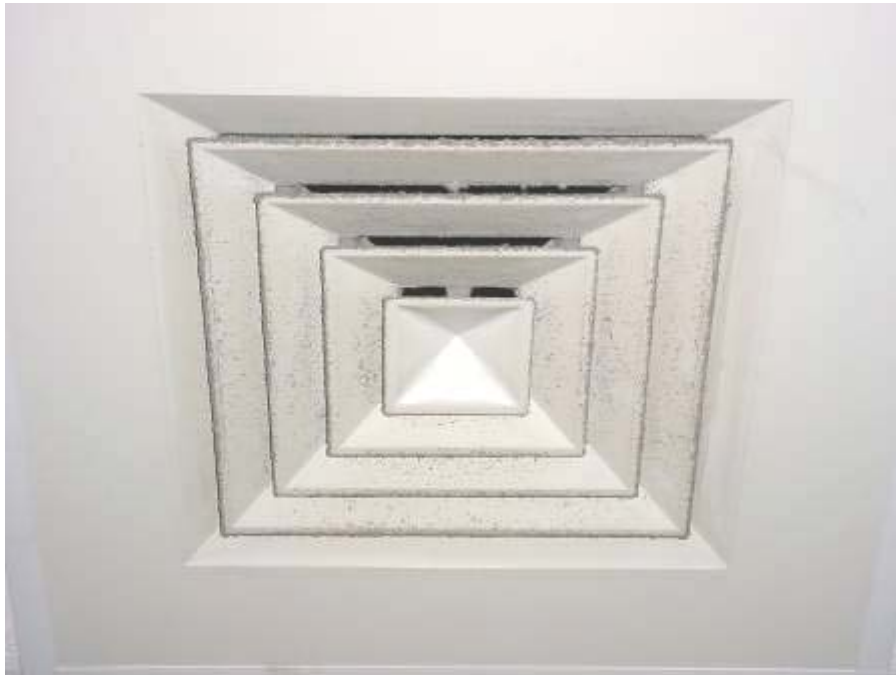
Picture 24

Exhaust Vent with Dirt and Dust

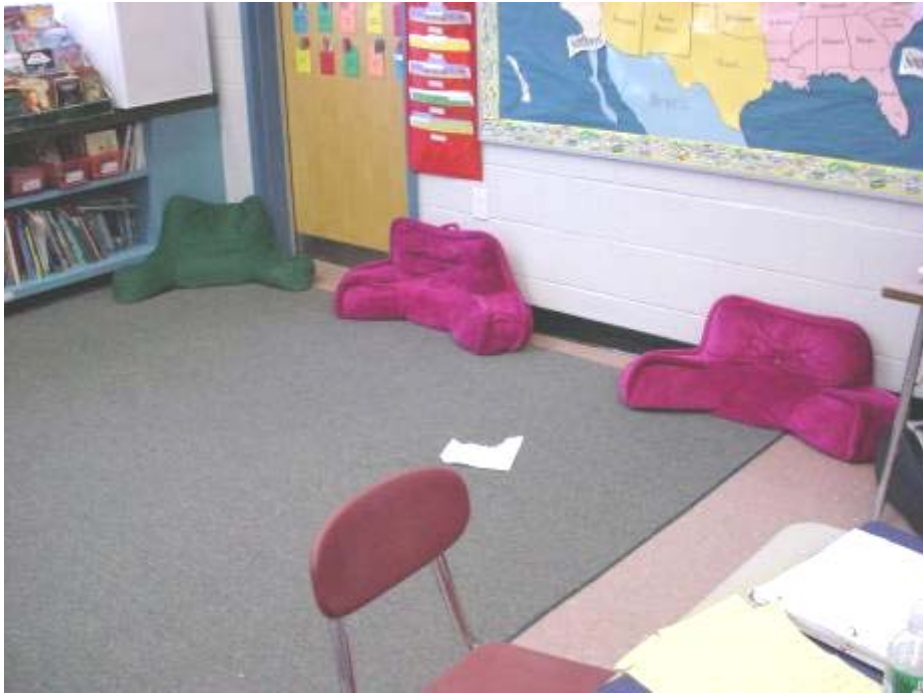
Picture 25

products that contain allergens. Furthermore, increased relative humidity levels above 60 percent can also perpetuate dust mite proliferation (US EPA, 1992). In order to remove dust mites and other pollutants, frequent vacuuming of upholstered furniture is recommended (Berry, 1994). It is also recommended that if upholstered furniture is present in schools, it should be professionally cleaned on an annual basis or every six months if dusty conditions exist (IICRC, 2000).

Upholstered Furniture/Cushions

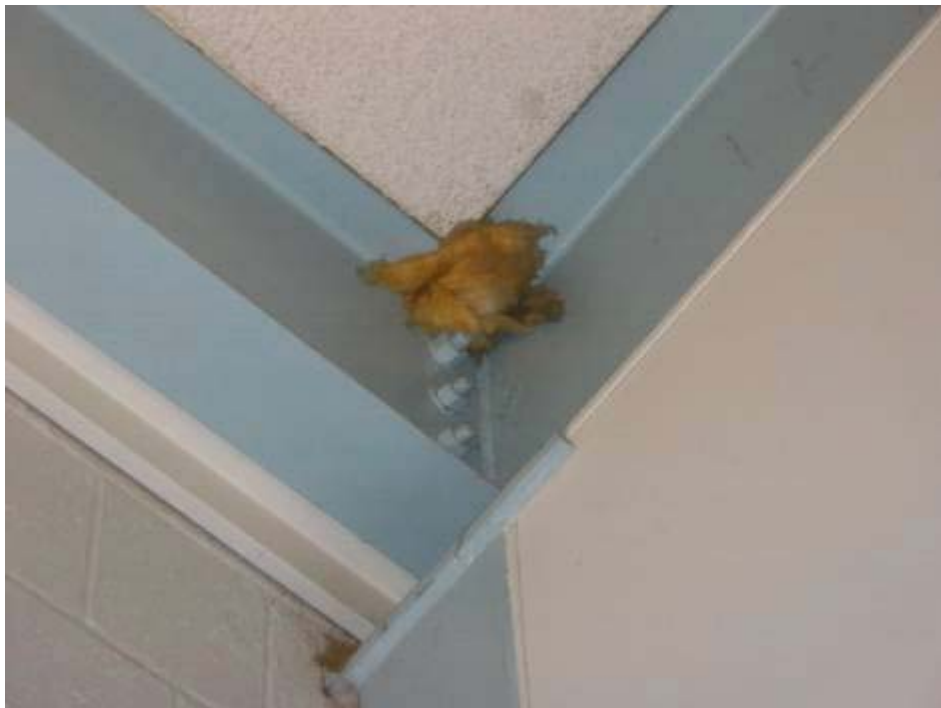
Picture 26

Finally, in a number of classrooms, exposed fiberglass insulation was observed in the top corners of the room. Fiberglass insulation can provide a source of skin, eye and respiratory irritation (Picture 26).

Exposed Fiberglass Insulation
