INDOOR AIR QUALITY ASSESSMENT

**North Shore Community College
Health Professions Building
Danvers Campus
1 Ferncroft Road
Danvers, Massachusetts**

Prepared by:
Massachusetts Department of Public Health
Bureau of Environmental Health
Indoor Air Quality Program
February 2010

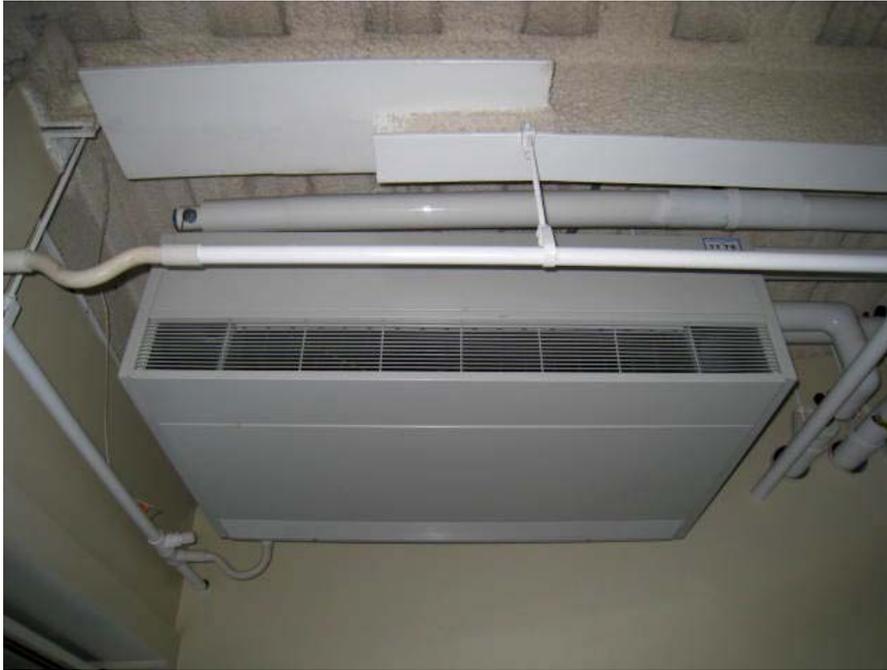
Picture 1

It can be seen from Table 1 that carbon dioxide levels were below 800 parts per million (ppm) in all but one area surveyed, which is generally indicative of adequate air exchange. Fresh air for the offices within suite 124 is provided by ceiling-mounted unit ventilators (univents; Picture 1). Outdoor air is supplied to the univent and returned through an intake located at the base of the unit. Fresh and return air is mixed, filtered, heat/cooled and provided through an air diffuser located on the front of the unit. All univents were operating at the time of assessment.

Univent in office

2. Increase the introduction of fresh air/circulation in areas equipped with univents by operating fans in medium or high setting.
3. Ensure the door between the suite common area and hallway is closed to regulate/maintain temperature control/comfort.

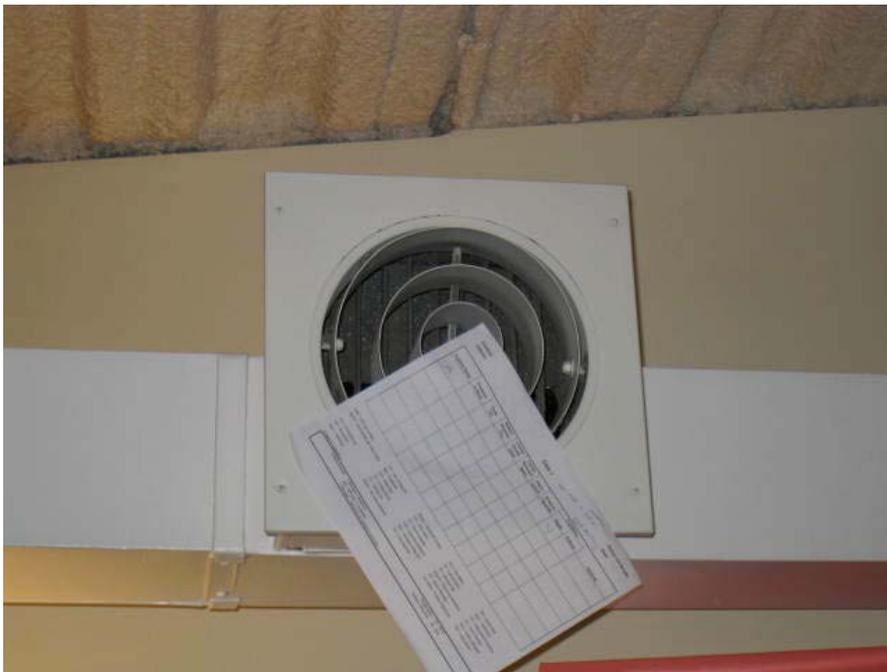
Picture 2

No dedicated exhaust is provided to individual offices. Positive pressure created by the operating univents pushes air into the common area via undercut doors. Exhaust ventilation is provided by an exhaust vent in the common area (Picture 2). The exhaust vent is ducted to a rooftop fan, which removes air from the suite. BEH staff observed that some doors were undercut less than half an inch. Consideration should be given to increasing the space between the door and floor to allow for increased air movement out of offices and into the common area.

Exhaust fan in common area, note paper shows draw of air into vent

4. Remove old food/drink containers to prevent odors/mold growth.
5. Consider further undercutting office doors to increase airflow out of offices.
6. Continue monitoring for leaks to ensure proper actions are taken to prevent mold growth.
Office staff should report all leaks to the facilities department as soon as a leak is discovered for prompt remediation.

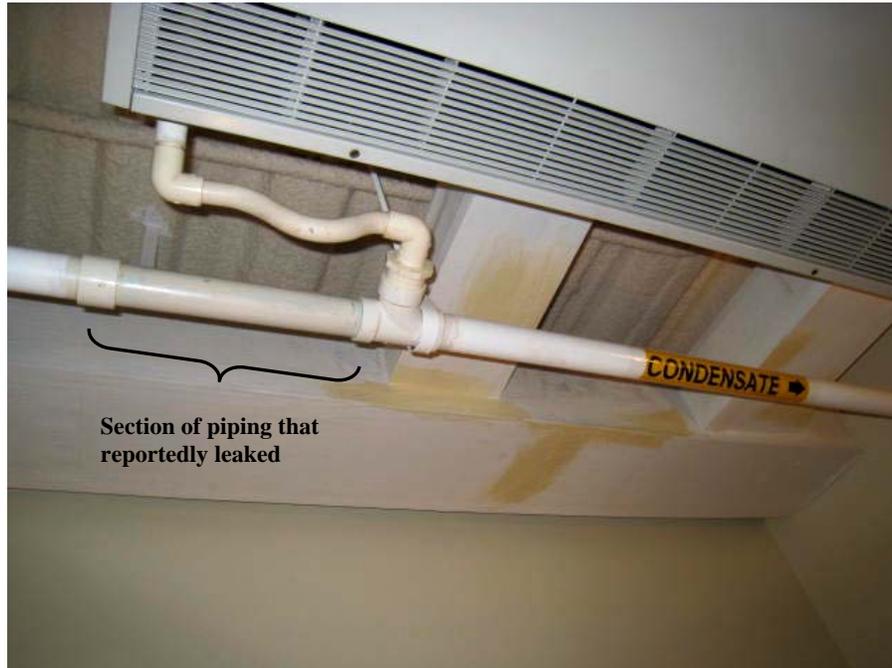
Picture 3

The primary purpose of this assessment was to investigate reports of musty odors related to a univent pipe leak in suite 124 and specifically office 124F (Picture 3). The pipe leak was reportedly discovered in August 2009. Water-damaged carpet was removed and replaced soon after the leak (Picture 4). NSCC facilities staff reportedly examined the gypsum wallboard (GW) and wall cavity for mold growth; reportedly no growth was observed on the GW or in the wall cavity. At the time of the BEH assessment, no odors were detected in office 124F or in the common area of the suite. BEH staff did not observe any mold growth or water damage on the surface of GW walls in office 124F. Moisture testing of these walls indicated that moisture levels were normal (i.e., dry). It is important to note that moisture content of materials measured is a real-time measurement of the conditions in the building at the time of the assessment.

Univent in office 124F

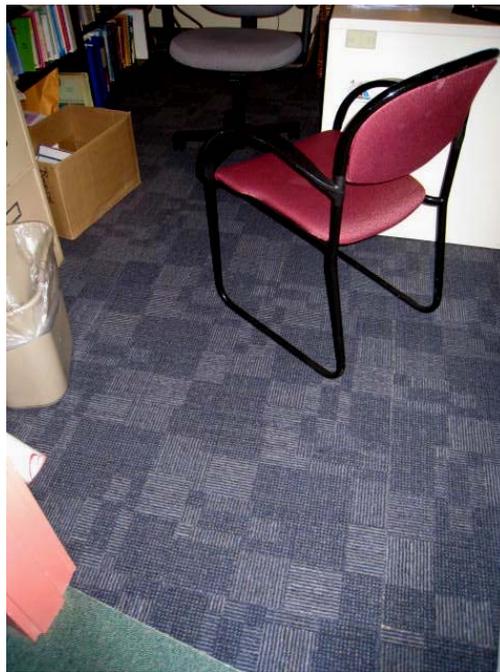
Picture 4

New carpet tiles in office 124F

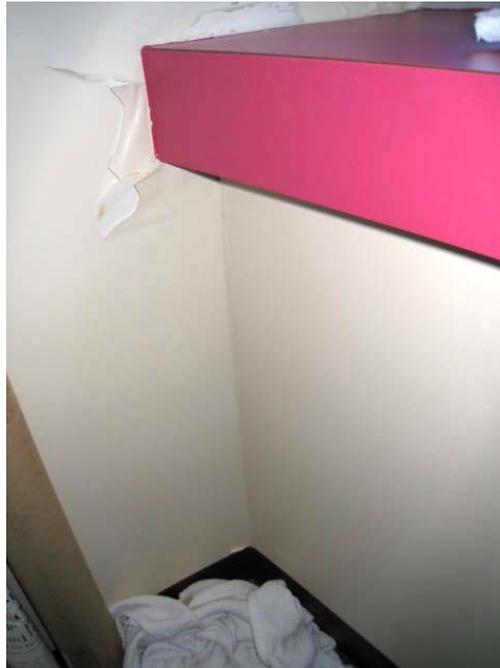
Picture 5

Evidence of a window leak was observed in office 124D (Picture 5). Rags and other absorbent materials were observed on the windowsill; bubbling paint was also observed on the walls. Staff in adjoining offices had indicated the window had been leaking for some time; however, no reports of window leaks were made to the facilities department. At the time of assessment, the wall, windowsill and carpeting all had normal moisture levels. Mr. Neunaber indicated that facilities staff would examine and repair the window leak during the following weekend. In correspondence subsequent to the BEH assessment, Mr. Neunaber reported that the

Leaking window in office 124D, note peeling paint and presence of rags

rubber window seals in that area of the building were re-caulked with silicone. NSCC staff also reported that no dampness appeared to be present in the wall areas around the repaired window.

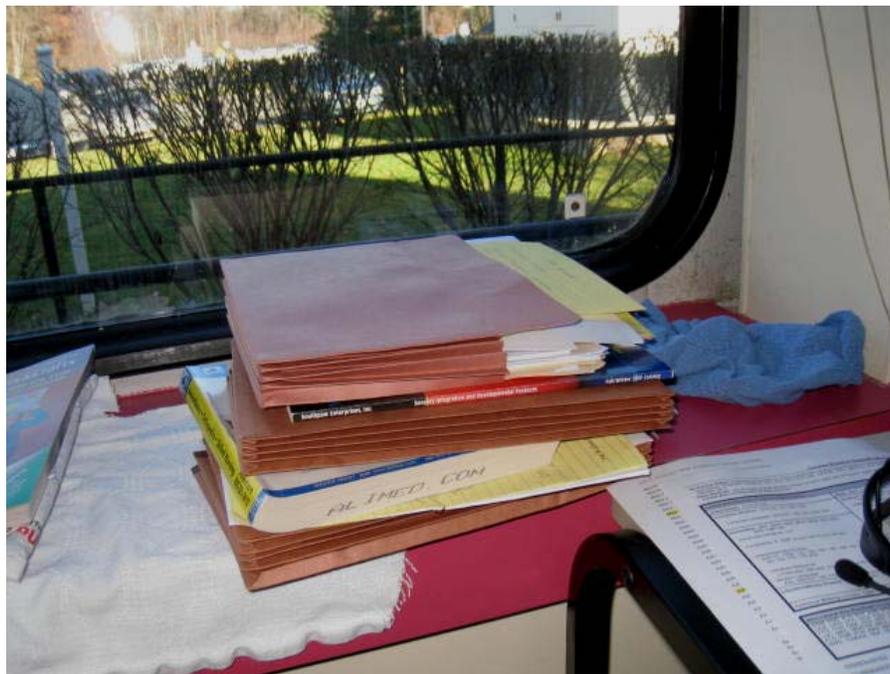
Picture 6

Materials such as papers, folders and books were on the windowsill in office 124D (Picture 6). These items should be examined to ensure that exposure to moisture has not resulted in mold growth. Water damaged paper products can serve as a source of mold growth and should be removed and discarded to prevent a source of respiratory irritation.

Paper products placed on rag near leaking window in Office 124D

7. Examine items in room 124D to ensure that moisture has not resulted in mold growth.
8. Seal utility holes to prevent movement of dusts and particulates between areas.

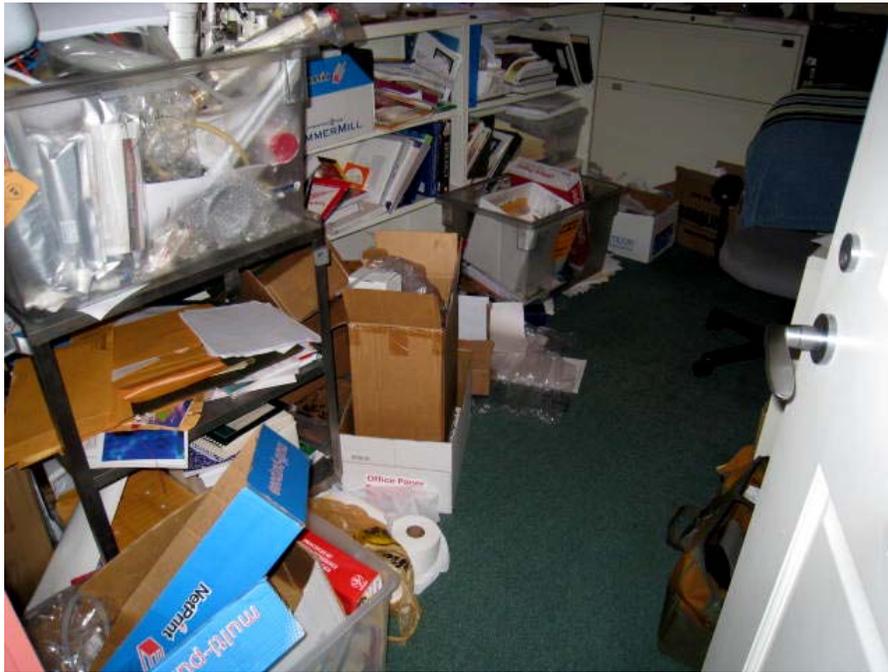
Picture 7

Additionally, accumulated items were observed on the floor, windowsills, tabletops, counters, bookcases and desks in office 124G (Picture 7). The large number of items stored in this office also provides a source for dusts to accumulate. These items (e.g., papers, folders, boxes) make it difficult for custodial staff to clean. Items should be relocated and/or be cleaned periodically to avoid excessive dust build up.

Accumulated items in office 124G

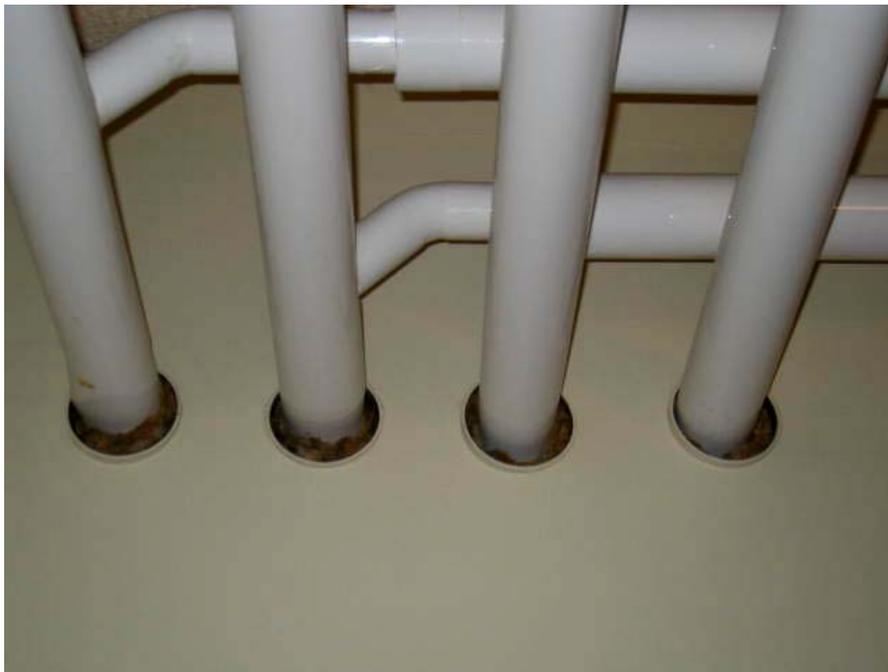
Picture 8

Utility holes were observed around pipes in the offices (Picture 8). Such spaces can allow movement of dust and other particles from the wall cavity into occupied spaces. These holes should be sealed to prevent such movement.

Open utility holes
