# **ODOR INVESTIGATION**

**Groton-Dunstable Regional High School  
703 Chicopee Row  
Groton, Massachusetts**

Prepared by:  
Massachusetts Department of Public Health  
Bureau of Environmental Health  
Indoor Air Quality Program  
June 2012

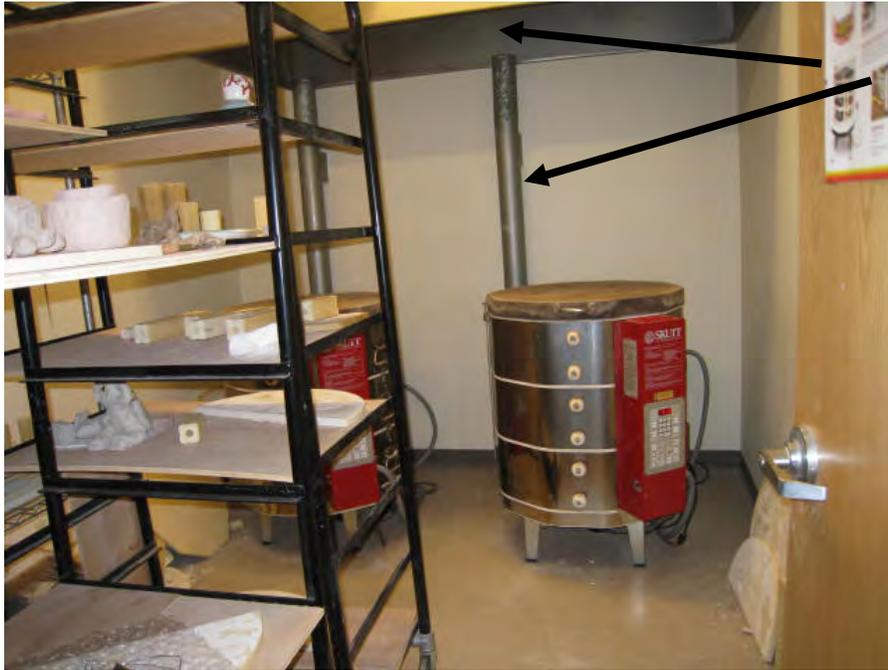
**Picture 1**

The kilns are located in a small dedicated kiln room off the ceramic arts classroom. The kiln room (Picture 1) has a dedicated exhaust system; an exhaust pipe from each kiln (Picture 2) is vented into an overhead hood (Picture 3) which is served by a dedicated exhaust fan on the roof (Picture 4). The fan was operating at the time of the visit and reportedly operates whenever the kilns are in use. The door to the kiln room is typically closed when the kilns are in operation.

**Two Kilns in Kiln Room (arrows point to kiln exhaust vent and hood)**

No dedicated make-up air supply for the kiln room was observed at the time of the visit. Instead, the room relies on air that is drawn via an undercut kiln room door. It was reported that a grilled vent would be installed in the kiln room door to allow for air flow so the exhaust vents can operate more efficiently in removing heat, odors and any other pollutants generated by the kiln.

1. Continue to operate the building ventilation systems continuously while the building is occupied;
2. Continue to operate the kiln exhaust ventilation whenever the kilns are in use. Install a vent in the door of the kiln room to allow for make-up air for proper operation of the kiln exhaust and keep the kiln room door closed at all times;

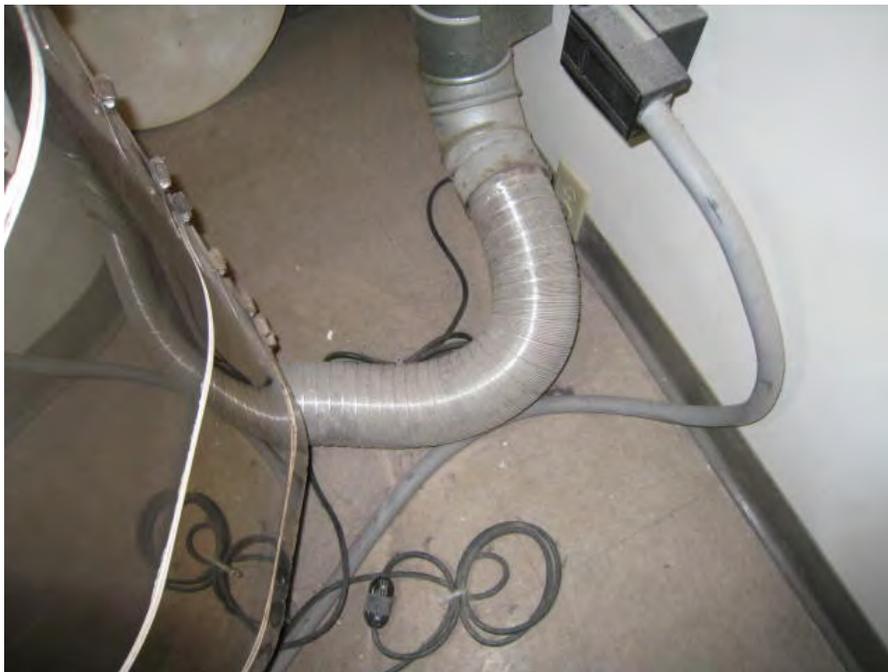
**Picture 2**

**Kiln Exhaust Pipe**

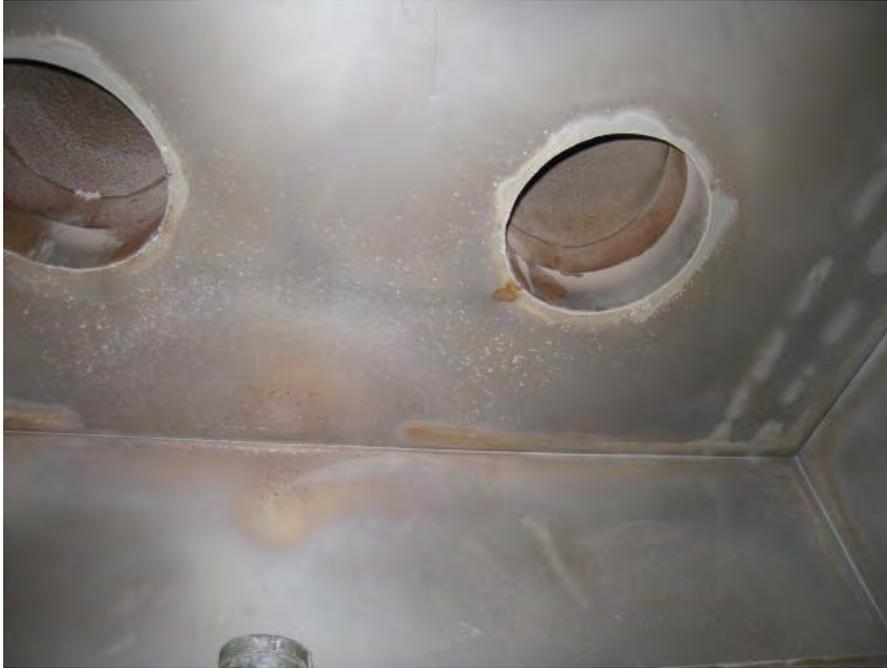
**Picture 3**

**Underside of Exhaust Hood Showing Exhaust Vents to Roof**

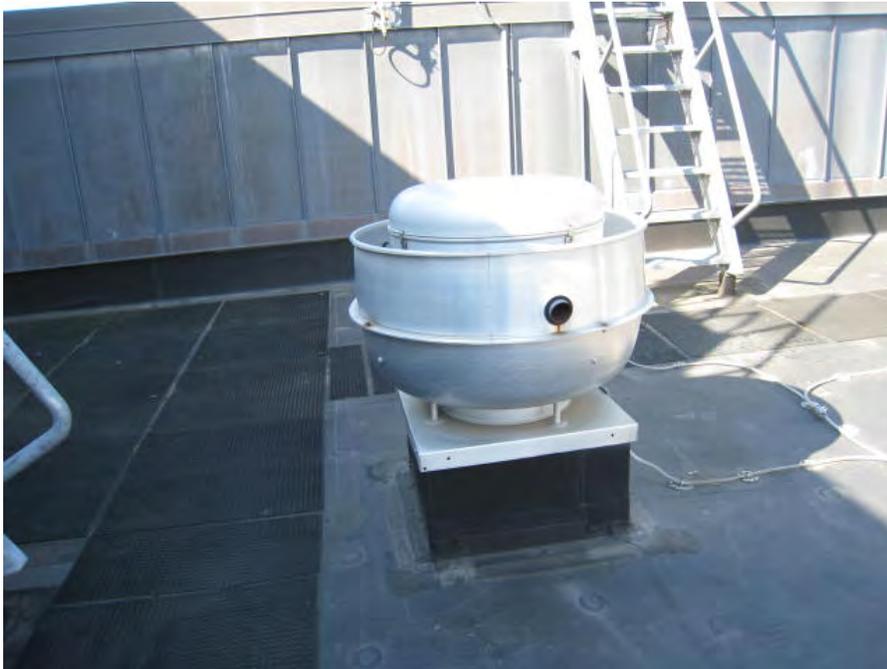
**Picture 4**

Based on an examination of the classrooms and roof area, there did not appear to be a transport pathway for kiln-generated odors/materials to move from the kiln room into adjacent areas. The kiln room exhaust vent is not adjacent to any air intakes, windows or other potential pathways back into the building.

**Rooftop Exhaust Vent for Kilns**
