# **INDOOR AIR QUALITY ASSESSMENT**

**Wayland Middle School  
201 Main Street  
Wayland, Massachusetts**

Prepared by:  
Massachusetts Department of Public Health  
Bureau of Environmental Health  
Indoor Air Quality Program  
June 2012

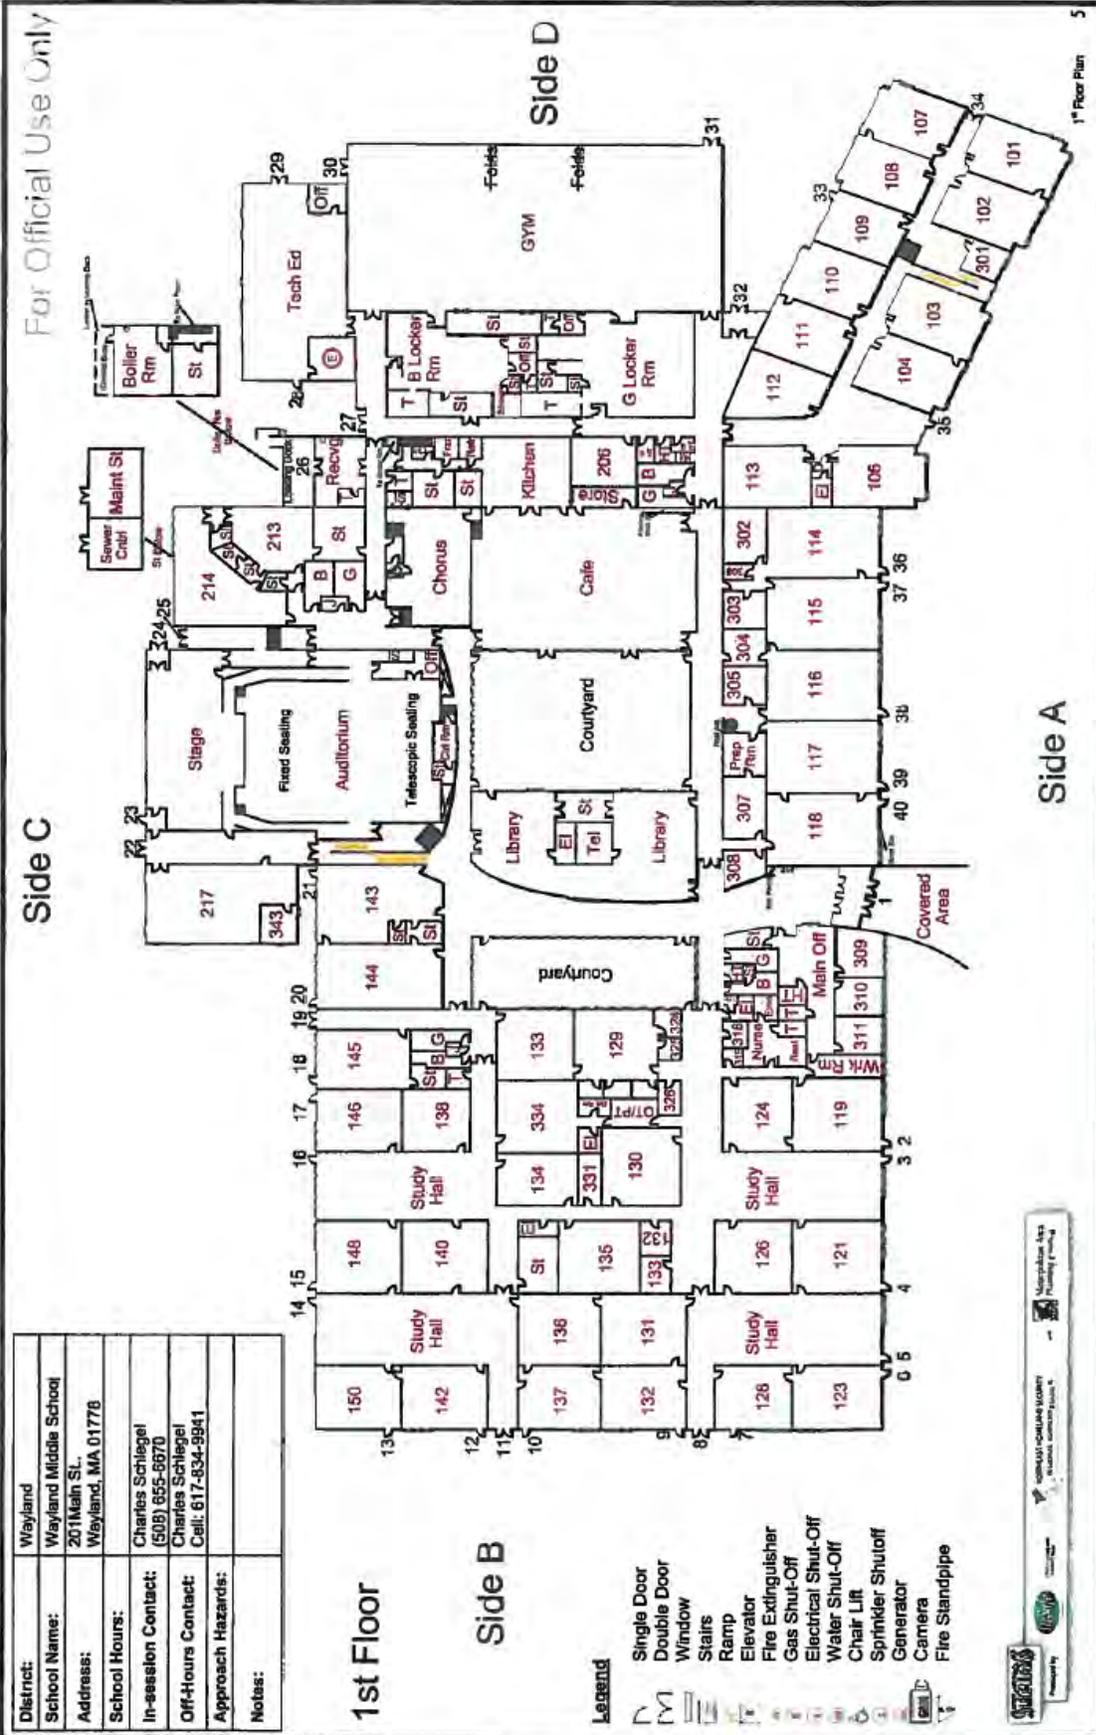
# Figure 2: Building Layout

Carpeting in a hallway between Rooms 104-106-112-113 had a significant musty odor (Figure 2; Picture 9). An exterior door with a significant space at its threshold exists in this location, which would allow for unconditioned hot, humid air to enter this hallway and moisten the carpet during summer months. The building is built on a slab foundation, which likely has a

It was also noted that the Wayland Department of Public Works (DPW) parking/work lots are located due west of the WMS, with equipment parked approximately 100 feet from the closest area of the school (at the end of the new wing, Figure 2, Picture 15). The DPW parking/work lots appears to be roughly 8-10 feet lower than the level of the fresh air intakes for univents of rooms 101, 102, 107, and 108. Typically, muffler pipes for DPW type of equipment vent exhaust 6-8 feet above ground level. Winds tend to be westerly in New England (Trewartha, G.T., 1943). Exhaust from the DPW parking/work lots may impact on rooms 101, 102, 107, and 108 under westerly, low velocity wind conditions. Consider working with the town to reduce vehicle idling in the location nearest the school, and keeping windows in the classrooms closed when necessary.

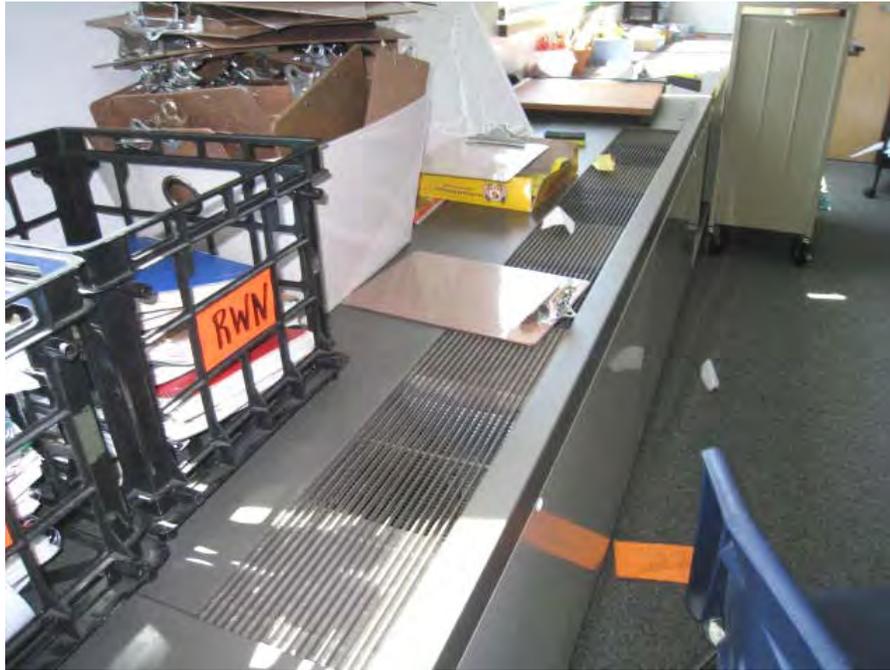
**Picture 1**

Fresh air to classrooms and other areas is supplied by a combination of unit ventilator (univent) systems (Picture 1), ceiling-mounted air-handling units (AHUs) and rooftop AHUs. A univent draws air from the outdoors through a fresh air intake located on the exterior wall of the building (Picture 2). Return air from the classroom is drawn through an air intake located at the base of the unit ([Figure 1](#)). Fresh and return air are mixed, filtered, heated or cooled and provided to classrooms through an air diffuser located in the top of the unit. The univents in WMS are atypical in that they are equipped with cooling coils for air conditioning as well as heating coils for heat. As mentioned, univents were found deactivated in some rooms at the time of assessment (Table 1) and several others were found obstructed by furniture and other items on top of air diffusers and/or in front of return vents along the bottom of the units (Picture 3). In order for univents to provide fresh air as designed, they must remain “on” and operating while rooms are occupied. Furthermore, units must remain free of obstructions.

**Classroom univent**

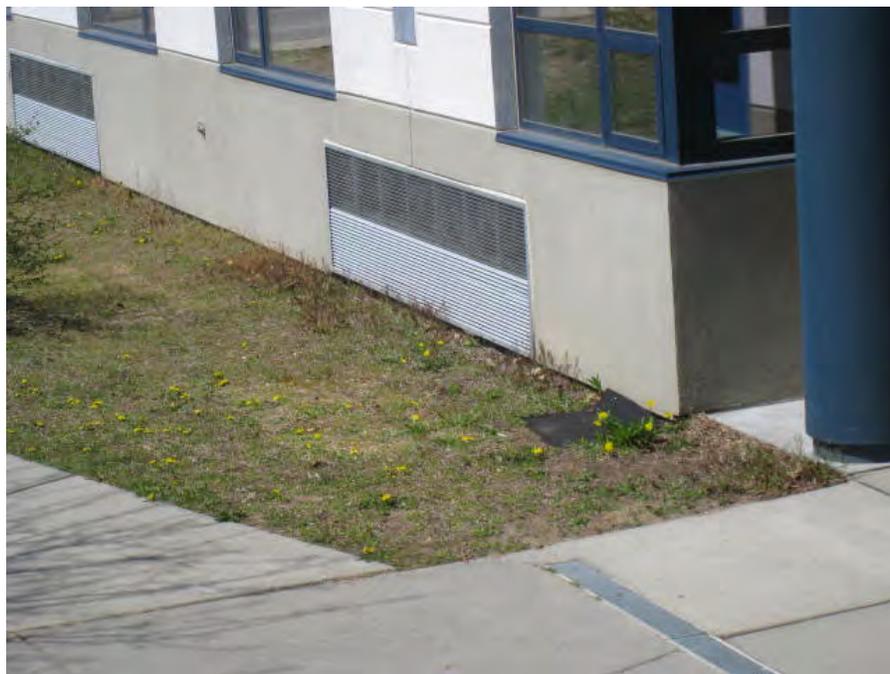
**Picture 2**

**Univent fresh air intake**

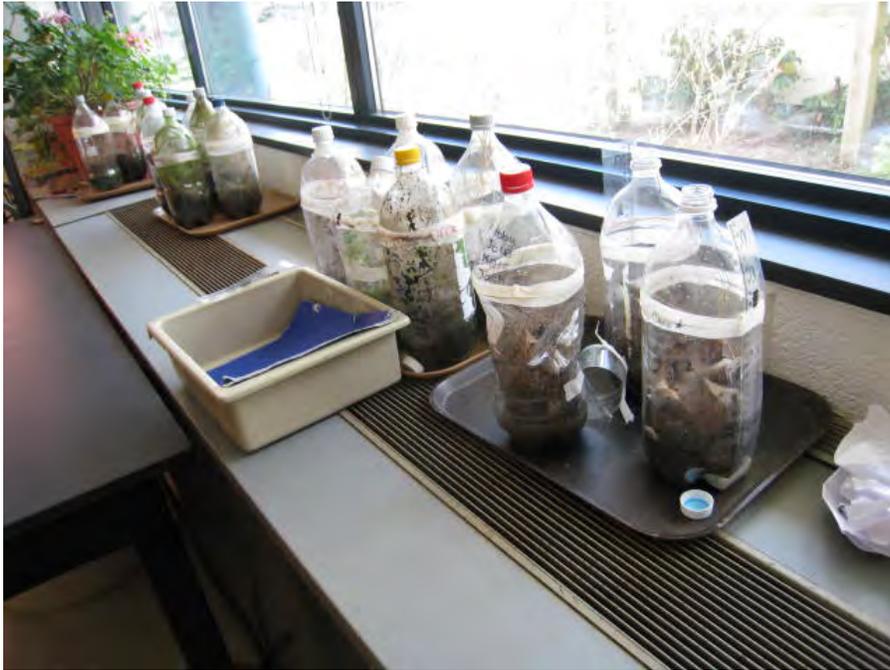
**Picture 3**

In some classrooms, items were observed on the floors, windowsills, tabletops, counters, bookcases and desks (Picture 17). Items stored in classrooms provide a source for dusts to accumulate. These items (e.g., papers, folders, boxes) make it difficult for custodial staff to clean. Items should be relocated and/or be cleaned periodically to avoid excessive dust build up. In addition, these materials can accumulate on flat surfaces (e.g., desktops, shelving and carpets) in occupied areas and subsequently be re-aerosolized causing further irritation. Similarly, dust/debris from items placed on top of univents can become airborne through movement of the heated air.

**Items on top and in front of univent**

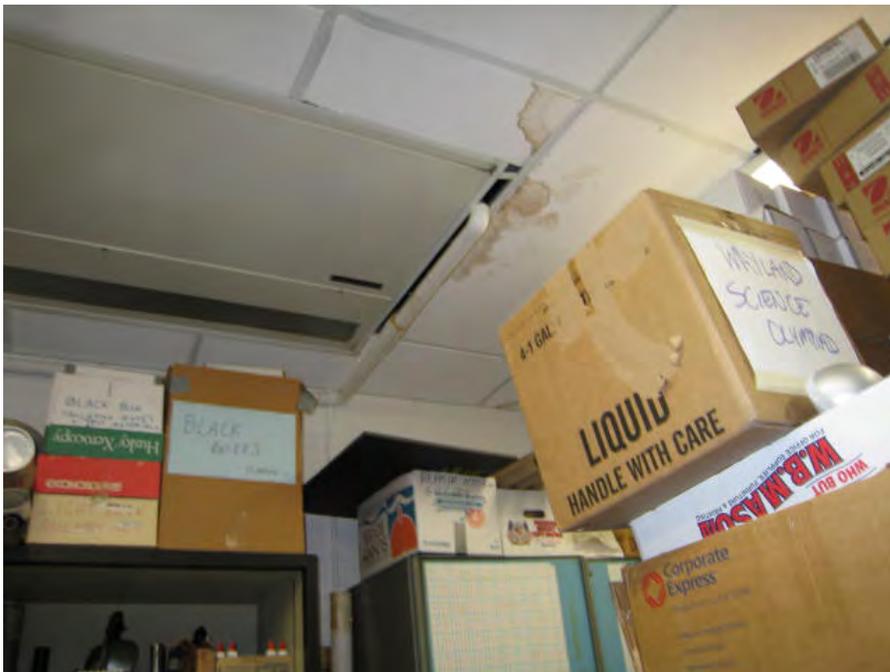
**Picture 4**

The ceiling-mounted AHUs (Picture 4) supply conditioned air to classrooms from vents on the roof. For rooms supplied by rooftop AHUs, fresh air is brought in through ceiling-mounted diffusers (Picture 5).

A number of areas in the building have water-stained ceiling tiles and plaster (Pictures 4 and 7, Table 1), which stem from roof leaks, plumbing leaks and/or leaks and condensation from air conditioning components. It was noted that some of the ceiling-mounted AHUs have drain pans that are connected to drain pipes with too little pitch (Picture 8). As a result condensation does not drain and may overflow, resulting in moistening of ceiling tiles and other materials below the ceiling mounted units. Water-damaged building materials can provide a source of mold and should be replaced after a water leak is discovered and repaired. It was reported that a new roof for this building is planned for the summer of 2012 which will reduce the opportunity for leaks into the building.

**Ceiling-mounted AHU, note water-damaged tiles and stored items**

9. Replace the roof as planned and replace any missing/water-damaged ceiling tiles and make repairs to water-damaged plaster and other building materials once the roof work is completed.

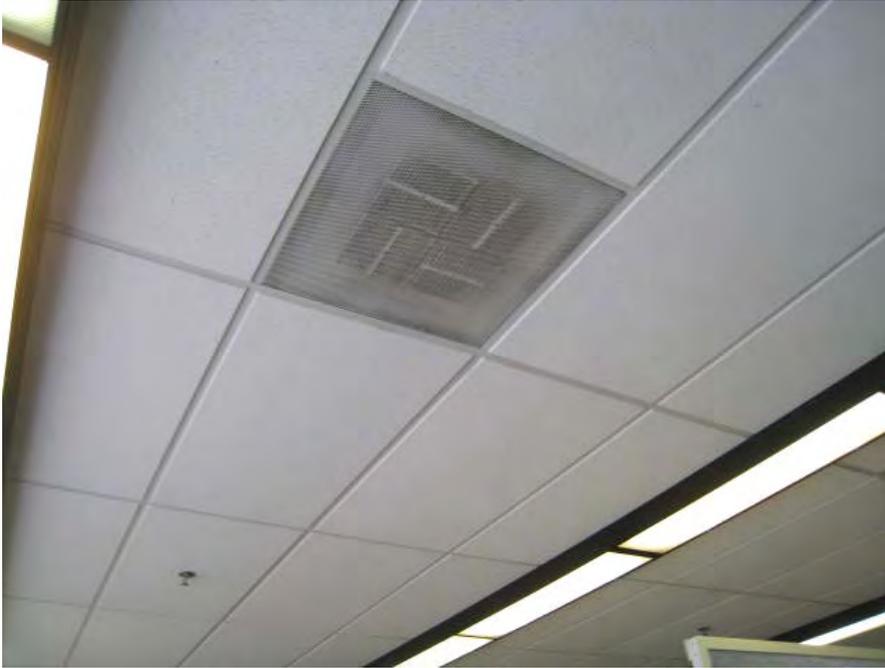
**Picture 5**

**Typical supply vent for areas served by rooftop AHUs**

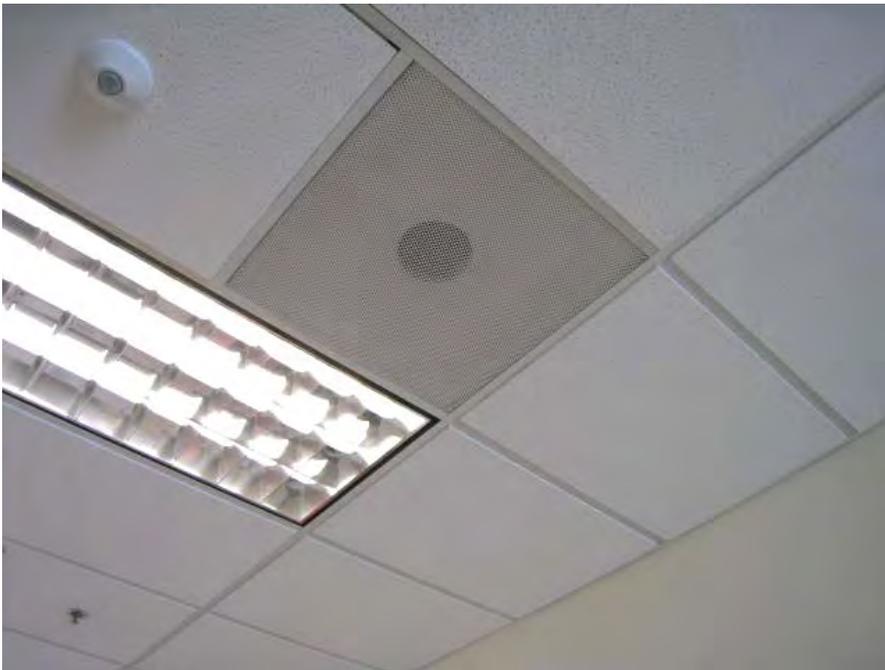
**Picture 6**

Exhaust ventilation for classrooms is provided by wall or ceiling-mounted exhaust vents ducted to rooftop motors (Picture 6). At the time of the assessment, some exhaust ventilation was not operating. As with supply ventilation, in order to function properly, exhaust vents must be activated and allowed to operate while rooms are occupied. Without adequate supply and

**Ceiling-mounted exhaust vent**

1. Implement recommendations made by Envirotest.
2. To maximize air exchange, operate existing ventilation equipment continuously throughout the building during periods of school occupancy. Ensure all blockages to supply and exhaust vents are removed. Ensure that exhaust ventilation fans and motors are operational.

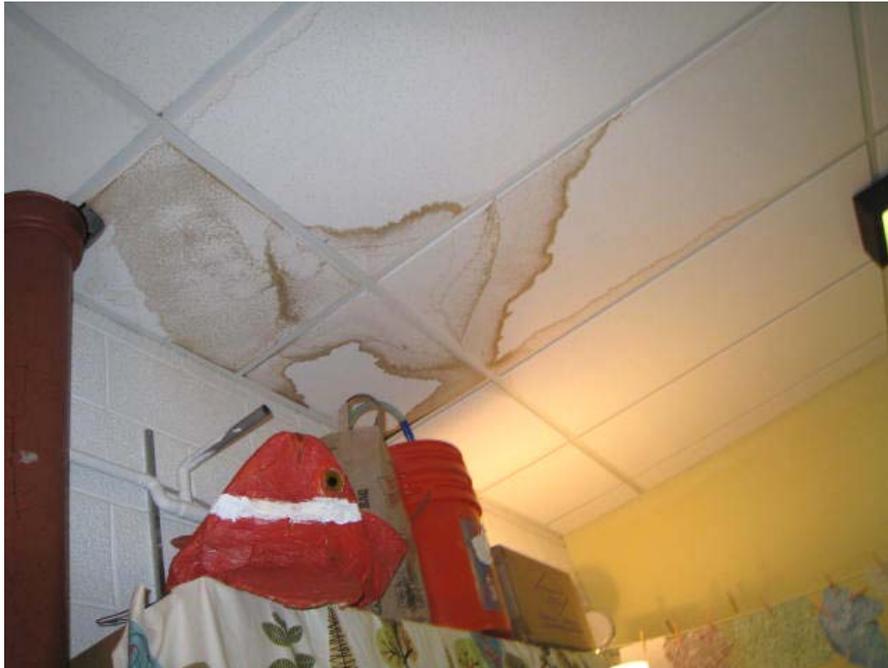
**Picture 7**

**Water-damaged ceiling tiles**

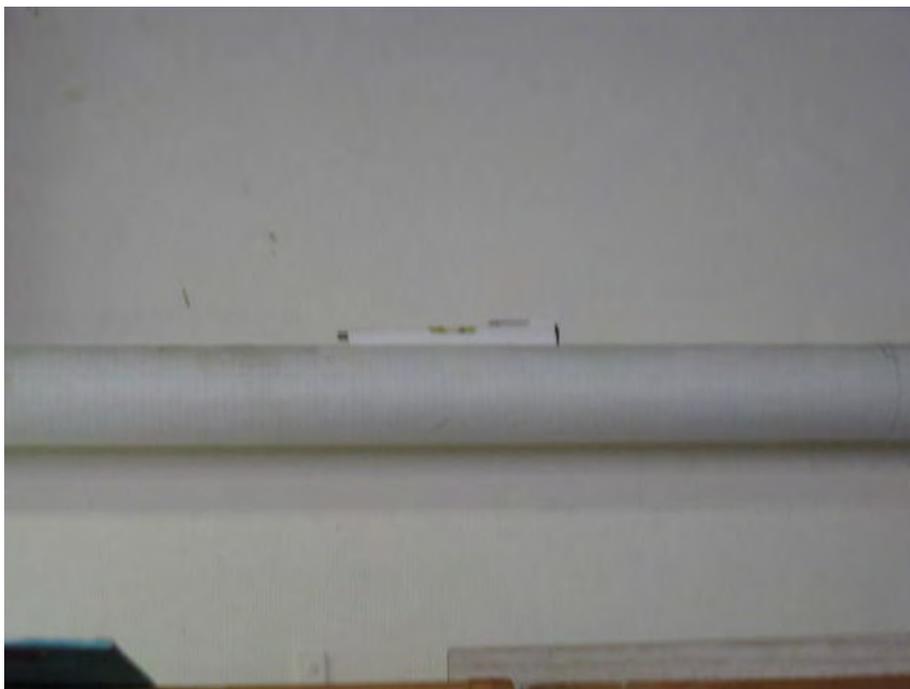
**Picture 8**

**Condensation Drain Pipe with Level, Indicates No Pitch to Pipe**

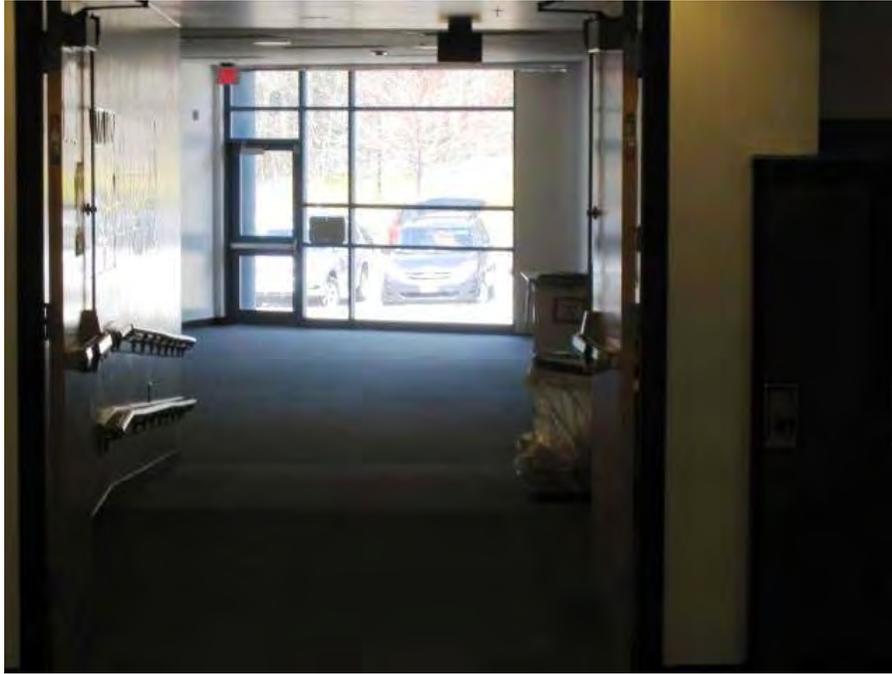
**Picture 9**

temperature that is below the dew point<sup>1</sup> of air in the building during hot, humid weather.

During summer months, moist air can penetrate through the door and condense water on the cooler floor, moistening the carpet. If the carpet is repeatedly moistened and not promptly dried, it can become mold-colonized and give off unpleasant odors. Carpeting near doors, especially those that are regularly opened or not tightly sealed, can be moistened by wind-driven rain or through tracking in of water on shoes and clothing. Removal of this carpeting and substitution of tile flooring is recommended.

**Location of Carpet with Musty Odor in Hallway between Rooms 104, 106, 112 and 113**

10. Assess carpeting in areas subject to moistening, such as in hallways near doors and prioritize water-damaged carpeting for replacement. Consider installing tile flooring in hallways and classrooms when possible, particularly in areas such right inside of exterior doors, science storage and where food is stored, prepared and eaten.

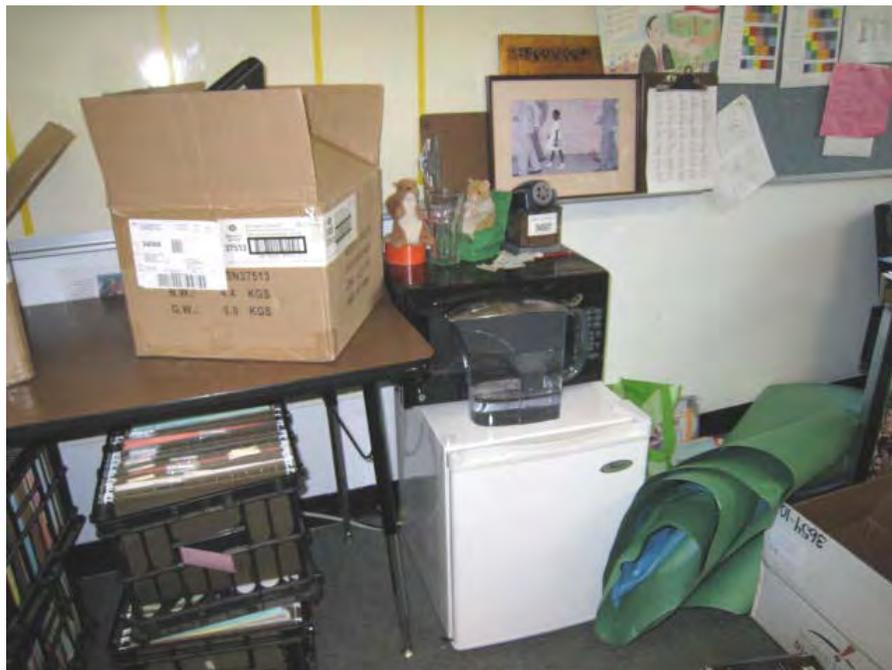
**Picture 10**

Refrigerators and other food preparation equipment were also found located on carpet (Picture 10), which can become moistened due to spills or leaks; these items should be moved to uncarpeted areas when possible, or placed on waterproof mats. In general, use of carpeting in school hallways and classrooms is not recommended; additional discussion of this can be found in the “Other Conditions” section below.

**Refrigerator and other food-preparation items on carpet**

11. Consider relocating refrigerators to areas with tile floors, or use impermeable mats to contain potential spills or leaks.
12. Seal breaches between sink countertops and backsplashes to prevent water damage. Avoid storage of porous/excess materials under sinks.

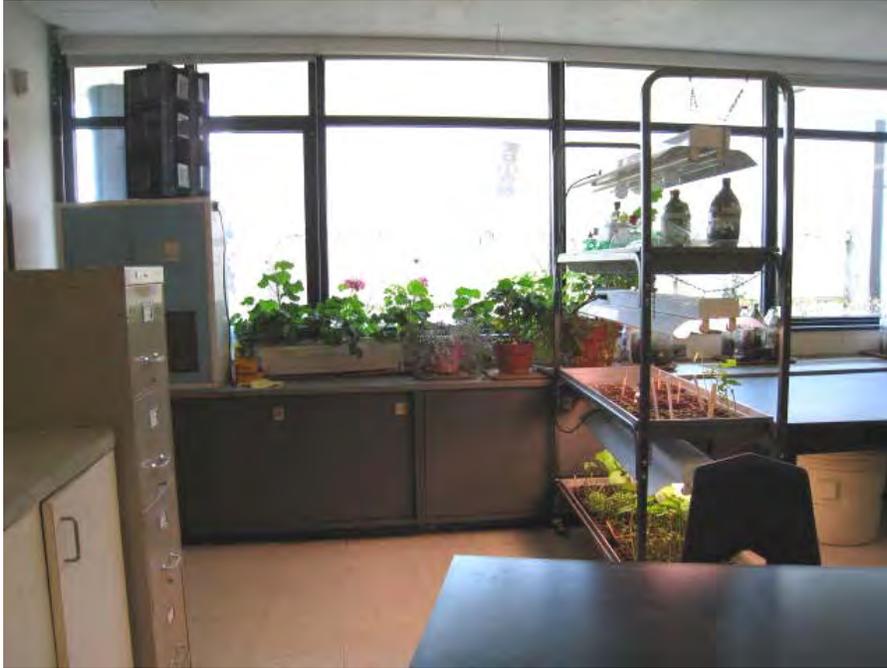
**Picture 11**

Several classrooms had a number of plants (Picture 11; Table 1). Moistened plant soil and drip pans can serve as a source of mold growth. Plants should also be located away from univents to prevent aerosolization of dirt, pollen or mold.

**Plants on univent next to air diffuser**

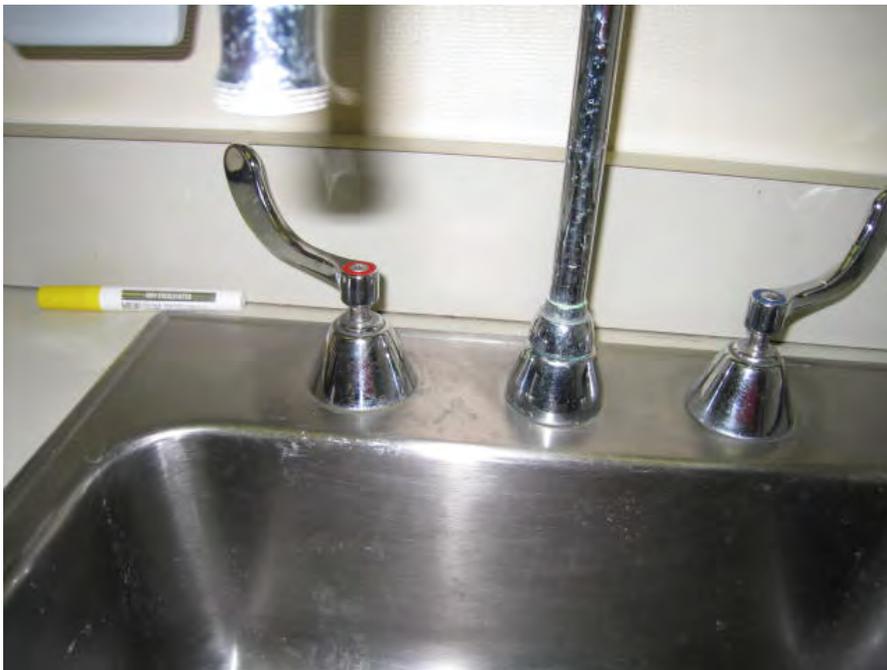
**Picture 12**

Sinks were observed in some classrooms. In some cases open or weakly-sealed seams were observed between backsplashes and countertops (Picture 12). If these areas are not made

watertight, water can penetrate through the seam, causing water damage to the material under or behind the sink. Water penetration and chronic exposure of porous and wood-based materials can cause these materials to swell and show signs of water damage. A few sinks had porous materials (e.g., paper towels, cloth) stored beneath them (Picture 13). Repeated moistening of these porous materials through condensation or plumbing leaks can result in mold growth. Storage of large amounts of material under the sinks can also prevent rapid detection of leaks.

**Sink with weakly-sealed backsplash**

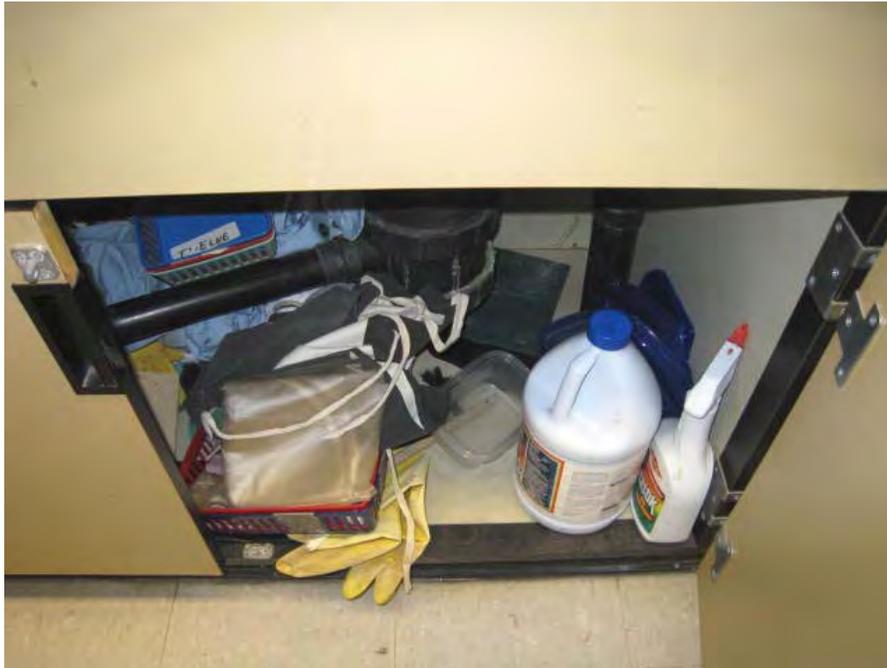
**Picture 13**

**Porous items and cleaning products under sink**

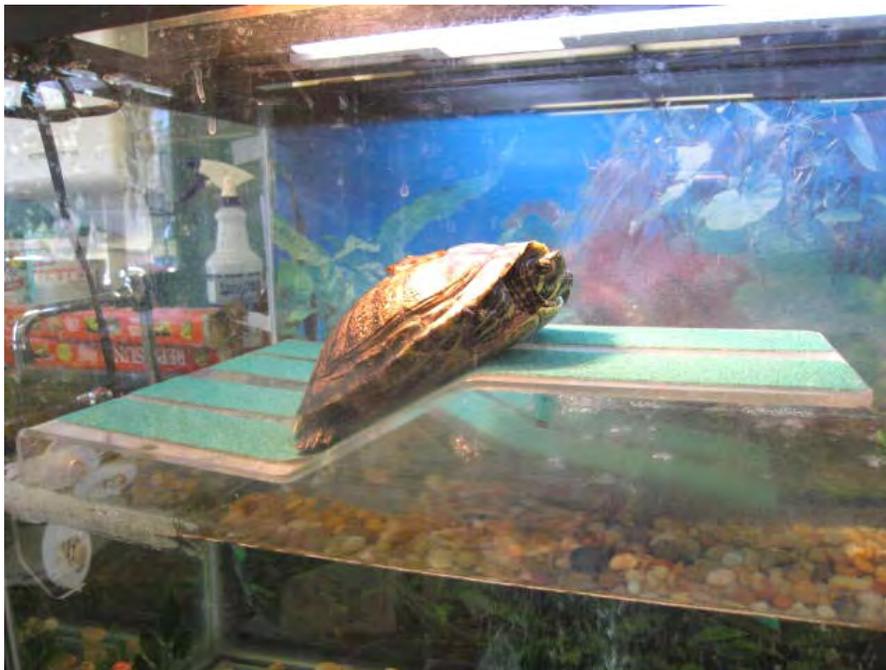
**Picture 14**

An aquarium containing a turtle was noted in one of the science classrooms (Picture 14). Aquariums should be properly maintained to prevent microbial/algal growth as they can emit unpleasant odors into the classroom.

**Aquarium with turtle**

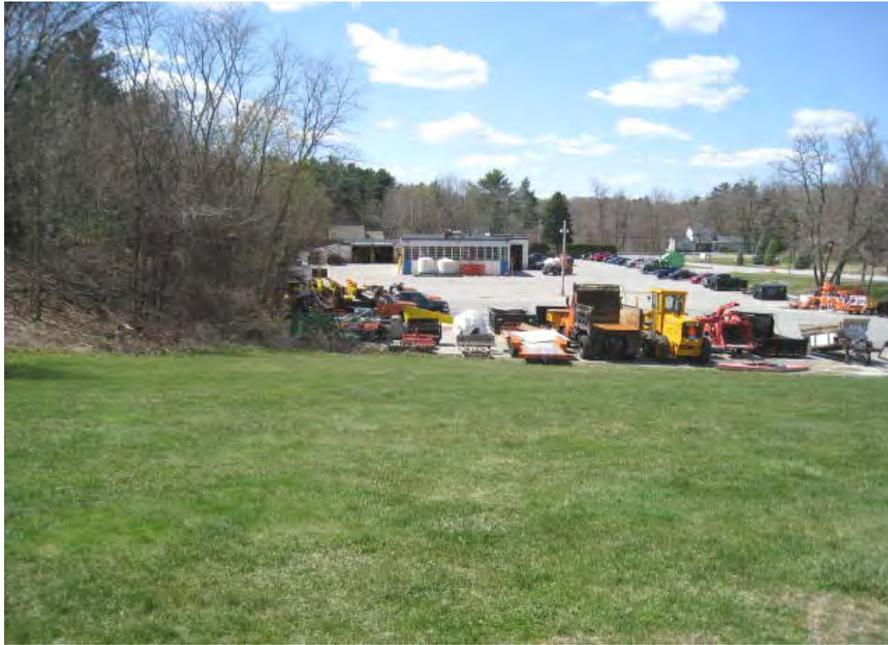
**Picture 15**

**View from schoolyard near new wing of vehicles and diesel-powered equipment in DPW yard**

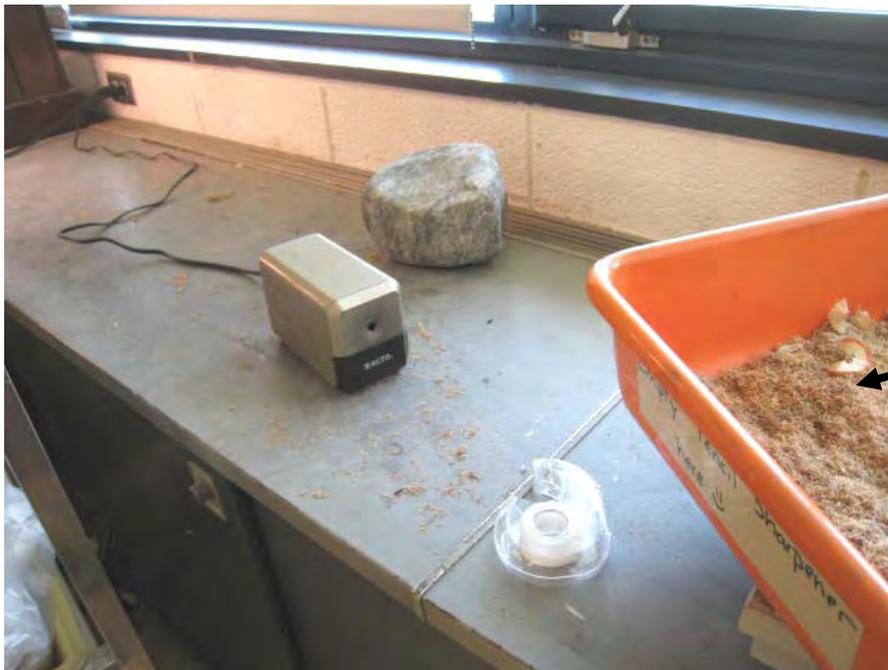
**Picture 16**

BEH staff observed accumulation of pencil shavings in trays and on tables/floors (Picture 16), and in some cases adjacent to univents. This material can be aerosolized by mechanical ventilation components, air movement from doors opening and closing, and/or foot traffic and may present a respiratory irritant.

**Pencil shavings on counter and bin of pencil shavings (arrow)**

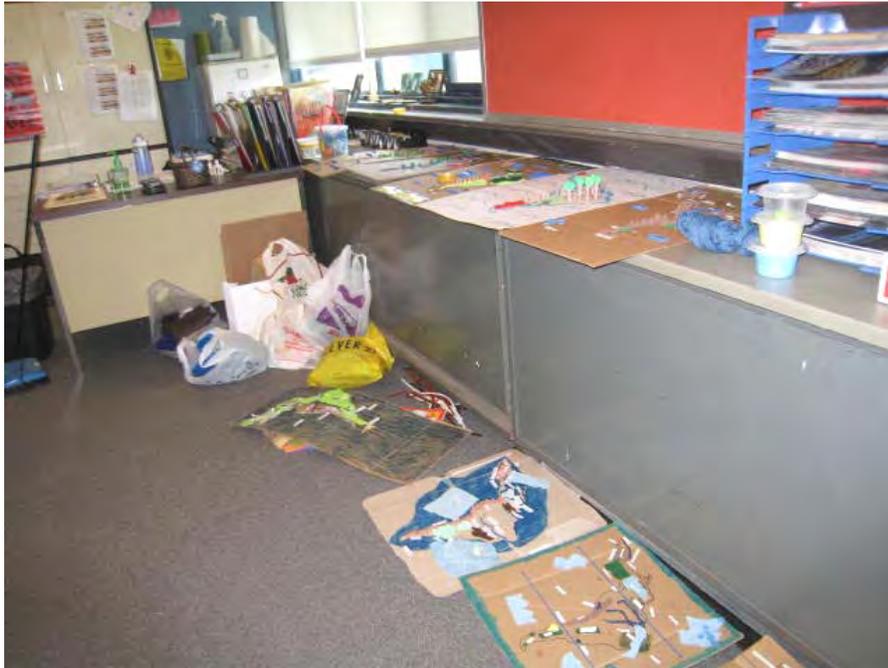
**Picture 17**

**Items stored/displayed in classroom, including on top of univent**

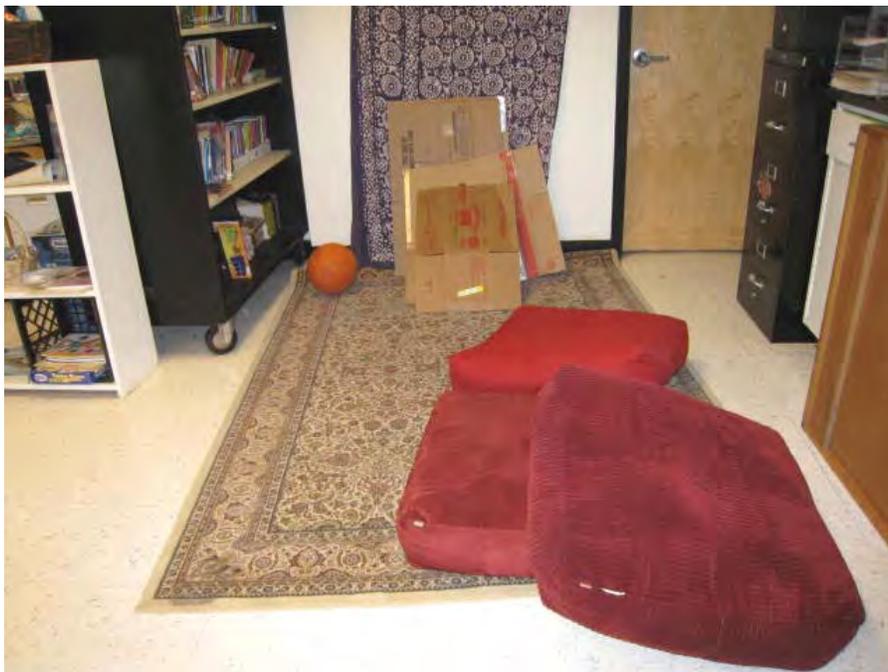
**Picture 18**

Upholstered furniture, plush toys and area carpets were observed in some classrooms (Picture 18; Table 1). Upholstered furniture is covered with fabrics that are exposed to human skin. This type of contact can leave oils, perspiration, hair and skin cells. Dust mites feed upon human skin cells and excrete waste products that contain allergens. In addition, if relative humidity levels increase above 60 percent, dust mites tend to proliferate (US EPA, 1992). In

**Upholstered pillows and area carpet in classroom**

order to remove dust mites and other pollutants, frequent vacuuming of upholstered furniture is recommended (Berry, 1994). It is also recommended that upholstered furniture (if present in schools), be professionally cleaned on an annual basis. Where an excessively dusty environment exists due to outdoor conditions or indoor activities (e.g., renovations), cleaning frequency should be increased (every six months) (IICRC, 2000).

23. Clean plush toys, upholstered furniture and area rugs frequently to remove dust and dust mites. Consider purchasing new area rugs to replace those brought in from outside.
