# **INDOOR AIR QUALITY ASSESSMENT**

**Burke Elementary School  
127 Birch Street  
Peabody, MA**

Prepared by:  
Massachusetts Department of Public Health  
Bureau of Environmental Health  
Indoor Air Quality Program  
September 2012

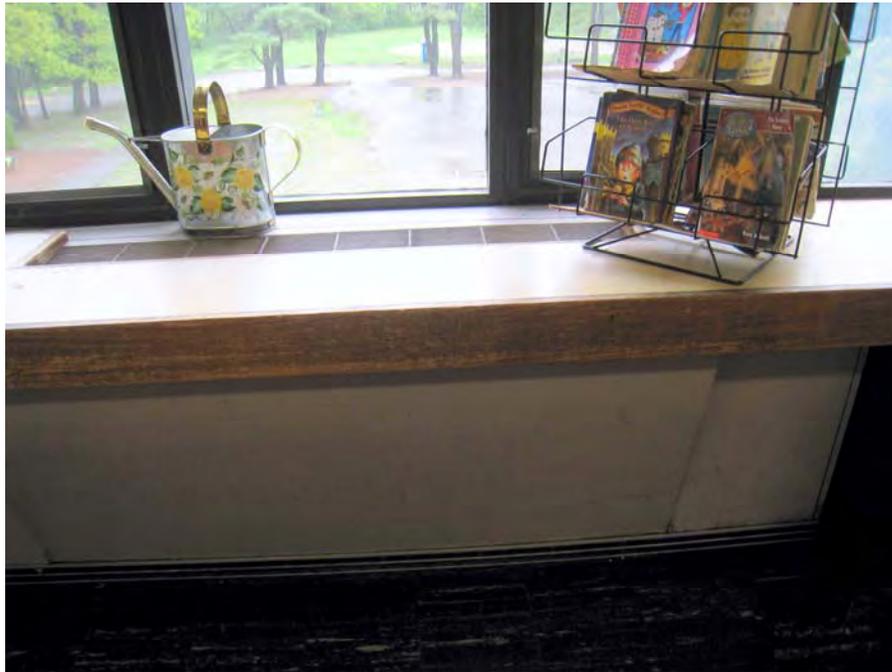
**Picture 1**

Fresh air is supplied to classrooms by unit ventilator (univent) systems (Picture 1). A univent draws air from the outdoors through a fresh air intake located on the exterior wall of the building (Picture 2). Return air from the classroom is drawn through an air intake located at the base of the unit ([Figure 1](#)). Fresh and return air are mixed, filtered, heated and provided to classrooms through an air diffuser located in the top of the unit. As mentioned, univents were found deactivated in the majority of rooms/areas in the school at the time of assessment (Table 1). In addition, several univents were found obstructed by furniture and/or other items found on top of air diffusers and/or in front of return vents along the bottom of the units (Picture 3). In order for univents to provide fresh air as designed, they must remain “on” and operating while rooms are occupied. Furthermore, units must remain free of obstructions.

**Classroom univent**

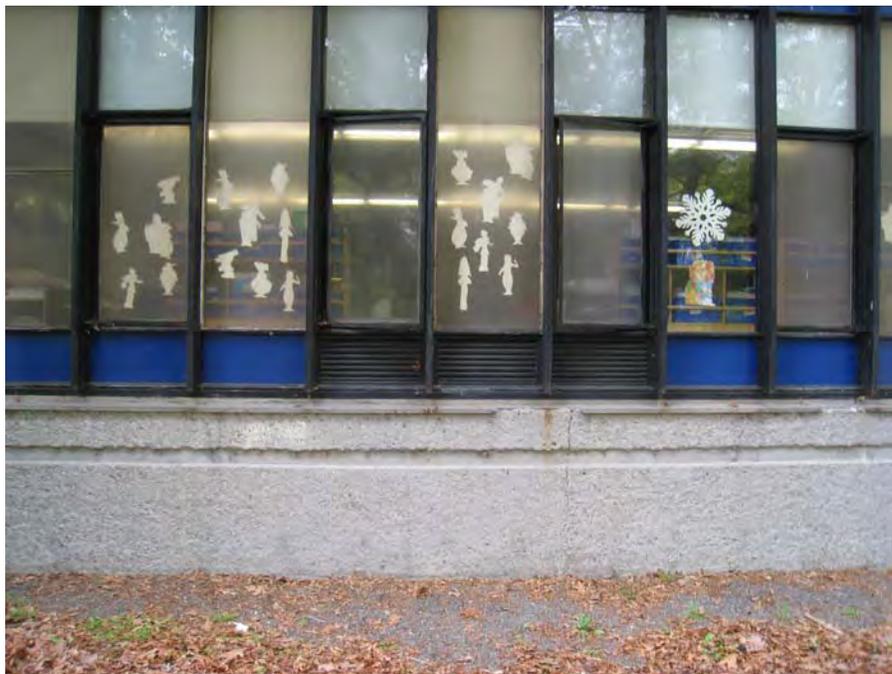
**Picture 2**

**Univent fresh air intake**

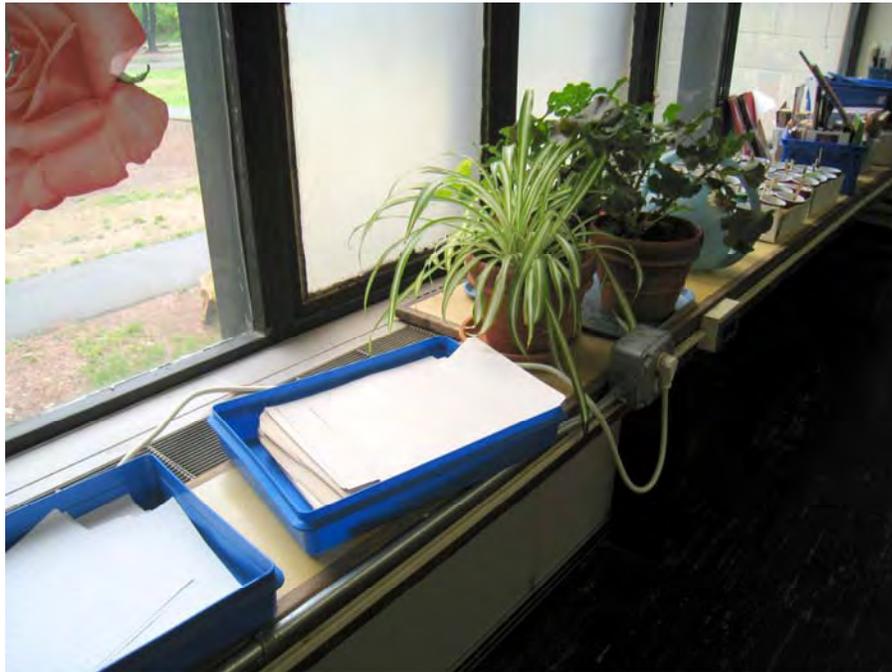
**Picture 3**

Plants were observed in several areas, some of which were located on or directly adjacent to univents (Table 1; Picture 3). One classroom also had a terrarium (Table 1). Plants should be properly maintained and equipped with washable drip pans. Plants should be located away from ventilation sources to prevent aerosolization and distribution of dirt, pollen or mold. Plants should also not be placed on porous materials (e.g., paper or cardboard), since water damage to porous materials may lead to microbial growth.

**Items on univent, note proximity of plants to univent diffuser**

17. Ensure plants are equipped with drip pans. Examine drip pans periodically for mold growth and disinfect with an appropriate antimicrobial, as needed. Move plants away from fresh air supply sources.

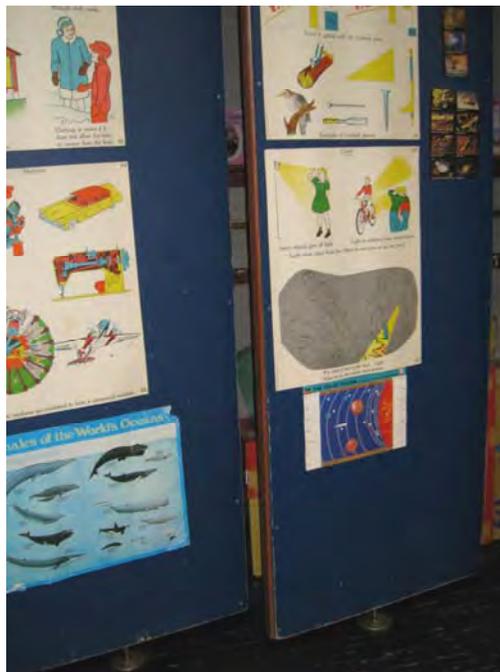
**Picture 4**

Exhaust ventilation for classrooms is provided by exhaust vents located in closets. The undercut closet door allows air to be drawn into the closet and exhausted from the building via rooftop-mounted exhaust fans (Pictures 4 to 6). In some areas, closet vents were blocked or air flow was hindered by materials stored in the closet. Some exhausts also appeared to be drawing weakly. As with supply ventilation, exhaust ventilation must be free of blockages and allowed to operate while the building is occupied. Rooftop exhaust fans should be examined periodically to ensure proper function. Consideration should also be given to keeping closet doors open to improve exhaust ventilation.

**Undercut closet doors**

7. Reduce the amount of materials stored below closet exhaust vents to allow for proper airflow. Consider removal of closet doors in classrooms where the doors block airflow to the exhaust vents.

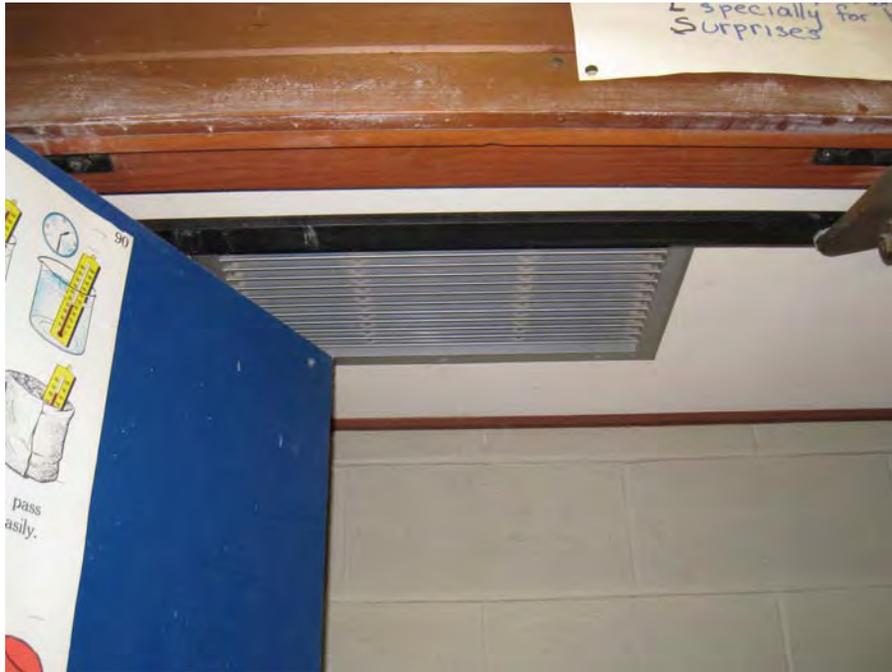
**Picture 5**

**Exhaust vent in closet**

6. Examine the exhaust system for function. This evaluation would include exhaust ventilation motor location, motor function and air flow through this system.

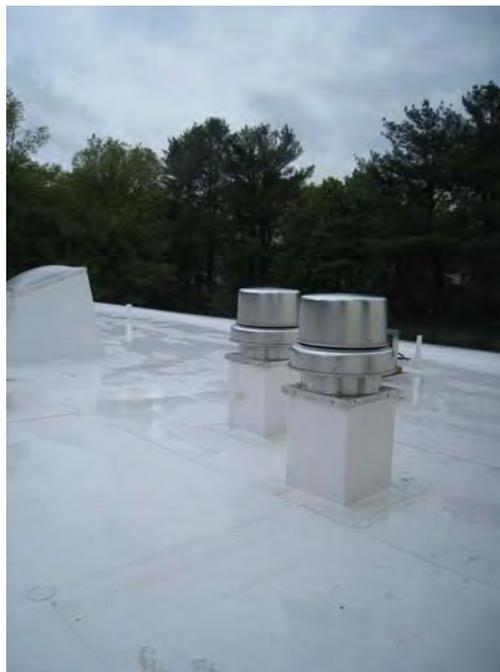
**Picture 6**

Mechanical ventilation for common areas (e.g., auditorium, cafeteria) is provided by rooftop air-handling units (AHUs) (Picture 6). Fresh air is distributed via ceiling-mounted air diffusers and ducted back to AHUs via ceiling or wall-mounted return vents. As with univents, AHUs should be activated and allowed to operate continuously during occupied periods.

**Rooftop exhaust fans**

8. Operate all ventilation systems throughout the building (e.g., gym, cafeteria, classrooms) continuously during periods of occupancy independent of thermostat control to maximize air exchange.

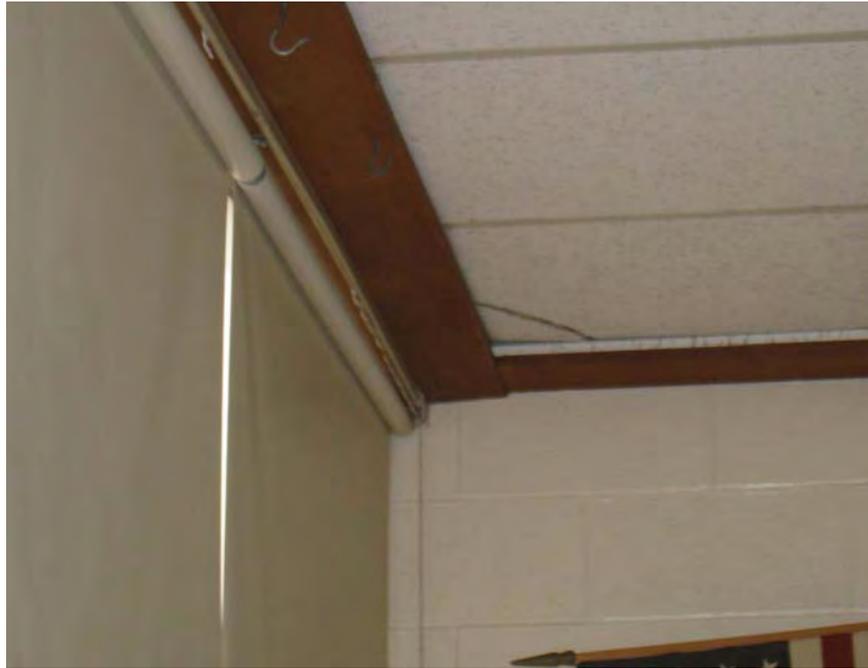
**Picture 7**

Water-stained and damaged/broken ceiling tiles were observed in the building are likely from roof leaks (Picture 7). Ms. Cameron and school staff reported that the ceiling tiles may contain asbestos. As mentioned, a new roof was installed at the school. Since the source of water has been repaired, consideration should be given to replacing missing and damaged ceiling tiles as soon as possible.

**Broken ceiling tile**

At the time of assessment, BEH staff recommended that PPS contact the Massachusetts Department of Labor Standards' (MDLS) Asbestos Program regarding any damaged tiles. Consideration should be given to replacing the asbestos-containing tiles during the window replacement project, since classrooms will be isolated for renovation.

4. Seal broken ceiling tiles and window caulking with duct tape as a temporary measure for reducing exposure opportunities to regulated substances, such as asbestos and PCBs. Similarly, ensure floors are waxed appropriately to ensure a continuous seal to prevent damaging floor tiles.

15. Repair any existing water leaks and replace any remaining water-damaged ceiling tiles. Examine the area above these tiles for mold growth. Disinfect areas of water leaks with an appropriate antimicrobial, as needed.

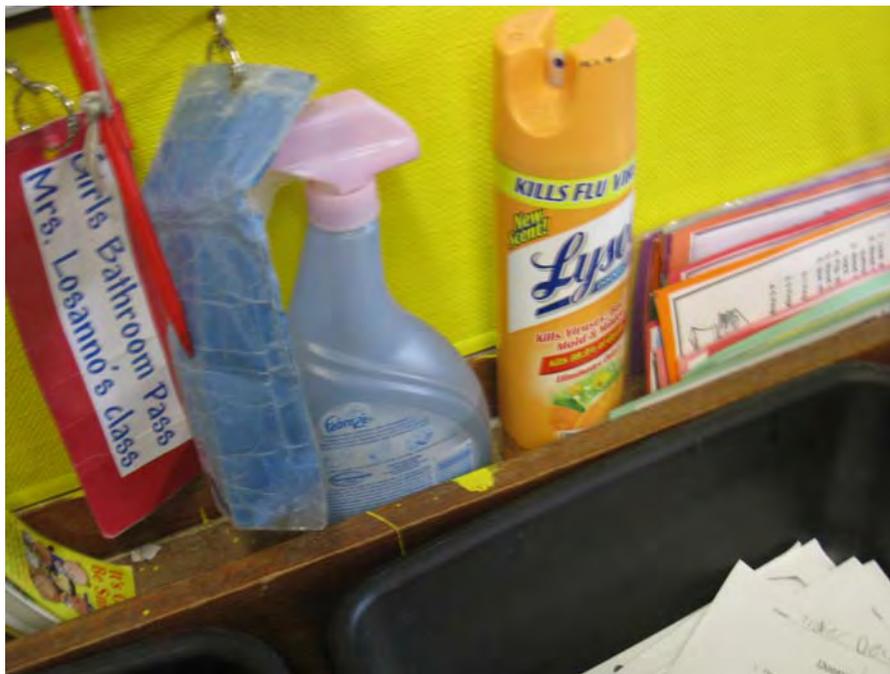
**Picture 8**

Cleaning, sanitization and air-deodorizing products were observed in a number of rooms (Picture 8; Table 1). These products contain chemicals that can be irritating to the eyes, nose and throat of sensitive individuals. Cleaning products should be properly labeled and stored in an area inaccessible to children. In addition, a Material Safety Data Sheets (MSDS) should be available at a central location for each product in the event of an emergency. Consideration should be given to providing staff with school issued cleaning products and supplies to prevent any potential for adverse chemical interactions between residues left from cleaners used by the facilities staff and those left by other cleaners.

Fragrant air deodorizers contain chemicals that can be irritating to the eyes, nose and throat of sensitive individuals. Many air fresheners contain 1,4-dichlorobenzene, a VOC which may cause reductions in lung function (NIH, 2006). Furthermore, deodorizing agents do not remove materials causing odors, but rather mask odors that may be present in the area.

**Cleaning and air deodorizing products**

18. Store cleaning products properly and out of reach of students. All cleaning products used at the facility should be approved by the school department with MSDS' available at a central location.

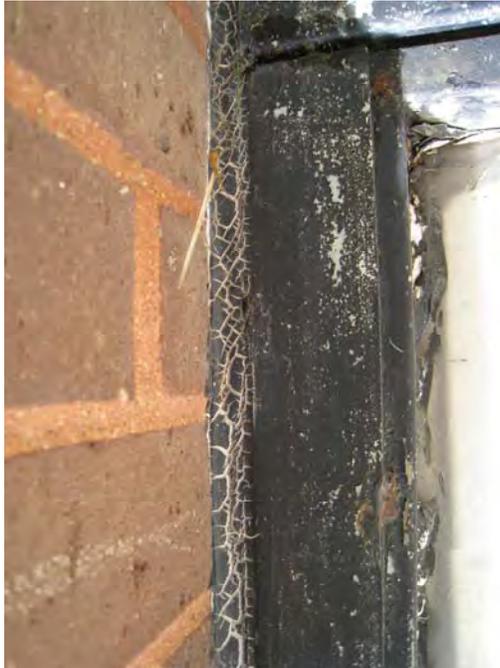
**Picture 9**

Window caulking and sealant were in disrepair at the time of assessment (Pictures 9 and 10). As mentioned, windows were scheduled to be replaced during the 2012 Summer Vacation. Window caulking reportedly contains poly-chlorinated biphenyls (PCBs). Such materials should be addressed in accordance with US Environmental Protection Agency (US EPA) regulations; however, for additional information regarding PCBs in building materials and exposure/health concerns, please consult MDPH guidance (Appendix C). In the interim, to prevent the aerosolization of caulking dust/debris, duct tape can be used to enclose window caulking.

**Aged window caulking**

2. Remediate asbestos-containing materials in conformance with Massachusetts asbestos remediation and hazardous waste disposal laws.
3. Caulking and expansion joint sealants containing regulated materials should be addressed in accordance with EPA regulations; however, for further information on addressing PCB-containing materials in schools and exposure/health concerns, consult MDPH guidance (Appendix C).

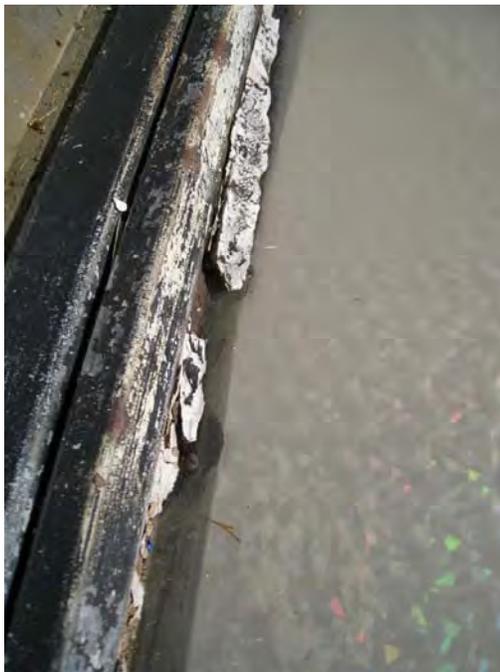
**Picture 10**

**Crumbling window sealant**

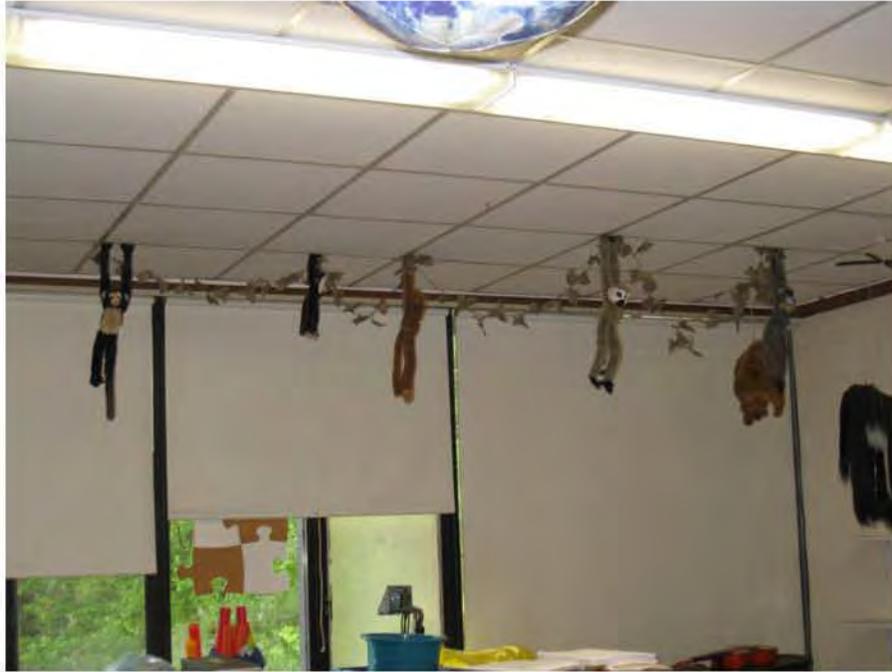
**Picture 11**

Items were observed hanging from the ceiling tile system (Picture 11). These items can disrupt the ceiling system, allowing dust/debris that may have settled on ceiling tiles to enter the classroom area through dislodged/ajar or missing ceiling tiles. Items hanging from the ceiling tile system should be removed to ensure tiles are flush.

**Items hanging from ceiling tile system**
