INDOOR AIR QUALITY ASSESSMENT

**Massachusetts Department of Children and Families
140 High Street
Springfield, MA**

Prepared by:
Massachusetts Department of Public Health
Bureau of Environmental Health
Indoor Air Quality Program
December 2012

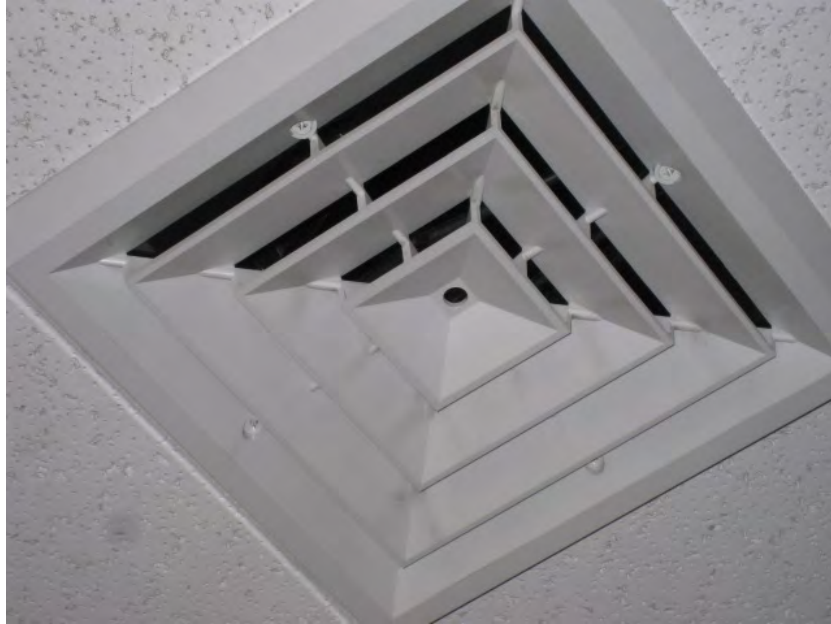
Picture 1

The heating, ventilating and air conditioning (HVAC) system consists of air-handling units (AHU) located in a closet. The AHUs draw in fresh air and distribute it to occupied areas via ceiling-mounted air diffusers and fresh air intake vents (Pictures 1 and 2). The offices do not have return ventilation; rather the HVAC system exhausts air via vents located in the ceiling and/or walls (Pictures 3 and 4) which are ducted directly to the outside and powered by rooftop motors. Of note, several ceiling-mounted air diffusers were partially blocked with plastic or cardboard, hence they were not operating as designed (Picture 5 and 6; Table 1). In addition, many wall exhaust vents are located near hallway doors, which can limit the effectiveness of exhausting stale air from the room when the door is open. Some of the exhaust vents were also located in areas partially or fully obstructed by items (Table 1).

Typical Fresh Air Supply Diffuser

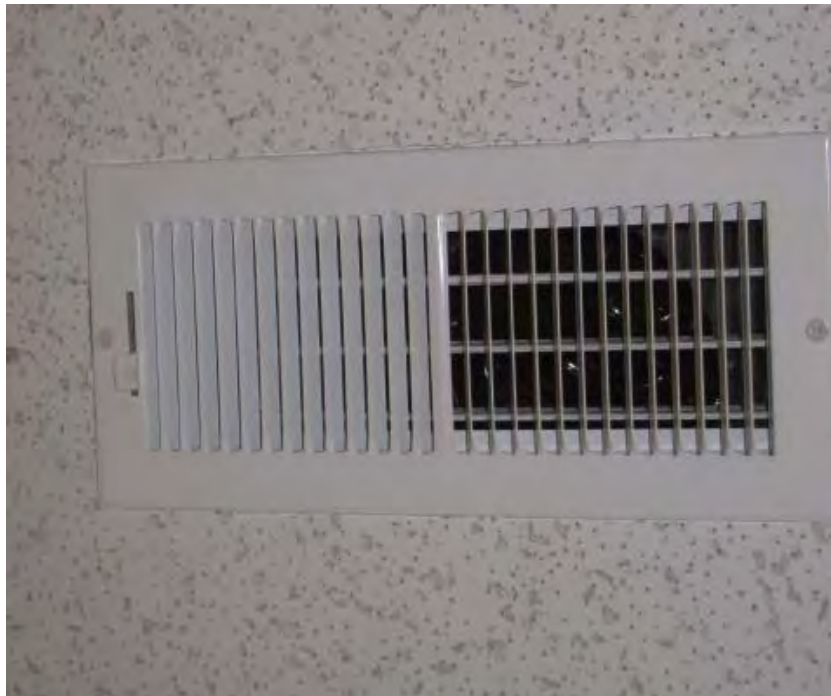
Picture 2

Typical Fresh Air Supply Vent

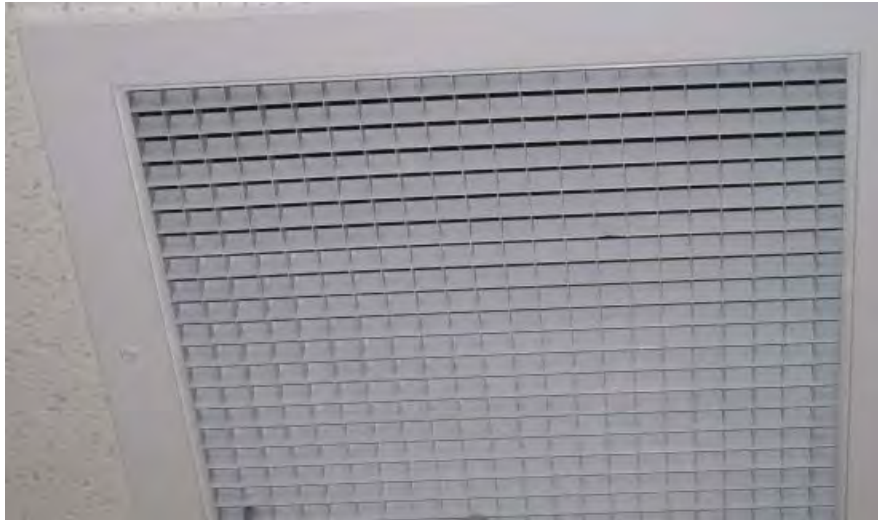
Picture 3

Ceiling Exhaust Vent

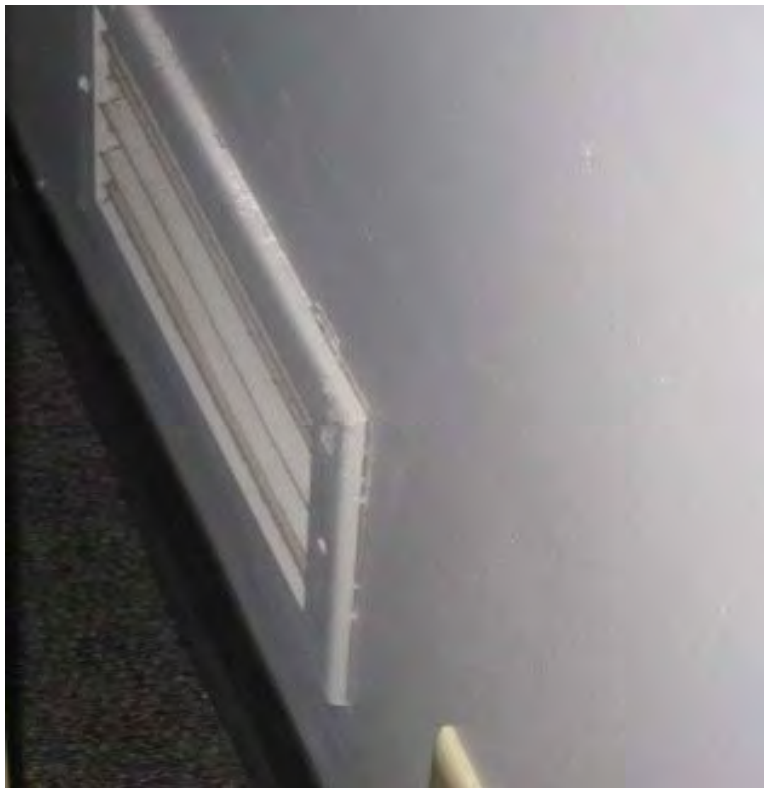
Picture 4

Typical Wall Exhaust Vent

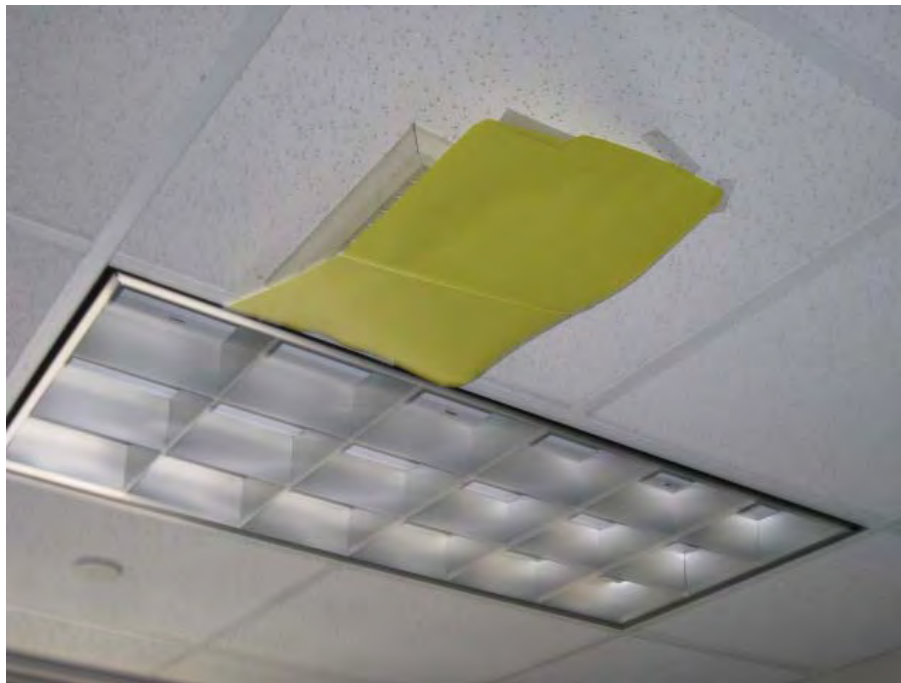
Picture 6

Supply Vent Blocked with Cardboard

1. Remove materials and obstructions from air supply, exhaust vents and FCU intakes and diffusers.

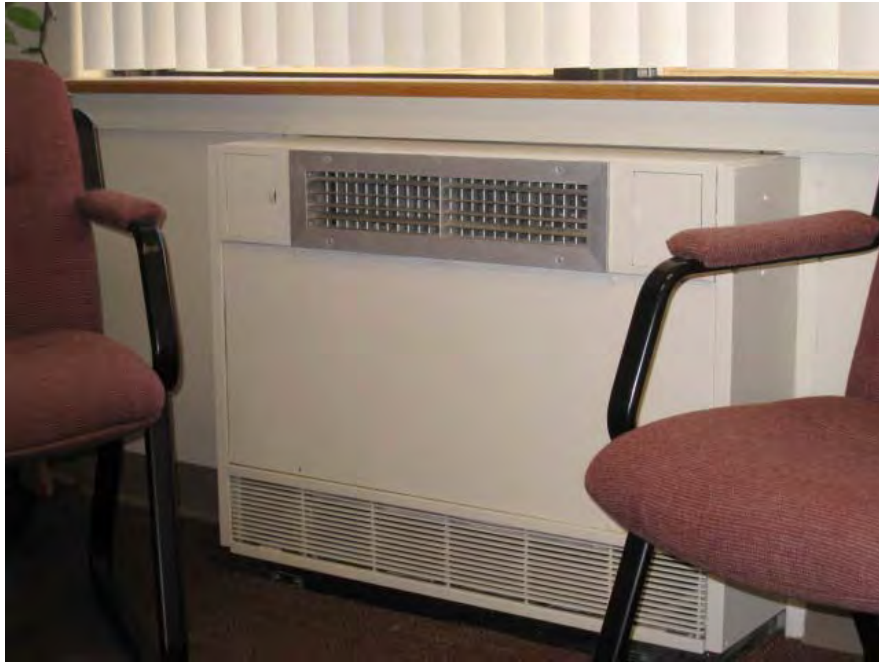
Picture 7

ceilings (Pictures 7 and 8) and provide supplemental heating or cooling to perimeter areas. FCUs do not introduce outside air; these units are limited to recirculating air. The FCUs were operating in all of the areas surveyed during the assessment. In some areas, FCUs were blocked/obstructed by several items including cardboard boxes, books and other stored materials (Picture 9). In order for FCUs to facilitate airflow as designed, they must remain free of obstructions. FCUs located at the base of walls appear to be original to the building, which would make them approximately 50 years old. Mechanical ventilation equipment of this age is difficult to maintain because replacement parts are often unavailable.

Typical Fan Coil Unit

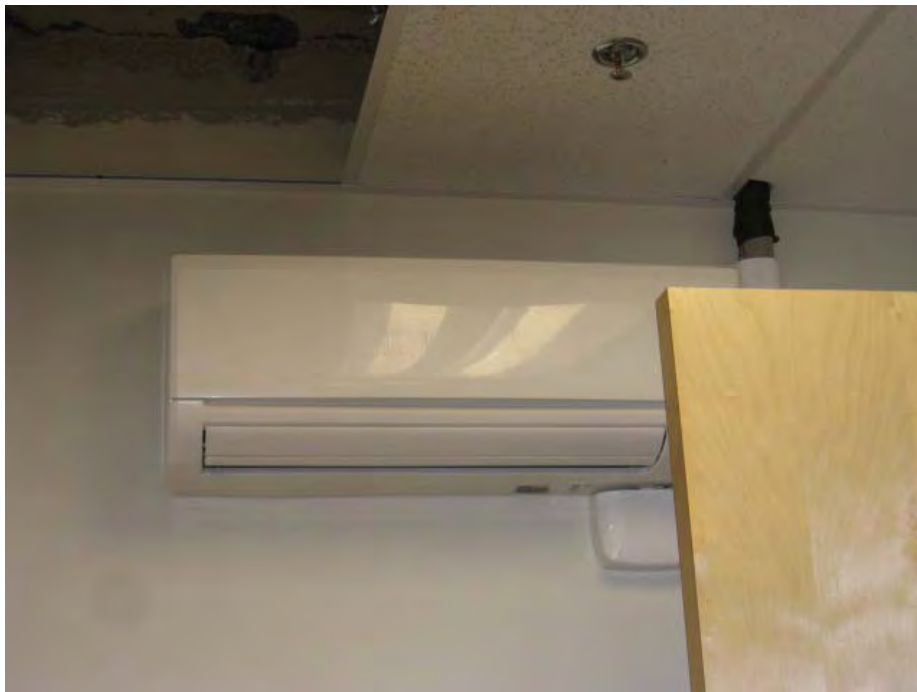
Picture 8

Typical Wall-Mounted Fan Coil Unit

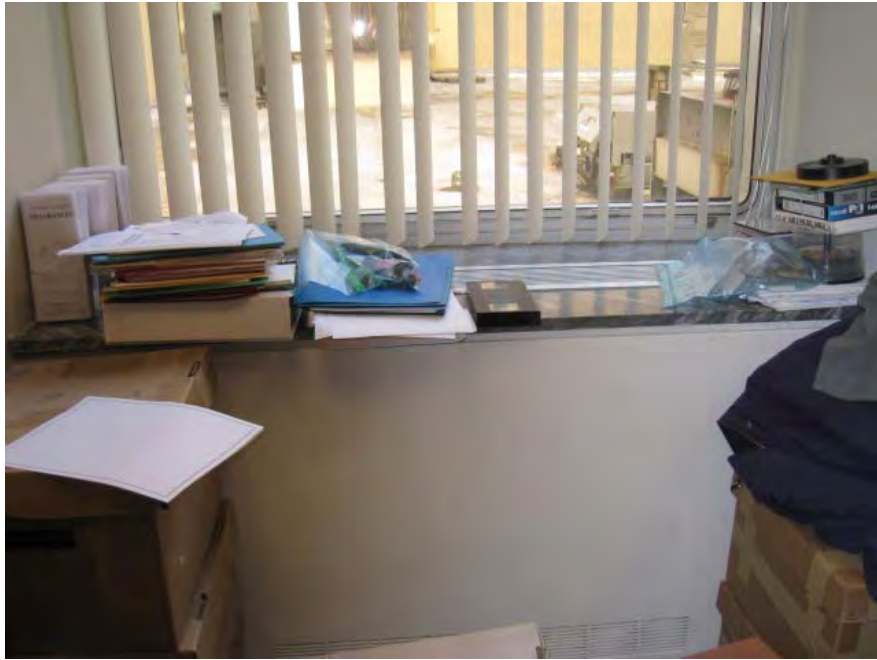
Picture 9

Obstructed Fan Coil Unit

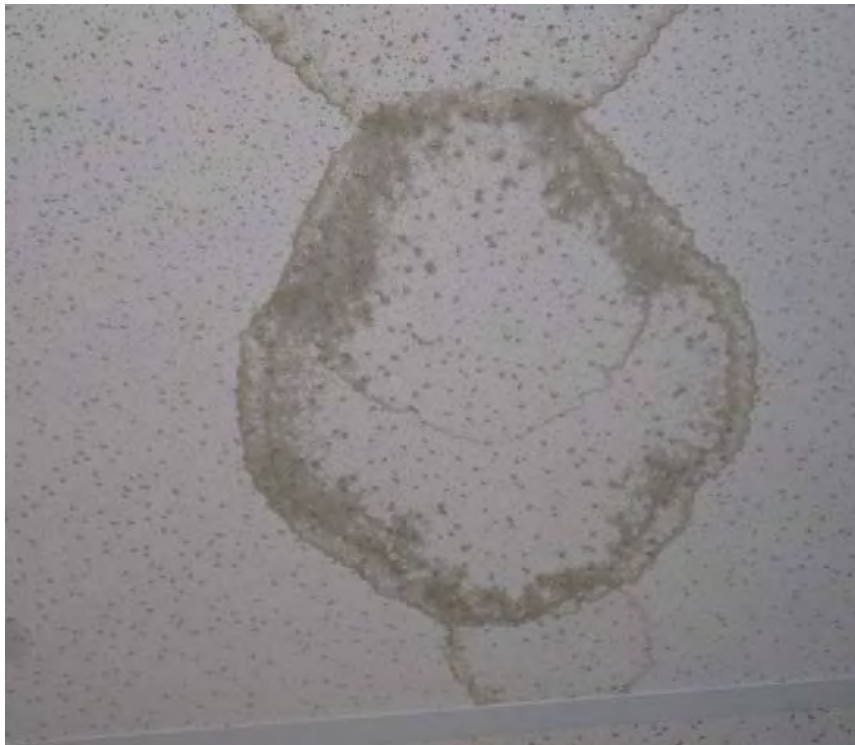
Picture 10

Water-damaged ceiling tiles were observed in some areas (Picture 10). Water-damaged ceiling tiles can stem from roof leaks, leaks in the plumbing system and/or leaks and condensation from air-conditioning systems and can provide a source of mold. These tiles should be replaced after a water leak is discovered and repaired.

Water-damaged Ceiling Tile

4. Remove water-damaged ceiling tiles and examine for source of water. Monitor for future leaks.
5. Consider moving water dispensing equipment to areas with tiled floors instead of carpeting, or installing waterproof mats to prevent leaks from damaging carpet.

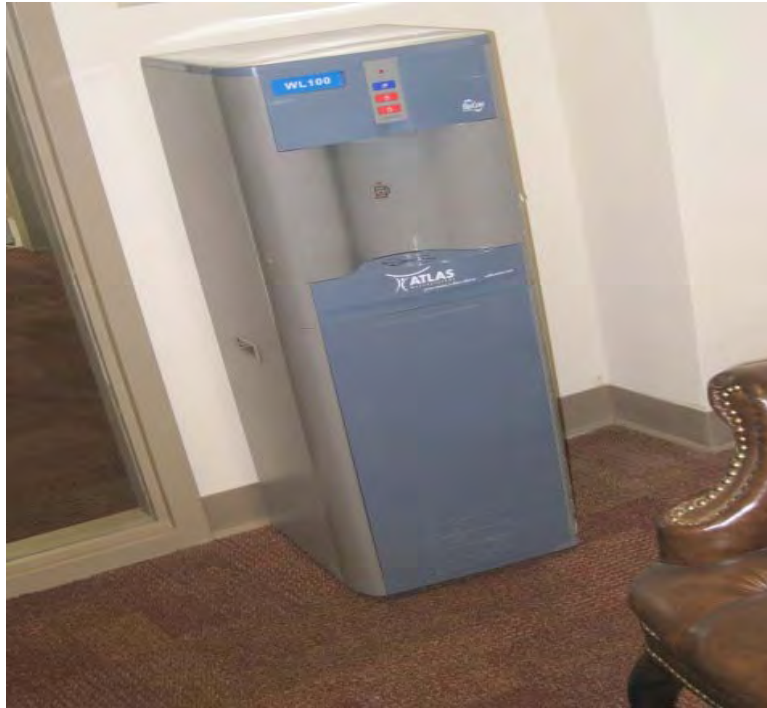
Picture 11

Water dispensers were located on carpeted areas (Picture 11). Spills/condensation from these units can be a source of moisture in carpeting that can lead to water damage and mold growth. When possible, these units should be located in tiled areas or placed on a waterproof mat.

Water Dispenser on Carpet

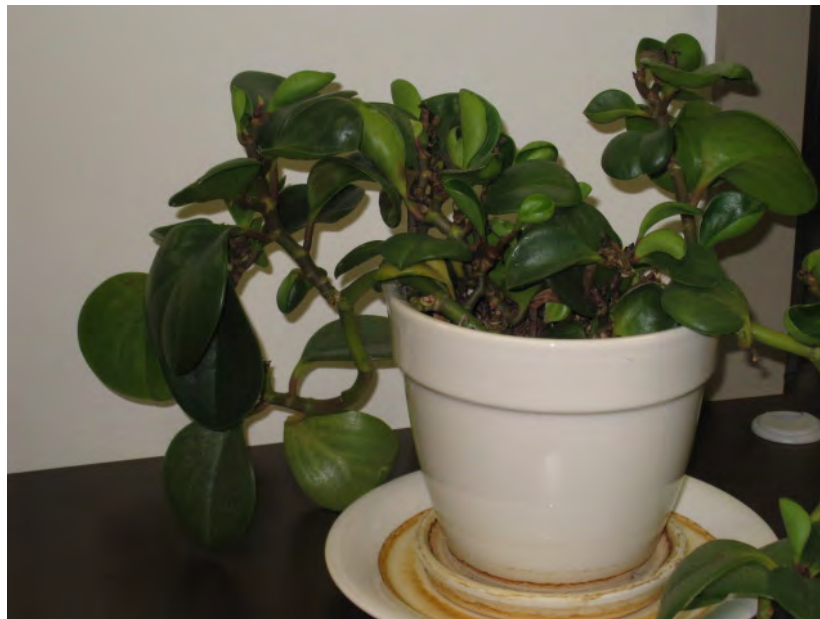
Picture 12

Plants were observed in office areas (Picture 12). Plants should be properly maintained and equipped with drip pans. Plants should be located away from ventilation sources (e.g., FCUs) to prevent aerosolization of dirt, pollen or mold. Plants should not be placed on porous materials, since water damage to porous materials may lead to microbial growth.

Plant in Office

6. Avoid overwatering of plants. Ensure flat surfaces around plants are free of potting soil and other plant debris. Examine drip pans periodically for mold growth and disinfect with an appropriate antimicrobial where necessary. Do not place plants on porous materials (e.g., paper/cardboard).

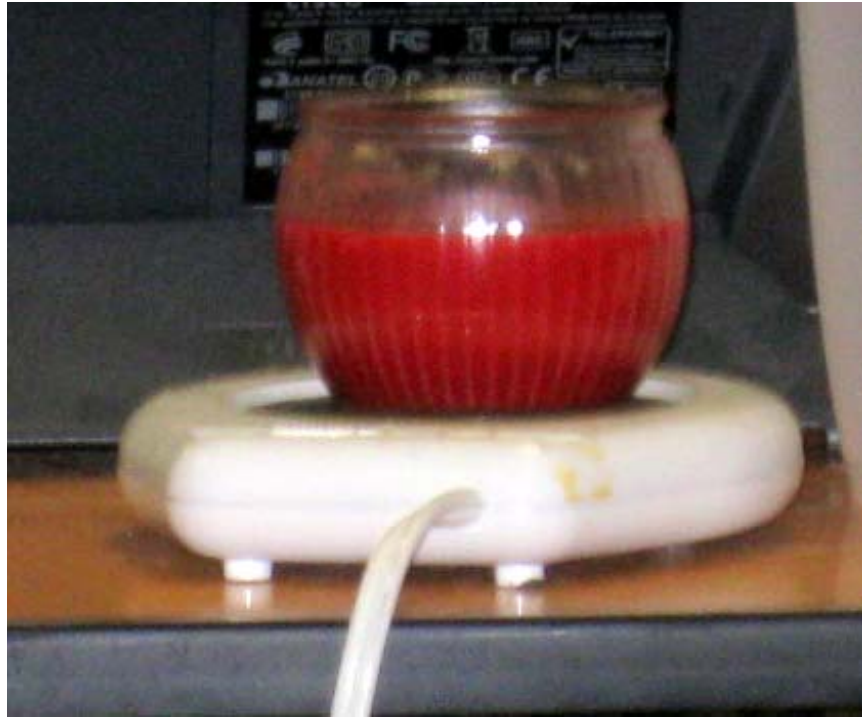
Picture 13

Air deodorizers and scented candles (Picture 13; Table 1) were noted in several areas of the building. Scented candles contain chemicals that can be irritating to the eyes, nose and throat of sensitive individuals. Scented products were also noted in restrooms. Deodorizing agents do not remove materials causing odors, but rather mask odors that may be present in the area.

Scented Candle in Office

7. Refrain from having scented candles or using air fresheners/deodorizers to prevent exposure to VOCs.
8. Replace missing ceiling tiles. Ensure all ceiling tiles are flush to prevent movement of materials from the plenum.

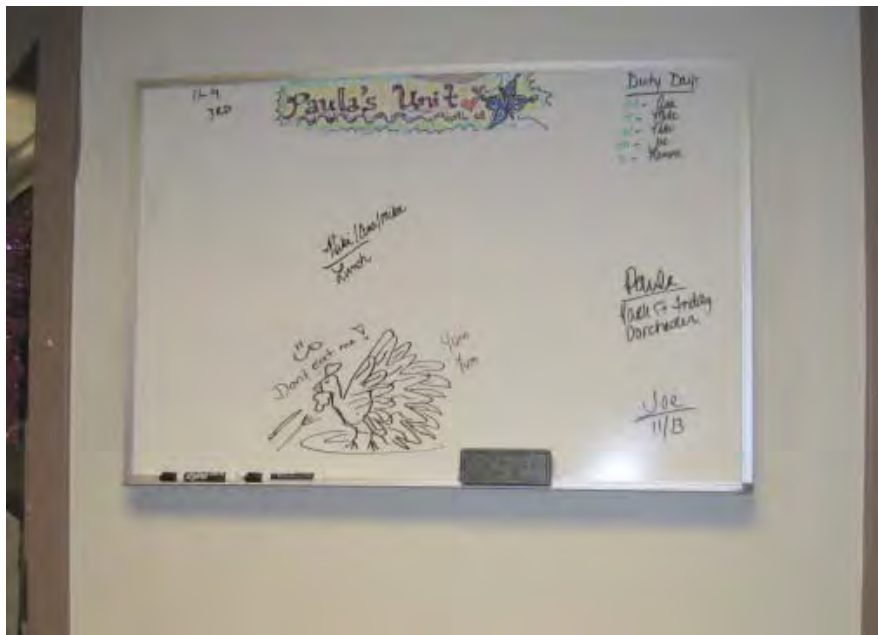
Picture 14

Several rooms contained dry erase boards and related materials (Picture 14). Materials such as dry erase markers and dry erase board cleaners may contain VOCs, such as methyl isobutyl ketone, n-butyl acetate and butyl-cellusolve (Sanford, 1999), which can be irritating to the eyes, nose and throat.

Dry Eraser Board and Materials

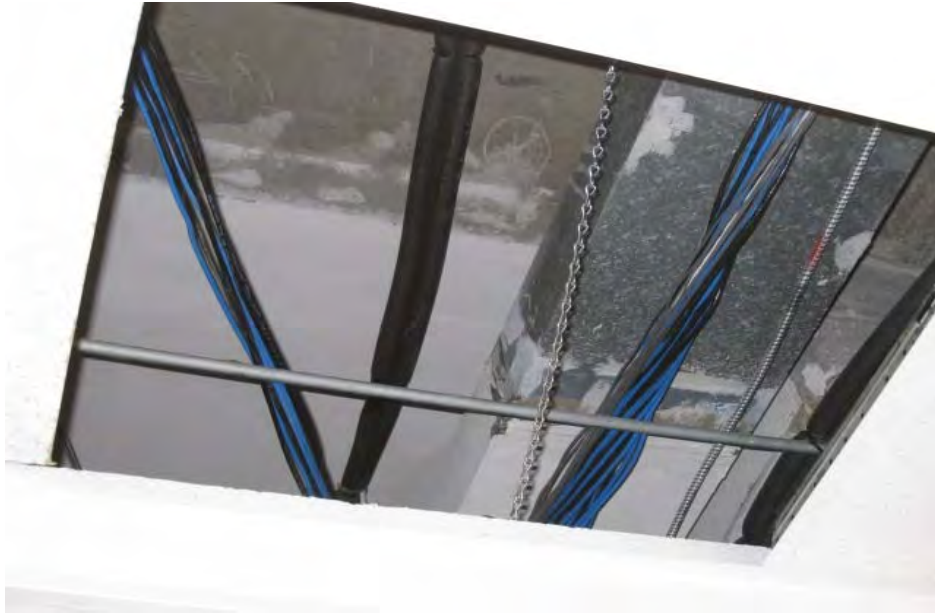
Picture 15

Missing and ajar ceiling tiles were observed in some areas (Picture 15). Breaches in the ceiling tile system can provide pathways for dust, dirt, odors and other pollutants to move into occupied areas.

Missing Ceiling Tile

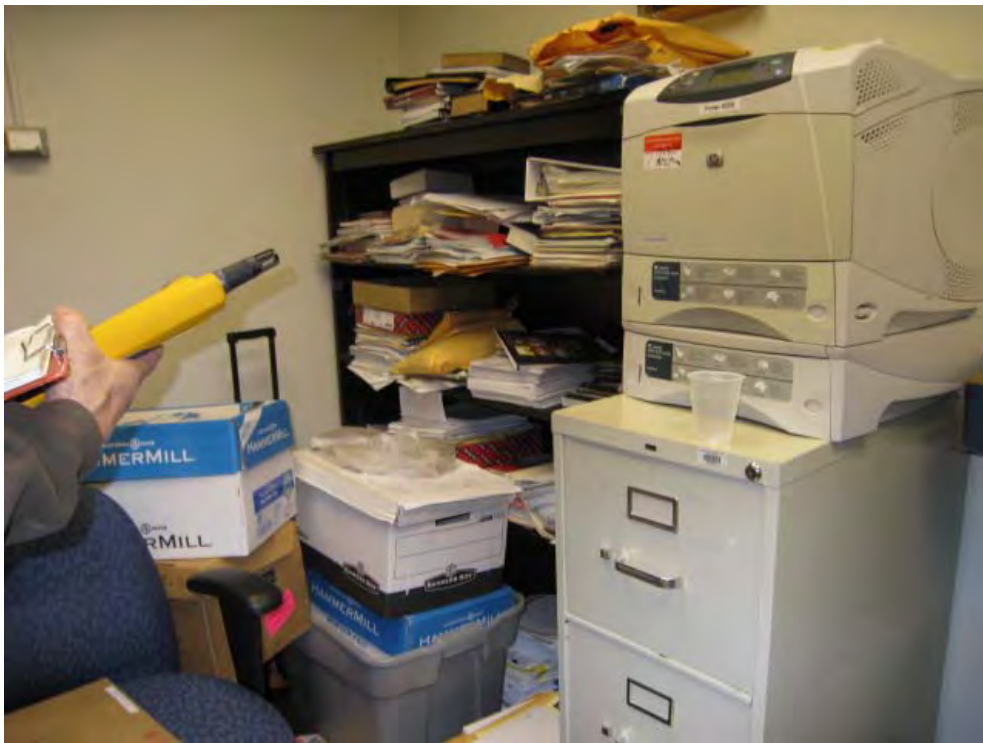
Picture 16

In several offices, items were observed on the FCUs, floors, windowsills, tabletops, counters, bookcases and desks (Picture 16). The large number of items stored in offices provides a source for dusts to accumulate. These items (e.g., papers, folders, boxes, books) make it difficult for custodial staff to clean. Items should be relocated and/or be cleaned periodically to avoid excessive dust build up. In addition, these materials can accumulate on flat surfaces (e.g., desktops, shelving and carpets) in occupied areas and subsequently be re-aerosolized causing further irritation.

Large Amount of Items Stored on Floor and Bookcases

9. Relocate or consider reducing the amount of materials stored in offices and common areas to allow for more thorough cleaning.

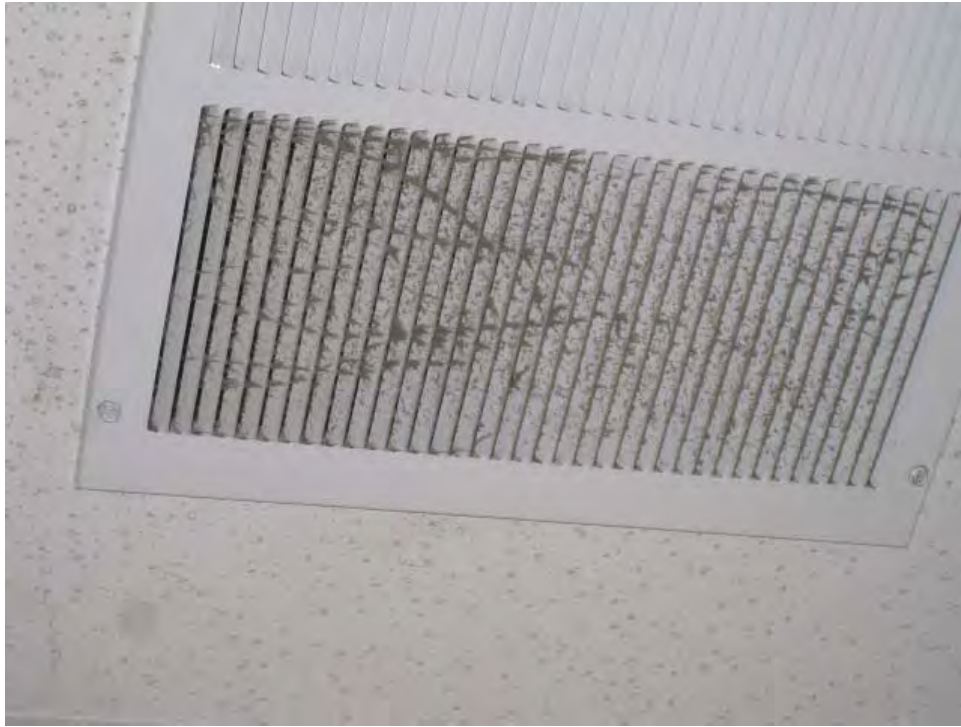
Picture 17

A number of FCUs, air diffusers, exhaust vents and personal fans were observed to have accumulated dust/debris (Picture 17; Table 1). These diffusers, vents and fans should be cleaned in order to prevent dust/debris from being aerosolized and redistributed throughout the room.

Example of Dirty Exhaust Vent

10. Clean FCUs, air vents and personal fans periodically of accumulated dust.
11. Refer to resource manual and other related indoor air quality documents located on the MDPH's website for further building-wide evaluations and advice on maintaining public buildings. These documents are available at: <http://mass.gov/dph/iaq>.
