INDOOR AIR QUALITY ASSESSMENT

**Morningside Community School
100 Burbank Street
Pittsfield, Massachusetts**

Prepared by:
Massachusetts Department of Public Health
Bureau of Environmental Health
Indoor Air Quality Program
August 2013

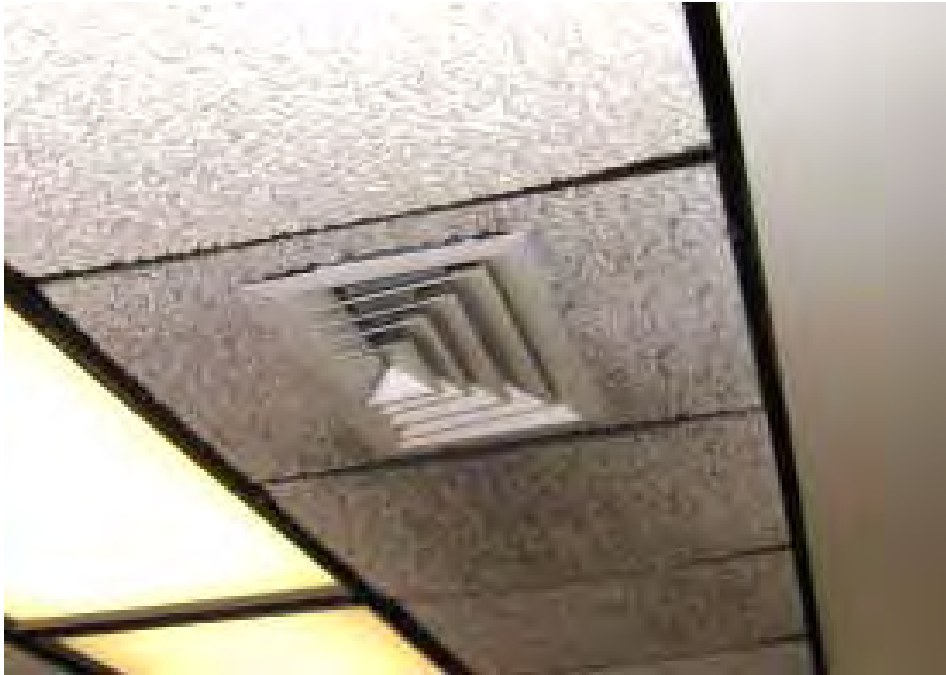
Picture 1

- Ceiling tiles around supply diffusers were soiled with dust/debris (Picture 1).

Soiling of ceiling tiles around fresh air supply diffuser

7. Clean air diffusers, exhaust/return vents and adjacent ceiling tiles periodically of accumulated dust/debris. If soiled ceiling tiles cannot be cleaned, they should be replaced.

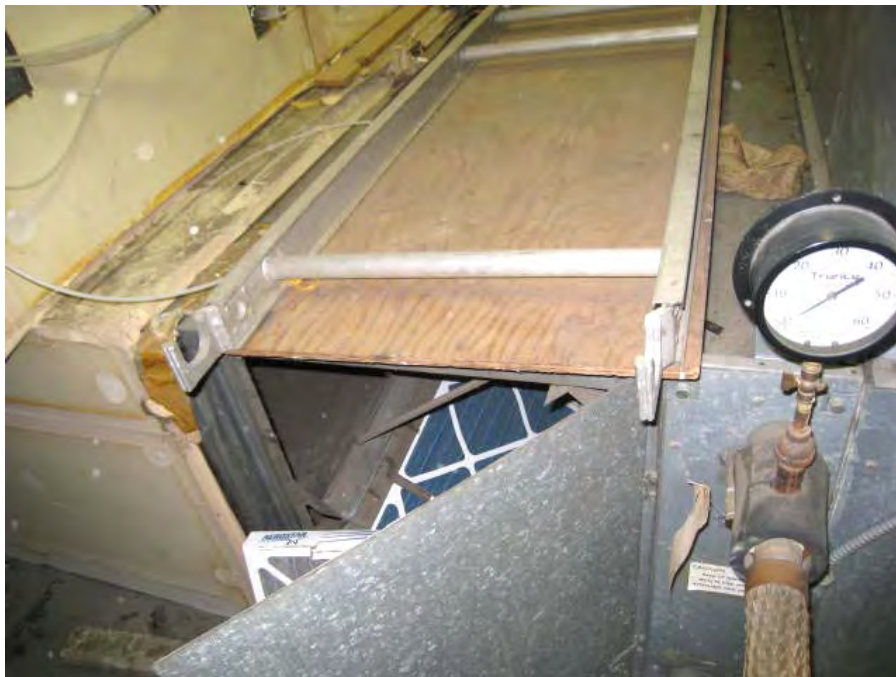
Picture 2

- The AHU in the second floor mechanical room had its filter doors open and was not operating (Picture 2).
- The interior of some AHUs on the roof could not be examined because the access panels were held in place with screws that were too corroded to be readily opened. This also indicates that the filters are unlikely to have been changed recently. Typically, filters in schools are changed two to four times a year.
- Gaps between filters were noted in the mechanical room AHU.
- Some AHUs appear to have wire mesh/metal filters in place of disposable filters (Picture 3). These filters were observed to be heavily caked with dirt, dust/debris, occluding them to a point where draw through the filter would be extremely limited.

AHU with access doors open

4. Ensure all doors for AHUs close properly and that they can be opened for maintenance.
5. Consider extending or moving exhaust vent away from fresh air intake of AHU to prevent entrainment of exhaust.

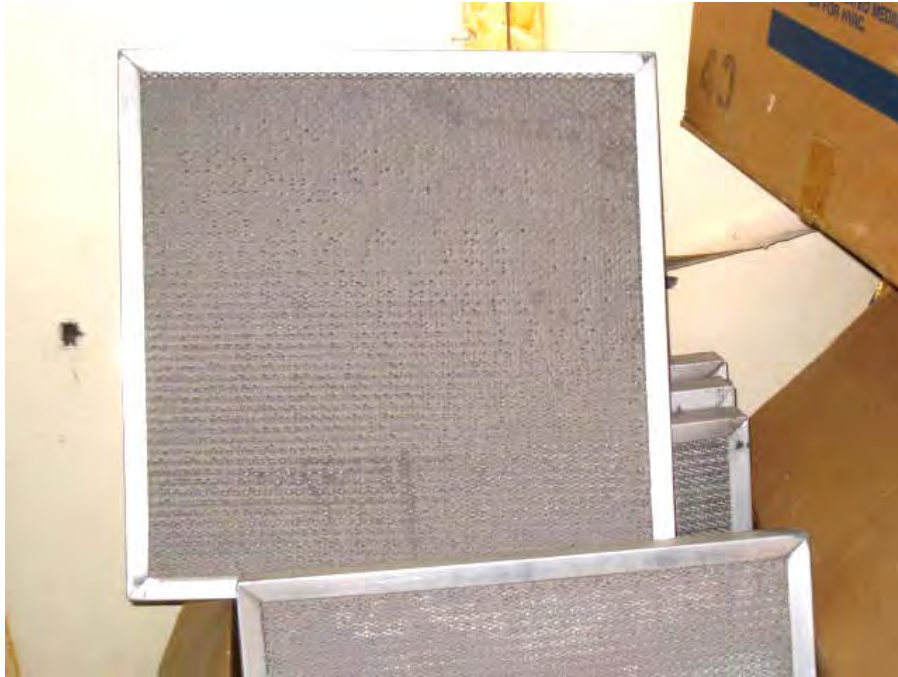
Picture 3

Wire mesh filters, note occlusion with dust/debris

2. Repair all exhaust fans on the roof.
3. Install properly-sized filters in AHUs. Change filters for air-handling equipment (e.g., univents, AHUs) as per the manufacturer's instructions or more frequently if needed. Vacuum interior of units prior to activation to prevent the aerosolization of dirt, dust and particulates. Ensure filters fit flush in their racks with no spaces in between which might allow bypass of unfiltered air into the unit.

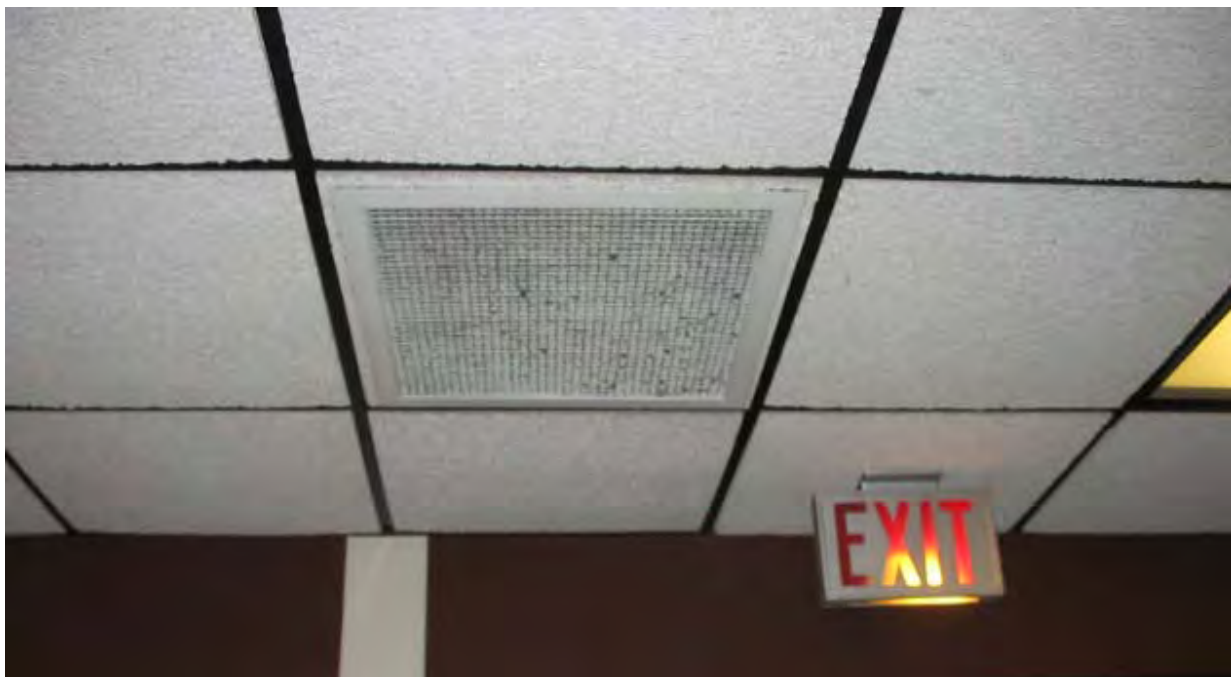
Picture 4

BEH/IAQ staff found no evidence of water damage attributable to roof or window leaks (such as stained ceiling tiles or damaged wall plaster). However, the ceiling tile system throughout the main floor was found to have significantly bowing tiles (Picture 4, Table 1). This suggests that there are chronic levels of water vapor/high relative humidity in the building.

Bowing ceiling tiles

14. Replace water-damaged ceiling tiles. Examine the area above and around these areas for mold growth. Disinfect areas of water leaks with an appropriate antimicrobial.

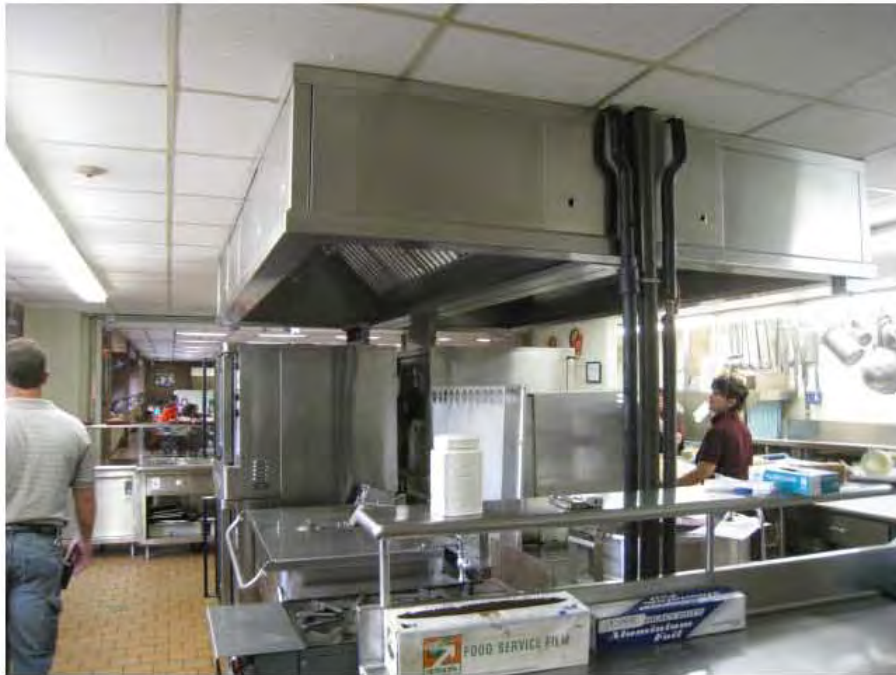
Picture 5

At least half of the exhaust vents on the roof were deactivated at the time of assessment. The exhaust fan for the kitchen hood was found to be drawing minimally. The fan motor on the roof was producing a rattle noise, which can indicate worn/failing ball bearings in the motor or fan. Exhaust ventilation is necessary to remove water vapor and other normally occurring pollutants that accumulate within the building.

One likely source of water vapor is the kitchen. As previously mentioned, the kitchen hood was found drawing minimal air (Picture 5), which would result in odors/water vapor accumulating in the building. Kitchen staff had portable fans operating to increase comfort (Picture 6). Use of fans in this manner directs water vapor into the cafeteria, which may result in moistened ceiling tiles. As noted previously, the rooftop exhaust fan connected to the kitchen hood was producing noise indicating worn or failed bearings, which would reduce the ability of the fan to draw air.

Kitchen hood

1. Repair the kitchen hood. Operate the kitchen hood continuously to provide exhaust ventilation for stove pilot lights. Consideration should be given to replacing the stove with an automatic ignition system. Once the hood is repaired, refrain from using portable fans in the kitchen area.

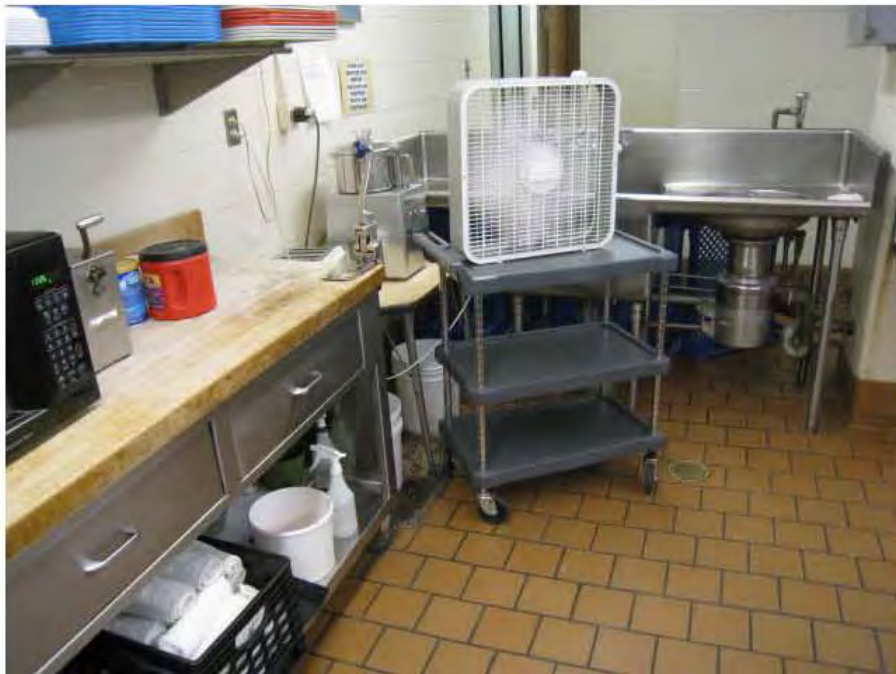
Picture 6

Portable fan in the kitchen

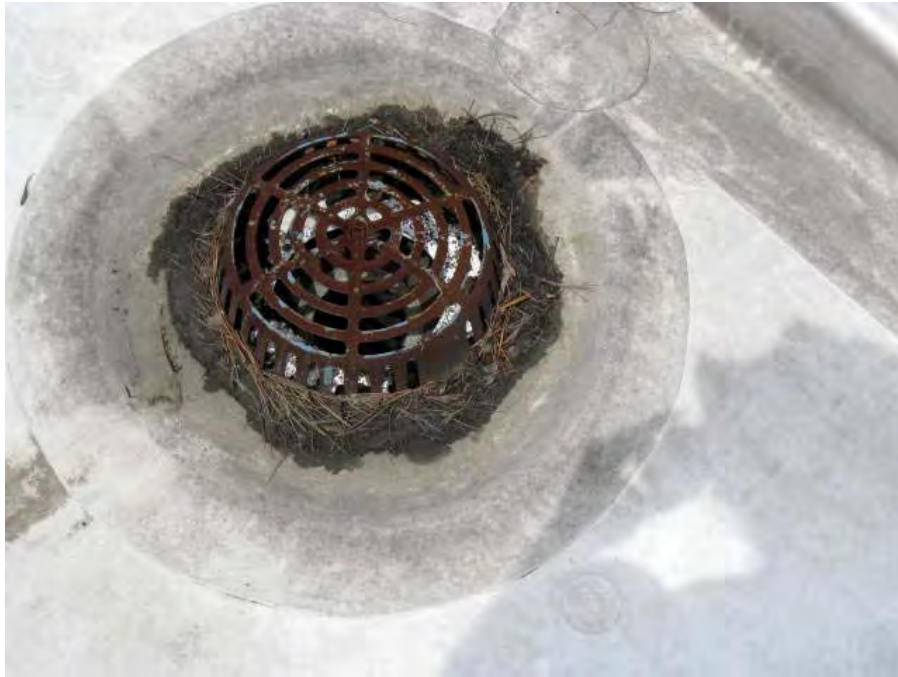
Picture 7

Standing water was observed on portions of the roof. Some roof drains are installed at a point higher than the level of the roof (Picture 7). The freezing and thawing of water during winter months can lead to roof leaks and subsequent water penetration into the interior of the building. Pooling water can also become stagnant, which can lead to mold and bacterial growth, and serve as a breeding ground for mosquitoes.

Roof drain installed at a point higher than level of roof

16. Clean debris from rooftop drains. Routinely inspect roof drains to prevent pooling of water. Reinstallation/adjustment of roof drains may be required for proper drainage.

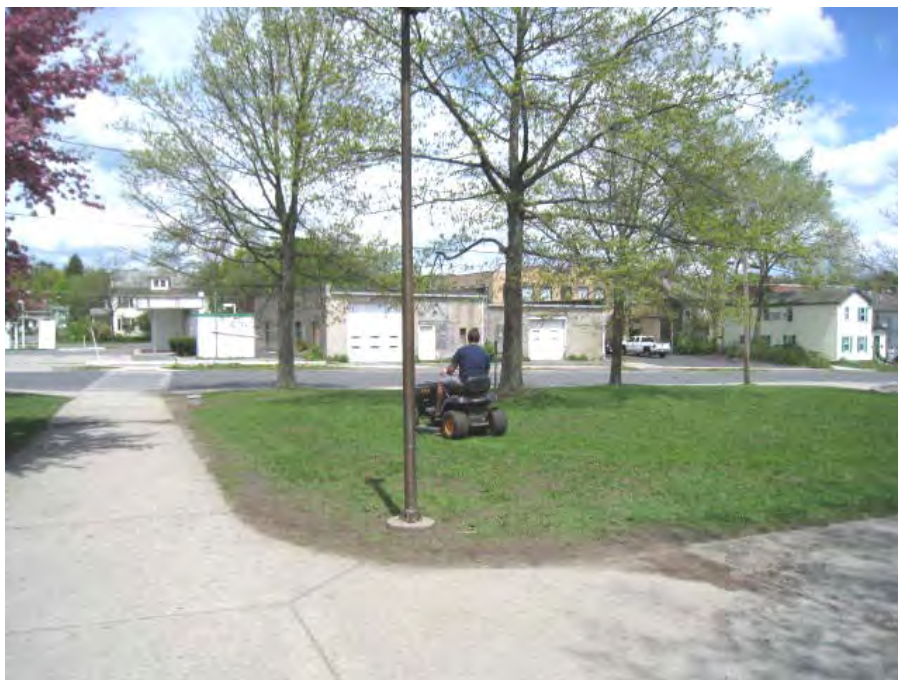
Picture 8

During the course of the assessment, BEH/IAQ staff noted the strong odor of lawn mowing. Building maintenance staff were observed mowing the lawn adjacent to the building during school hours (Picture 8). Engine exhaust, pollen, dust, dirt and other pollutants from lawn mowing were likely entering the building through open windows. Lawn mowing can produce a significant number of respiratory irritants that may cause symptoms in individuals who have allergies or asthma.

School staff mowing lawn during school hours

11. Schedule lawn mowing after school hours.
12. Seal floor drains in unused shower areas. Disconnect water service to showers and properly cut and cap plumbing as needed.

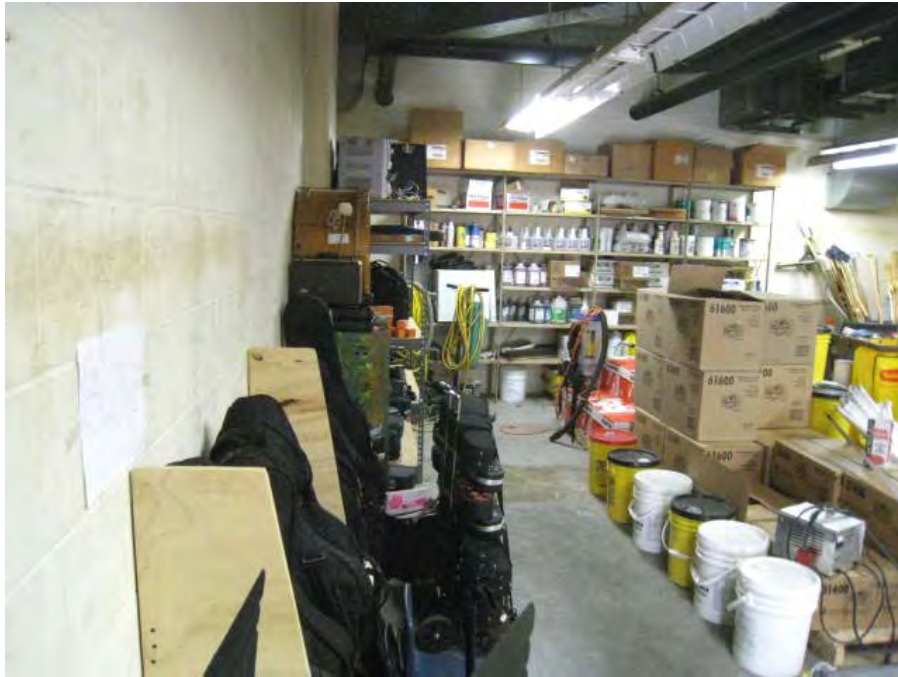
Picture 9

Of note is the storage of musical instruments in the custodial storeroom (Picture 9). It was reported by school officials that students have ready access to the room to retrieve instruments. It is highly recommended that the custodial storeroom be secure and that students should not have access to this area used to store custodial cleaners and other chemicals.

Musical instruments in the custodial storeroom

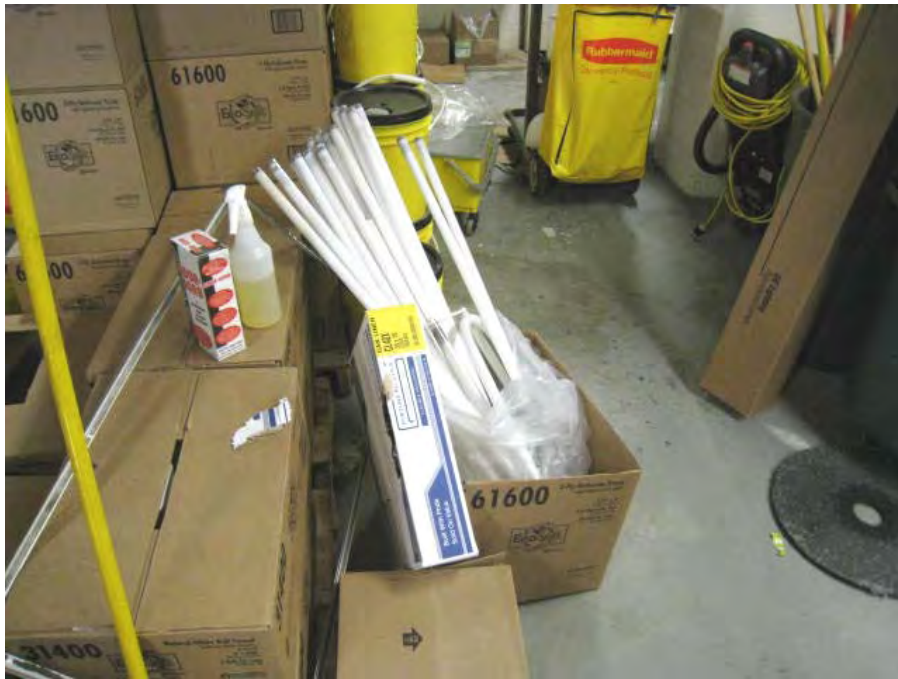
Picture 10

Fluorescent light bulbs were observed to be stored in a non-secure manner in the mechanical room (Picture 10). These bulbs contain mercury, and must be properly handled and stored in order to prevent breaks and mercury spills.

Freestanding fluorescent lights in storeroom

19. Properly store and dispose of fluorescent light bulbs.
20. Consider adopting the US EPA (2000) document, “Tools for Schools”, as an instrument for maintaining a good indoor air quality environment in the building. This document is available at: <http://www.epa.gov/iaq/schools/index.html>.
