INDOOR AIR QUALITY ASSESSMENT

**Commonwealth of Massachusetts
Department of Children and Families
Massachusetts Rehabilitation Commission
110 Mulberry Street
Brockton, MA**

Prepared by:
Massachusetts Department of Public Health
Bureau of Environmental Health
Indoor Air Quality Program
May 2014

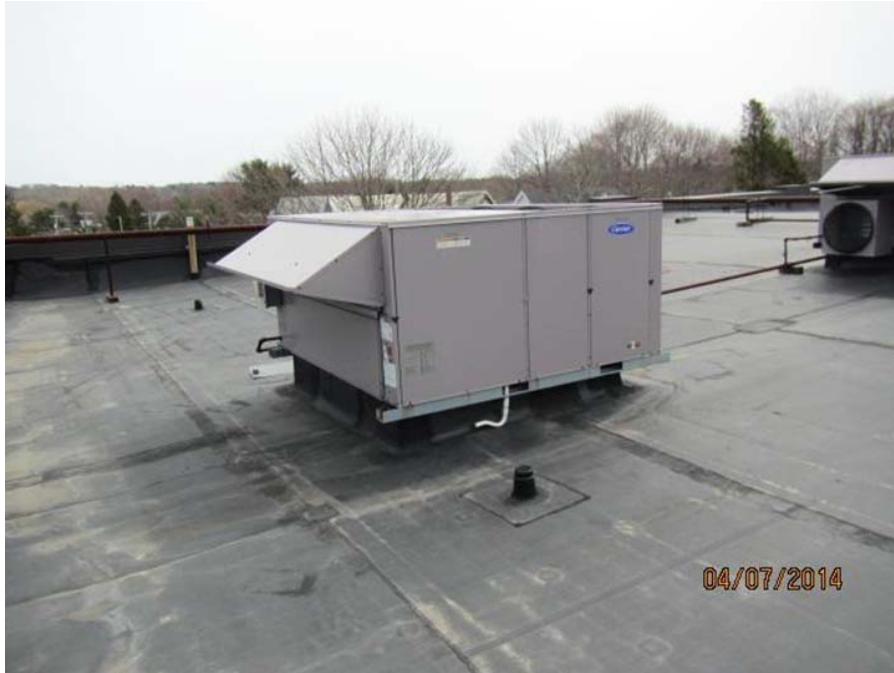
Picture 1

Fresh air is provided by rooftop air-handling units (AHUs; Picture 1). Fresh air is drawn into the AHUs through a bank of air filters, heated or cooled and delivered to occupied areas via ducted air diffusers (Picture 2). Return air is drawn into ceiling -mounted vents (Picture 3) or vents around light fixtures (Picture 2) and ducted back to rooftop AHUs.

Air handling unit (AHU) on the roof

1. Set thermostats to the fan “on” position to provide continuous air circulation/filtration during business hours. Consult with an HVAC technician to increase fresh air intake/delivery, particularly on the second floor.

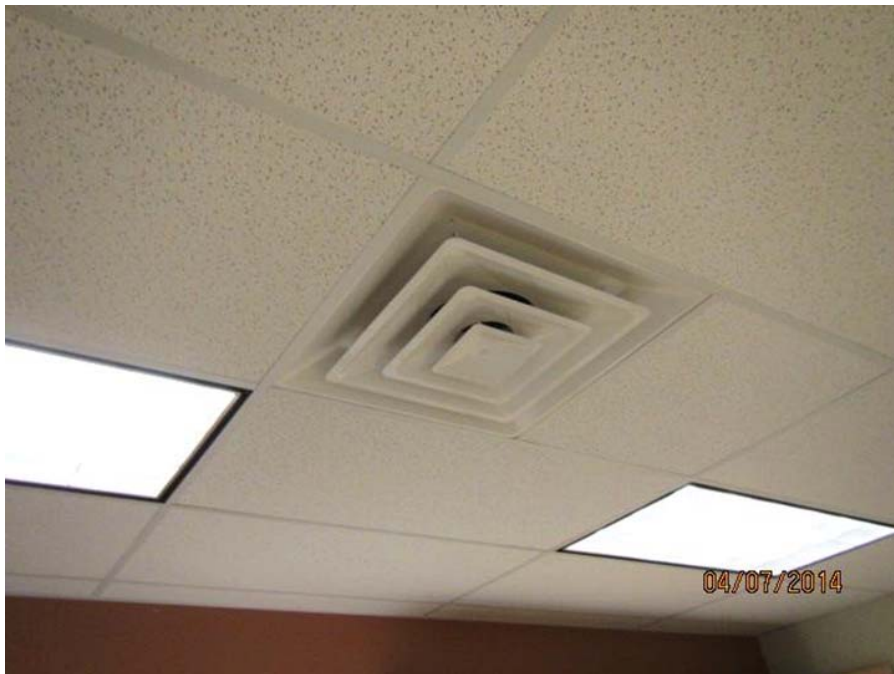
Picture 2

Typical supply diffuser

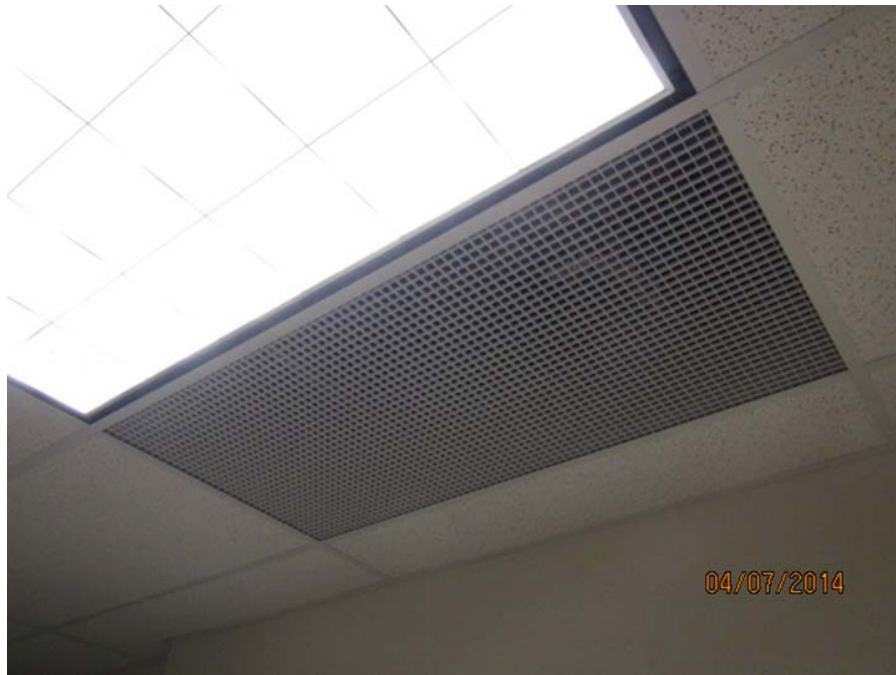
Picture 3

Typical exhaust grate

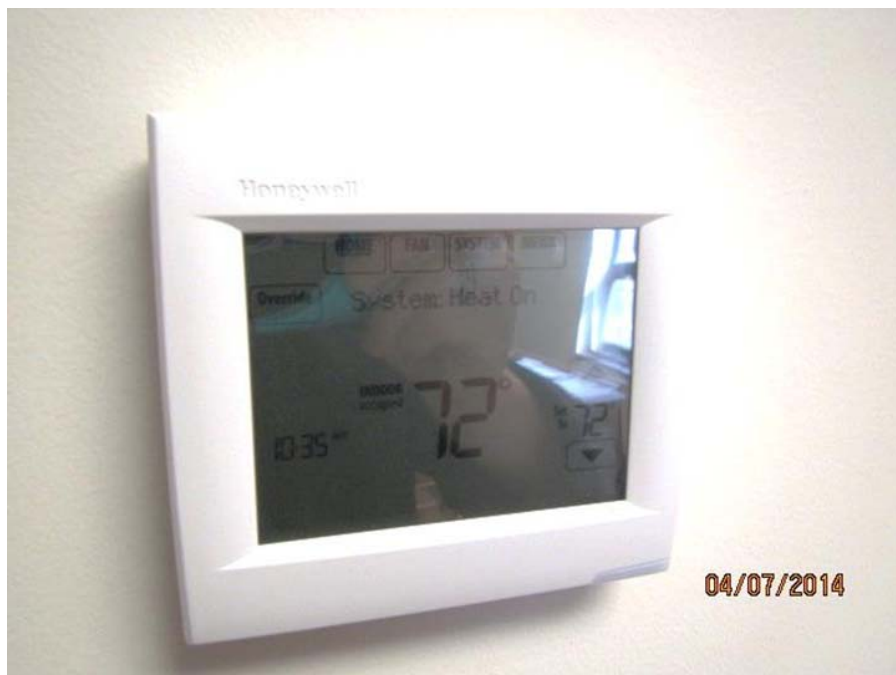
Picture 4

The HVAC system is controlled by digital thermostats. Thermostats examined had a fan switch with two settings, *on* and *auto* (Picture 4). When the fan is set to *on*, the system provides a continuous source of air circulation and filtration. The *automatic* setting on the thermostat activates the HVAC system at a pre-set temperature. Once the pre-set temperature is reached, the HVAC system is deactivated. Therefore, no mechanical ventilation is provided until the thermostat re-activates the system. At the time of assessment, all thermostat fan settings were in the “auto” position. As mentioned, this thermostat setting can limit airflow. The MDPH typically recommends that thermostats be set to the fan *on* setting during occupied hours to provide continuous air circulation.

Thermostat in the office

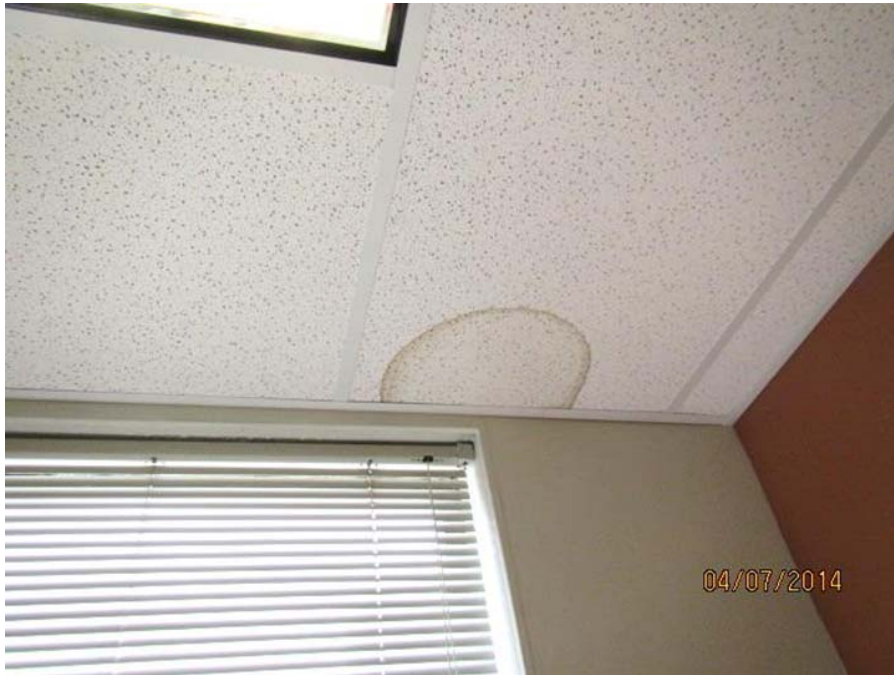
Picture 5

In order for building materials to support mold growth, a source of water exposure is necessary. Water-damaged ceiling tiles were observed in a few areas (Table 1; Picture 5). According to building occupants in one area of the second floor, there had been a significant leak reportedly from the HVAC system above and that the ceiling tiles had been recently changed.

Water-damaged ceiling tile

Water-damaged ceiling tiles can provide a source of mold and should be replaced after a water leak is discovered and repaired. If leaks from the HVAC system continue to occur, an HVAC technician should be consulted about repairs to the system or condensate drainage.

4. Replace water-damaged ceiling tiles when a leak is discovered and repaired. If chronic HVAC leaks occur, consult with an HVAC engineer to repair systems. Staff should be encouraged to report building leaks to management for prompt remediation.

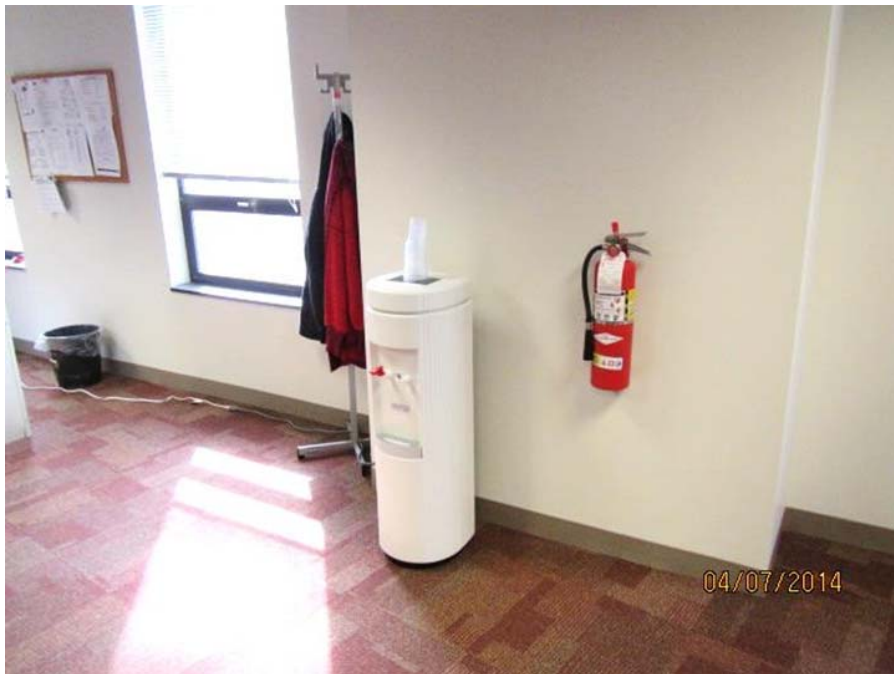
Picture 6

Water dispensing equipment and small refrigerators were observed in carpeted areas (Table 1; Picture 6). Spills or leaks from this equipment can moisten carpet and lead to microbial growth and carpet degradation. In addition, gaskets in one of the kitchen refrigerators was found to be colonized with mold (Picture 7), which can result in odors and exposure to mold spores. All refrigerators should be cleaned regularly and if gaskets and other components cannot be adequately cleaned with an anti-microbial agent, they should be replaced.

Water dispenser on carpet

6. Place refrigerators and water dispensing equipment in non-carpeted areas or consider using a waterproof mat to contain spills or leaks.
7. Ensure refrigerators are cleaned out regularly. Clean moldy gaskets with a mild detergent or antimicrobial agent, if cannot be adequately cleaned consider replacing. Consider reducing the number of refrigerators in use in the office.

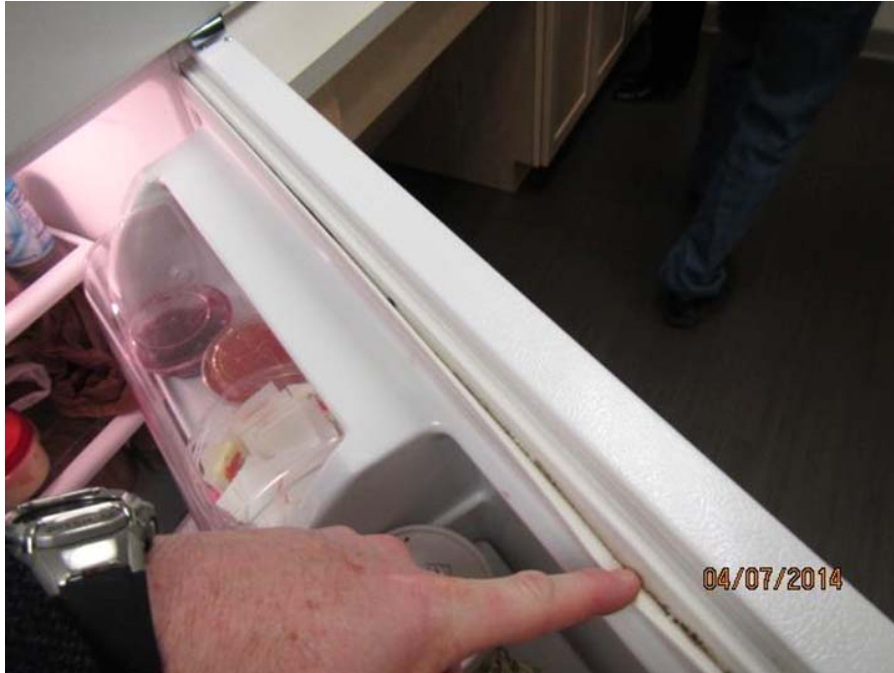
Picture 7

Mold-colonization (dark staining) on refrigerator gasket

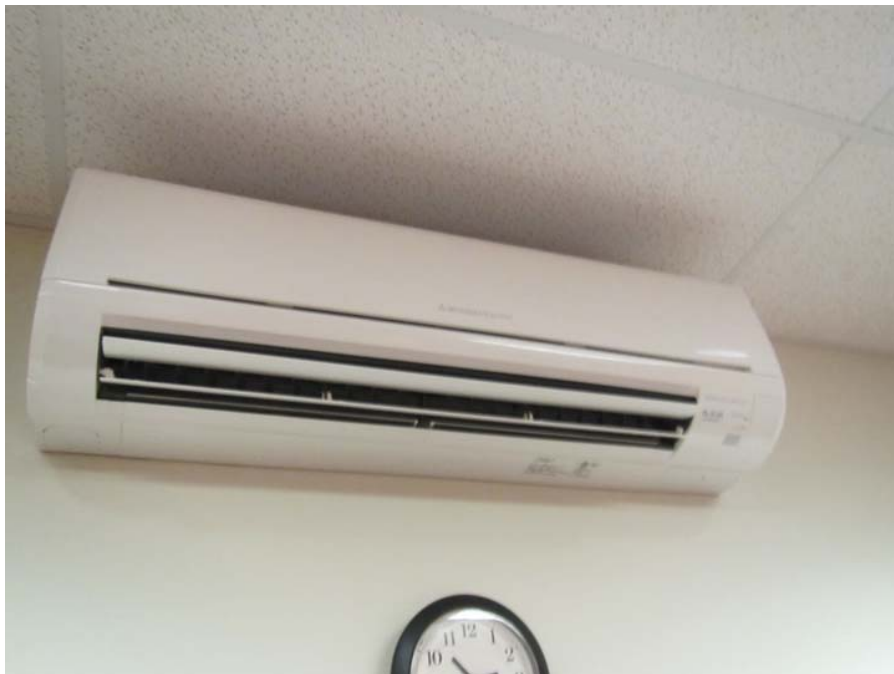
Picture 8

A ductless air conditioning unit was observed in one conference room (Picture 8). These units typically have a condensation drain to remove accumulated moisture. The drain should be inspected regularly to ensure that it is not leaking into the wall cavity or becoming stagnant where it can create odors.

Ductless air conditioning unit

8. Monitor the condensation drain from ductless air conditioners for leaks and stagnant water.

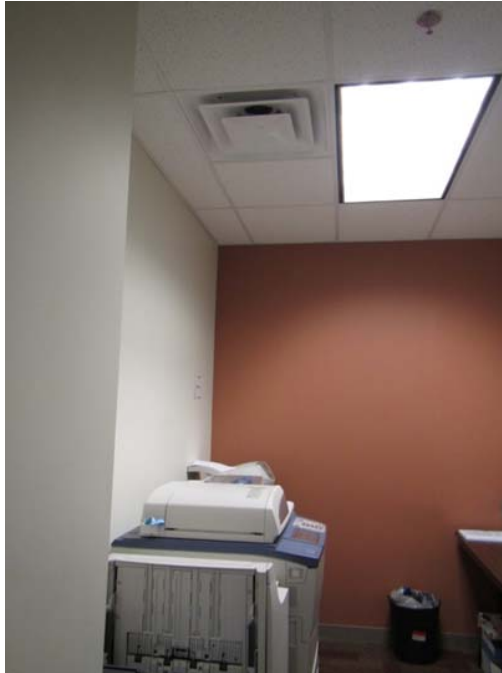
Picture 9

Photocopiers were located in several areas. VOCs and ozone can be produced by photocopiers, particularly if the equipment is older and in frequent use. Ozone is a respiratory irritant (Schmidt Etkin, 1992). It was noted that most copiers were located in areas not directly adjacent to occupied areas, which is recommended. However, no dedicated exhaust ventilation was observed near copiers. One copier was observed to have a *supply* vent directly above it (Picture 9), which may push/distribute odors and particulates from the use of the photocopier to other areas of the office.

Photocopier directly below supply vent

9. When possible, move photocopiers to areas with exhaust ventilation; consider removing the supply vent over the photocopier shown in Picture 9.
10. Use properly sized filters in rooftop AHUs and change in accordance with manufacturer's recommendations.

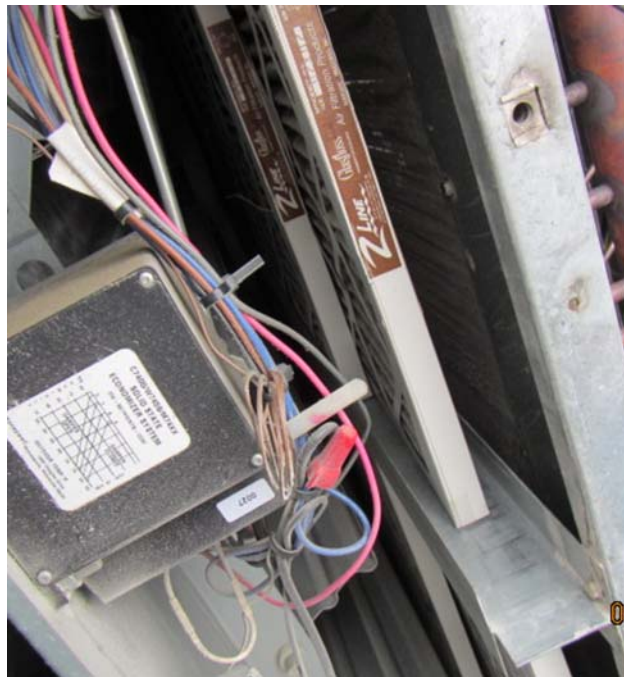
Picture 10

Other conditions that can affect indoor air quality were observed during the assessment. Filters in AHUs located on the roof were examined and some were found to be the wrong size for the units (Picture 10). Filter should be correctly sized to fit into AHU filter racks without gaps that can allow unfiltered air to bypass.

Opened rooftop AHU showing wrong-sized filter

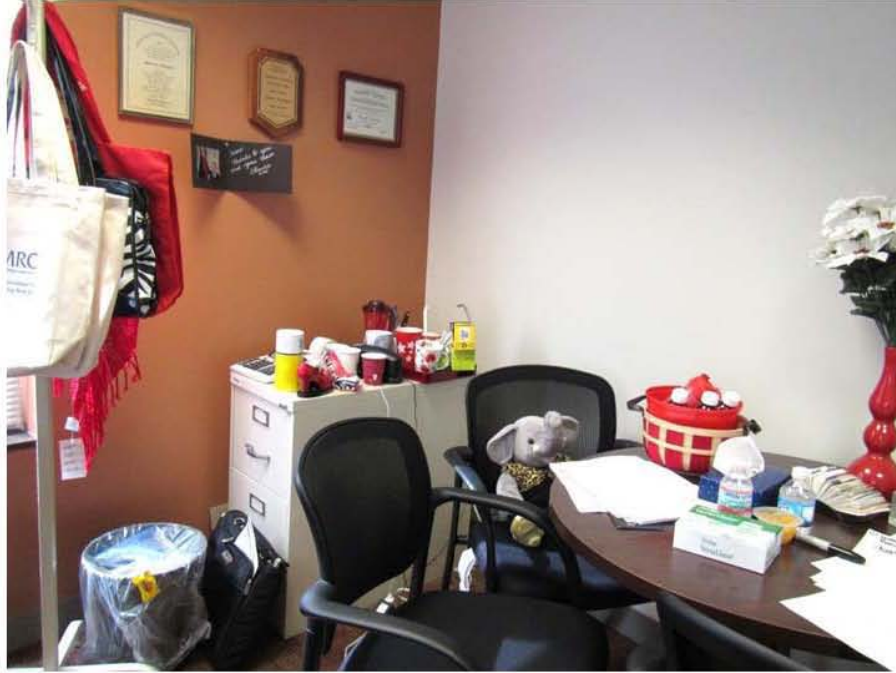
Picture 11

In some offices, a large number of items were on flat surfaces (e.g., floors, windowsills, tabletops), which provide a source for dusts to accumulate (Picture 11). These items (e.g., papers, folders, boxes) make it difficult for areas to be cleaned. Items should be relocated and/or be cleaned periodically to avoid excessive dust build up. In addition, dust and debris can accumulate on flat surfaces (e.g., desktops, shelving and carpets) in occupied areas and subsequently be re-aerosolized causing further irritation. Storage areas, including those for clothing and car seats, were examined and appeared well-designed for the items stored, although some items were found on floors in storerooms and many of the plastic totes were open with items spilling out of them (Picture 12). Keeping items off the floor and totes sealed will protect the stored items from dust and moisture.

Items in an office

11. Clean/maintain heaters, personal fans and air purifiers regularly to prevent aerosolization of dust and debris.
12. Relocate or consider reducing the amount of stored materials in offices to allow for more thorough cleaning. Move items from floors when possible. Clean items regularly with a wet cloth or sponge to prevent excessive dust build-up.

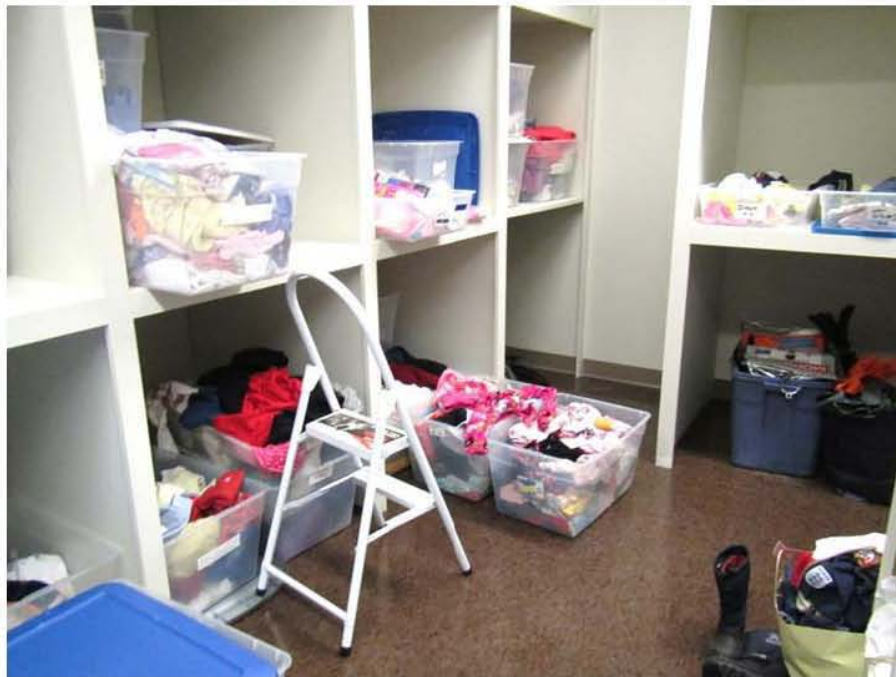
Picture 12

Stored items in open totes

13. Continue to use shelving and totes/bins in storerooms and keep bins closed when not in use.
14. Ensure that food is kept tightly sealed and food preparation equipment is cleaned regularly to prevent smoke, odors and attracting of pests.
