# **INDOOR AIR QUALITY POST-OCCUPANCY ASSESSMENT**

**Department of Transitional Assistance  
245 Commercial Street  
Malden, MA**

Prepared by:  
Massachusetts Department of Public Health  
Bureau of Environmental Health  
Indoor Air Quality Program  
May 2014

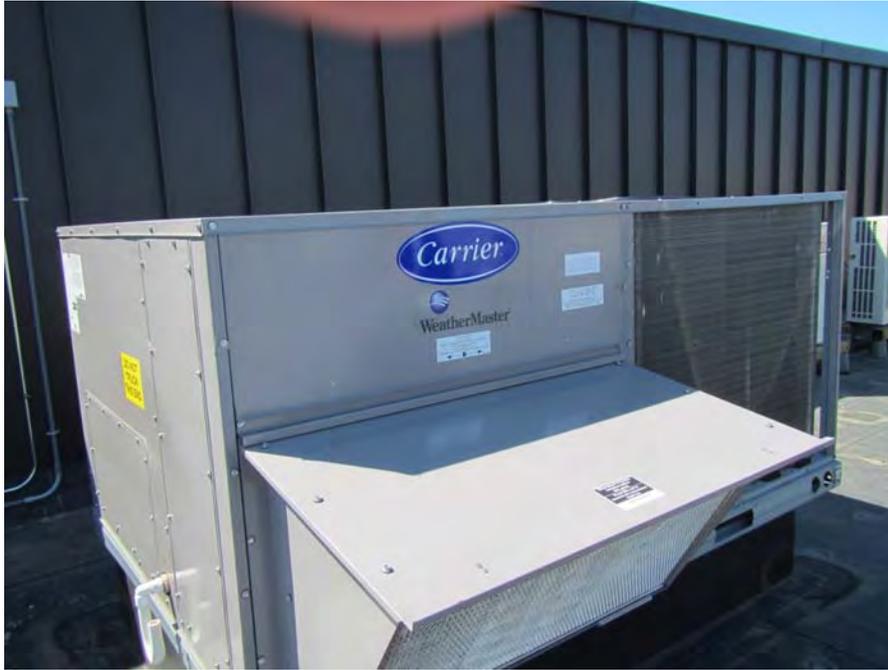
**Picture 1**

It can be seen from Table 1 that carbon dioxide levels were above 800 parts per million (ppm) in 36 of 39 areas tested, indicating a lack of air exchange at the time of assessment. The heating, ventilation and air-conditioning system (HVAC) consists of air handling units (AHUs; Picture 1) located on the roof, which draw in outside air and heat/cool it. Fresh air is delivered to spaces via ceiling-mounted supply vents. Return air is drawn into an above-ceiling plenum via ceiling grates (Picture 2) and ducted back to AHUs. Supplemental heating in some areas is provided by electric heating units. Supplemental cooling in some areas, including the data room, is provided by wall-mounted ductless air-conditioning (AC) units. The AHUs and other units are new to the building and were installed as part of the DTA renovations.

**Air handling unit**

1. The fan setting on all thermostats should remain in the “ON” setting during business hours to provide adequate ventilation throughout the building. Ensure fresh air louvers on AHUs are working properly and adjust to increase outside air intake as needed.

2. Operate and maintain HVAC systems in accordance with manufacturer’s recommendations, including regular filter changes/cleaning of all AHUs and ACs.
3. Consider adopting a balancing schedule of every 5 years for all mechanical ventilation systems, as recommended by ventilation industrial standards (SMACNA, 1994).

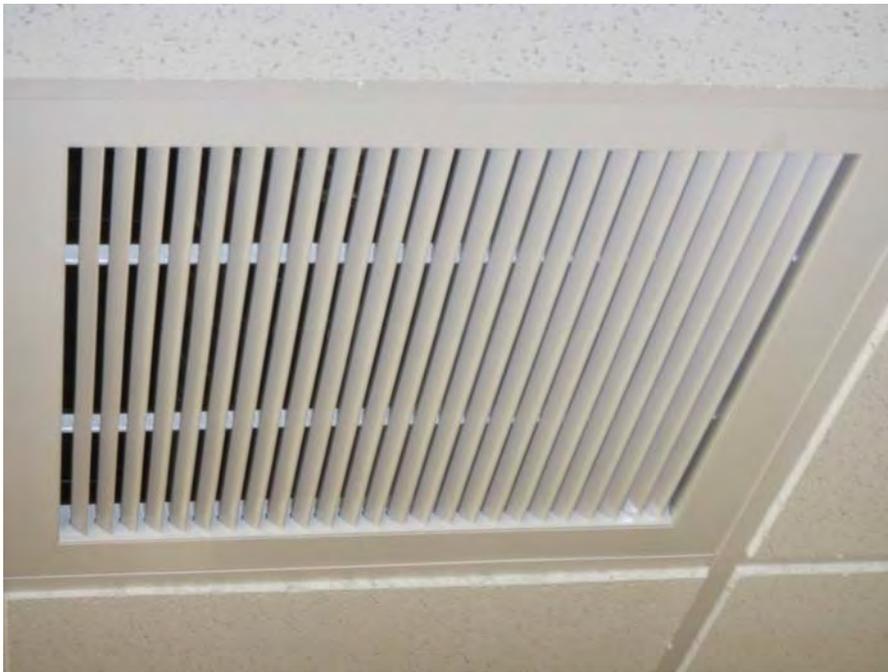
**Picture 2**

**Return air grate**

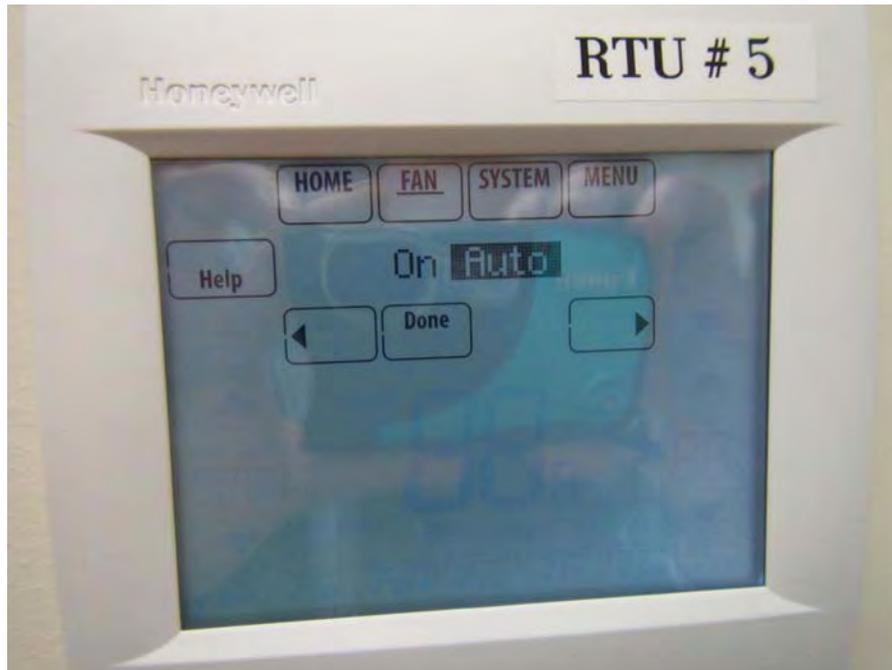
**Picture 3**

system is deactivated. Therefore, no mechanical ventilation is provided until the thermostat re-activates the system. At the time of assessment, most thermostat fan settings were in the “auto” position (Picture 3). The MDPH typically recommends that thermostats be set to the fan “on” setting during occupied hours to provide continuous air circulation. In addition, if thermostats are shut off, no fresh air would be supplied to these areas while in this setting. This can lead to IAQ/comfort complaints due to lack of air exchange, particularly since windows are not openable and the HVAC system is the sole source of fresh, outside air.

**Thermostat with fan set to “auto”**

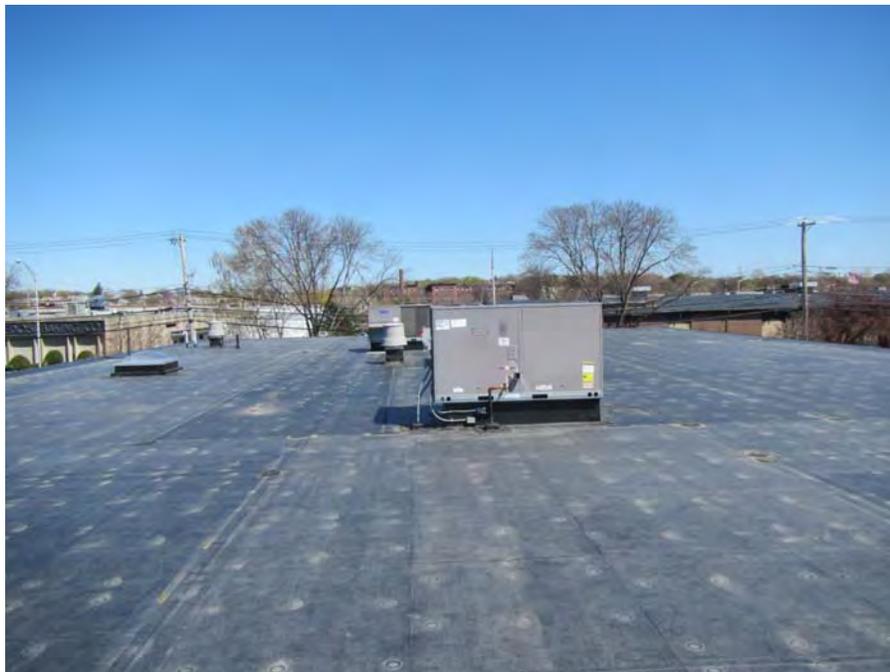
**Picture 4**

No evidence of leaks and/or water-damaged building materials was observed during the assessment. The building renovation included the installation of a new rubber membrane roof (Picture 4).

**New rubber membrane roof**

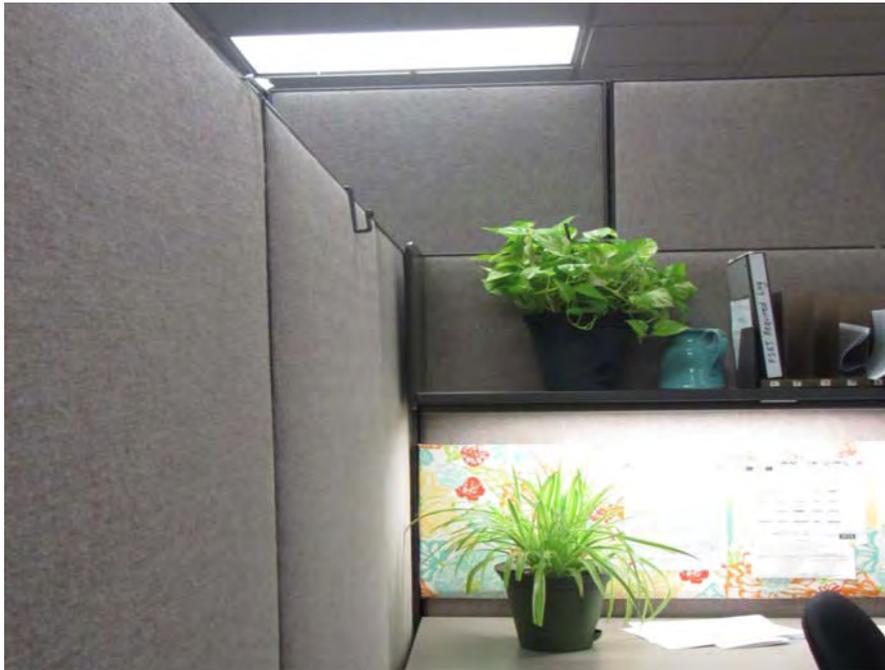
**Picture 5**

Plants were observed in some areas (Table 1). Plants should be properly maintained and equipped with drip pans. Plants should be located away from ventilation sources to prevent aerosolization of dirt, pollen or mold. Plants should not be placed on carpets or other porous materials (Picture 5), since water damage to porous materials may lead to microbial growth.

**Plants on or near porous surfaces**

5. Ensure plants have drip pans and avoid over-watering. Examine drip pans periodically for mold growth. Disinfect with an appropriate antimicrobial where necessary.

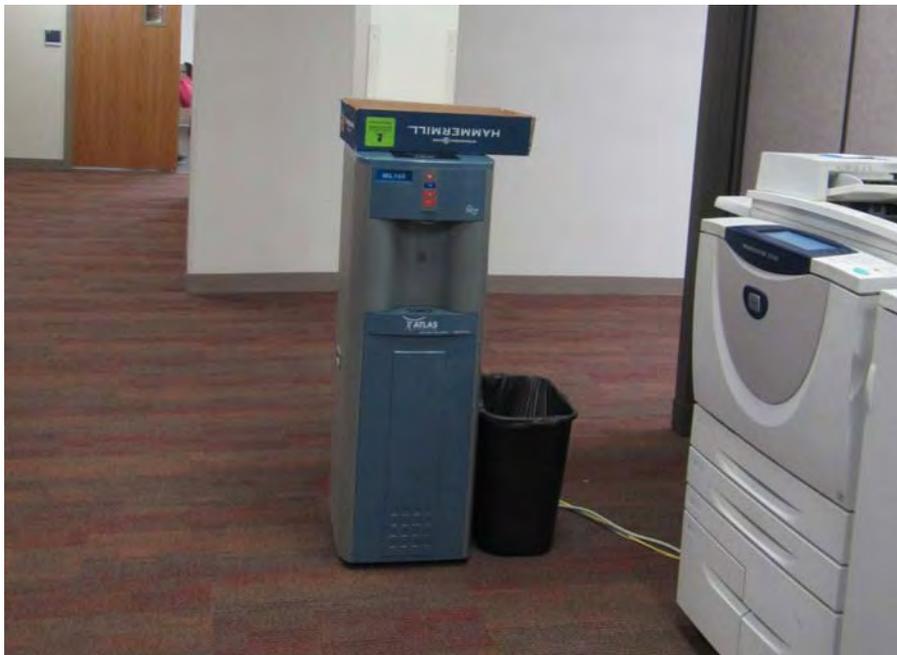
**Picture 6**

BEH/IAQ staff observed a water cooler and water fountains on/over carpeted surfaces (Pictures 6 and 7). Spills or leaks from this equipment can moisten carpet and lead to microbial growth and degradation of the carpet. MDPH typically recommends placing rubber mats or non-

**Water cooler on carpet**

porous flooring (e.g., vinyl tile) beneath this equipment to protect the porous carpet from leaks and spills.

6. Place protective rubber mats beneath water coolers and water fountains or use non-porous flooring to prevent damage to carpeting.
  7. Avoid the use of scented products such as air deodorizers and fresheners.

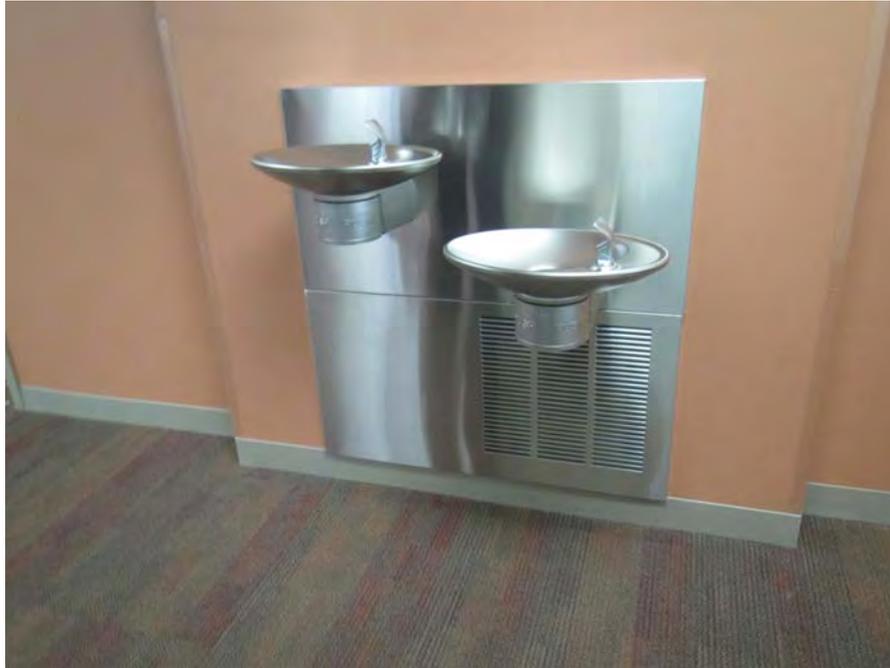
**Picture 7**

**Water fountain over carpet**

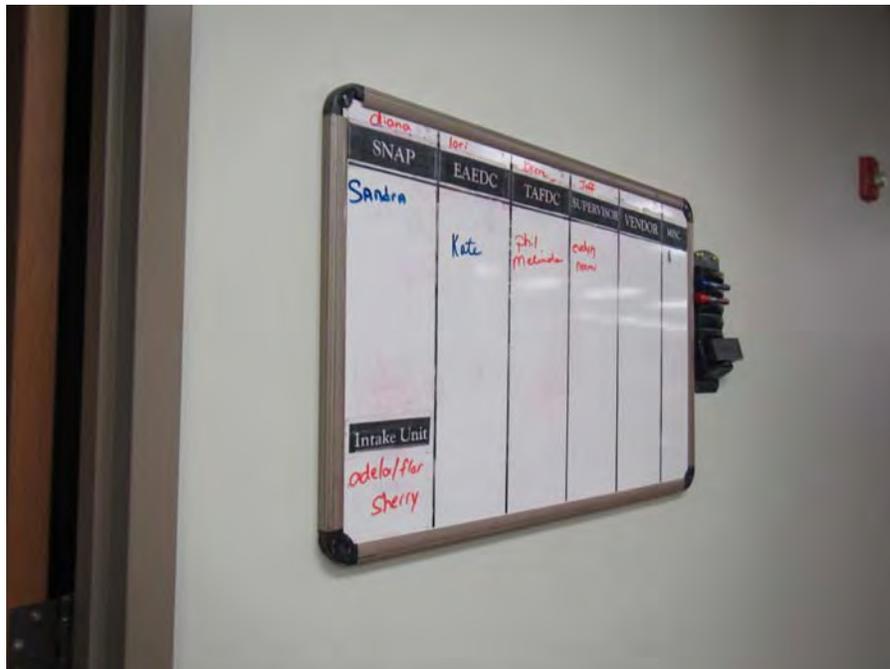
**Picture 8**

One room contained a dry erase board and related materials (Picture 8; Table 1). Materials such as dry erase markers and dry erase board cleaners may contain VOCs, such as methyl isobutyl ketone, n-butyl acetate and butyl-cellusolve (Sanford, 1999), which can be irritating to the eyes, nose and throat.

**Dry erase board**

8. Clean dry-erase marker trays of accumulated dust and debris regularly using a damp cloth.
  9. Consider reducing, consolidating or relocating items and papers to allow for more thorough cleaning.
