INDOOR AIR QUALITY POST-OCCUPANCY ASSESSMENT

**Department of Transitional Assistance,
and Department of Children and Families
80 Everett Avenue
Chelsea, MA**

Prepared by:
Massachusetts Department of Public Health
Bureau of Environmental Health
Indoor Air Quality Program
June 2014

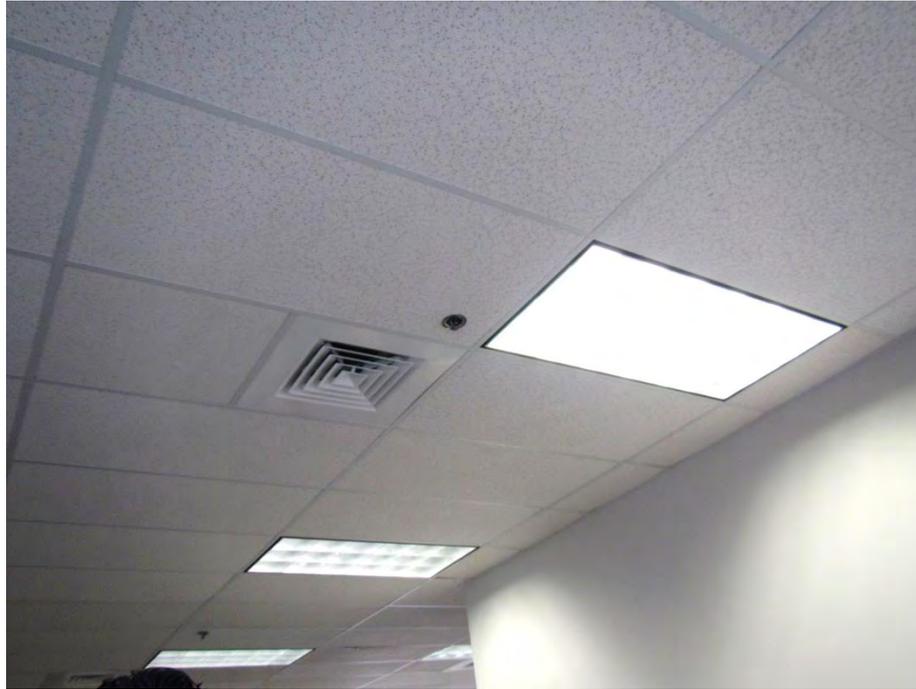
Picture 1

The heating, ventilation and air-conditioning system (HVAC) consists of air handling units (AHUs) located on the roof, which draw in outside air and heat/cool it. Fresh air is delivered to spaces via ceiling-mounted supply vents (Picture 1). Return air is drawn into an above-ceiling plenum via ceiling grates (Picture 2) and space around light fixtures and ducted back to AHUs. Supplemental cooling in some areas, including the data room, is provided by wall-mounted ductless air-conditioning (AC) units.

Ceiling-mounted supply vent

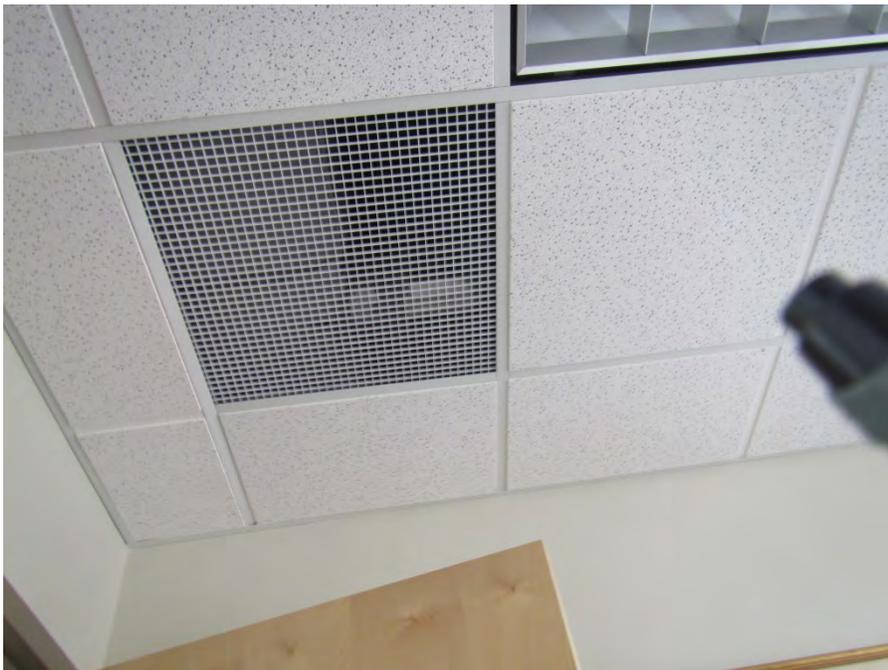
Picture 2

In some offices, exhaust vents were observed to be close to office doors, which had been left open (Picture 2). This may allow for air to be drawn into offices from the hallways rather than exhausting air from the offices.

Ceiling-mounted return grate; note proximity to room door

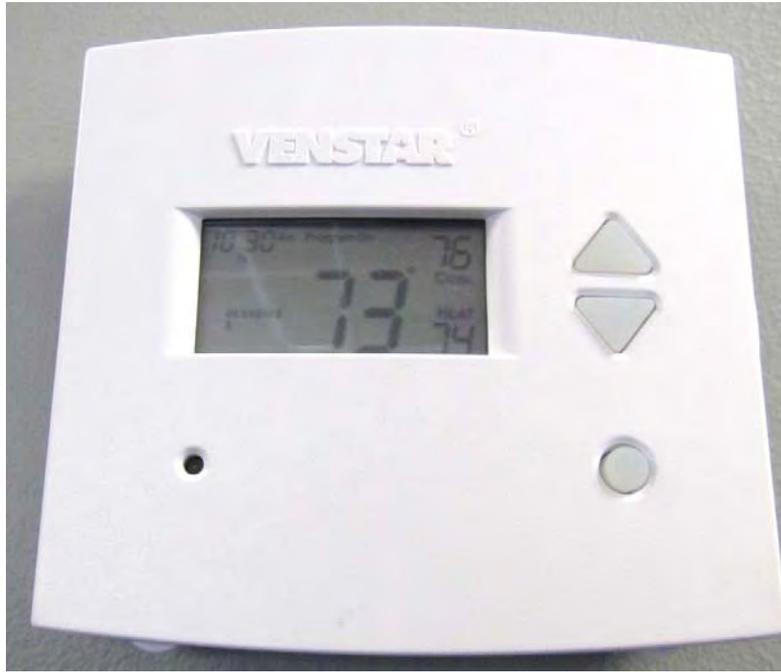
Picture 3

The HVAC system is controlled by digital thermostats. Thermostats examined were in “occupied” mode (Picture 3), in accordance with a weekly timer. It could not be determined if the “occupied” mode provided for continual air circulation during occupied hours or if this was

just used to determine the temperature settings for the building. When the system fans are continually on, as recommended during occupied hours, the system provides a continuous source of air circulation and filtration. An “automatic” setting would instead activate the HVAC system based on pre-set temperature and only supply fresh/filtered air when heating or cooling was called for in the space. Settings for these thermostats should be investigated and adjusted to allow for additional fresh air circulation, particularly in the first floor DTA area.

Thermostat in “occupied” mode

1. Thermostats should be programmed such that the fan/air circulation is **ON** during business hours to provide adequate ventilation throughout the building. Ensure fresh air

louvers on AHUs are working properly and adjust to increase outside air intake as needed.

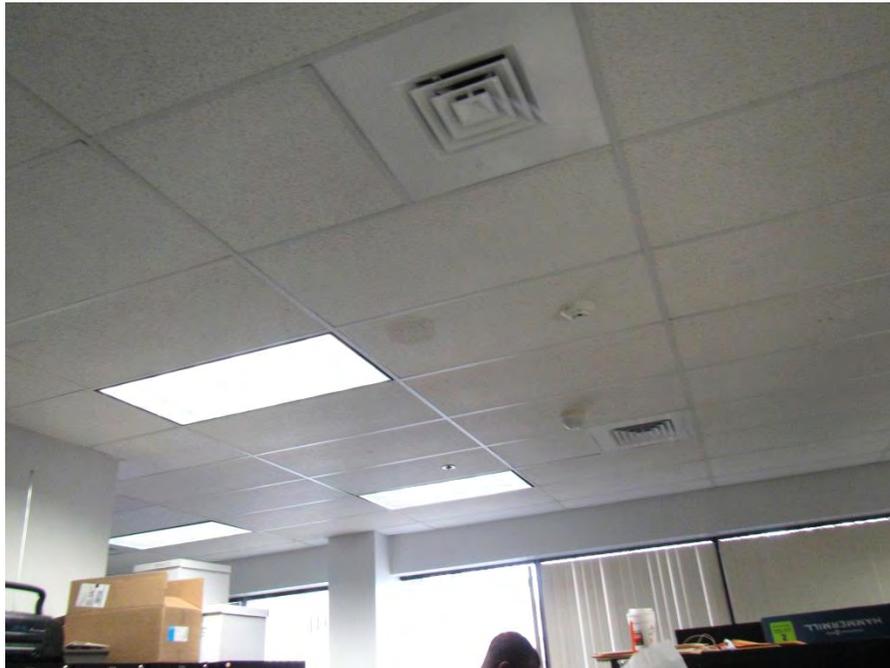
Picture 4

A few water-damaged ceiling tiles were observed (Picture 4; Table 1). Water-damaged ceiling tiles indicate a leak from plumbing or the building envelope and can be a source of mold. Damaged ceiling tiles should be replaced after a leak is discovered and repaired. There were also reports of water infiltrating through windows during heavy rain events. While no water-damaged windowsills or nearby materials were observed, areas subject to potential water infiltration should be kept clear of items, particularly porous items, which may become damaged. Many windowsills were used to store papers, binders and other porous materials (Picture 5).

Water-damaged ceiling tile

6. Ensure roof/plumbing leaks are repaired and replace any remaining water-damaged ceiling tiles. Examine the area above these tiles for mold growth. Disinfect areas of water leaks with an appropriate antimicrobial, as needed.

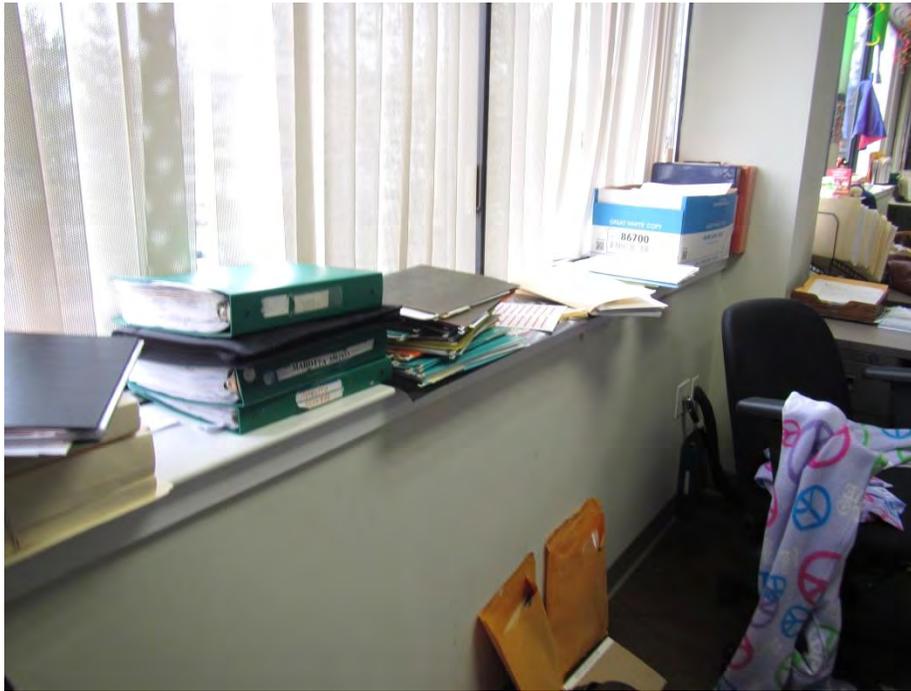
Picture 5

Porous items stored on windowsill

11. Store porous items such as cardboard boxes off the floor and away from windowsills.
12. Ensure that condensation drain hoses from ductless AC units drain properly; inspect periodically for leaks.

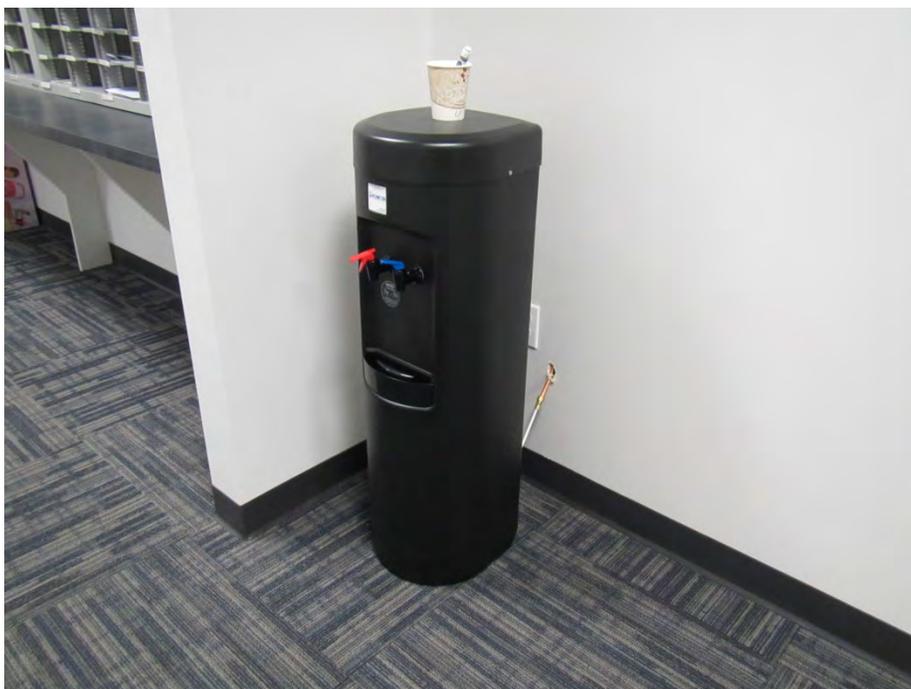
Picture 6

BEH/IAQ staff observed water coolers and refrigerators on carpeted surfaces (Picture 6). Spills or leaks from this equipment can moisten carpet and lead to microbial growth and carpet degradation. MDPH typically recommends placing rubber mats or non-porous flooring (e.g., vinyl tile) beneath this equipment to protect the porous carpet from leaks and spills. In addition, the kitchen area on the second floor is carpeted (Picture 7). Carpeting in kitchens may be subject to leaks, spills and accumulations of food debris, which may attract pests.

Water dispenser on carpet

8. Place protective rubber mats beneath water coolers and water fountains or use non-porous flooring to prevent damage to carpeting.
9. Consider replacing the carpeting in the kitchen with non-porous floor tile.

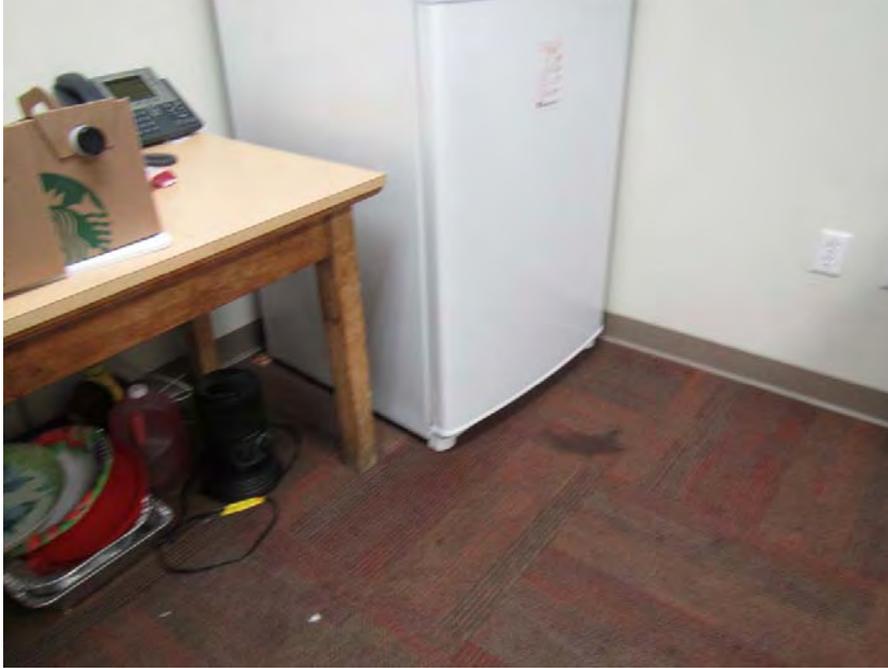
Picture 7

Refrigerator on carpet in kitchen area; note water stain in front of refrigerator

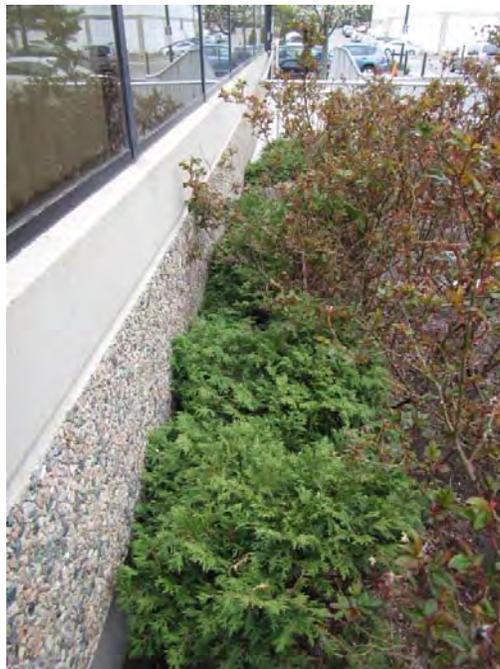
Picture 8

BEH/IAQ staff examined the exterior of the building to identify breaches in the building envelope and/or other issues that could provide sources of water penetration. Plants and shrubbery were observed growing in close proximity to the foundation (Pictures 8 and 9), which can allow moisture and pollen to be drawn into the building if windows are not tight. These conditions can also undermine the integrity of the building envelope and provide a means of water entry by capillary action into the building through exterior walls, foundation concrete and masonry (Lstiburek & Brennan, 2001). In addition, breaches in exterior areas can provide a means of drafts and pest entry into the building.

Shrubbery against the foundation

13. Ensure plants, trees and shrubs are located at least five feet away from exterior walls/foundation of the building.
14. Avoid the use of scented products such as air deodorizers and fresheners.

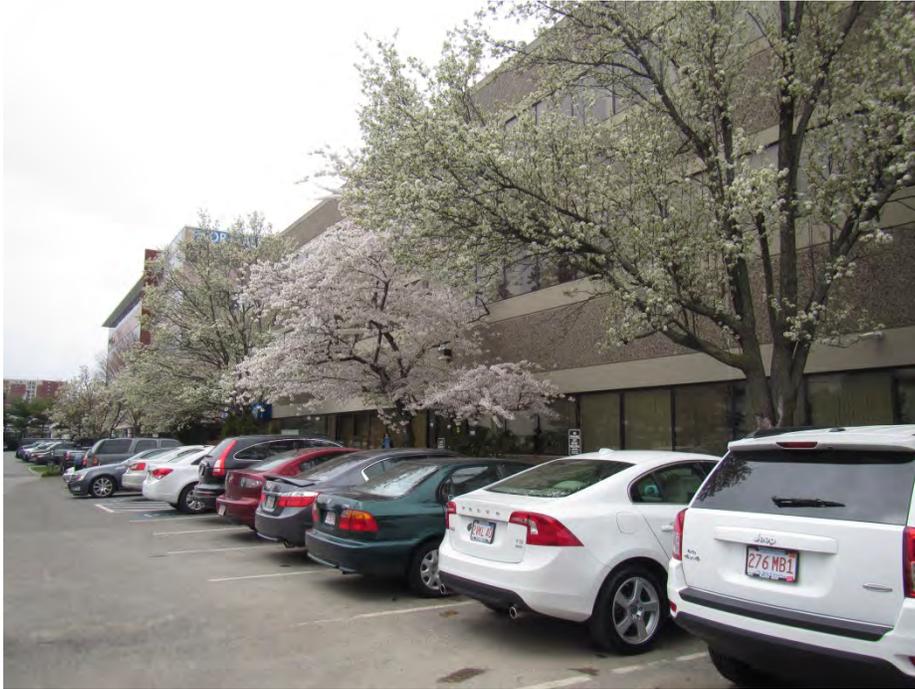
Picture 9

Flowering trees up against windows

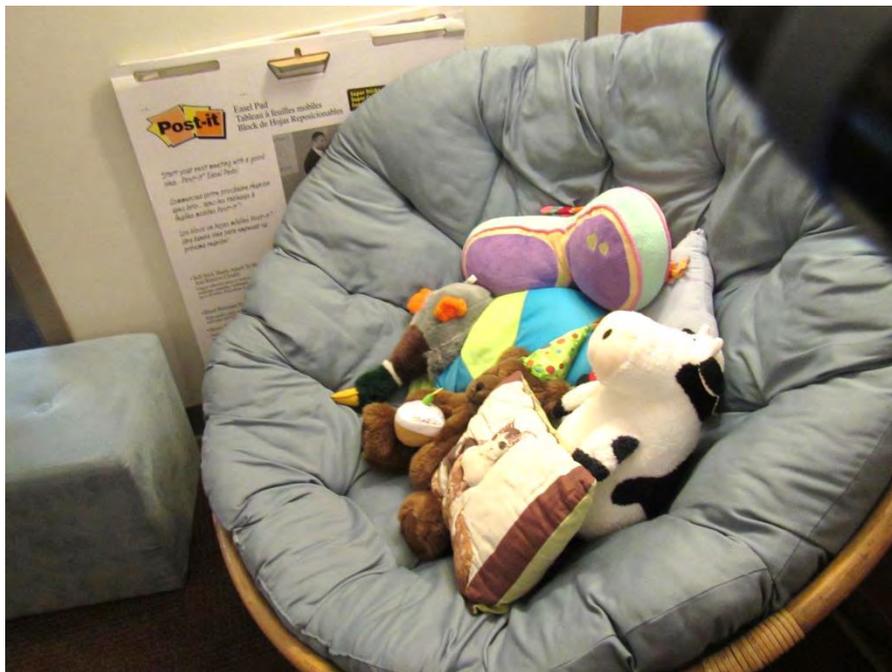
Picture 10

Plush and upholstered furniture and plush toys were observed in some areas (Picture 10). Upholstered furniture pillows and cushions are covered with fabrics that are exposed to human skin. This type of contact can leave oils, perspiration, hair and skin cells. Dust mites feed upon human skin cells and excrete waste products that contain allergens. In addition, if relative humidity levels increase above 60 percent, dust mites tend to proliferate (US EPA, 1992). In order to remove dust mites and other pollutants, frequent vacuuming of upholstered furniture is recommended (Berry, 1994). It is also recommended that upholstered furniture be professionally

cleaned on an annual basis. If an excessively dusty environment exists due to outdoor conditions or indoor activities (e.g., renovations), cleaning frequency should be increased (every six months) (IICRC, 2000).

Plush items and upholstered furniture

18. Clean/vacuum upholstered furniture and plush toys on a regular basis (e.g., annually/semi-annually such as carpets) to remove dust and debris.
19. Refrain from hanging items from the suspended ceiling tile system.

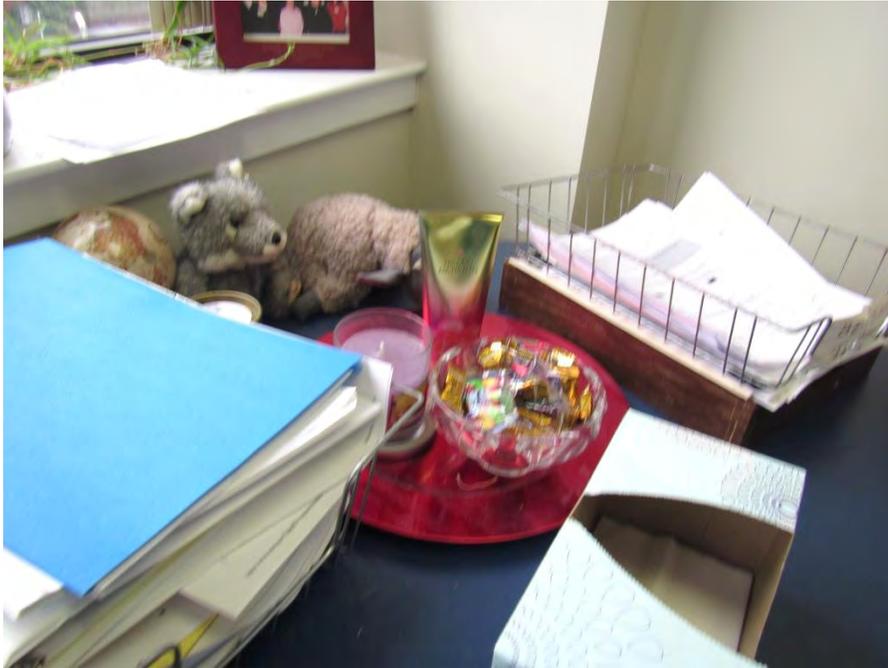
Picture 11

In some areas, accumulation of items, including papers, boxes and personal items were found stored on desks, tables and counters (Picture 11). Decorative items, including plush and organic items were also observed. Large numbers of items provide a source for dusts to accumulate. These items make it difficult for custodial staff to clean. Items should be relocated and/or cleaned periodically to avoid excessive dust build up. Stored clothing and other items were observed loosely held in plastic bags, many of which were open with items spilling out to the floor (Picture 12). Stored clothing can provide harborage for pests and is also subject to dust accumulation. Items should be stored in well-sealed containers such as plastic totes. Items were also observed hanging from the ceiling tiles systems in a few places. Disturbance of the ceiling tile systems can dislodge dust and debris and these items are difficult to keep clean.

Food and food preparation equipment were also noted in some areas (Picture 11; Table 1). The use of this equipment can provide a source of particulates and odors, particularly if the equipment is not kept clean. Food/debris remaining on heating elements can burn the next time the items are used, producing smoke and odors. In addition, unsealed food, including crumbs remaining on food-preparation equipment, can be attractive to pests.

Items including food in an office

15. Clean dry-erase marker trays of accumulated dust and debris regularly using a damp cloth.
16. Consider reducing, consolidating or relocating items and papers to allow for more thorough cleaning.

20. Ensure that food is kept tightly sealed and food preparation equipment is cleaned regularly to prevent smoke, odors and attracting of pests.

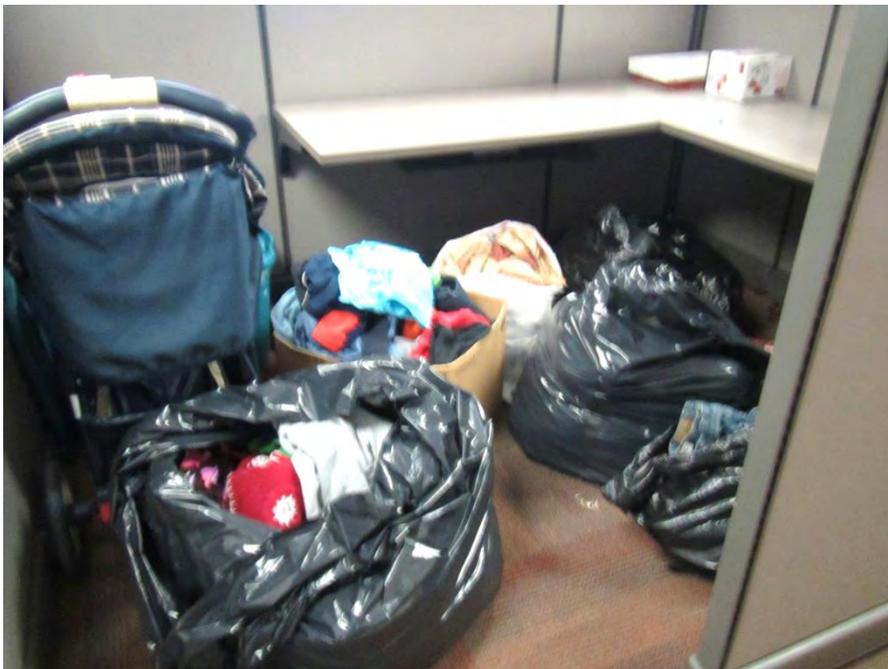
Picture 12

Clothing stored in plastic bags
