INDOOR AIR QUALITY ASSESSMENT

**Massachusetts Department of Transitional Assistance
473 Main Street
Fitchburg, Massachusetts**

Prepared by:
Massachusetts Department of Public Health
Bureau of Environmental Health
Indoor Air Quality Program
July 2014

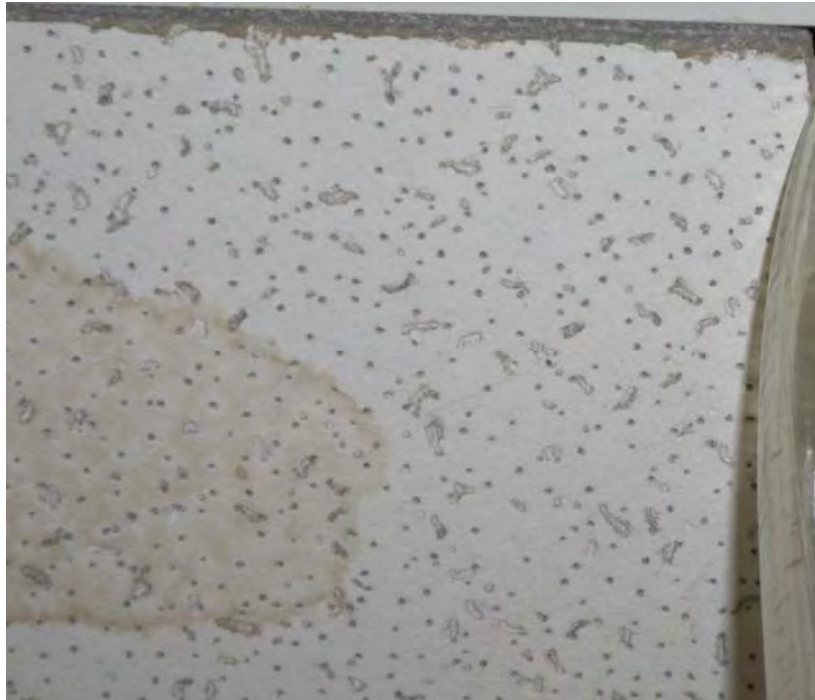
Picture 3

As mentioned in the MDPH IAQ 2010 report (Appendix A), the DTA was subject to chronic water penetration in the central area of the office space due to damaged/detached rubber membrane on the roof and standing water which resulted in water penetration/damage from the AHU into the interior DTA office space. During the 2014 visit, BEH/IAQ staff observed that conditions in the central area of the office space had not improved since the 2010 assessment. Ceiling tiles in the central area above Room 286 (cubicle) were observed to be water-damaged (Picture 3). A hose was also observed extending from the exhaust ductwork that terminated into a barrel (Pictures 4 and 5) reportedly to collect water drainage from roof leaks into the building. Although BEH/IAQ staff observed no water accumulation and the barrel was dry at the time of the assessment, the source of water leaks in this area should be identified and repaired. Water-damaged ceiling tiles should be replaced after the water leak is identified and repaired and monitored for future leaks.

Water-damaged ceiling tile above Room 286

4. Identify sources of water damage in the central portion of the office space. Ensure roof leaks are repaired and replace water-damaged ceiling tiles. Examine above and around these areas for mold growth. Disinfect areas of water leaks with an appropriate antimicrobial.

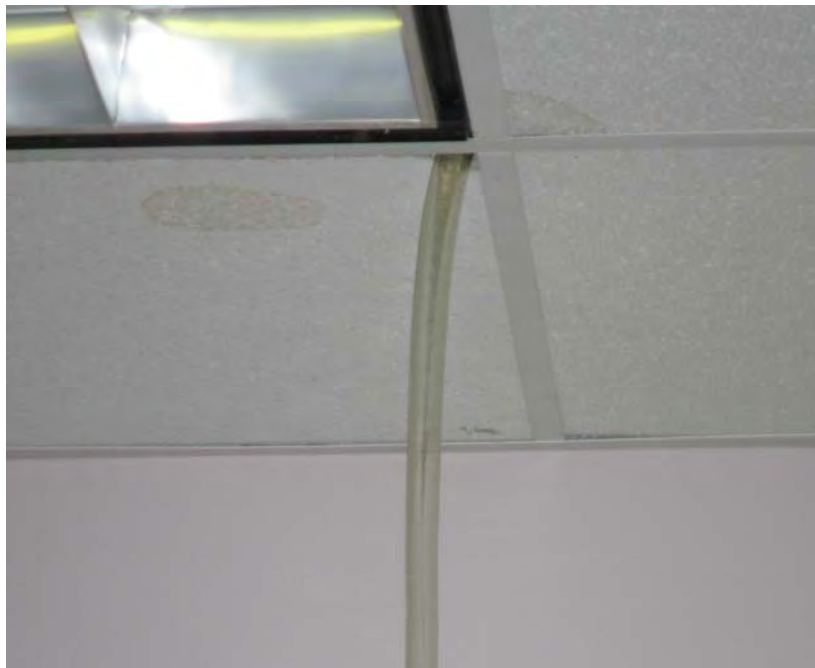
Picture 4

Drainage hose extending from ceiling plenum above room 286

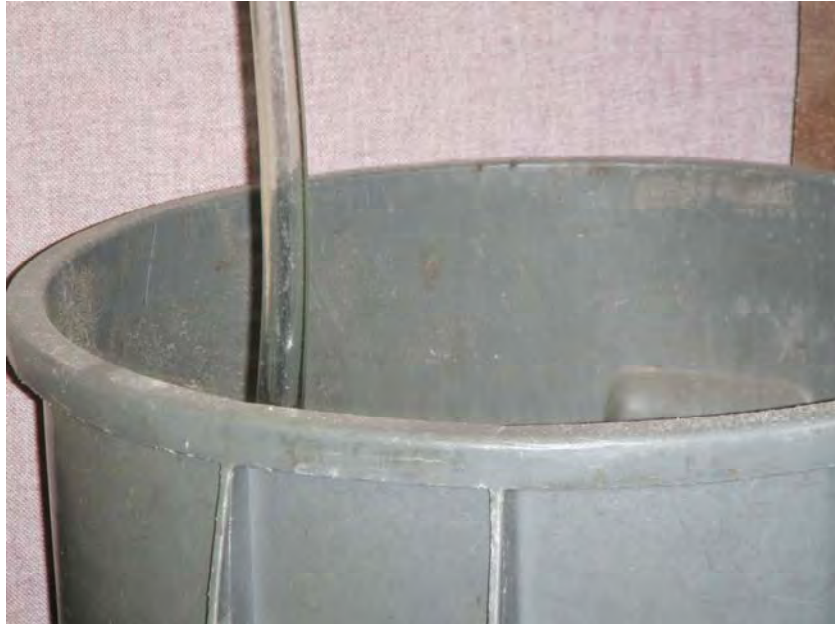
Picture 5

Drainage hose terminating into a barrel in room 286

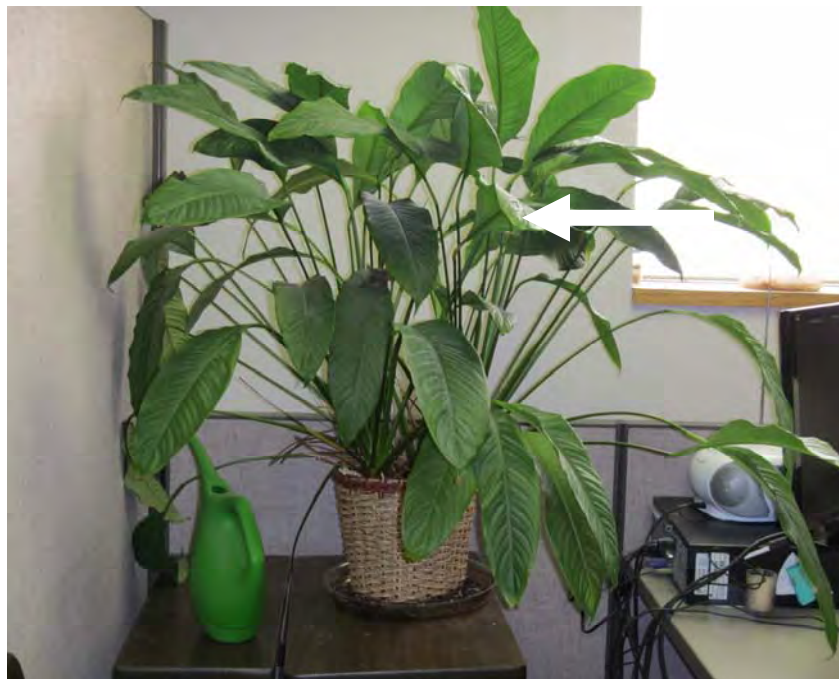
Picture 6

Plants were observed in several areas (Picture 6; Table 1). Plants should be properly maintained and equipped with drip pans. Plants should be located away from ventilation sources to prevent aerosolization of dirt, pollen or mold. Plants should not be placed on carpets or other porous materials, since water damage to porous materials may lead to microbial growth.

Plant located in office

5. Ensure plants have drip pans and avoid over-watering. Examine drip pans periodically for mold growth. Disinfect with an appropriate antimicrobial where necessary.

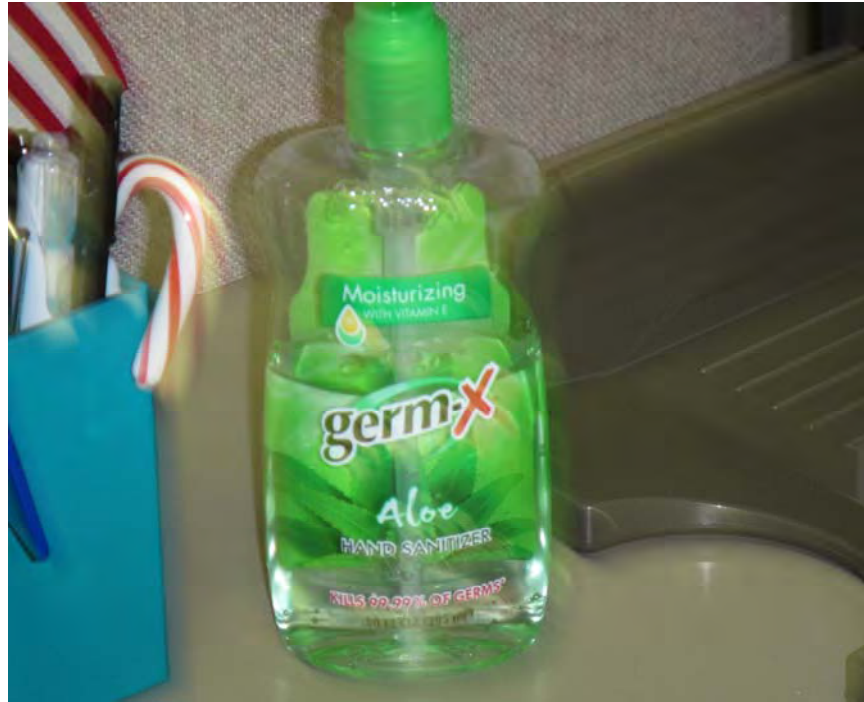
Picture 7

Hand sanitizer was observed in some areas (Table 1; Picture 7). Hand sanitizer products may contain ethyl alcohol and/or isopropyl alcohol which are highly volatile and may be irritating to the eyes and nose, and may also contain fragrances to which some people may be sensitive.

Hand sanitizer

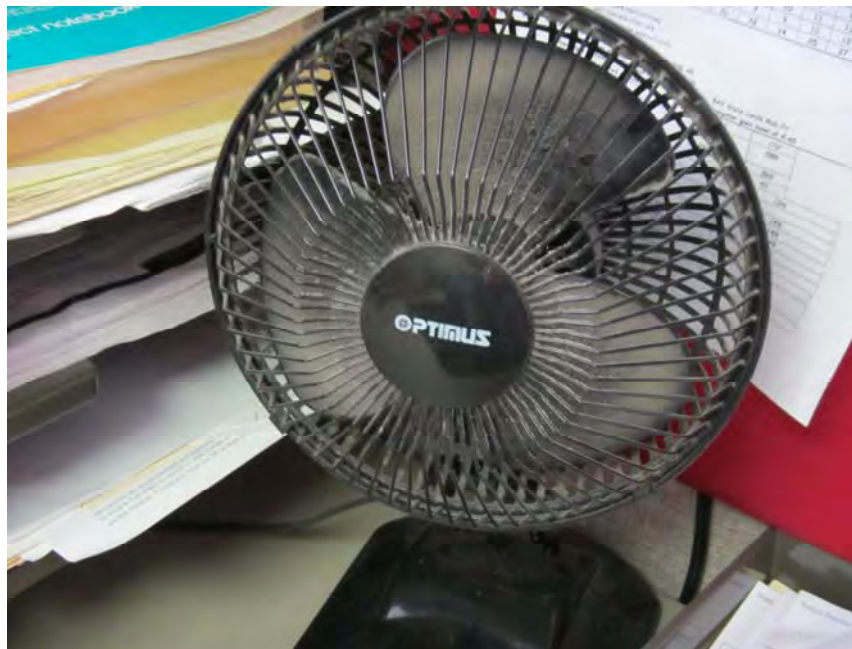
Picture 8

BEH/IAQ staff observed accumulated dust/debris on air diffusers, exhaust vents, personal fans (Picture 8) and along the top of cloth dividers. If exhaust/return vents are not functioning, back drafting can occur, which can re-aerosolize accumulated dust particles. Re-activated supply vents can re-aerosolize dust accumulated on louvers and adjacent surfaces causing further irritation. Diffusers, vents and fans should be cleaned periodically in order to prevent dust/debris from being aerosolized and redistributed throughout the room.

Dust and debris on personal fan

7. Clean supply/exhaust vents and personal fans regularly to prevent dust accumulation.
8. Clean plush toys and upholstered furniture frequently to remove dust and mites.

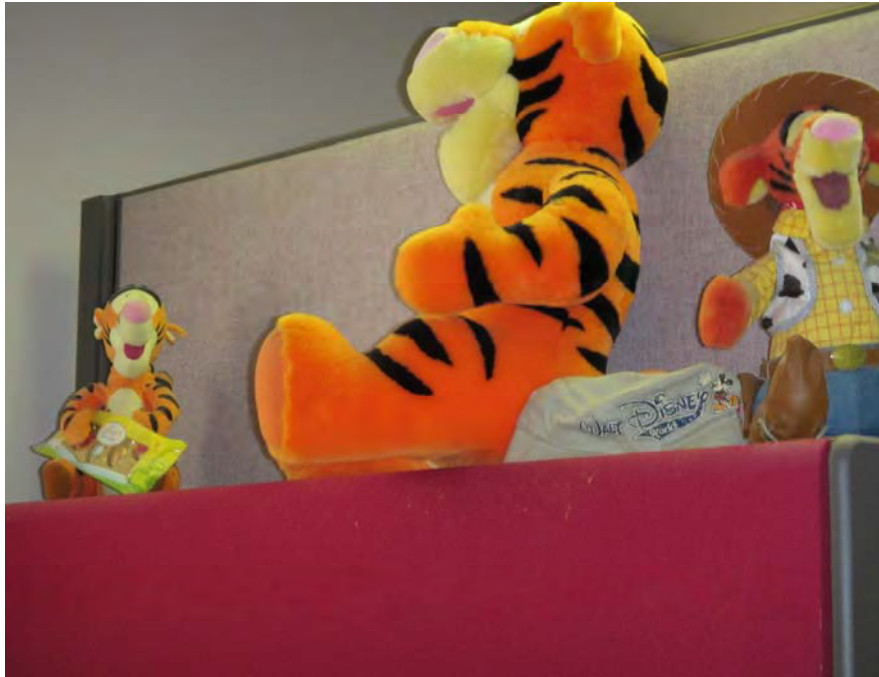
Picture 9

Most of the DTA space consists of cubicles with cloth dividers. Plush toys were also observed in some areas (Pictures 9 and 10). Upholstery and plush toys are covered with fabrics that may be exposed to human skin. This type of contact can leave oils, perspiration, hair and

Plush toys in office space
