# **INDOOR AIR QUALITY ASSESSMENT**

**Morningside Community School  
100 Burbank Street  
Pittsfield, Massachusetts**

Prepared by:  
Massachusetts Department of Public Health  
Bureau of Environmental Health  
Indoor Air Quality Program  
August 2014

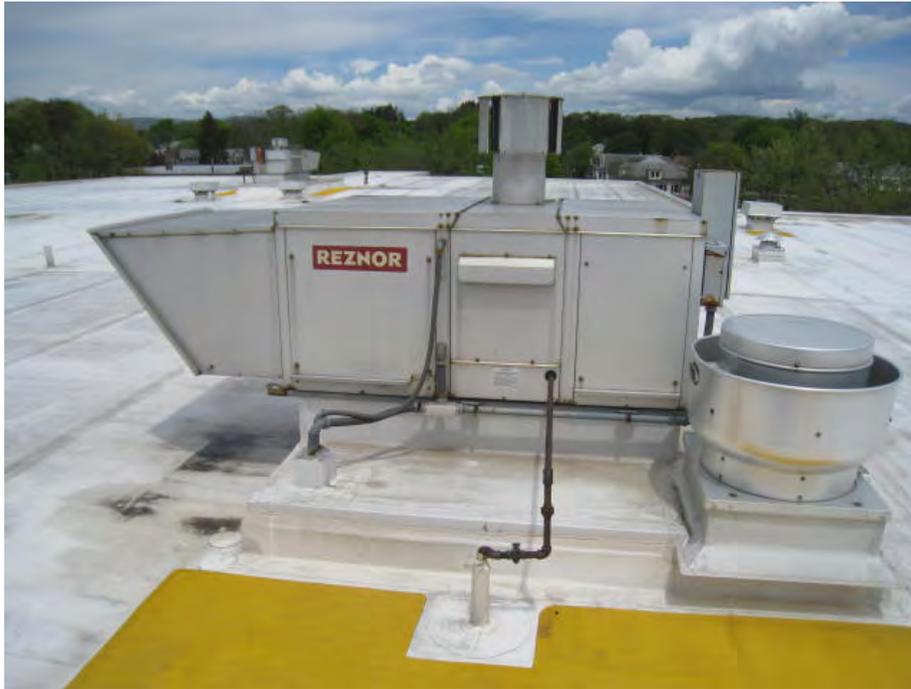
**Picture 1**

Mechanical ventilation is provided by three roof-top air-handling units (AHUs) (Picture 1). A fourth AHU located in a mechanical room provides ventilation for common areas (i.e. library, meeting rooms, administrative offices) of the building. The AHUs draw in fresh air

through air intakes and distribute it via ceiling-mounted air diffusers (Picture 2). Return air is ducted back to AHUs via ceiling-mounted return vents (Picture 3). BEH/IAQ staff observed that one roof-top AHU was deactivated/non-functioning at the time of the assessment. Facilities staff reported that a HVAC firm had been contacted to assess the AHU and make repairs as needed.

**Roof-top AHU**

1. Implement all the recommendations made in the previous May 10, 2013 MDPH assessment (Appendix A).
2. Facilities management should work with an HVAC contractor to assess the non-functioning/deactivated roof-top AHU and make repairs as needed.
3. Ensure that the media center mechanical room floor drain has water poured into in to maintain the seal of its trap regularly.
4. Consider extending or moving exhaust vent away from fresh air intake of AHU to prevent entrainment of exhaust.

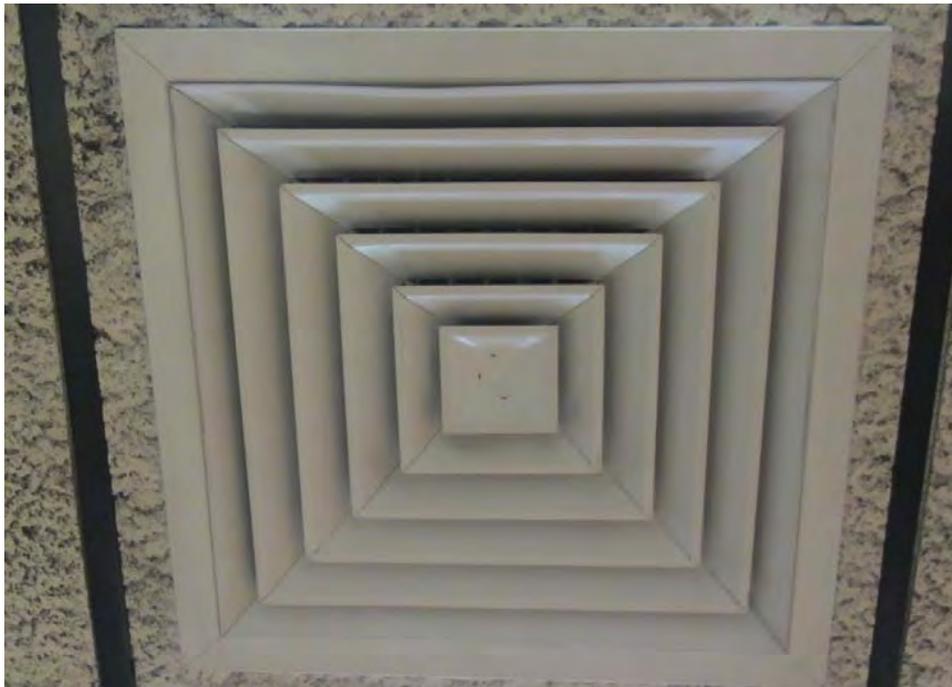
**Picture 2**

**Ceiling-mounted supply diffuser**

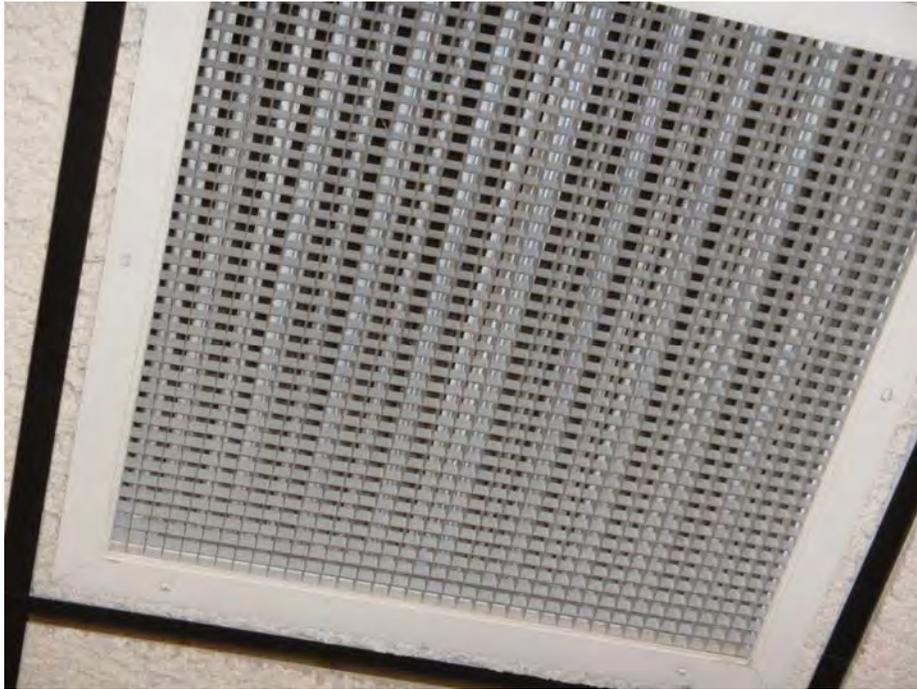
**Picture 3**

**Ceiling-mounted return vent**

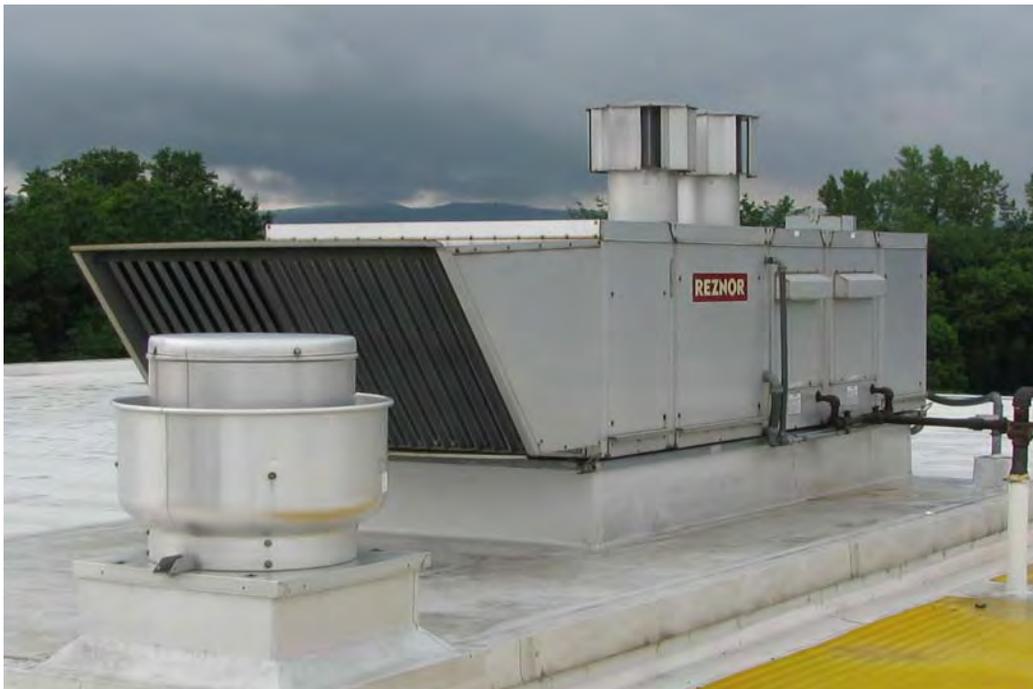
**Picture 4**

As mentioned in the MDPH 2013 report, an exhaust vent was located within several feet of the fresh air intake (Picture 4). In this configuration, exhaust may be drawn in by the air intake and pollutants can be distributed back into the building. The building code requires that pollutant sources must be ten feet away from and two feet above fresh air intakes (BOCA, 1993; SBBRS, 2011). An exhaust extension several feet above the fresh air intake may be needed to prevent exhaust entrainment.

**Exhaust vent in close proximity to AHU fresh air intake**

- **Action:** Not completed. No action was taken on this recommendation.
- **Operate the HVAC system continuously during periods of occupancy to maximize air exchange.**

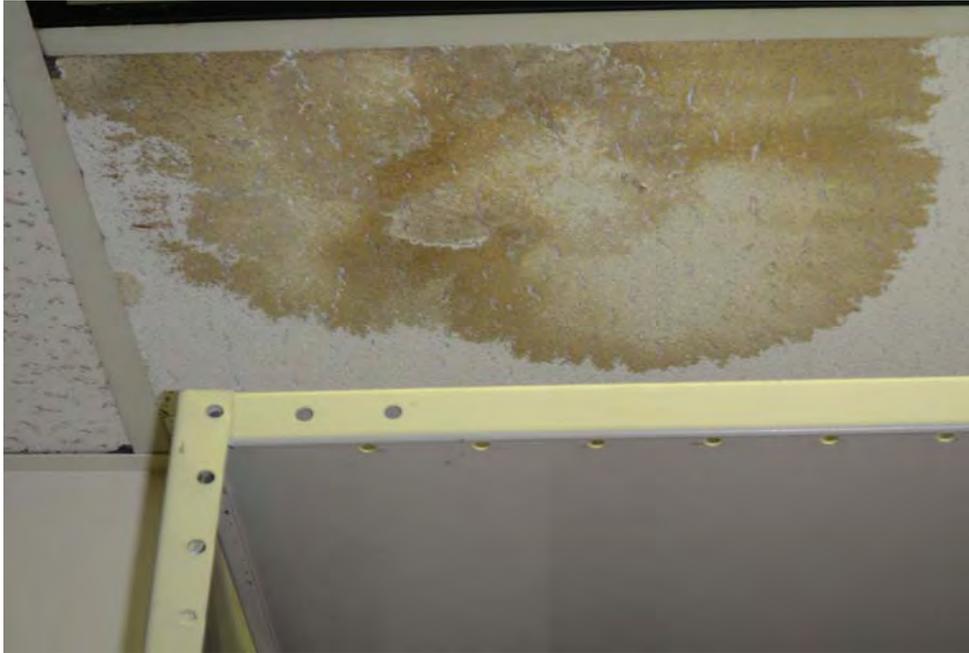
**Picture 5**

Several rooms in the building had water-damaged ceiling tiles (Table 1; Picture 5), which may stem from roof leaks or plumbing leaks. If repeatedly moistened, ceiling tiles can be a medium on which mold can grow. Water-damaged tiles should be replaced after a water leak is discovered and repaired.

**Water-damaged ceiling tile**

9. Replace water-damaged ceiling tiles. Examine the area above and around these areas for mold growth. Disinfect areas of water leaks with an appropriate antimicrobial.

- **Action:** It was reported that all water-damaged ceiling tiles have been removed/replaced following the 2010 assessment. At the time of the 2014 visit, water-damaged ceiling tiles were found throughout the building. Measures should be taken to identify the source of the water leaks and custodial staff should continue to replace tiles as needed.

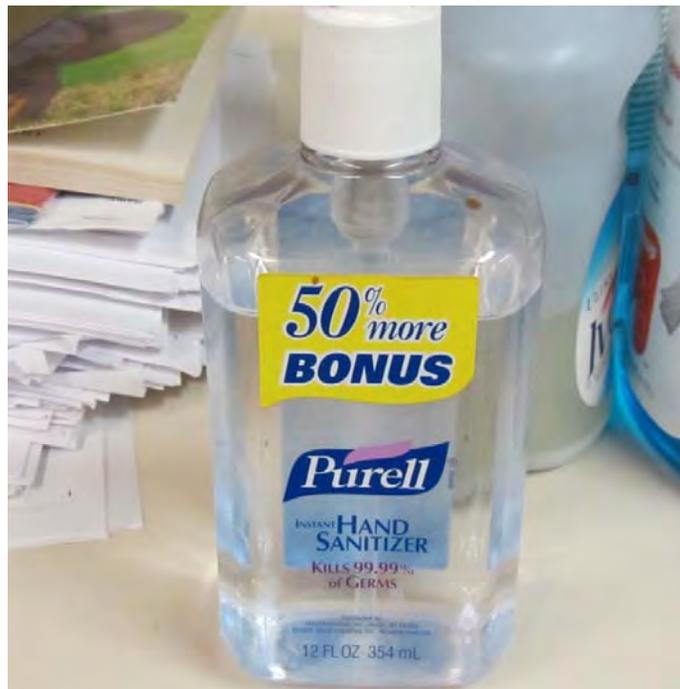
**Picture 6**

Hand sanitizer was observed in some areas (Table 1, Picture 6). Hand sanitizer products may contain ethyl alcohol and/or isopropyl alcohol which are highly volatile and may be irritating to the eyes and nose, and may also contain fragrances to which some people may be sensitive.

**Hand sanitizer**

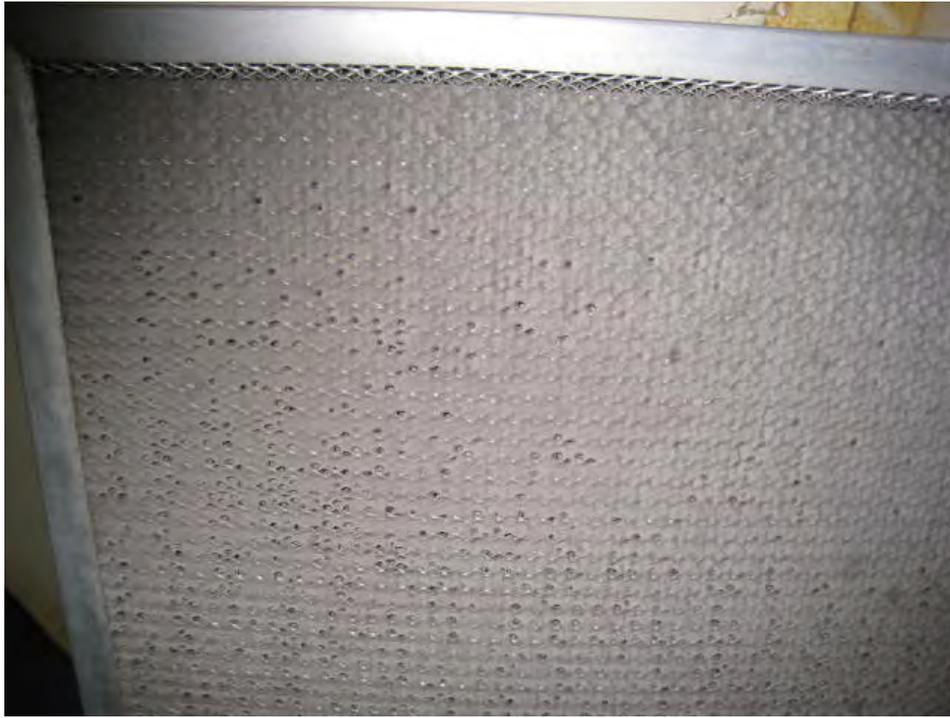
**Picture 7**

BEH/IAQ staff observed accumulated dust/debris on air diffusers, exhaust vents and personal fans (Picture 7). If exhaust/return vents are not functioning properly, backdrafting can occur, which can re-aerosolize accumulated dust particles. Re-activated supply vents can re-aerosolize dust accumulated on louvers and adjacent surfaces causing further irritation. Diffusers, vents and fans should be cleaned periodically in order to prevent dust/debris from being aerosolized and redistributed throughout the room.

**Exhaust vent occluded with dust and debris**

14. Clean air diffusers, exhaust/return vents and adjacent ceiling tiles periodically of accumulated dust/debris. If soiled ceiling tiles cannot be cleaned, they should be replaced.
