INDOOR AIR QUALITY ASSESSMENT

**Dartmouth Town Hall
400 Slocum Road
Dartmouth, Massachusetts**

Prepared by:
Massachusetts Department of Public Health
Bureau of Environmental Health
Indoor Air Quality Program
December 2015

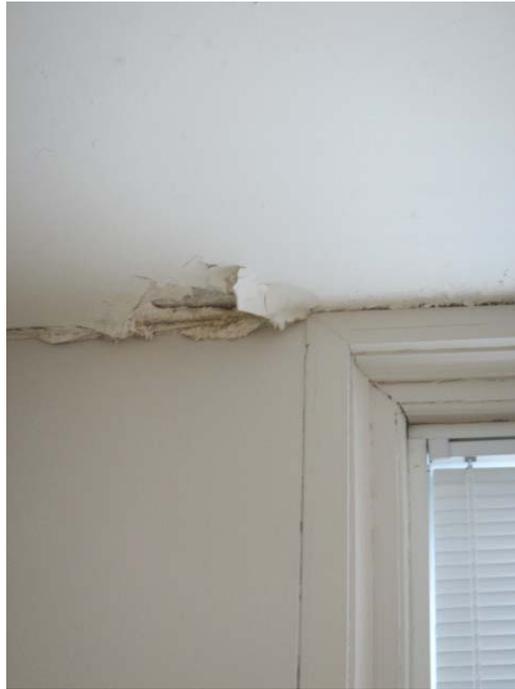
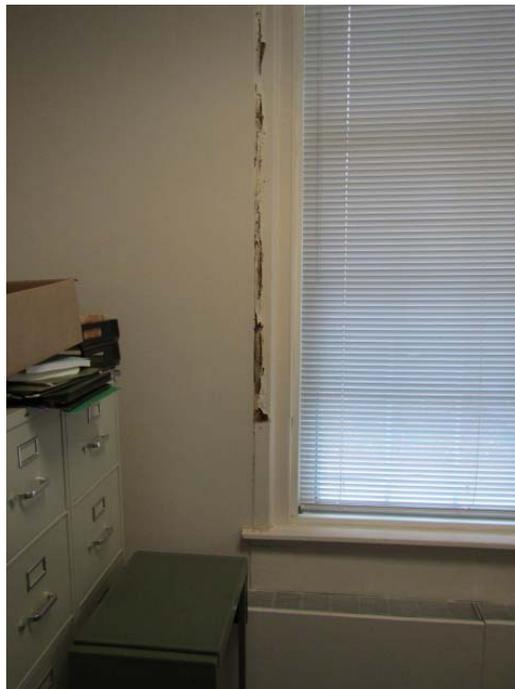
Offices along the south exterior walls had peeling paint and efflorescence on interior plaster walls (Pictures 1 and 2). This water damage is likely the result of water infiltration through exterior brickwork and windows, which indicates the need for recaulking/repairing window frame and repointing of exterior brickwork. DTH staff report that rainwater readily enters into some offices during wind-driven rainstorms. In an effort to absorb water, used mop heads were placed on top of radiators in two offices (Picture 3). The source of the odor reported

Water-damaged paint and efflorescence

1. Remove mop heads from offices.
2. Re-caulk/seal window frames along the south exterior wall as needed.
3. Remove carpeting beneath leaking windows along the south exterior wall.

4. Scrape bubbled paint and repair plaster as needed.
5. Seal the condensation drains for AHU during the heating season. Please note that this drain must be unsealed during the air-conditioning season in order to drain condensation. Failure to remove condensation drain seals can result in water back up into AHUs and produce mold growth.

1. Consider repointing the brick of the south exterior wall.
2. Consider replacing window system along the south exterior wall.

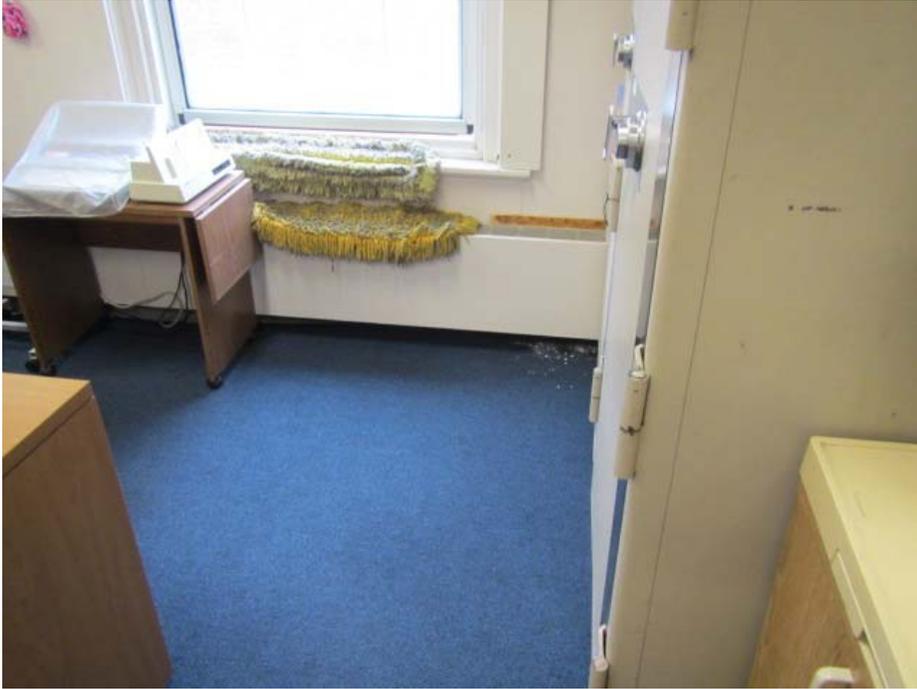
Picture 3

in Room 215 appears to be the mop head on top of the radiator. Also of note is the installation of wall-to-wall carpeting beneath the windows, which can easily become wet during these wind-driven rain events.

The United States Environmental Protection Agency (US EPA) and the American Conference of Governmental Industrial Hygienists (ACGIH) recommend that porous materials be dried with fans and heating within 24 to 48 hours of becoming wet (US EPA, 2001; ACGIH, 1989). If porous materials (e.g., carpeting and mop heads) are not dried within this time frame, mold growth may occur. Once mold has colonized porous materials, they are difficult to clean and should be removed and discarded.

Mop heads on radiator; Note carpeting and paint chips below window

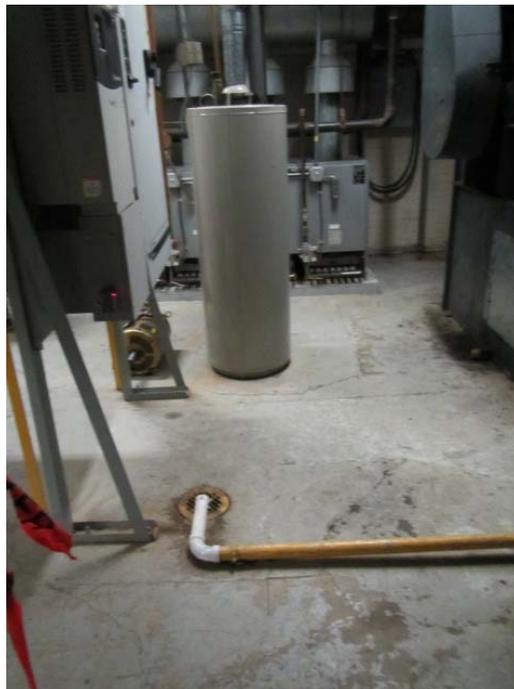
Picture 4

Of note is the configuration of the mechanical room. As mentioned previously, the AHU for the building is located in the same room as the gas-fired furnaces and water heater (Picture 4). BEH staff found that the condensation drain pipe for the AHU is drawing air and therefore depressurized when the AHU is in heating mode (Picture 5). In this condition, products of combustion from the water heater and furnaces as well as odors and pollutants from the floor drain may be drawn into the AHU via the condensation drain during the heating season.

Furnaces and water heater in mechanical room

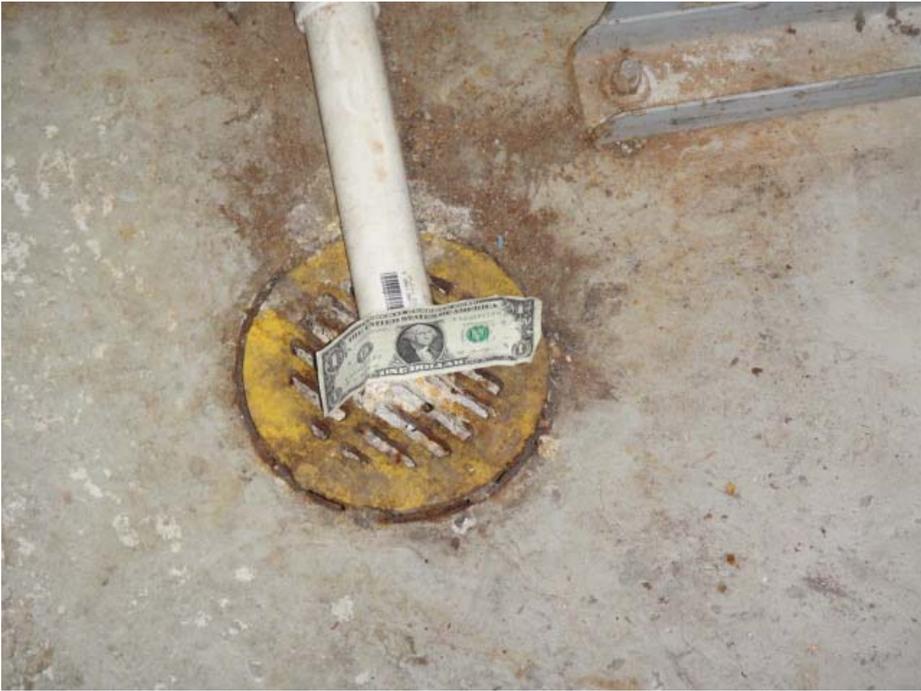
Picture 5

Condensation drain drawing air from room
