# **INDOOR AIR QUALITY ASSESSMENT**

**Department of Revenue  
1 Federal Street  
Springfield, MA**

Prepared by:  
Massachusetts Department of Public Health  
Bureau of Environmental Health  
Indoor Air Quality Program  
May 2016

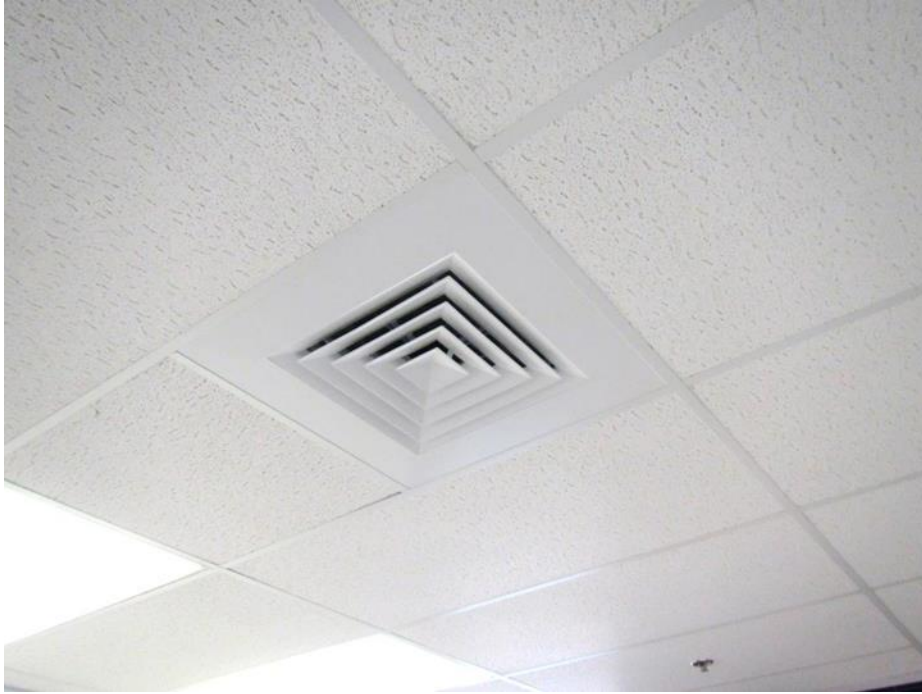
**Picture 1**

Fresh air for the space is provided by air handling units (AHU) via ducts to supply vents (Pictures 1 - 3). Ducted wall-mounted or ceiling-mounted exhaust vents remove stale air (Picture 4). Draw of air from restroom exhaust vents in the men's and women's restrooms appeared to be weak or non-existent.

**One type of supply vent in the DOR offices**

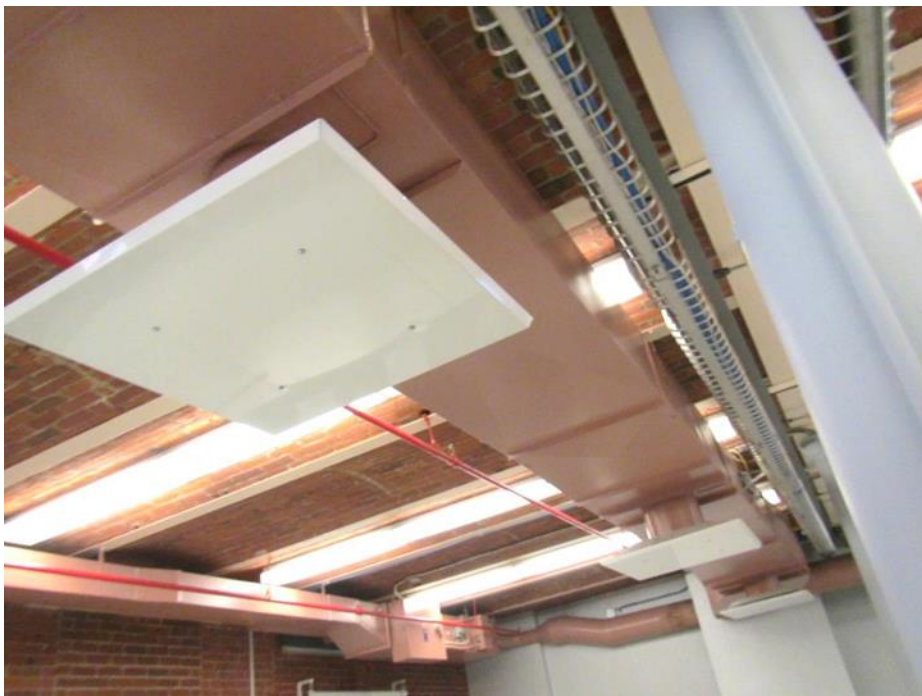
**Picture 2**

**Supply vent in open areas of the DOR office**

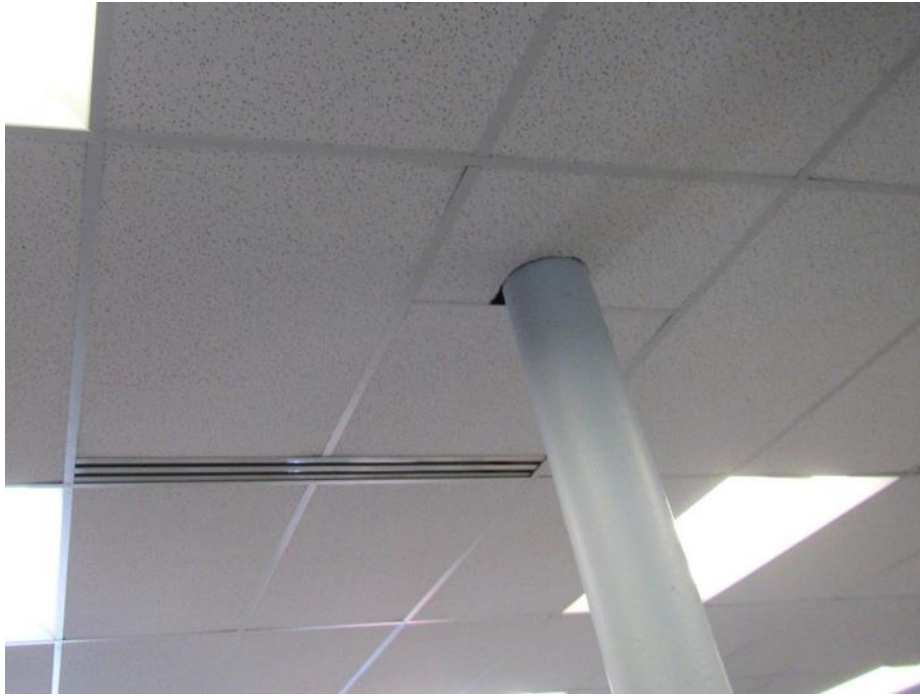
**Picture 3**

**Slot-style supply vent**

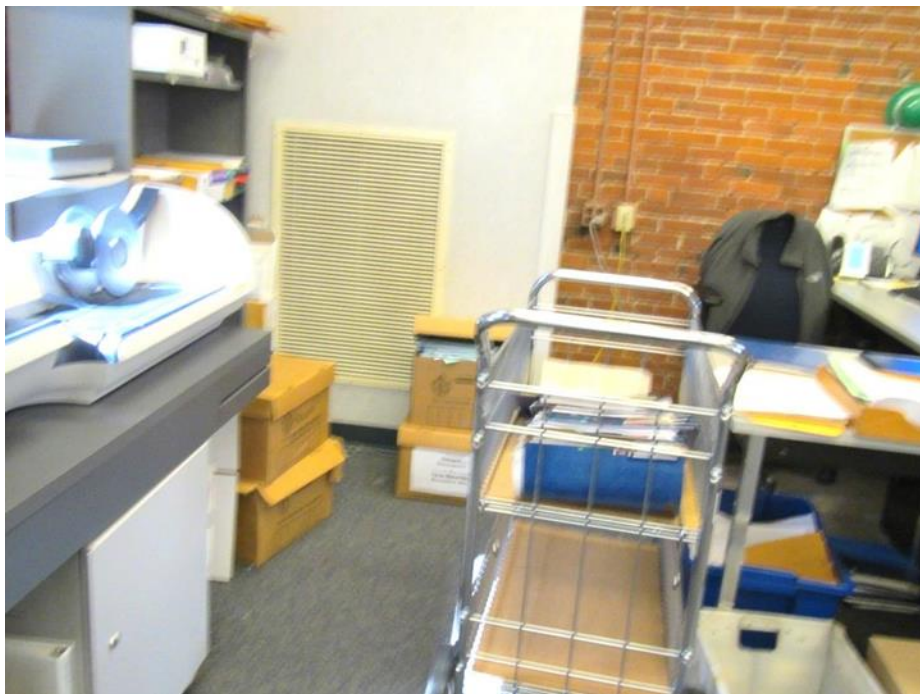
**Picture 4**

**Wall-mounted exhaust vent**

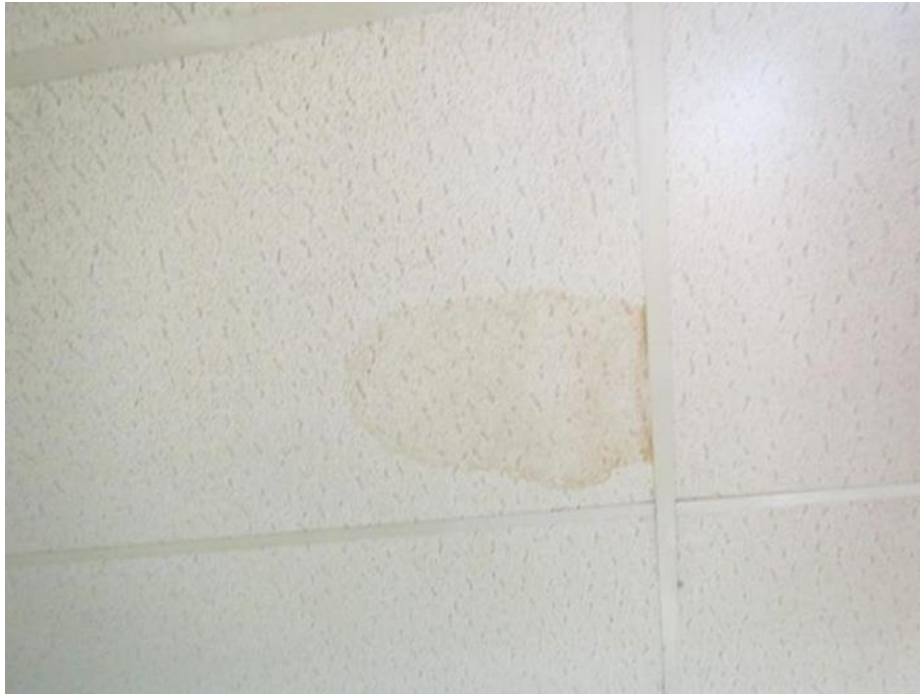
**Picture 5**

A single water-damaged ceiling tile was observed in the men's restroom (Picture 5). This likely stems from a plumbing leak in a space above. Once that leak has been repaired, the ceiling tile should be replaced.

**Water-damaged ceiling tile in men's restroom**

6. Repair plumbing leaks and replace stained ceiling tiles.
7. Consider putting water dispensers and refrigerators on waterproof mats or in areas without carpeting. During carpet replacement, areas of tile may be used in places where dispensers and refrigerators will be located.

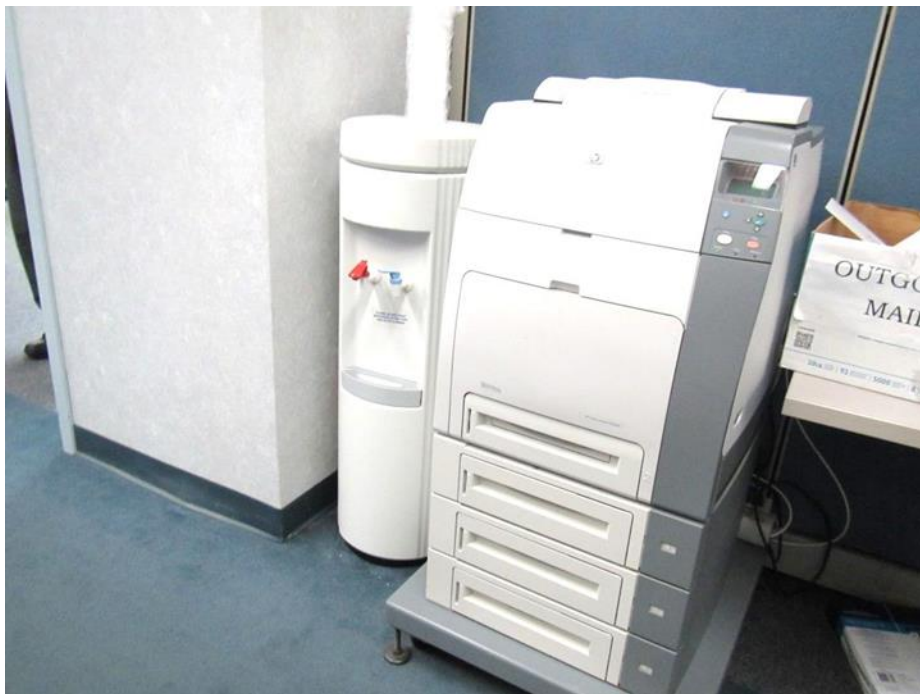
**Picture 6**

Water coolers and small refrigerators were observed on carpeting (Picture 6). Spills and leaks from these appliances can moisten carpeting and lead to microbial growth and odors.

**Water cooler on carpet**
