INDOOR AIR QUALITY ASSESSMENT

**Department of Revenue
703 West Housatonic Street
Pittsfield, MA**

Prepared by:
Massachusetts Department of Public Health
Bureau of Environmental Health
Indoor Air Quality Program
September 2016

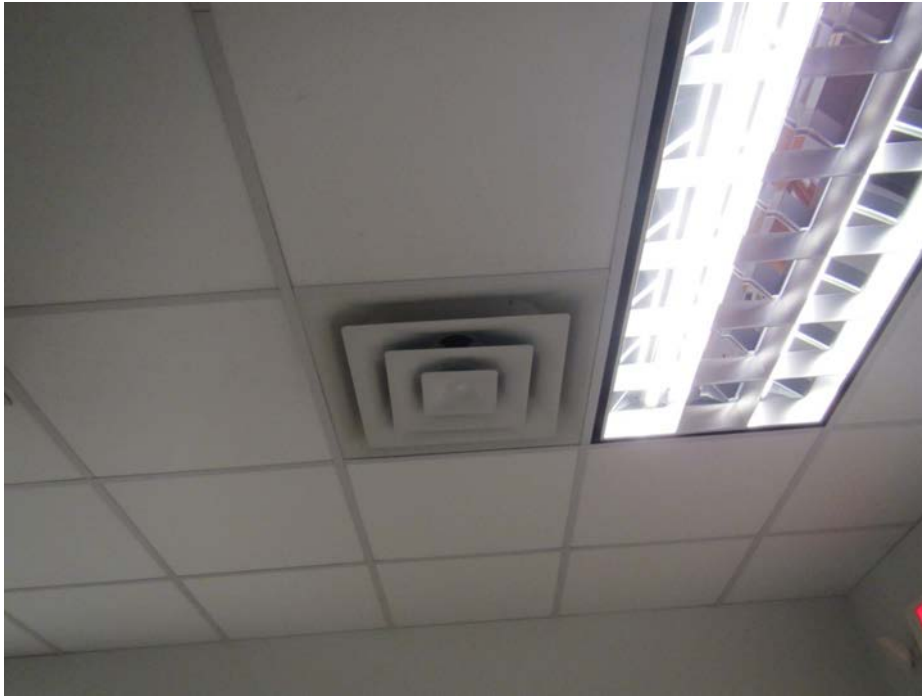
Picture 1

Fresh air is provided by air handling units (AHUs). Air from the AHUs is filtered, heated/cooled, and delivered to rooms via ducted supply vents (Picture 1). Air is returned/exhausted through vents in the ceiling (Picture 2).

Supply vent

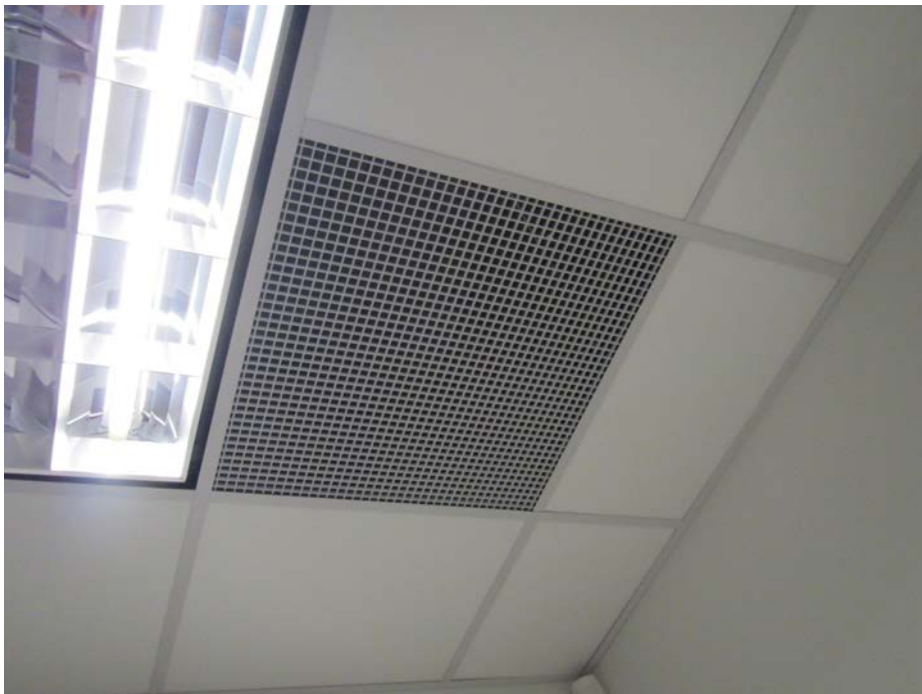
Picture 2

Return/exhaust vent

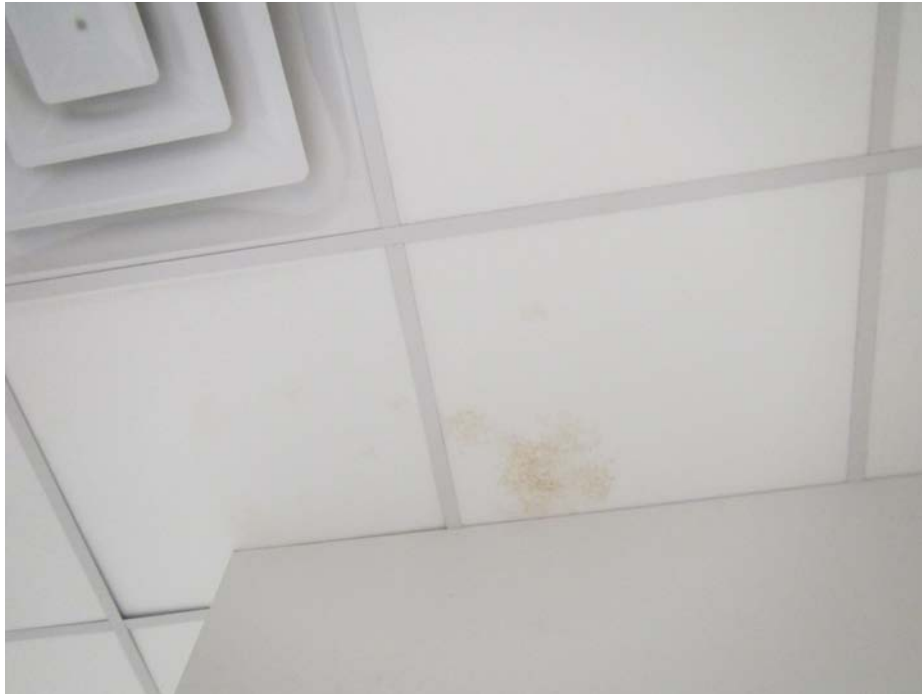
Picture 3

A few water-damaged ceiling tiles were observed in the conference/storage room (Picture 3) and the core facility restroom. The conditions causing the leak should be fixed, and the tiles should be replaced.

Water-damaged ceiling tile in conference/storeroom

2. Have the HVAC system balanced every 5 years in accordance with SMACNA recommendations (SMACNA, 1994).
3. Repair conditions leading to ceiling leaks and water-damaged ceiling tiles, and replace the tiles.

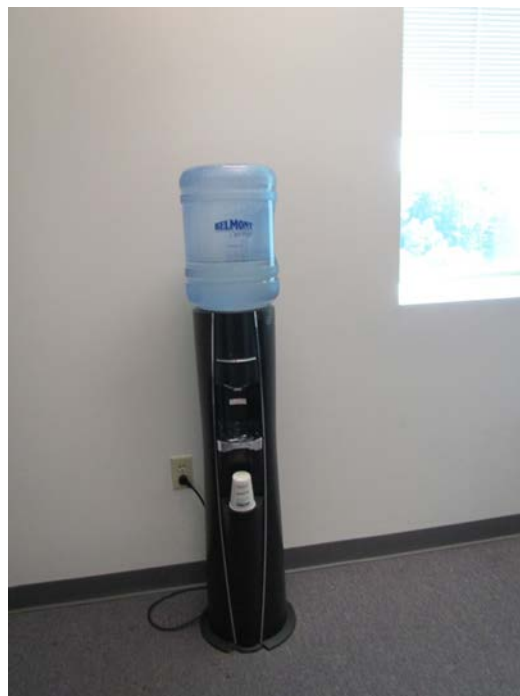
Picture 4

Water dispensers were observed in carpeted areas (Picture 4). These appliances may spill or leak and lead to carpet damage and microbial growth. It is recommended that these appliances be located in areas without carpeting or on waterproof mats. The kitchen sink cabinet had water stains, which suggests that leaks or condensation is occurring. The area underneath sinks tends to

Water cooler on carpet

4. Consider locating water dispensers in non-carpeted areas or place on a waterproof mat.
5. Avoid storing porous items or large amounts of items under sinks and check for leaks and damp conditions regularly.

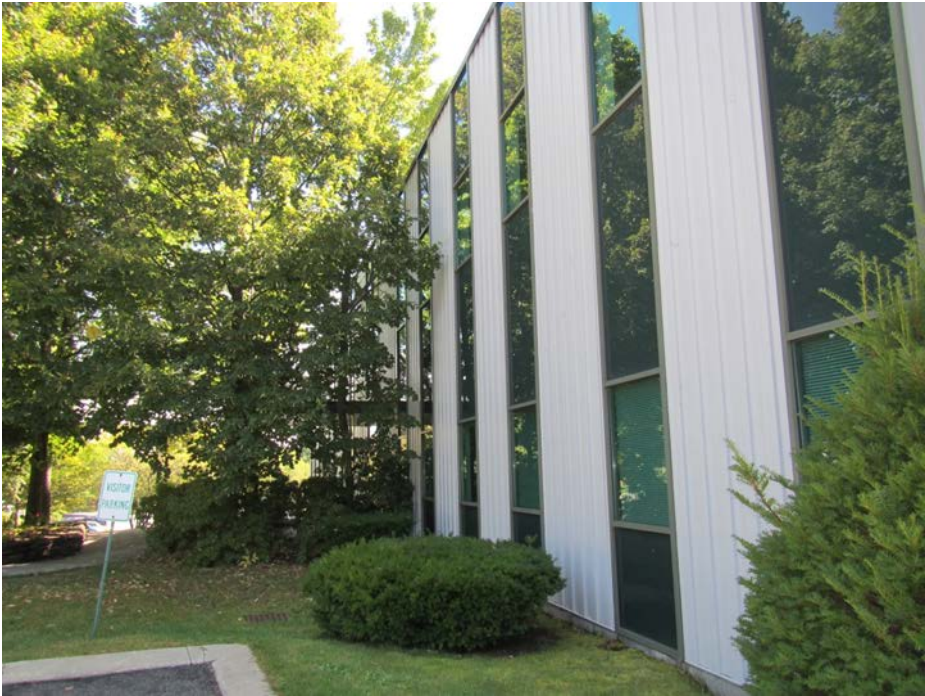
Picture 5

Plants and trees were observed very close to and touching the exterior of the building envelope (Picture 5). This can lead to deterioration of the building envelope due to root infiltration and dampness against the exterior surface. Plants can be a source of debris and pollen to air intakes. Plants should be trimmed away from the building and from overhanging the roof.

Plants and trees next to the building

6. Trim plants and trees back from the sides and overhanging the building.
7. For buildings in New England, periods of low relative humidity during the winter are often unavoidable. Therefore, scrupulous cleaning practices should be adopted to minimize common indoor air contaminants whose irritant effects can be enhanced when the relative humidity is low. To control for dusts, a high efficiency particulate arrestance (HEPA) filter equipped vacuum cleaner in conjunction with wet wiping of all surfaces is recommended. Avoid the use of feather dusters. Drinking water during the day can help ease some symptoms associated with a dry environment (throat and sinus irritations).
