INDOOR AIR QUALITY ASSESSMENT

**Department of Mental Health
Hadley Building
167 Lyman Street
Westborough, MA**

Prepared by:
Massachusetts Department of Public Health
Bureau of Environmental Health
Indoor Air Quality Program
October 2016

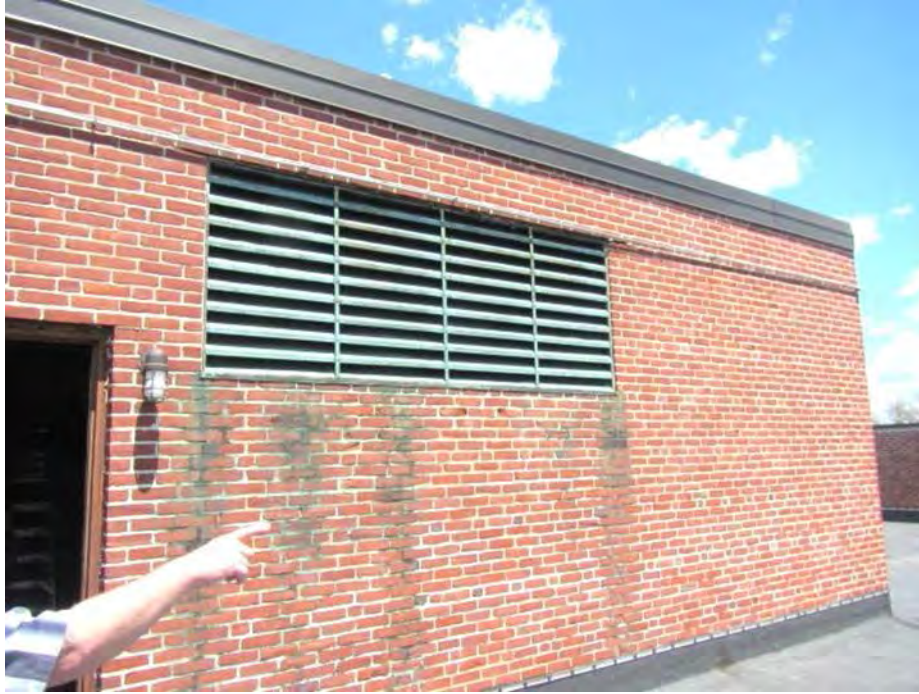
Picture 1

The building's mechanical ventilation system is not equipped with air conditioning (AC) capabilities. It was designed to draw outside air via large air handling units (AHUs), which feed into main hallways via ducted vents (Pictures 1 through 3). Individual rooms have an exhaust vent that pulls air into the room (Pictures 4 and 5). Doors were designed to have passive vents/grills in order to sustain airflow while shut (Picture 6), however the large majority of them have been sealed throughout the building (Picture 7). This system was reported to be under repair at the time of the assessment, therefore the building is not being ventilated the way it was designed. Currently, fresh air is mostly provided by openable windows. Most offices have two openable windows and a window-mounted AC.

Fresh air intake for AHU

1. Restore the building's HVAC system, continue with plans to repair hallway AHUs. Consider long-term plans to work with an HVAC engineer to determine if units can be retrofitted with chiller/AC capabilities.

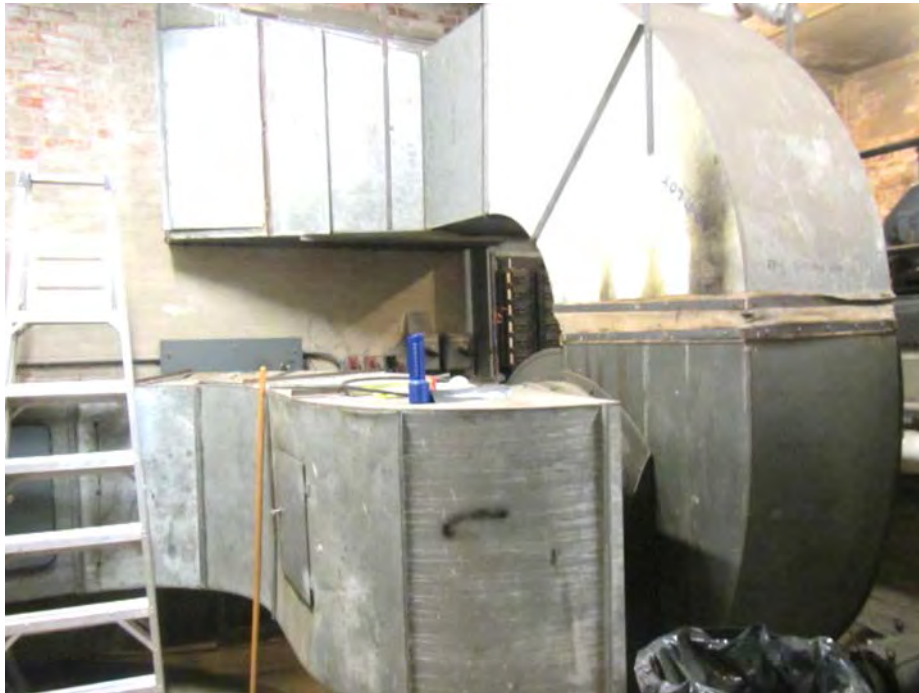
Picture 2

Air handling equipment in attic

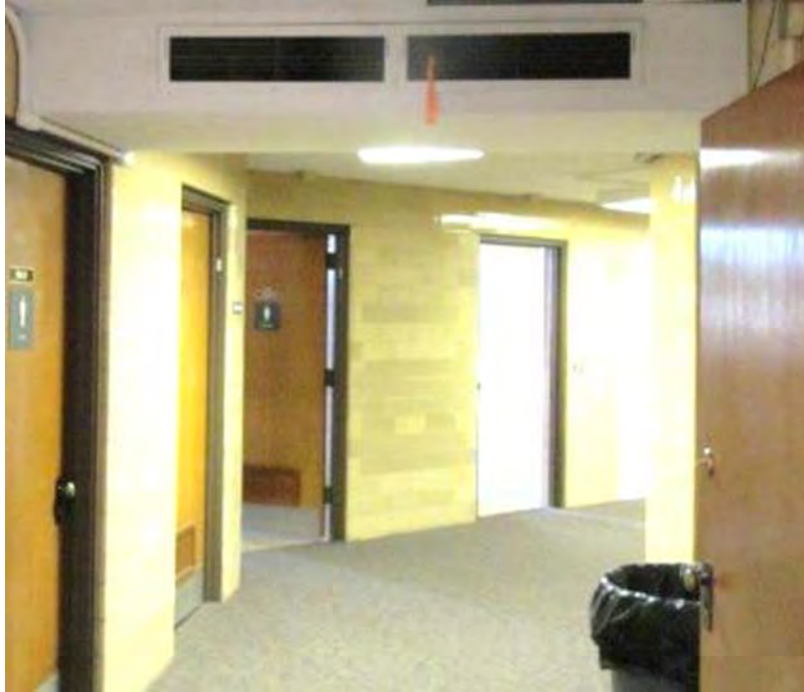
Picture 3

Hallway supply vents

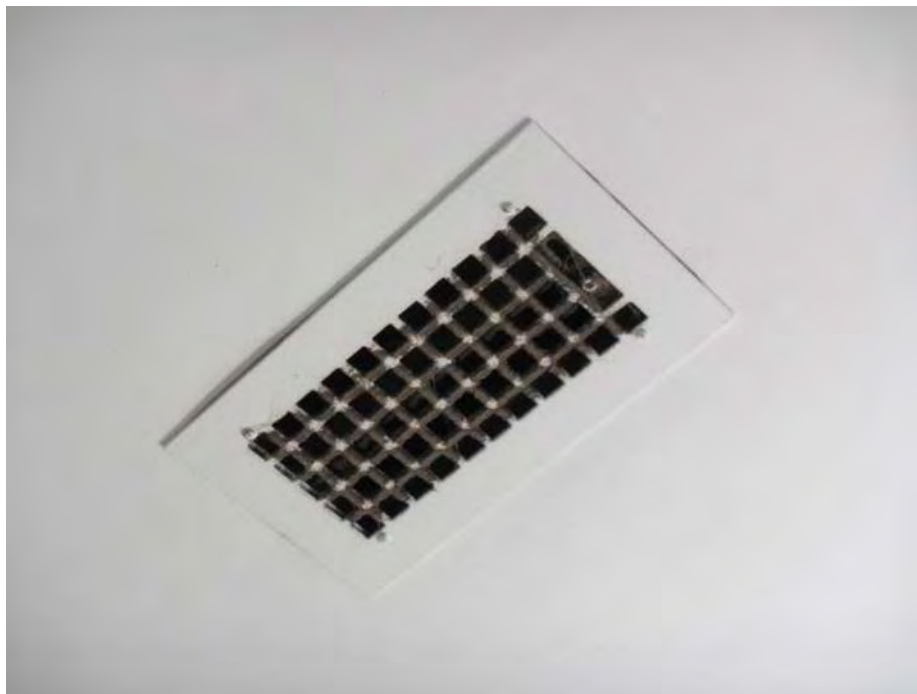
Picture 4

Accumulated items were found stored on floors and other flat surfaces, which can make it more difficult for custodial staff to clean. Some flat surfaces, exhaust vents (Pictures 4 and 5), and personal fans (Picture 16) were found to be dusty and have cobwebs. Dust can be reaerosolized and cause irritation; flat surfaces and items should be cleaned regularly.

Ceiling exhaust vent, note dust/debris

12. Clean AC filters prior to and periodically/as needed during the cooling season.
13. Clean supply and exhaust vents and personal fans regularly to prevent aerosolization of debris.

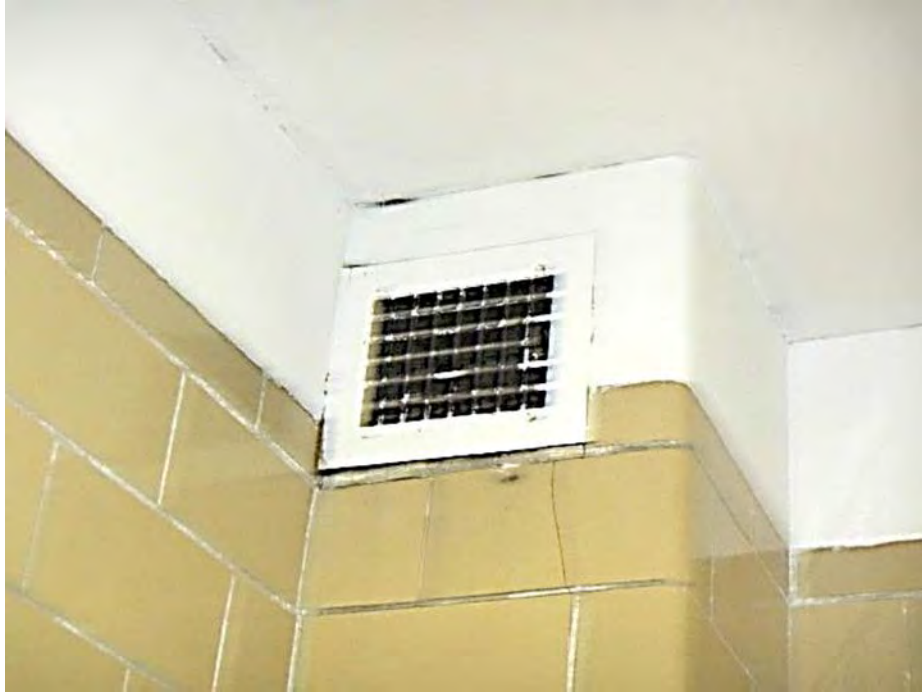
Picture 5

Wall-mounted exhaust vent, note dust/debris

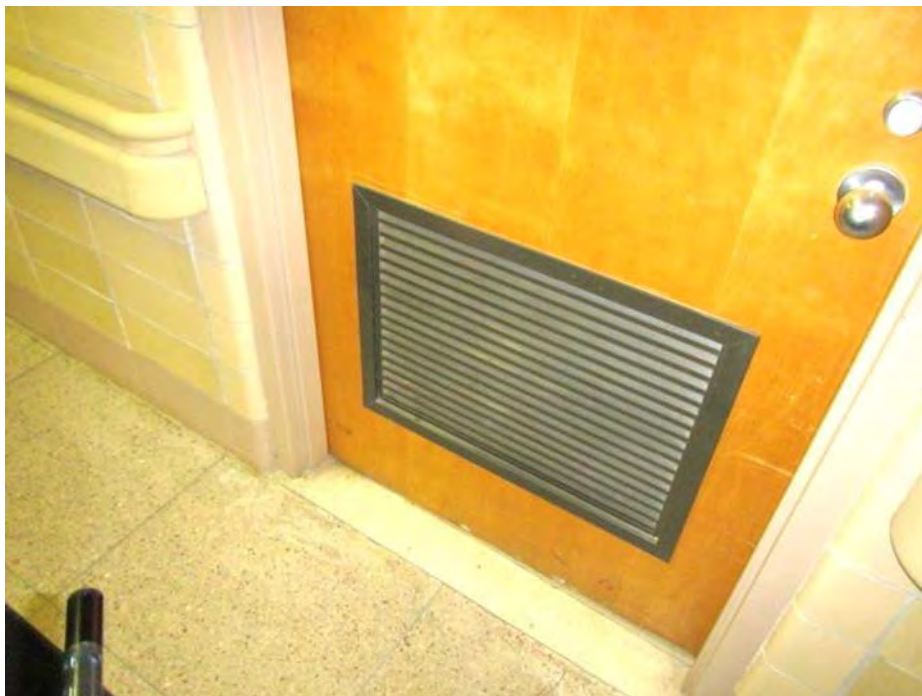
Picture 6

Restrooms are equipped with local exhaust vents to remove odors and moisture; however several of these were not operating during the assessment. Several of the restrooms also had passive door vents sealed. These vents should be restored (or doors undercut) to provide make-up air while exhaust vents are operating.

Passive door vent/grill

2. Ensure fans/motors for restroom exhaust vents are operational. Restore passive door vents or undercut doors to provide make-up air.
3. Use open windows (weather permitting), to temper rooms and provide fresh air.

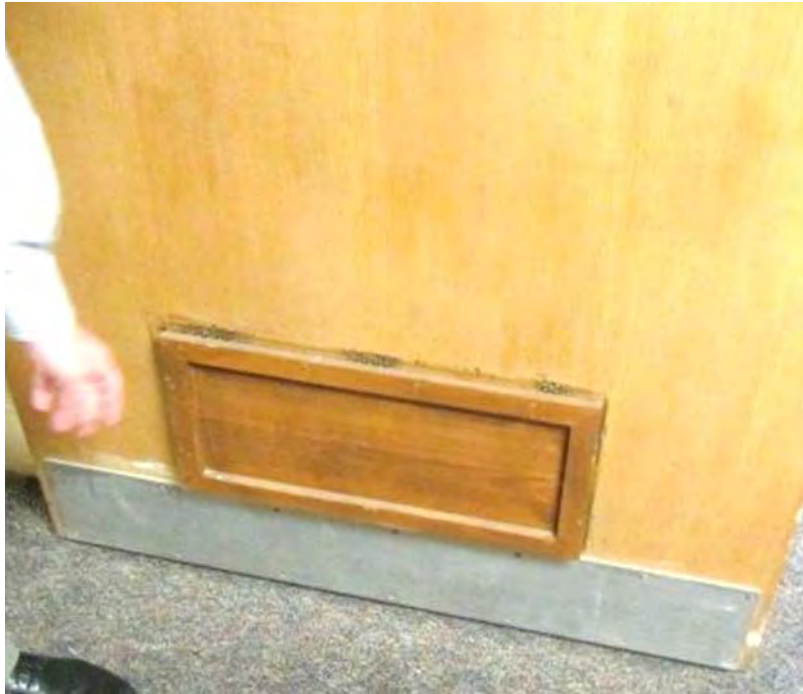
Picture 7

Sealed passive door vent

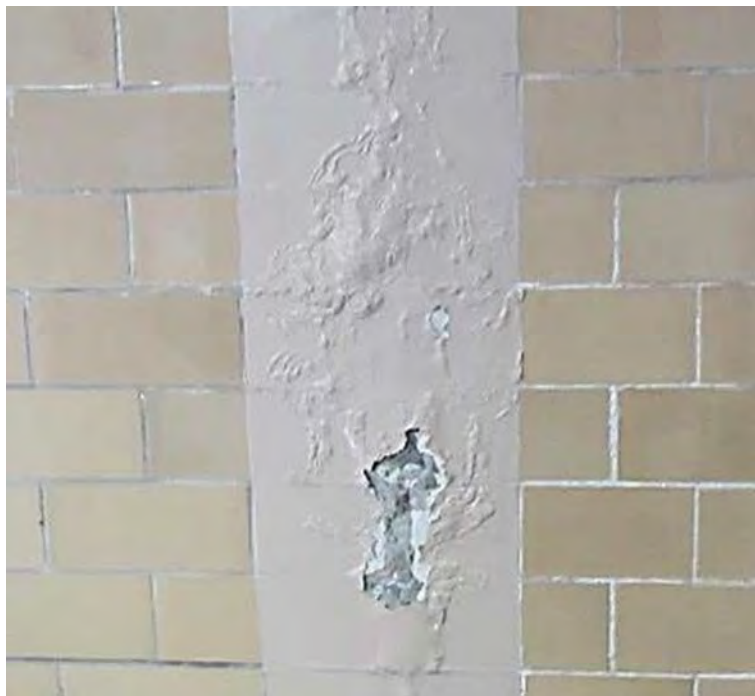
Picture 8

A number of areas (Table 1) exhibited signs of historic water damage in the form of peeling paint; efflorescence and water-damaged ceiling/wall plaster (Pictures 8 through 11). Efflorescence is a characteristic sign of water damage caused by salts and mineral deposits from water filtrating through materials such as brick and concrete, which may become aerosolized, and be a contributing source to eye and respiratory system irritation. Over the summer, repointing/waterproofing activities were conducted in a few areas along the exterior of the building.

Peeling paint and efflorescence

5. Continue with plans to repaint/waterproof the exterior.
6. Once waterproofing/repairs are complete, clean/scrape and repaint areas of water damage/peeling paint and efflorescence (e.g., walls, ceilings and windowsills). Given the age of the building Lead Safe renovating methods may be warranted.

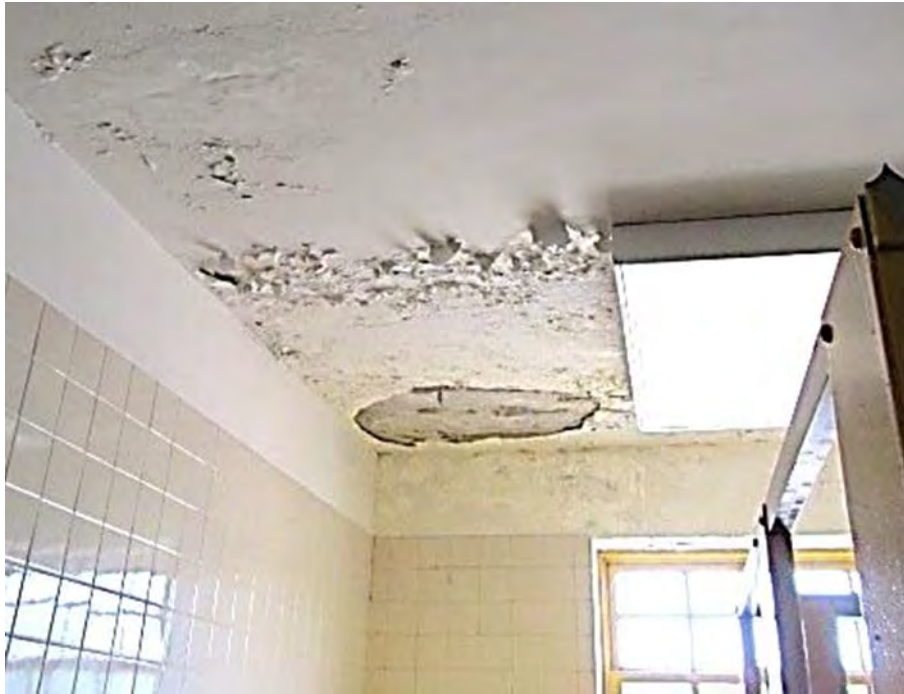
Picture 9

Severely water-damaged ceiling in 3rd floor women's restroom

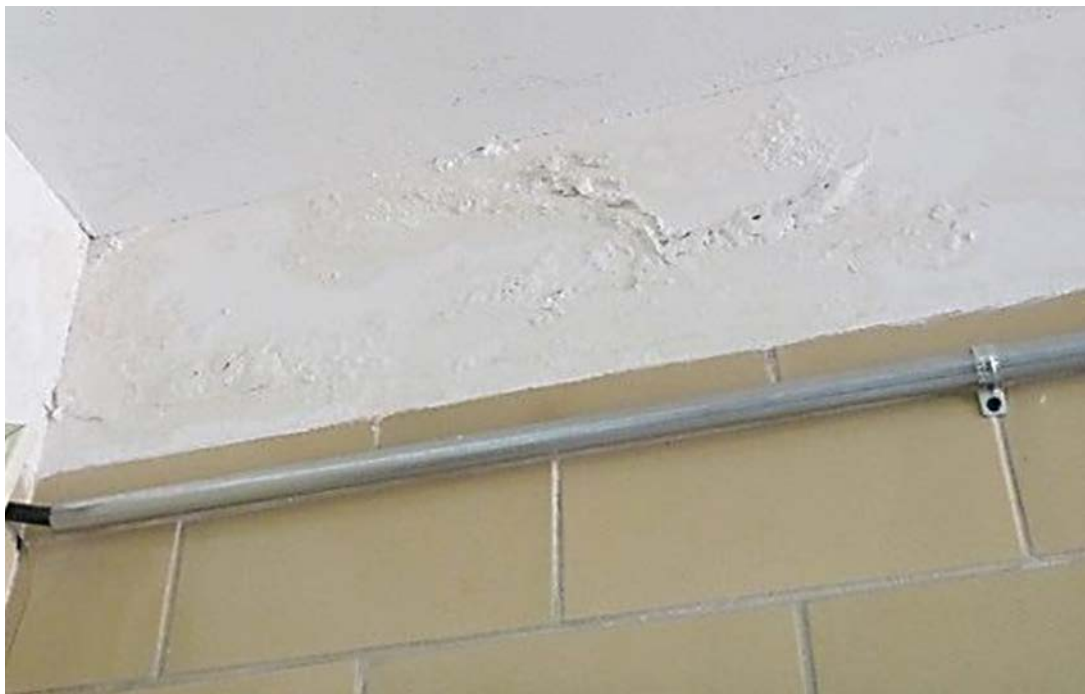
Picture 10

Peeling paint and efflorescence

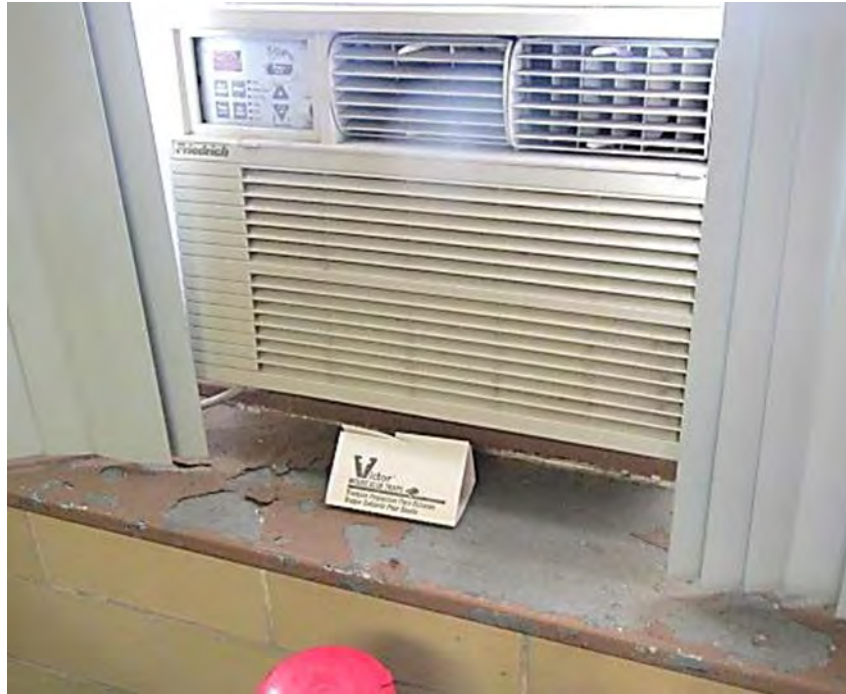
Picture 11

Peeling paint on windowsill

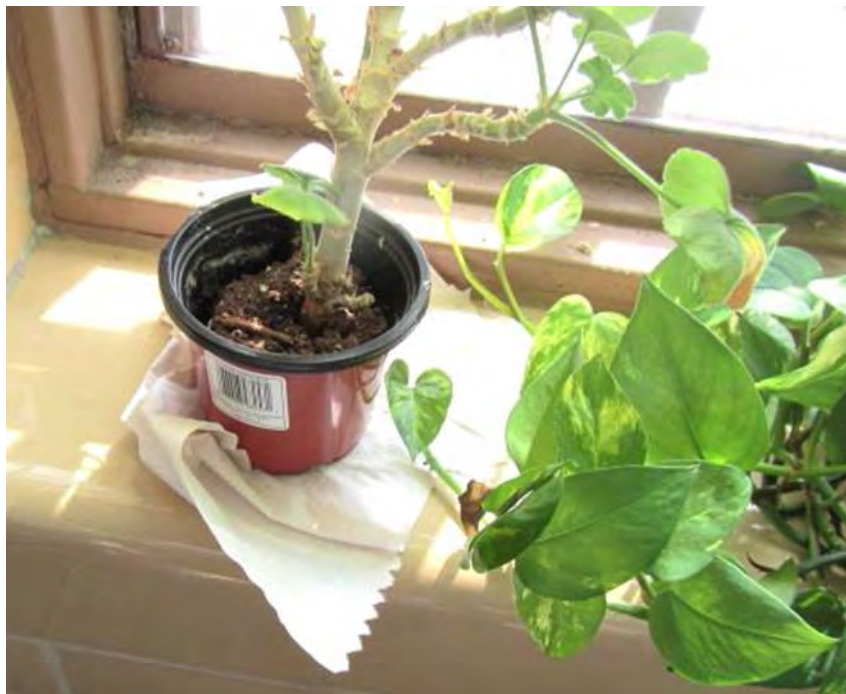
Picture 12

Plants were observed in several areas (Table 1). Plants, soil, and drip pans can serve as sources of mold/bacterial growth. In one case plants were observed on paper towels, which are a porous material that can grow mold (Picture 12). Plants should be properly maintained, over-watering of plants should be avoided, and drip pans should be inspected periodically for mold growth. In conference room 260, paper towels were noted around the window, presumably to stop leaks/drafts (Picture 13).

Plant on paper towel

8. Inspect wood around ACs for chronic water damage, clean/refinish/replace as needed.
9. Indoor plants should be properly maintained and equipped with drip pans to prevent water damage to porous building materials and be located away from ventilation sources to prevent the aerosolization of dirt, pollen or mold. Do not rest plants on porous materials (e.g., cloth, paper).

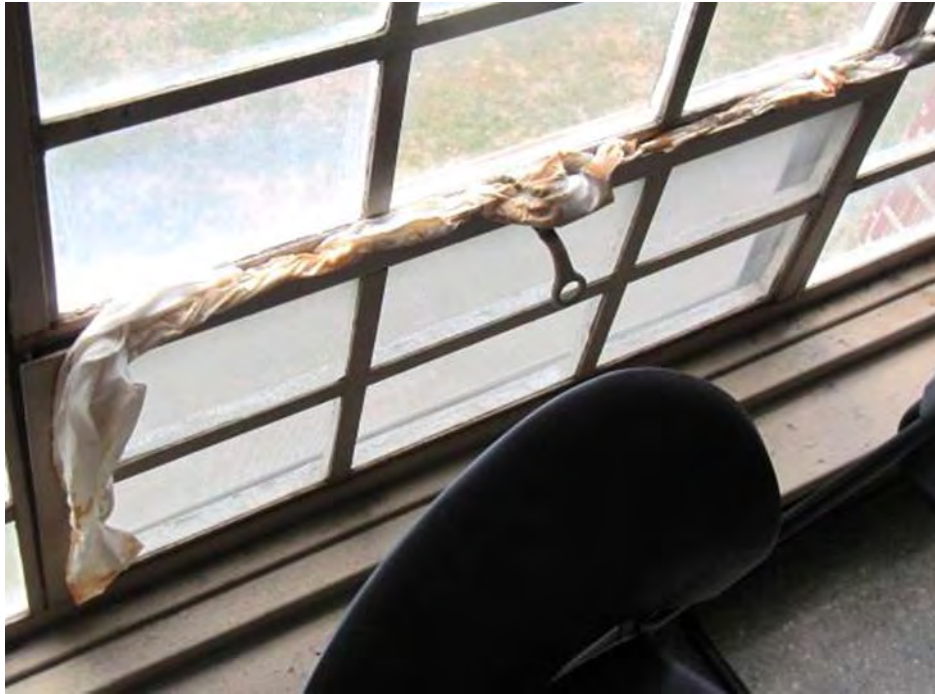
Picture 13

Soiled towels around window

7. Ensure window ACs are sealed properly to eliminate drafts and or/water penetration. Refrain from using cloth/porous materials around AC units and windows (Picture 13).

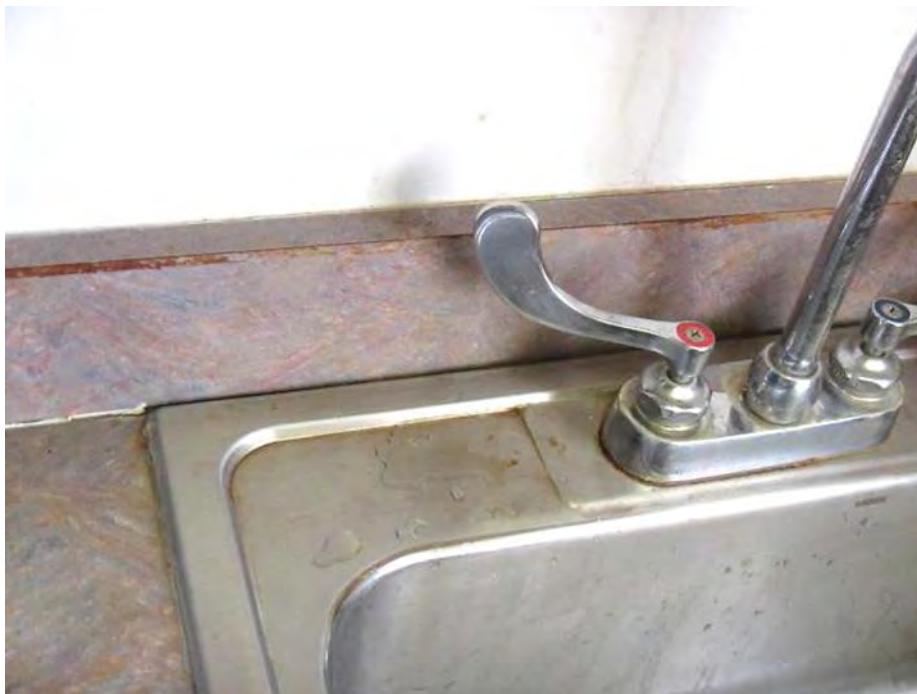
Picture 14

Open seams between the sink countertop and backsplash were observed in kitchen 228 (Picture 14). If seams are not watertight, water can penetrate the seam, causing water damage. Water penetration and chronic exposure of porous and wood-based materials can cause these materials to swell, show signs of water damage and lead to potential mold growth.

Loose/damaged backsplash kitchen 228

10. Install ACs and/or use dehumidifiers in storage rooms used for porous materials (e.g., G64, 274/275).
11. Seal around sink in kitchen 228 (and any other sinks with similar breaches) to prevent water damage to backsplash/countertop wood.

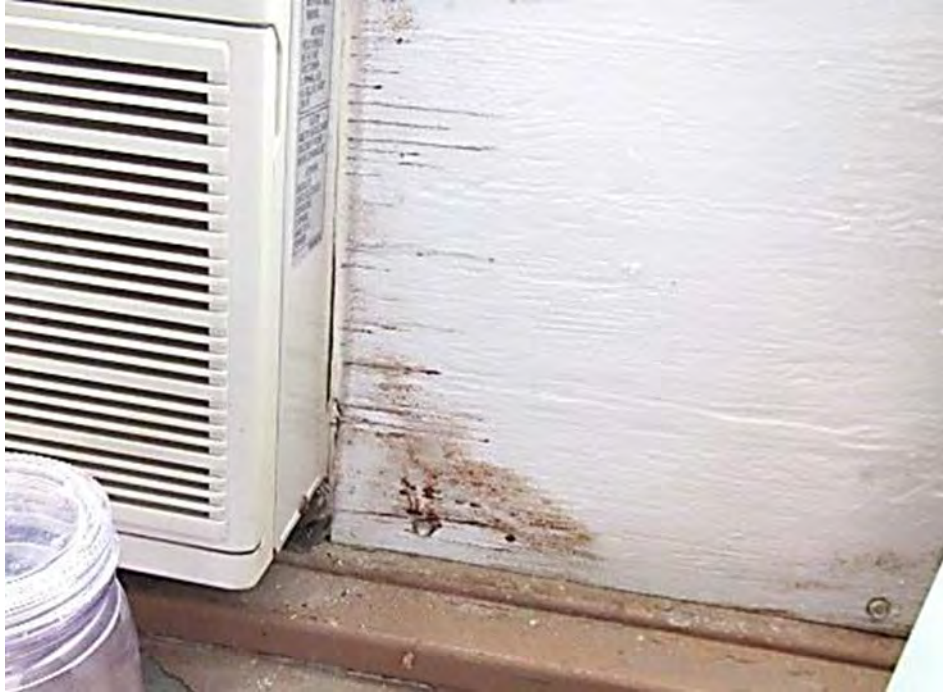
Picture 15

In many areas wood is used to seal spaces around ACs. Wood is a semi-porous material, which if subjected to chronic moisture can grow mold. In some cases the wood appears discolored/moldy (Picture 15) and may be in need of replacement.

Water-damaged wood/possible mold growth on wood around AC room 456

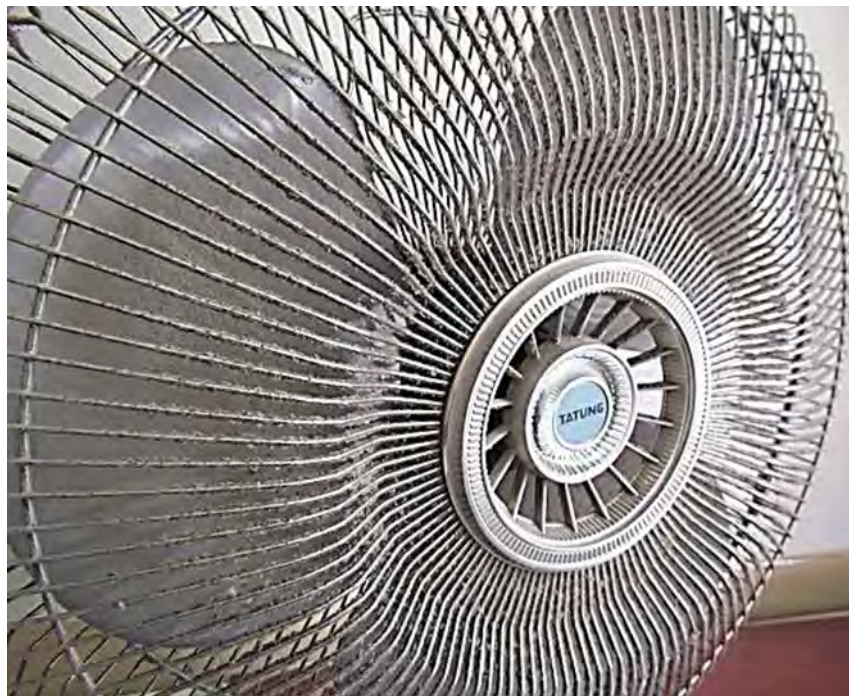
Picture 16

Accumulated dust/debris on personal fan

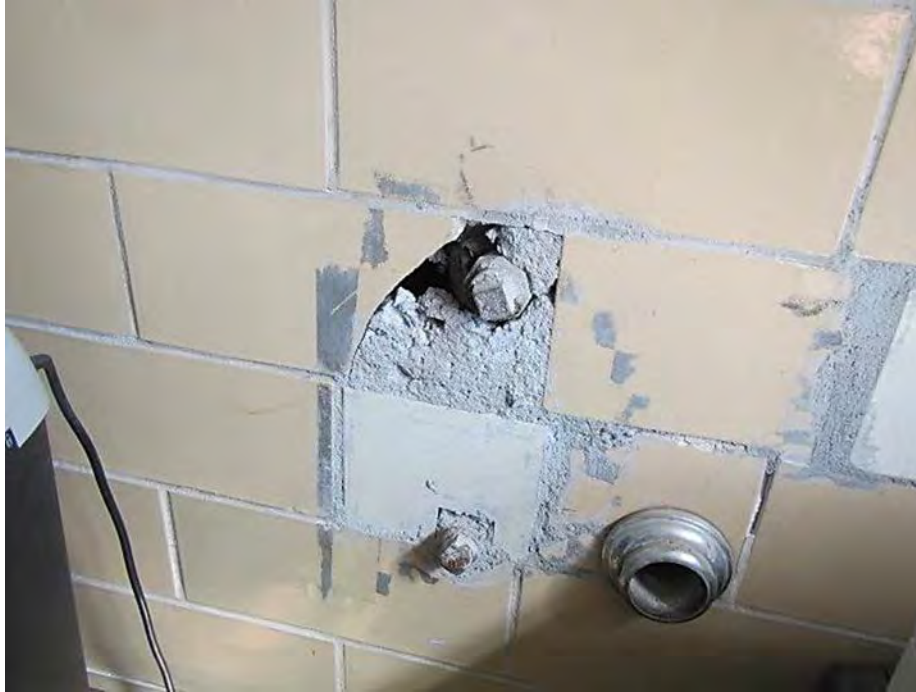
Picture 17

Room 458 had an open utility hole in the wall (Picture 17). These breaches can serve as pathways for dirt, dust and odors from the wall cavity into occupied space.

Hole in wall around utility pipe

17. Seal open utility holes/breaches in walls/ceilings.
18. Institute an IPM program to manage pests. Insecticides should be used as a last resort.
19. Reduce the use of air deodorizers, cleaning products, sanitizers, and other products containing VOCs. Considering adopting green cleaning procedures. Ensure cleaning products are properly labeled, and keep material safety sheets on file.

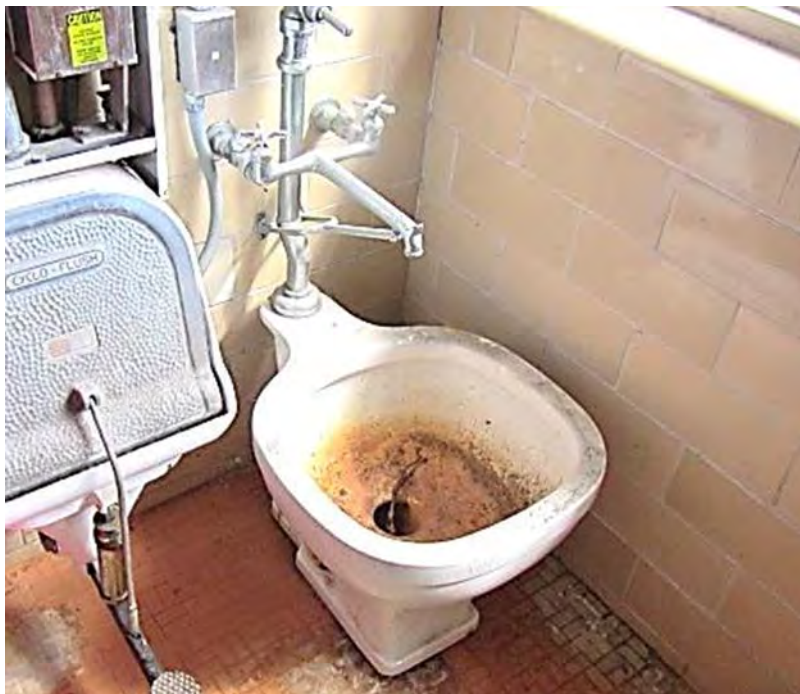
Picture 18

An abandoned toilet was observed in room 256 (Picture 18). If abandoned plumbing fixtures are not removed/capped properly, they can serve as conduits for sewer gasses/odors into occupied areas.

Abandoned toilet in room 256

15. Consider reducing the amount of items stored in offices to make cleaning easier. Periodically move items to clean flat surfaces.
16. Remove and cap abandoned toilet in room 256.

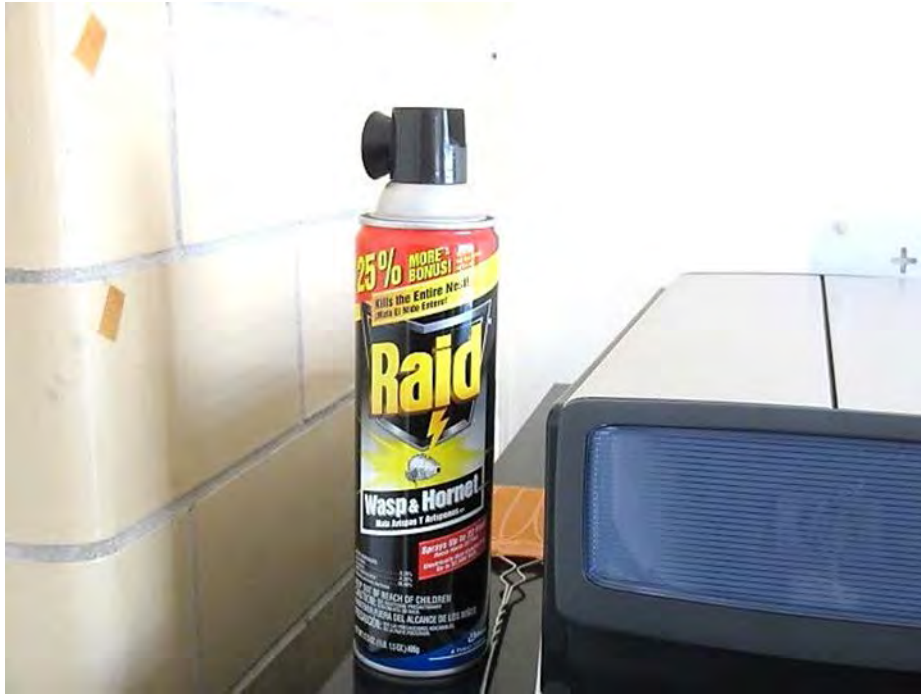
Picture 19

A spray can of insecticide was observed in an office (Picture 19). Pesticides contain harmful chemicals that can cause eye, and respiratory irritation and health effects. Integrated pest management (IPM) should be used in occupied buildings with pesticides as a last resort.

Spray insecticide in office
