INDOOR AIR QUALITY ASSESSMENT

**Massachusetts Rehabilitation Commission/
Disability Determination Services
110 Chauncy Street, Boston**

Prepared by:
Massachusetts Department of Public Health
Bureau of Environmental Health
Indoor Air Quality Program
January 2019

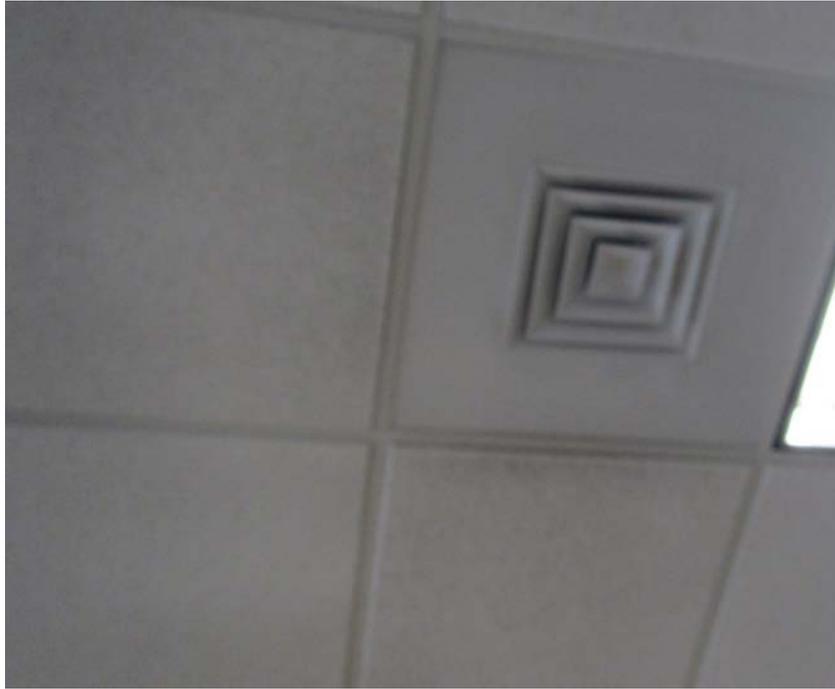
Picture 1

Fresh air is provided by air handling units which are located in mechanical closets on each floor. Air from the AHUs is filtered, heated/cooled, and delivered to rooms via ducted supply vents (Picture 1). Air is returned to the AHU through return vents via the ceiling plenum (Picture 2). Additional heating is provided by radiators along outside edges of the building (Picture 3). Each room should have a source of fresh air.

Supply vent

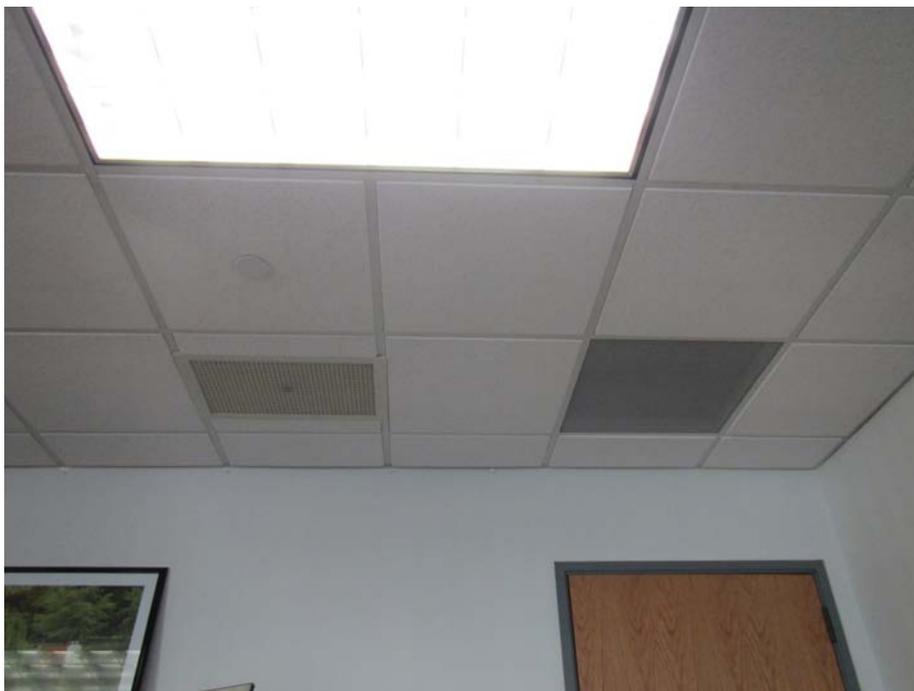
Picture 2

Return vents

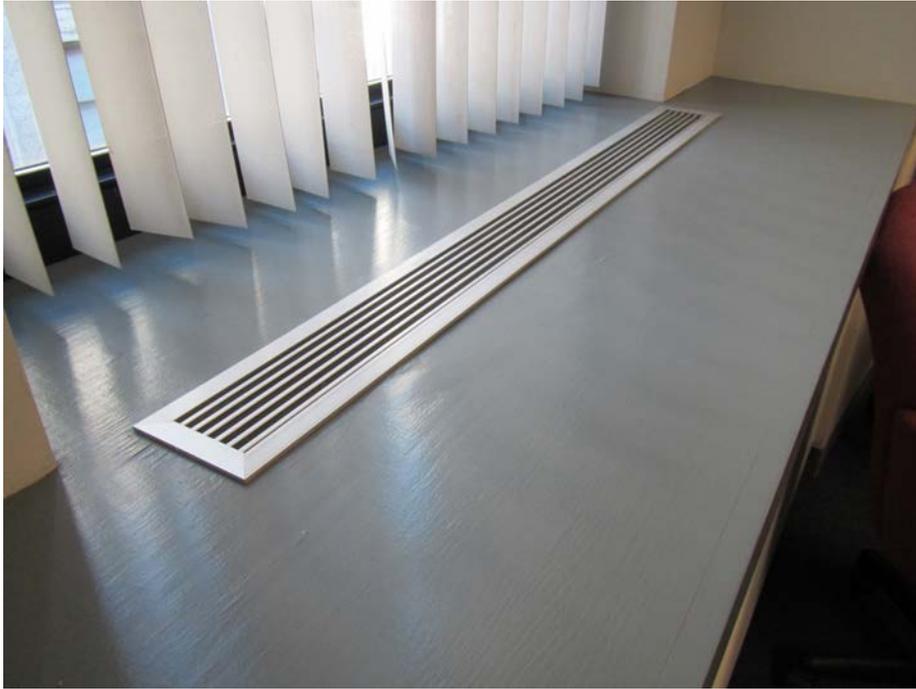
Picture 3

Heater

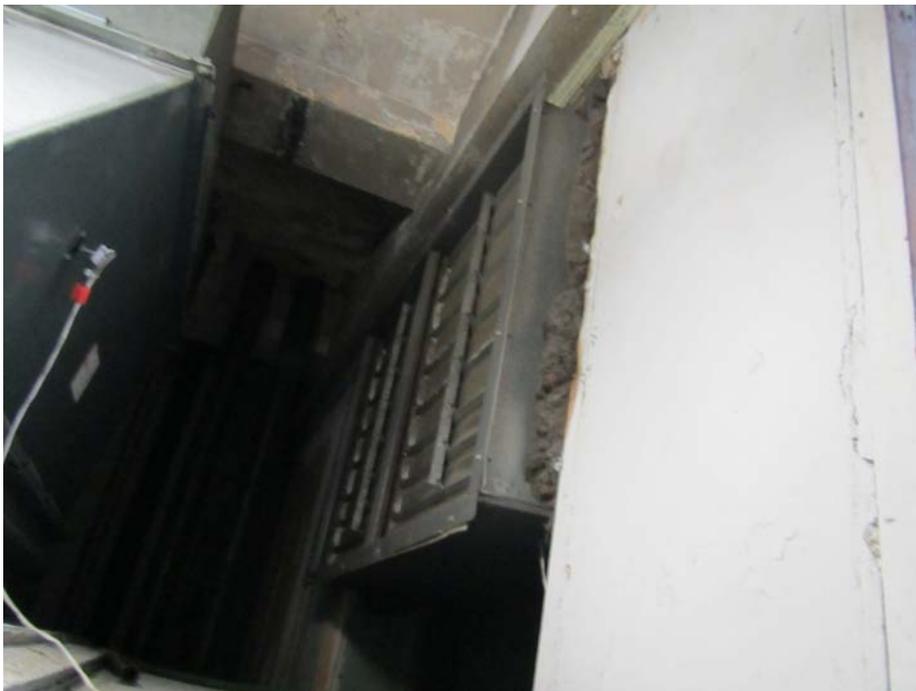
Picture 4

The AHUs draw air in from vents on the exterior of the building. In those AHU rooms examined, the louvers for the outside vents were closed (Picture 4). This is often done as an energy-saving measure to avoid bringing in and heating cold outside air, however without a fresh air supply, carbon dioxide levels and any other indoor pollutants will build up leading to indoor air complaints. On the second and third floors, the AHUs did not appear to be on at all, and no air circulation was being provided.

Closed louvers in AHU room

5. Ensure AHU filters are well-fitted into each AHU so that no air bypasses them.
6. Consider adjusting the louvers for the AHUs to allow more fresh air.

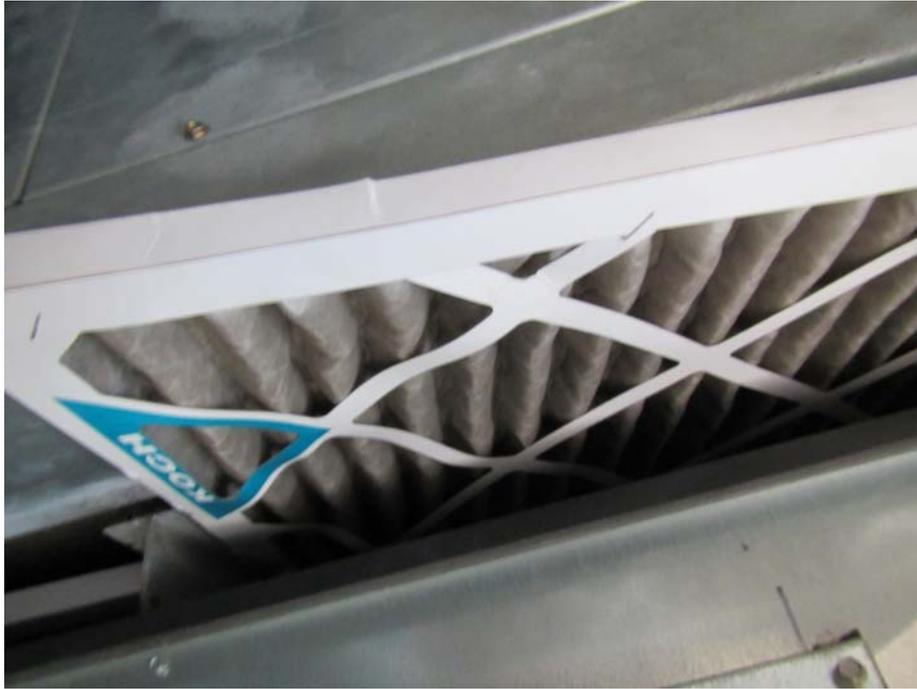
Picture 5

Note that at least one AHU had a filter that was improperly fitted into the cabinet, and was visibly soiled (Picture 5). Filters should be tightly seated inside each AHU filter frame to prevent air bypass. In addition, filters should be changed a minimum of 2 times a year. It was also noted that AHU rooms appeared open to the ceiling plenum through gaps (Picture 6). If this is intentional, the ceiling plenum is used for return air through these gaps, and the entire AHU room will function as a mixing room. This means that along with ensuring that filters are of good quality, well-seated, and changed frequently enough, the entire AHU room should be kept scrupulously clean to prevent dust and odors from being distributed to occupied areas. If these gaps are not used for air mixing, they should be sealed to prevent any back drafting of dust and odors through exhaust vents. Note that one occupant located on the fifth floor near that AHU room reported periodic odors that the occupant identified as emanating from an exhaust vent (Table 1).

Poorly-fitted, soiled AHU filter

4. Change filters for HVAC equipment 2-4 times a year. Use pleated filters of MERV 8 (or higher), which are adequate in filtering out pollen and mold spores (ASHRAE, 2012), if these can be used with current equipment.

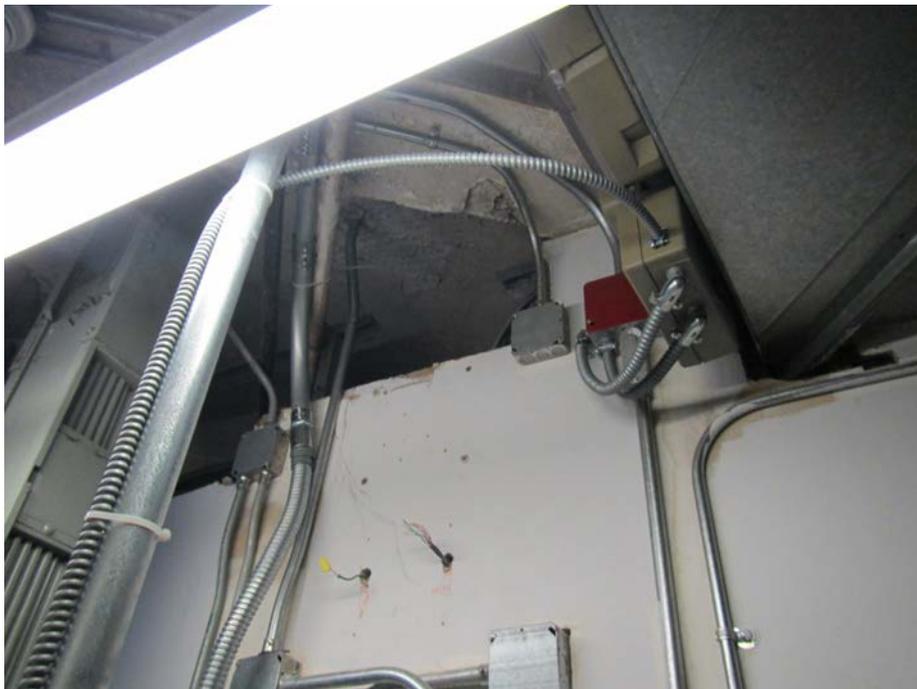
Picture 6

AHU room appears connected to ceiling plenum through this gap

7. Since the AHU rooms may serve as mixing rooms, ensure they are kept clean.
8. Unblock any blocked supply vents and remove obstructions from heater vents.

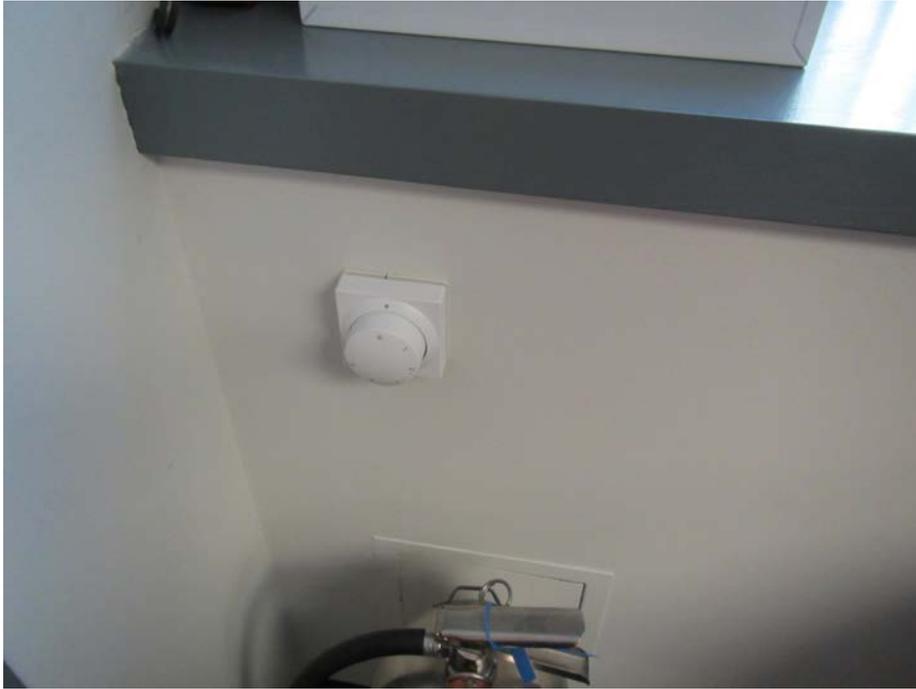
Picture 7

Lack of temperature control was reported by many occupants. A number of thermostats were reportedly deactivated during an energy upgrade project. Occupants reported that the only form of temperature control available were dials on heater vents (Picture 7). A few supply vents were found blocked (Picture 8) reportedly due to temperature concerns. Vents should be unblocked to allow for air circulation.

Heater adjustment knob

12. Mark inoperable/unused thermostats as such or remove.
13. Ensure windows are closed tightly at the end of each day, and that they remain closed during wet weather and when the air conditioning is operating.

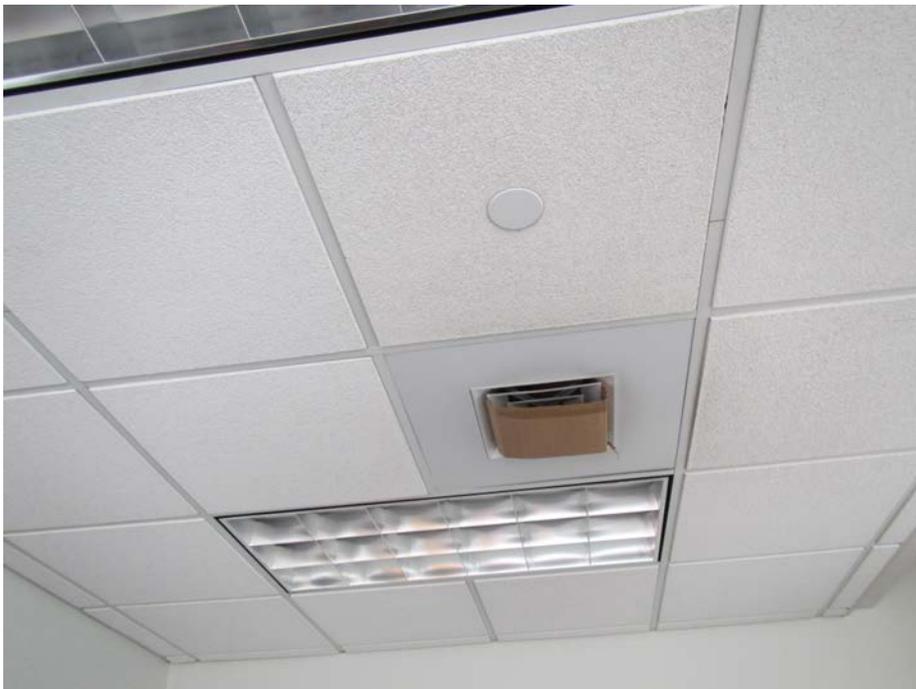
Picture 8

Supply vent blocked with cardboard

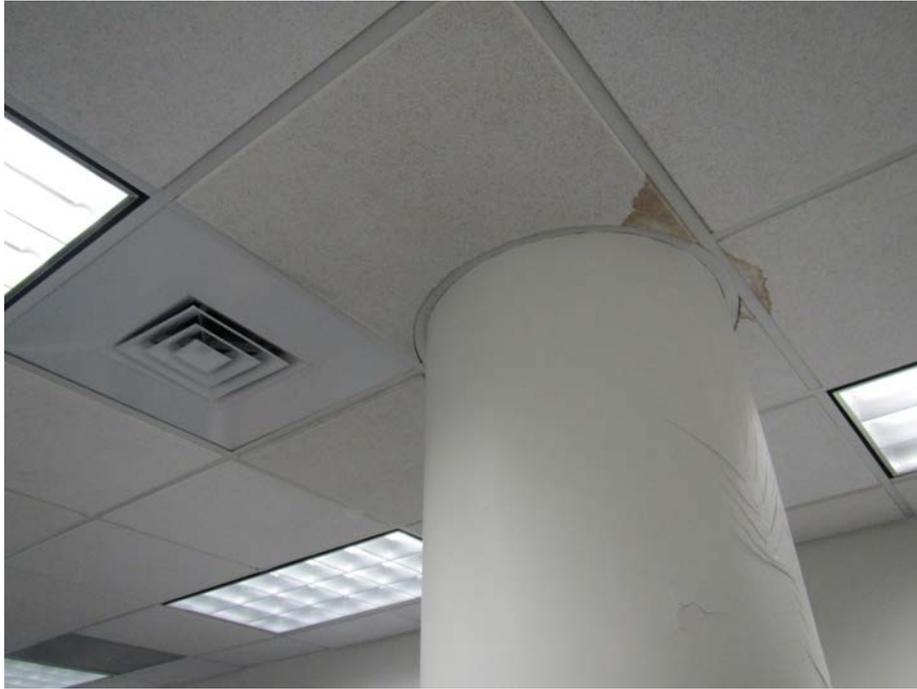
Picture 9

Other signs of water damage were observed, including water-damaged ceiling tiles, paint (Picture 9), and carpeting (Picture 10). The water-damaged ceiling tiles indicate leaks from the building envelope, plumbing, or HVAC system. Water-damaged tiles should be replaced once the leak is repaired. As shown in Picture 10, water damage to carpeting is often the result of spills or leaks from water dispensing equipment. It is recommended that refrigerators and water dispensers be placed in areas without carpeting or on a waterproof mat.

Water-damaged ceiling tiles and paint on a column

14. Adjustable blinds should be used to control for solar heating and glare.
15. Remove and replace water-damaged ceiling tiles.
16. Ensure carpeting that was moistened is properly dried and cleaned within 24-48 hours, or consider replacing.

17. Remediate areas of water-damaged building materials in accordance with the EPA guideline “Mold Remediation in Schools and Commercial Buildings” (US EPA, 2008).

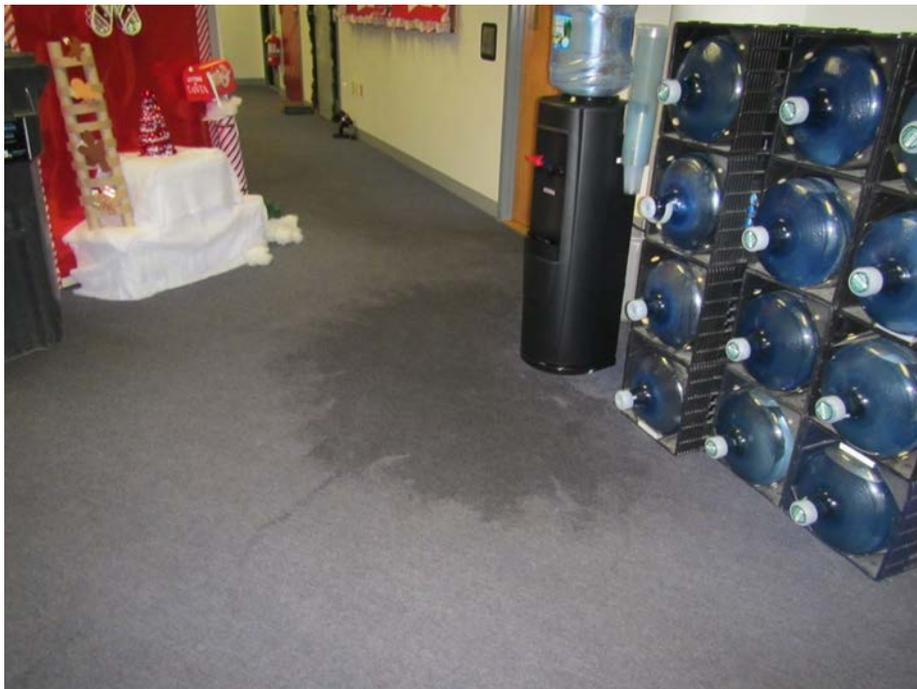
Picture 10

Wet carpeting from a water dispenser leak

18. Keep plants in good condition, avoid overwatering, and remove from the airstream of heating and ventilation equipment.
19. Use a waterproof mat under refrigerators and water dispensers to prevent spills onto carpeting or consider moving them to areas without carpeting. Keep refrigerators clean.

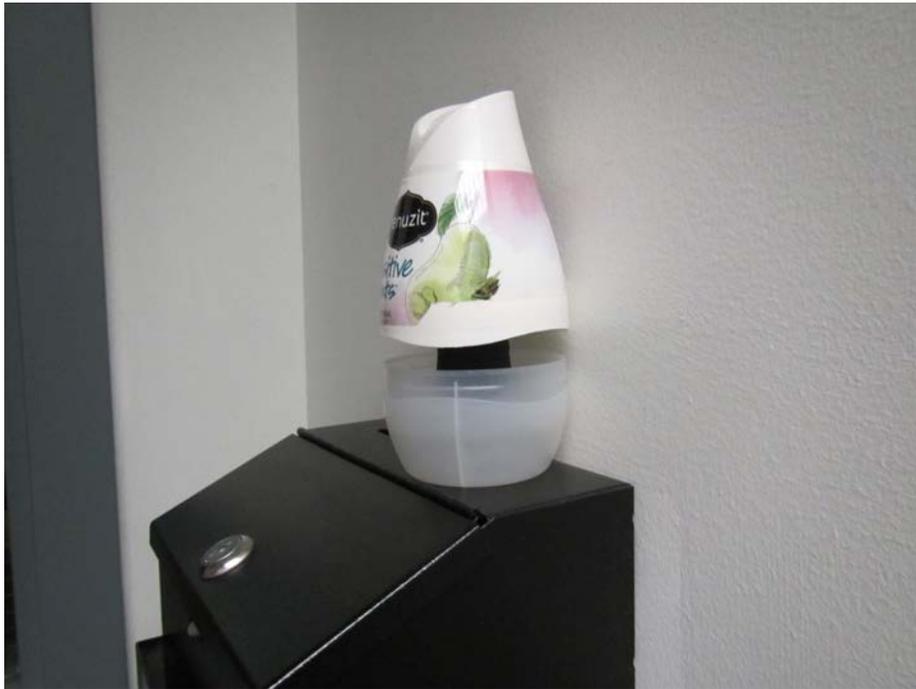
Picture 11

Air freshener

20. Reduce the use of cleaning products, sanitizers, and other items that contain VOCs. Minimize the use of scented products.
21. Increase supply and exhaust ventilation for the mailroom if possible.

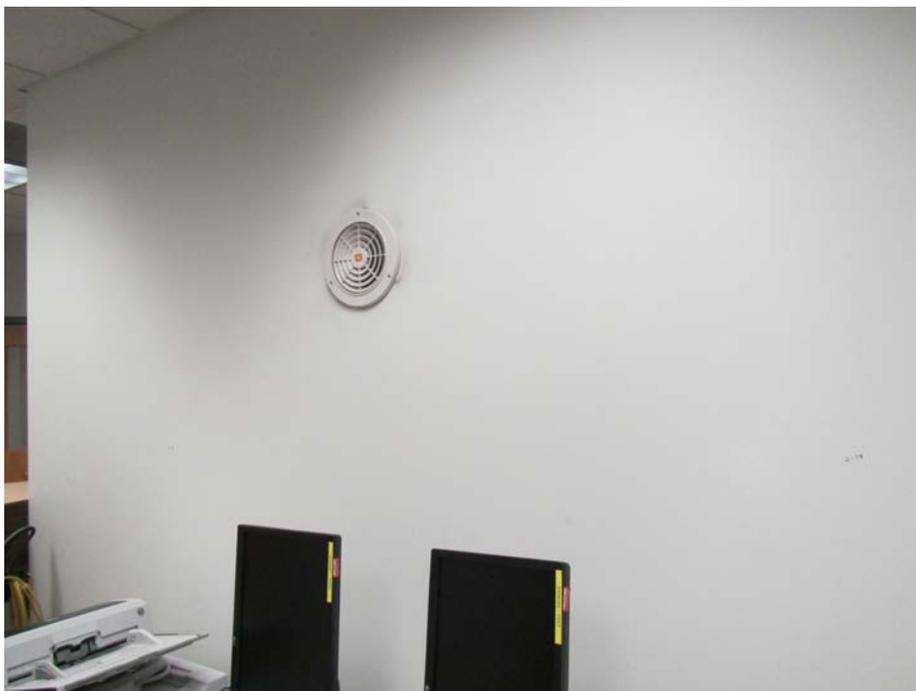
Picture 12

Exposure to low levels of total volatile organic compounds (TVOCs) may produce eye, nose, throat, and/or respiratory irritation in some sensitive individuals. To determine if VOCs were present, BEH/IAQ staff took measurements for TVOCs and examined rooms for products containing VOCs. TVOCs levels above background were detected in two areas, one near a hand sanitizer dispenser and one in the mailroom where printed materials are handled. Other sources of TVOCS such as dry erase markers, cleaning products and air freshening products were also present in the building (Picture 11; Table 1). All of these products have the potential to be irritants to the eyes, nose, throat, and respiratory system of sensitive individuals. It is especially important that there be good ventilation in areas where pollutants may be generated. The mailroom had a supplementary vent installed in the wall to a hallway to draw air from the room (Picture 12). This vent was not in use or inoperable at the time of the visit, however even if it is used, it will distribute odors and TVOCs from the mailroom into other occupied spaces.

Retrofitted wall fan for the mail room

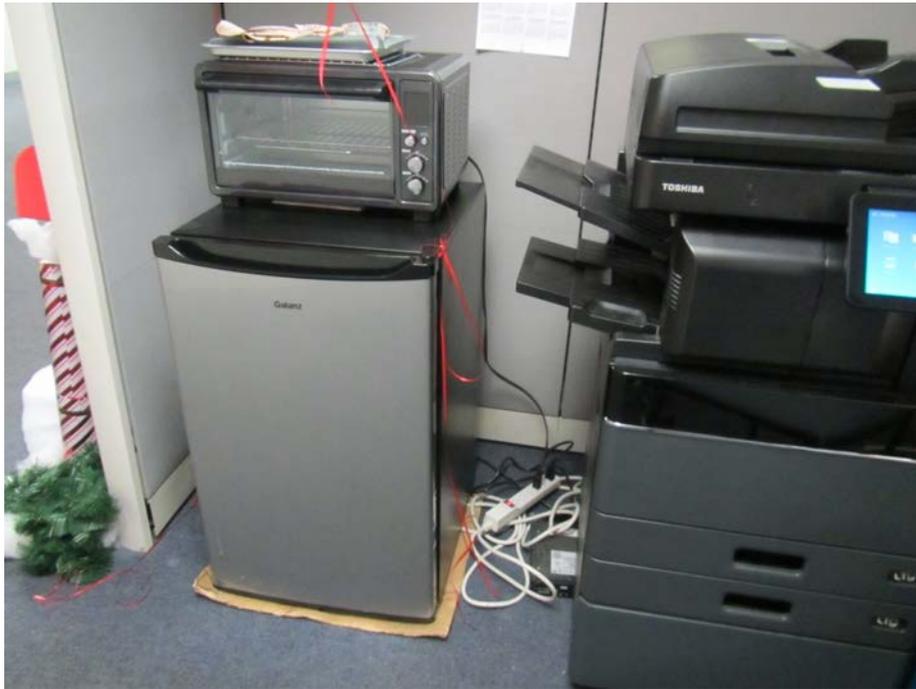
Picture 13

Cooking equipment, including toasters, microwave ovens, and coffee machines, were located in various parts of the office space (Picture 13). Food was even used in some of the seasonal decorations. Food areas and cooking equipment need to be kept clean to prevent odors and pests. Unsealed food should not be used as decorations.

Toaster and refrigerator

22. Ensure that all cooking equipment is kept clean. Ensure all food is enclosed in tight containers to prevent pests.
23. Reduce the amount of materials on surfaces to allow for more thorough cleaning.
