ODOR ASSESSMENT

**Hampden County Registry of Deeds
Hall of Justice
25 State Street
Springfield, MA**

Prepared by:
Massachusetts Department of Public Health
Bureau for Environmental Health
Indoor Air Quality Program
February 2012

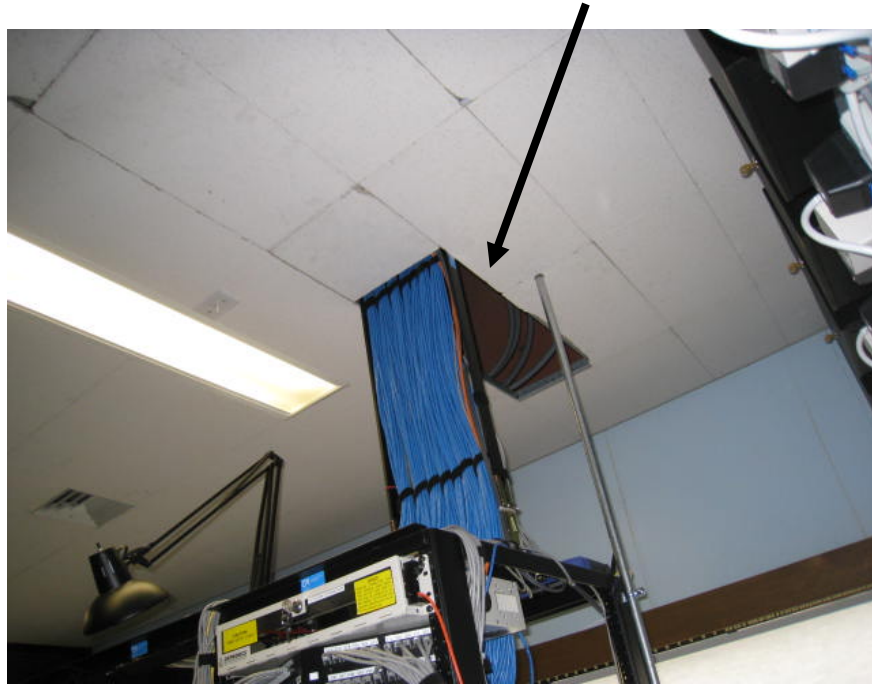
Picture 1

Because the HOJ does not use the ceiling plenum as part of the HVAC system, the ducting of the portable AC would pressurize the ceiling plenum, forcing waste heat and water vapor, and leaking RG if present, through spaces in the ceiling. Gaps in the ceiling tile system in Room 403C (Picture 1) and at the front desk near the main entrance to the ROD (Picture 2) would provide such pathways. In addition, pressurization of the ceiling plenum can force any dirt, dust and loose debris that accumulates above the ceiling tiles into occupied areas, providing sources of eye and respiratory irritation.

Space in Suspended Ceiling in Room 403C (arrow)

1. Discontinue the use of the portable AC unit unless it is vented directly outdoors.
2. ROD staff should consult with HOJ facilities staff on the most appropriate measures to provide additional supply and exhaust ventilation for the ROD offices and work areas.

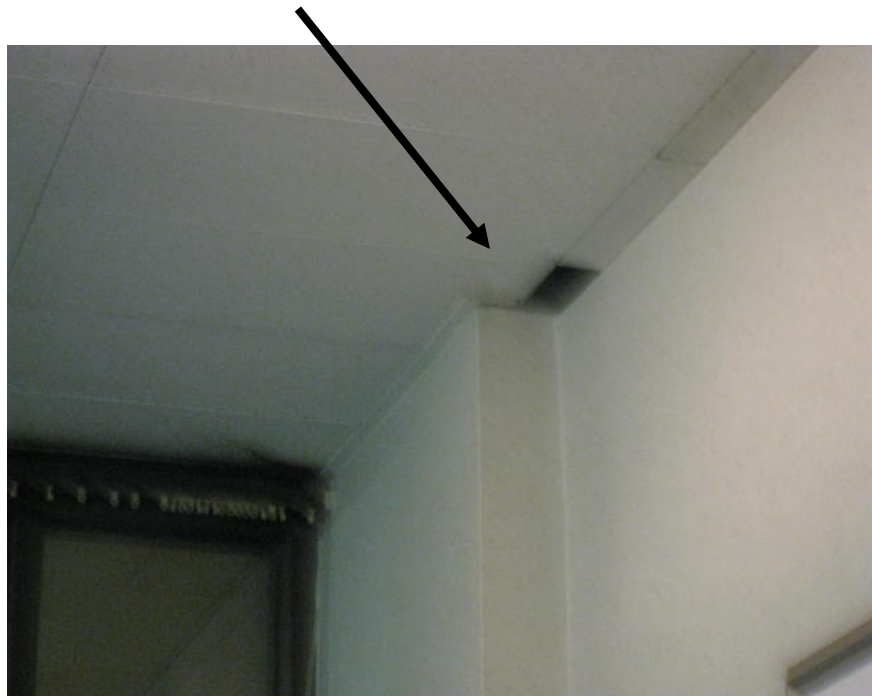
Picture 2

**Space in Suspended Ceiling near the Front Desk near
Main Entrance to the ROD (arrow)**
