INDOOR AIR QUALITY ASSESSMENT

**Waterford Street School
62 Waterford Street
Gardner, Massachusetts**

Prepared by:
Massachusetts Department of Public Health
Bureau of Environmental Health Assessment
November 2002

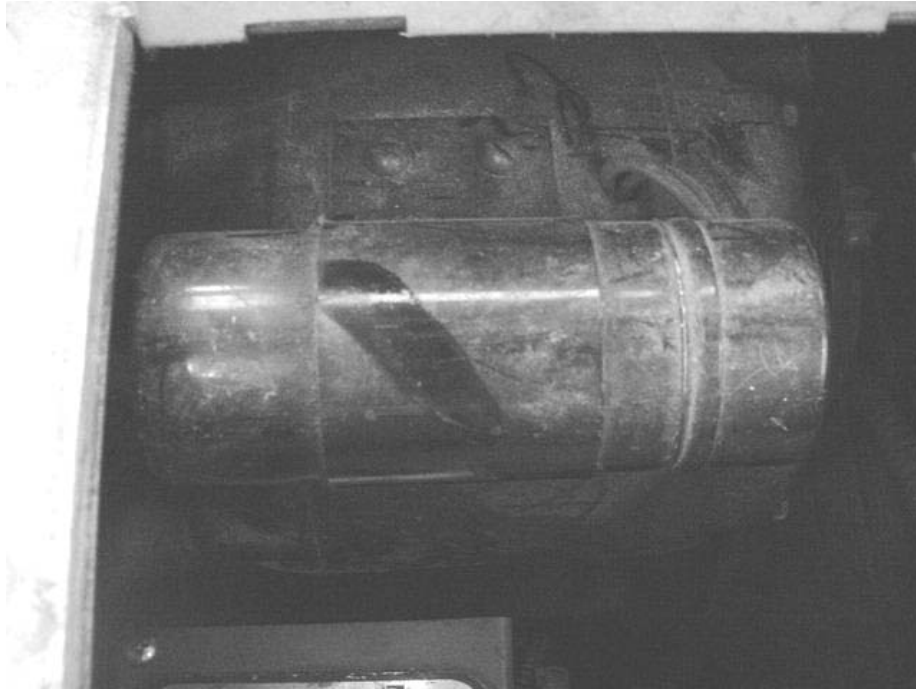
Picture 1

Fresh air in classrooms is supplied by a unit ventilator (univent) system. Univents draw air from outdoors through a fresh air intake located on the exterior walls of the building and return air through an air intake located at the base of each unit (see [Figure 2](#)). Fresh and return air are mixed, filtered, heated and provided to classrooms through a fresh air diffuser located in the top of the unit. Univents were operating during the assessment, however, BEHA staff recommended that univents be deactivated temporarily until filters were changed and univents could be cleaned of accumulated soot and dust (see Pictures 1 & 2).

Soot/Dust Accumulation on Motor inside Univent Cabinet

1. Ensure univent filters were changed and that the interior and exterior of univent cabinets were thoroughly cleaned. Activate univents continuous during periods of school occupation.

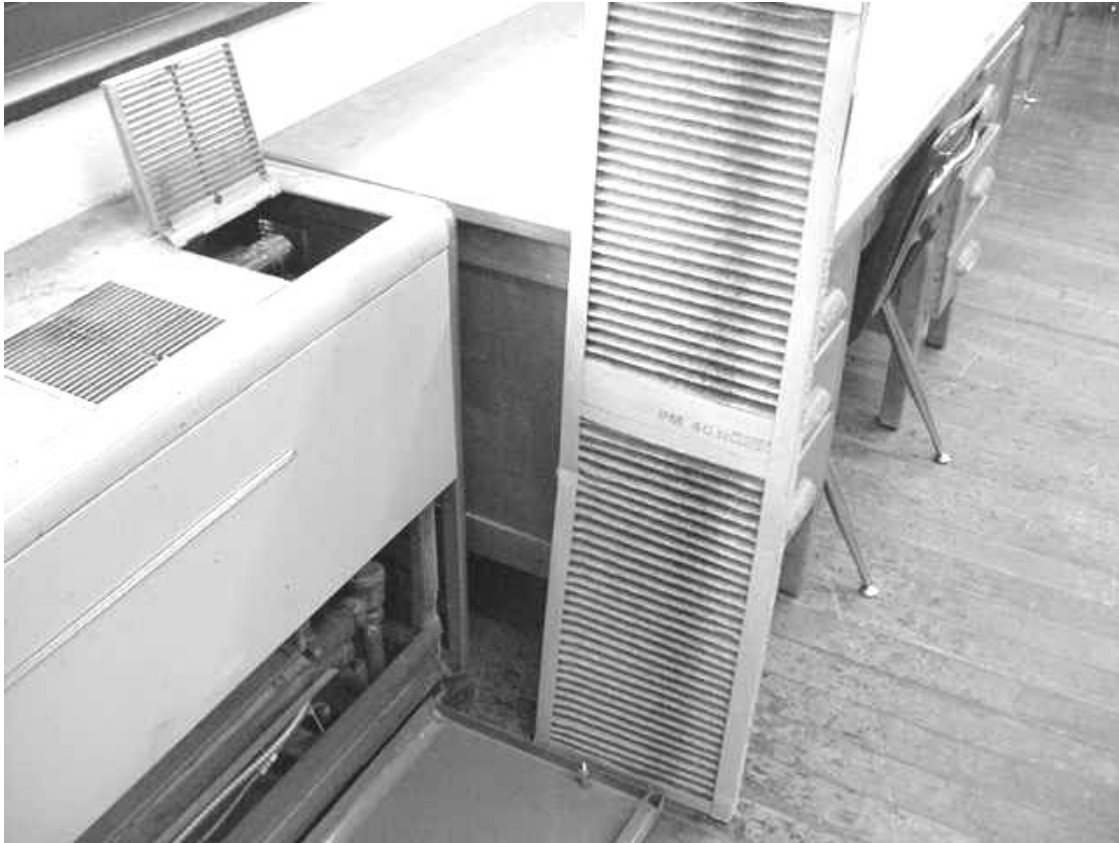
Picture 2

Soot Buildup on Univalent Filter as Indicated by Black Line across Filter Medium

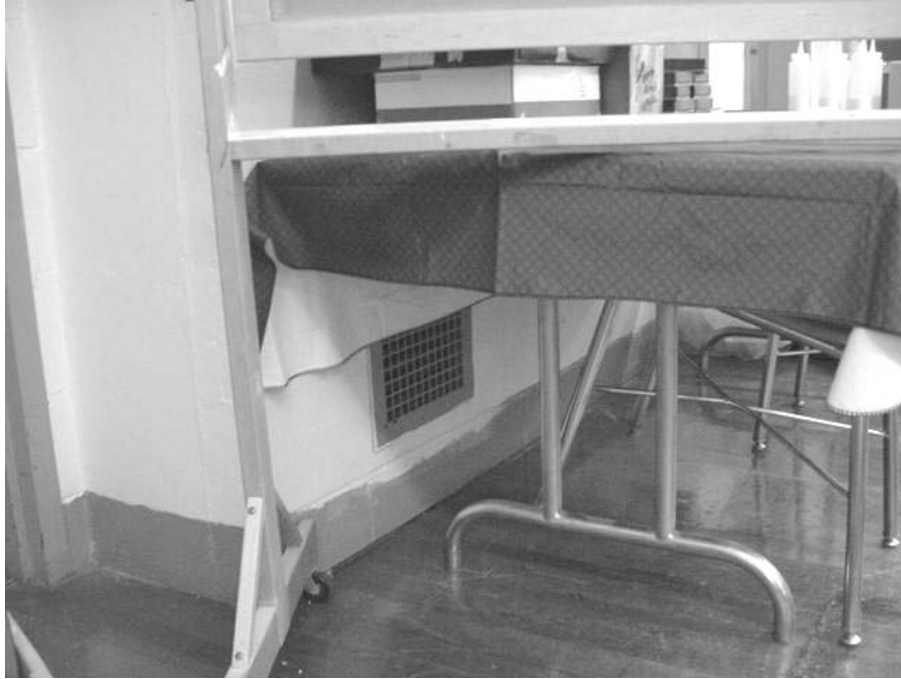
Exhaust ventilation in classrooms is provided by a mechanical system. The exhaust system in each classroom consists of grated wall vents (see Picture 3) connected via ductwork to rooftop motors. The art room exhaust vent in Picture 3 was partially obstructed by a table, which can restrict airflow. This system was operating during the assessment. BEHA staff recommended the opening of windows (while univents were temporarily deactivated) in combination with mechanical exhaust to ventilate classrooms of residual smoke odors.

Wall Mounted Exhaust Vent in Art Room, Note Vent is Partially Blocked by Table

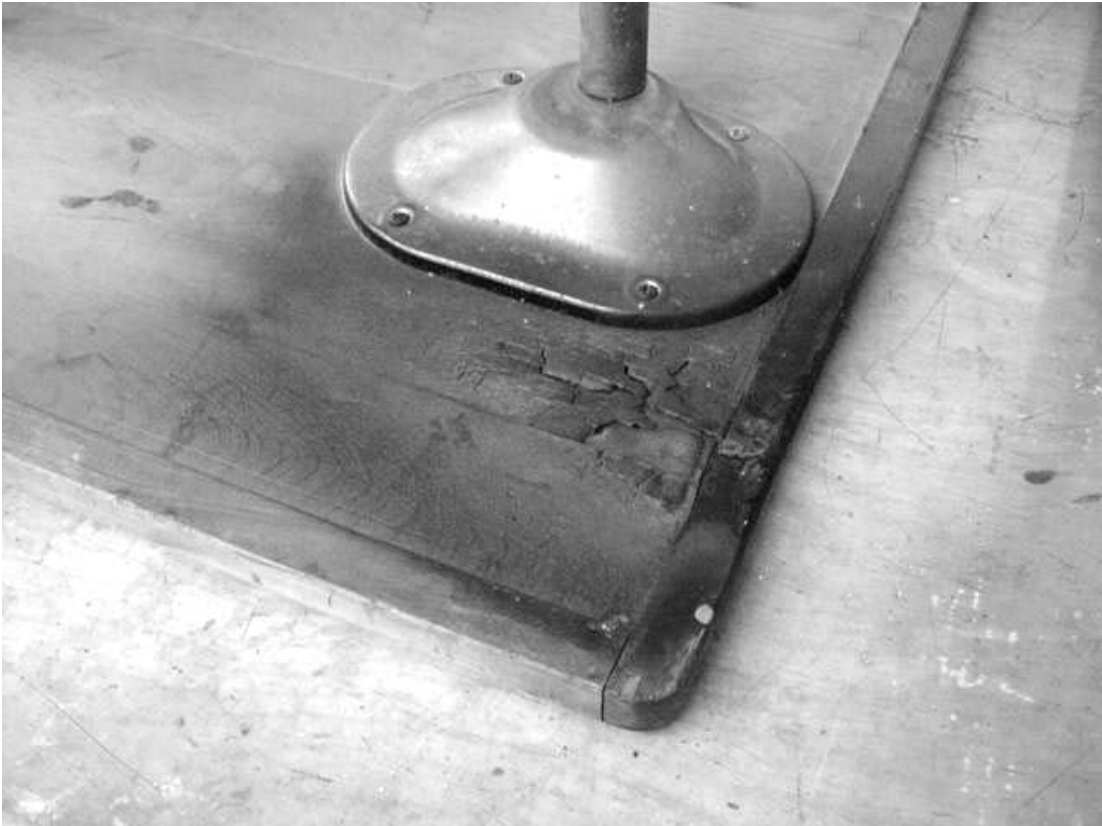
Picture 4

Residual smoke odors were most prevalent in the art room where the fire had taken place. The most obvious source of lingering odors was the presence of charred materials, which were still present in the room (see Pictures 4 & 5). In addition, numerous porous materials (paper, cloth, cardboard, etc.), which as mentioned can absorb odors, were stored throughout the area (see Pictures 6 & 7). BEHA staff and Mr. Sullivan recommended the removal of charred materials and porous items as soon as possible to eliminate the source of odors.

Charred Table In Art Room

2. Discard any charred and/or smoke damaged materials or if necessary seal in an airtight container. Plastic bags that can be made airtight can be used to seal materials (Zlotnik, C., 1996)
3. Ensure all flat classroom surfaces and the interior of lockers were cleaned and smoke contaminated clothing was removed.

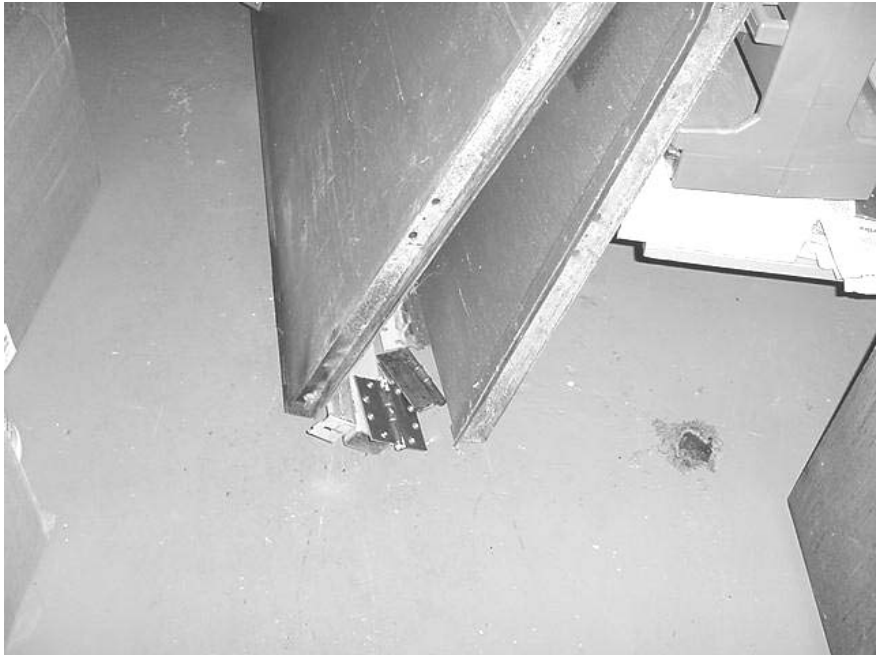
Picture 5

Charred Doors in Art Storeroom

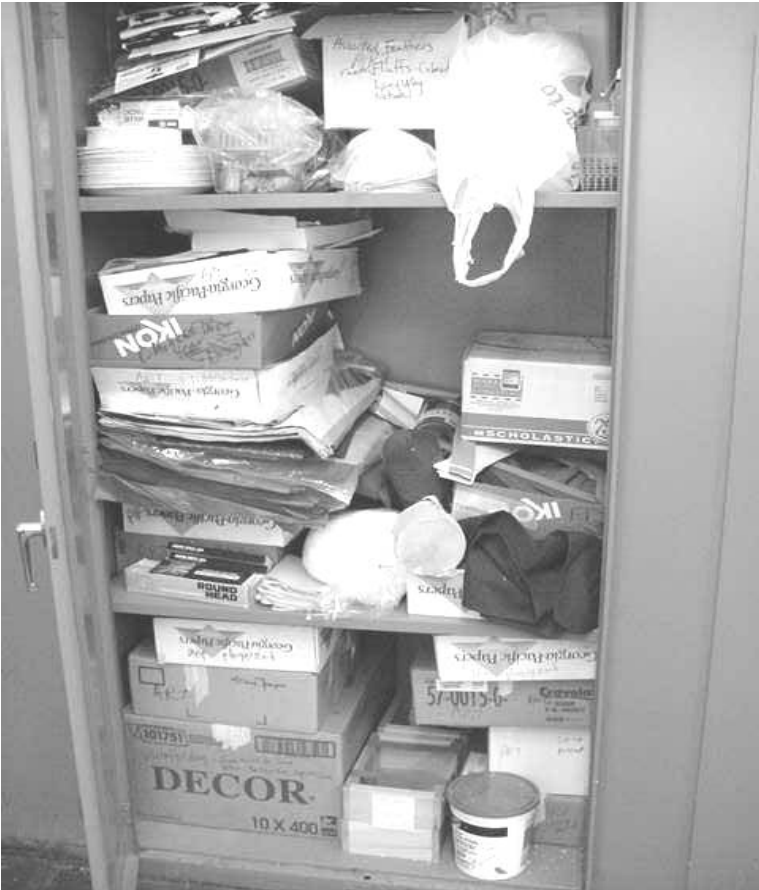
Picture 6

Porous Materials Stored in Art Room Cabinet

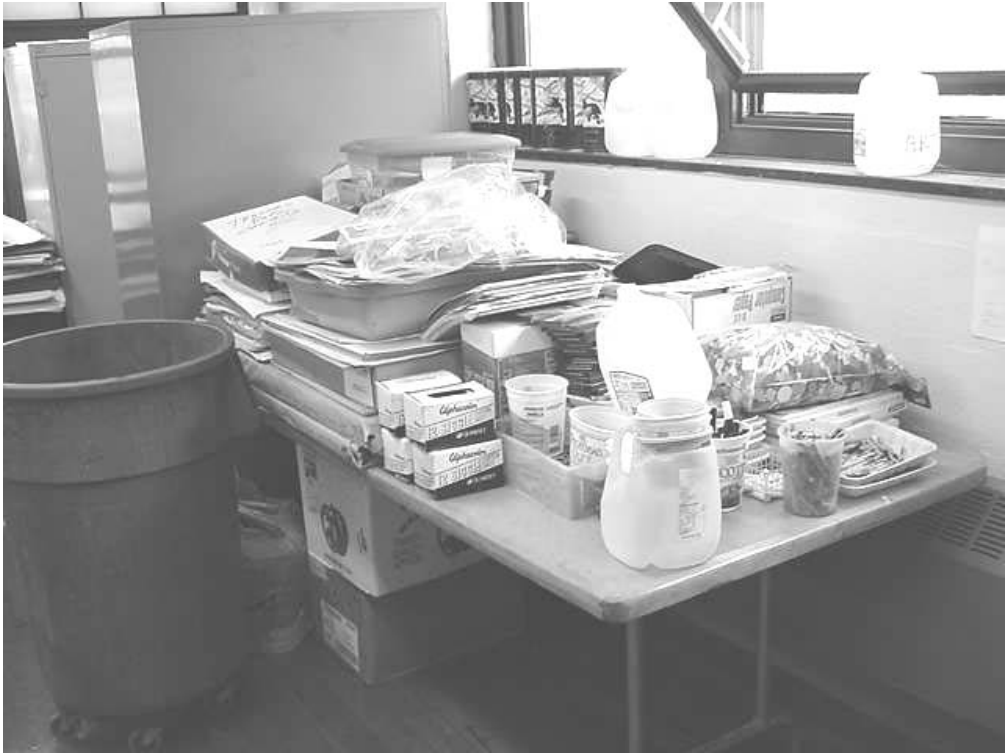
Picture 7

Porous Materials Stored in Art Room

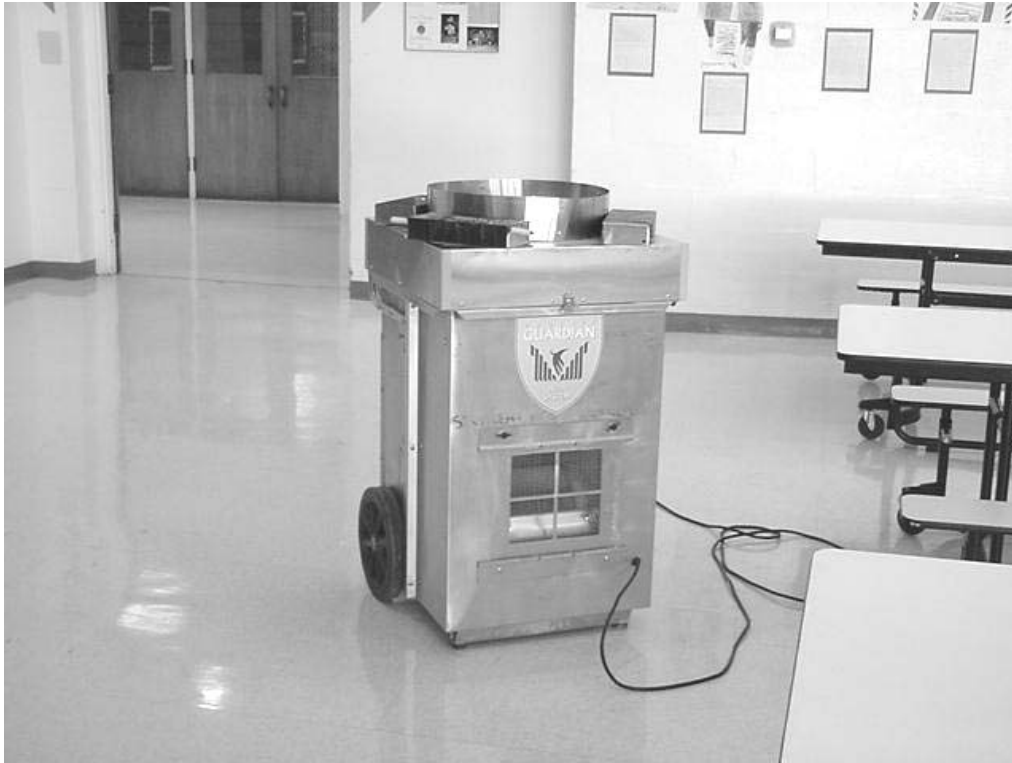
Picture 8

As discussed, high-powered ventilation fans equipped with high efficiency particulate arrestance (HEPA) filtration were placed throughout the building (see Picture 8) and a thorough cleaning of all classrooms was being conducted during the assessment. This involved wiping and vacuuming of all surfaces (ceiling tiles, walls, etc.) using HEPA filtered vacuum cleaners. Accumulation of soot and particulate deposition on art room surfaces was observed, notably on univent filters, interior components and on areas around the unit ventilator (see Pictures 1 & 2). Unless the interior and exterior of the univent is thoroughly cleaned, residual odors can continue to be emitted from the univent. In addition constant airflow from the univent can reaerosolize soot and particulates, which can be sources of on-going irritation to the eyes, nose and respiratory tract.

Exhaust Fan Equipped With HEPA Filtration
