INDOOR AIR QUALITY ASSESSMENT

**Bridgewater Raynham Regional High School
415 Center Street
Bridgewater, Massachusetts**

Prepared by:
Massachusetts Department of Public Health
Bureau of Environmental Health
Indoor Air Quality Program
April 2017

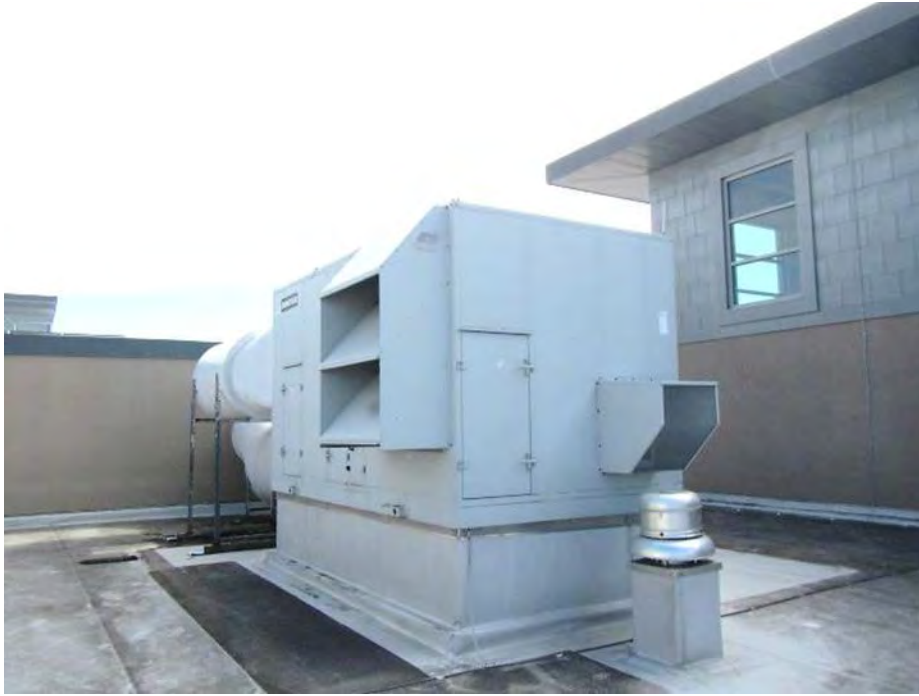
Picture 1

Mechanical ventilation is provided by rooftop air-handling units (AHUs; Pictures 1 and 2). Outside air is drawn through a bank of pleated filters (Picture 3), heated or cooled, and delivered to occupied areas via ducted supply diffusers (Picture 4). The filters in use at the BRRHS appear to have a Minimum Efficiency Reporting Value (MERV) rating of 8, which are reportedly changed quarterly and are adequate in filtering out pollen and mold spores (ASHRAE, 2012). Return air is drawn through ceiling grates (Picture 5) and returned back to the AHUs.

Rooftop air handling unit (AHU)

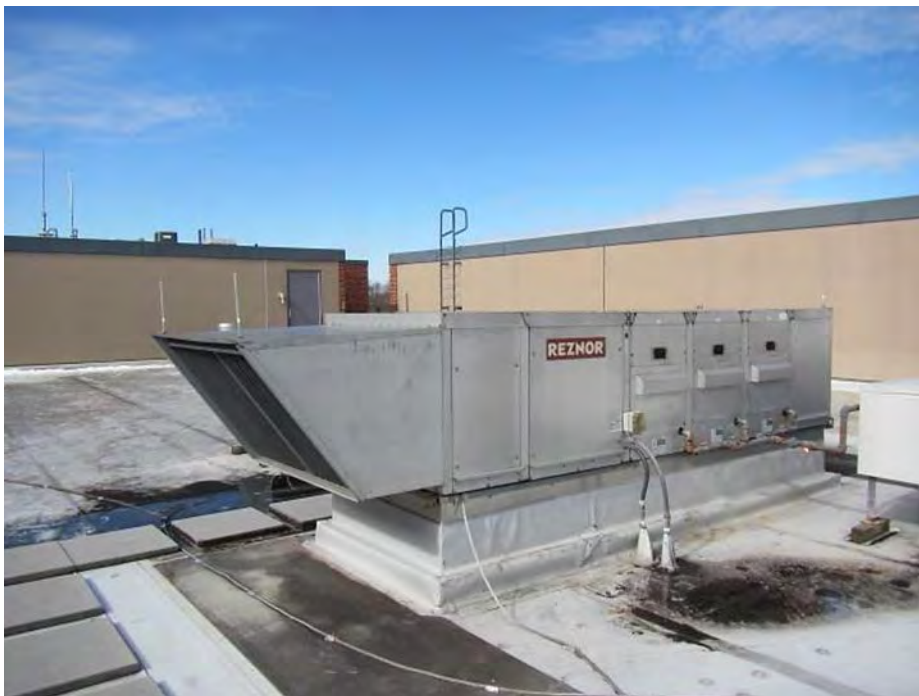
Picture 2

Rooftop AHU

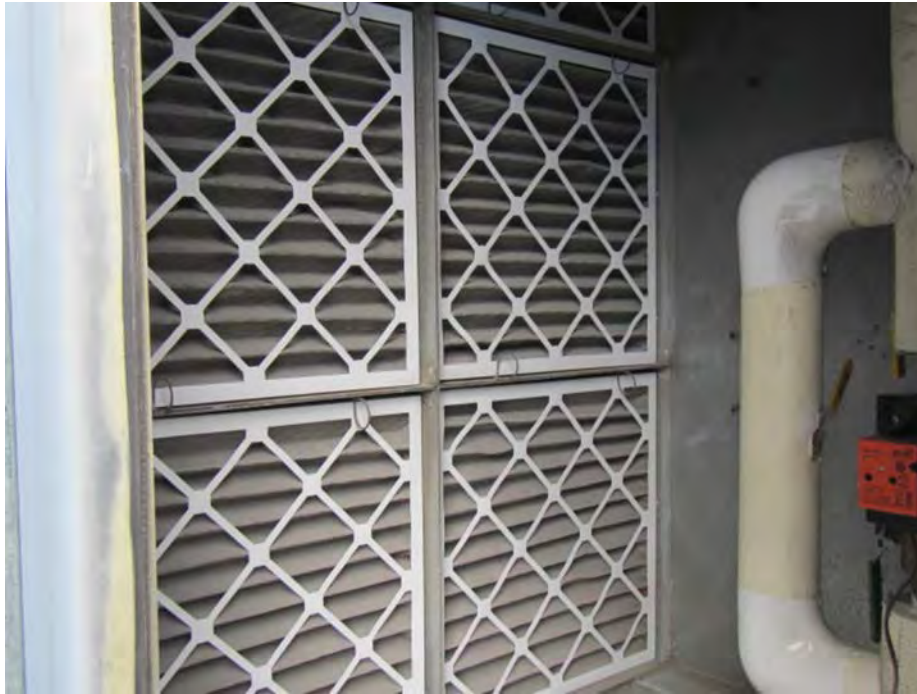
Picture 3

Bank of pleated air filters in AHU

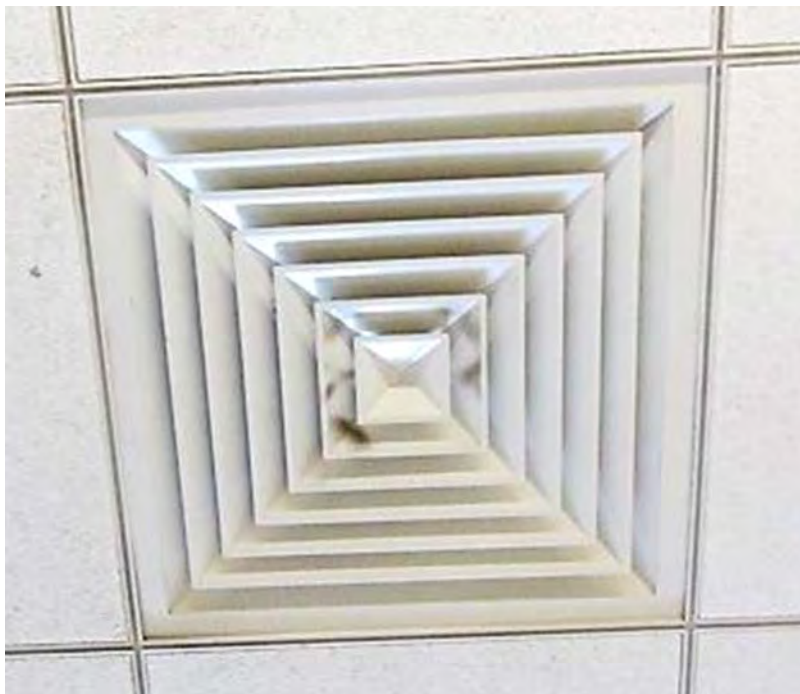
Picture 4

Some personal fans, supply, and exhaust vents were observed to have accumulated dust/debris (Table 1, Pictures 4, 5, and 16). Particulates can be reaerosolized from these items and they should be cleaned regularly. Dust accumulation was also observed on flat surfaces in some areas (Picture 10).

Supply air diffuser, note dust/debris accumulation on louvers

18. Clean personal fans, supply, and return vents periodically of accumulated dust, perhaps quarterly after filter changes.
19. Relocate or consider reducing the amount of stored materials to allow for more thorough cleaning. Clean items regularly with a wet cloth or sponge to prevent excessive dust build-up.

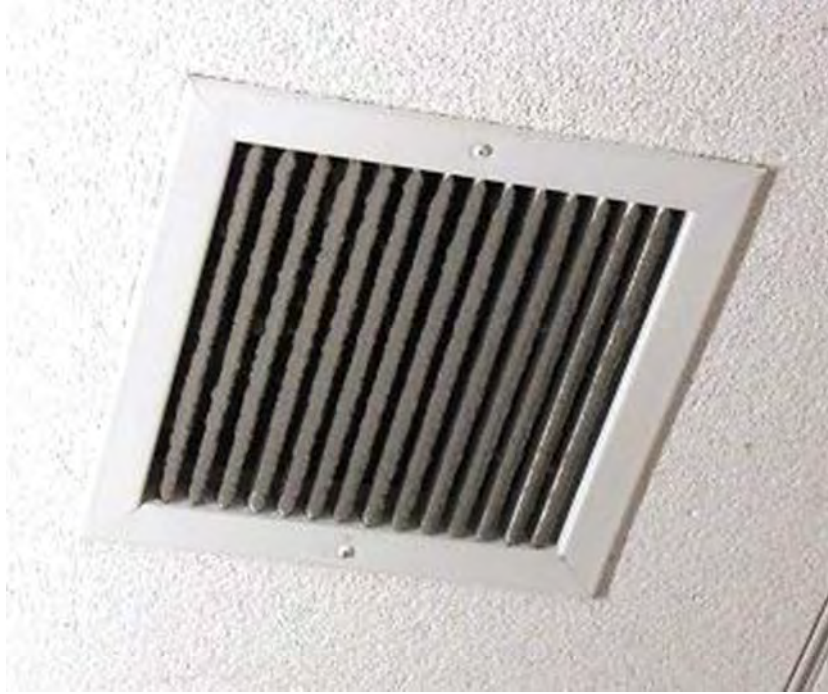
Picture 5

Return grill, note dust/debris accumulation on louvers

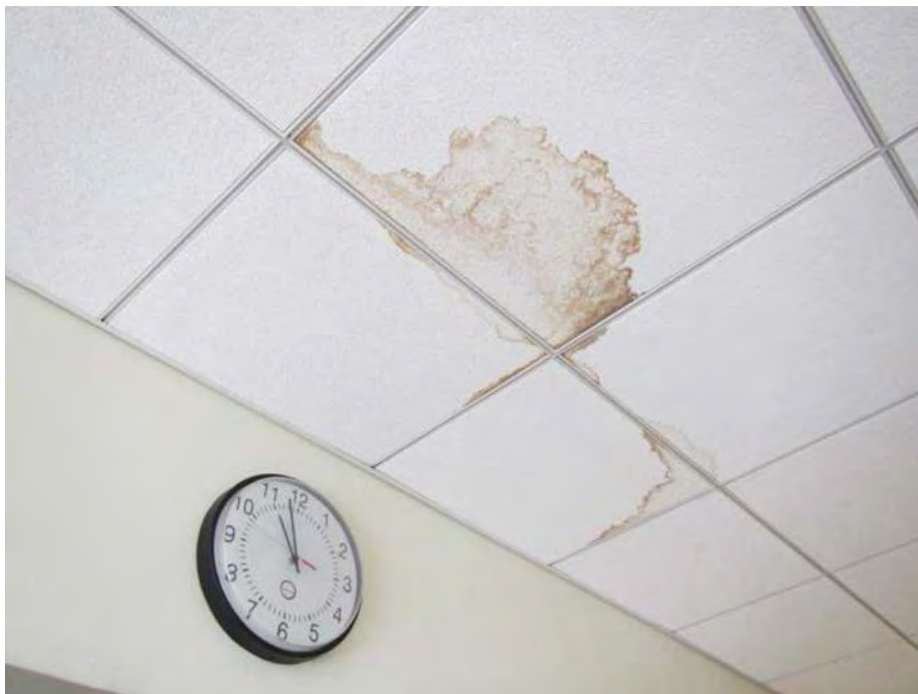
Picture 6

In order for building materials to support mold growth, a source of water is necessary. A number of areas had water-damaged ceiling tiles (Picture 6, Table 1), which can indicate current or historic roof/plumbing leaks. After the source of the leak above the ceiling tiles is repaired, water-damaged ceiling tiles should be removed and replaced. Other conditions that may result in water damage or infiltration, or conditions that can lead odors or microbial growth include:

Water-damaged ceiling tiles

4. Ensure any building envelope or plumbing leaks are repaired, and replace water-damaged ceiling tiles.
5. Repair broken window in room F304.
6. Make repairs to window gaskets (D206) and ensure window caulking is intact along exterior.

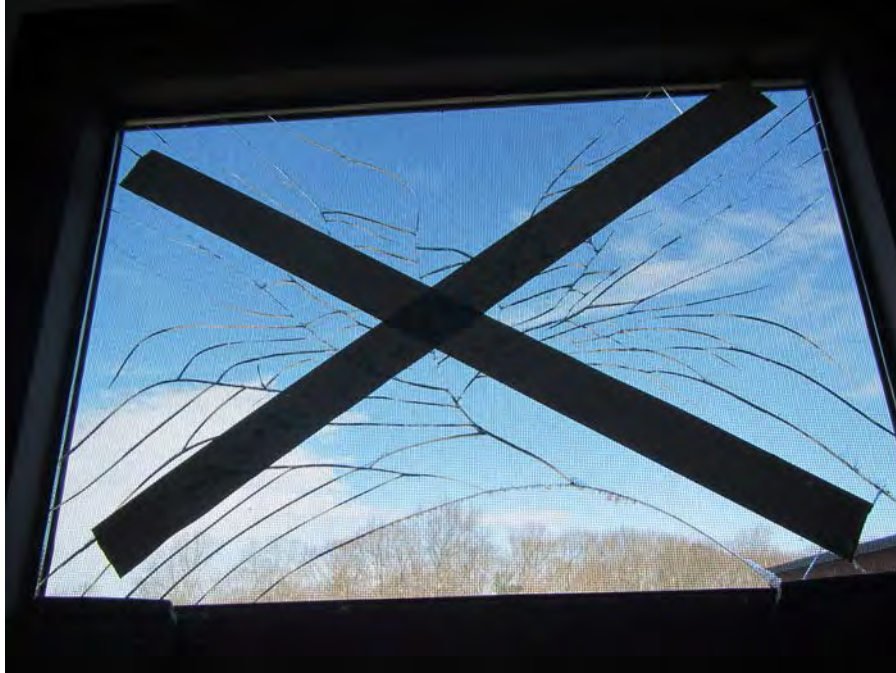
Picture 7

- Broken window in room F304 (Picture 7);

Broken classroom window

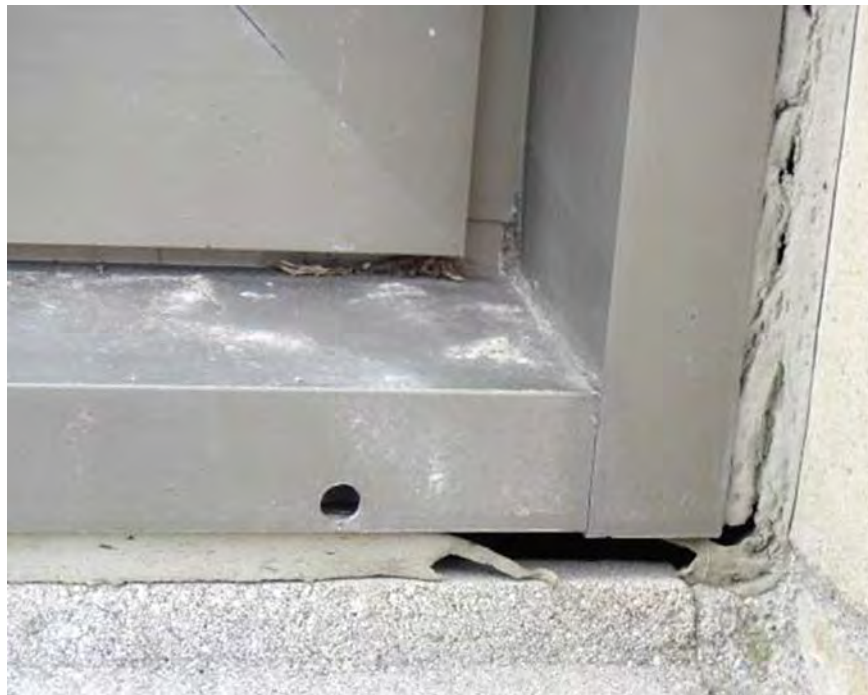
Picture 8

- Failing window gasket in room D208 and failing window caulking around the exterior of the building (Picture 8);
- Plant growth against the foundation along the exterior (Picture 9);
- Missing/damaged caulking between the sink countertop and backsplash in Room D208 (Picture 10);
- Aquariums and terrariums in several rooms. These items should be properly maintained to prevent bacteria/microbial growth; and
- Water cooler on the carpet in Room A150 (Picture 11).

Failing caulking around exterior window

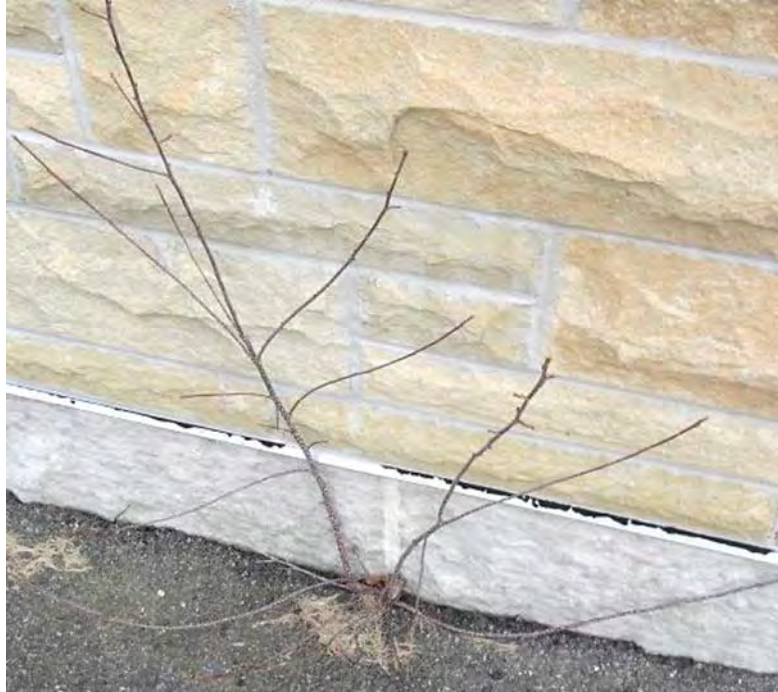
Picture 9

Plant growth against the building foundation

7. Remove plant growth from directly against foundation to prevent damage.
8. Seal sink countertop/backsplash with caulking in Room 208.
9. Consider placing water dispensers on non-carpeted areas or place a waterproof mat underneath them.

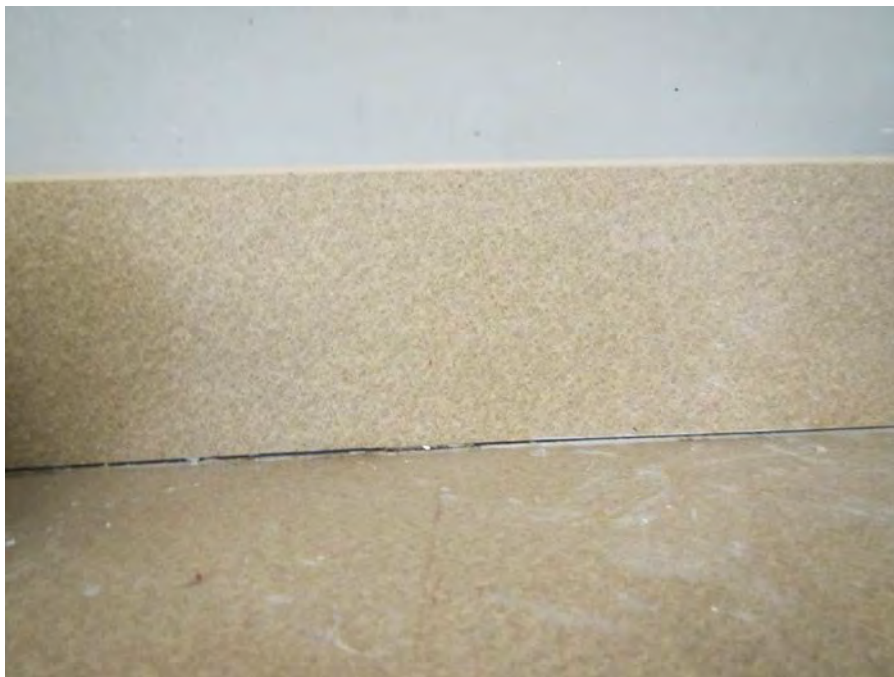
Picture 10

Breach between sink countertop and backsplash

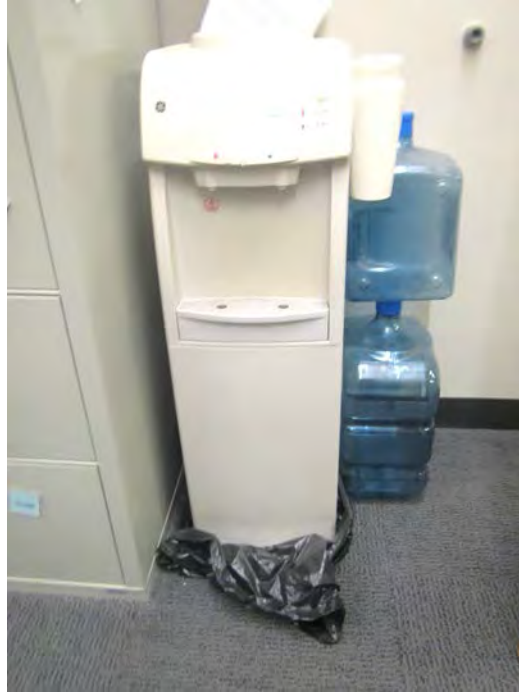
Picture 11

Water cooler on carpet

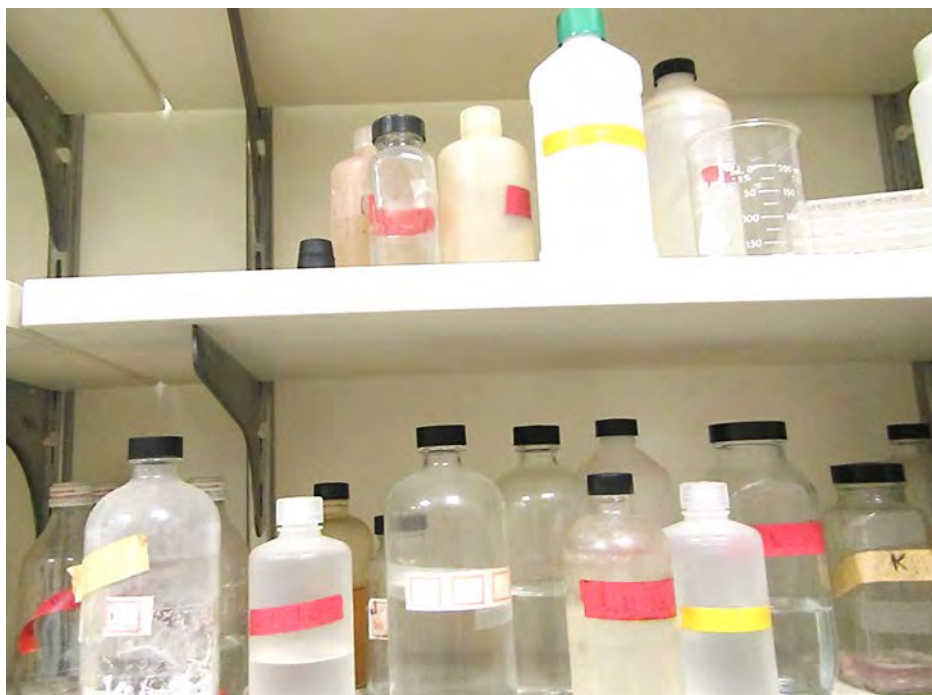
Picture 13

Of particular note were conditions found in the chemical prep rooms/science areas (Picture 13 to 15). It was determined that a calibration program does not exist for the chemical

lab hoods. Proper function of this equipment is essential for health and safety. Some chemical containers were found labeled with chemical formula rather than chemical name, and some materials were old/outdated/crystalized. Additionally, items were being stored in chemical lab hoods. Unused items should be properly discarded or returned to their proper storage cabinets.

Bottles labeled with chemical formula only, note some labels are peeling

15. Conduct a building-wide chemical audit to ensure proper storage, and initiate removal of old/outdated materials. Refer to the following resources on storage and cleanout:

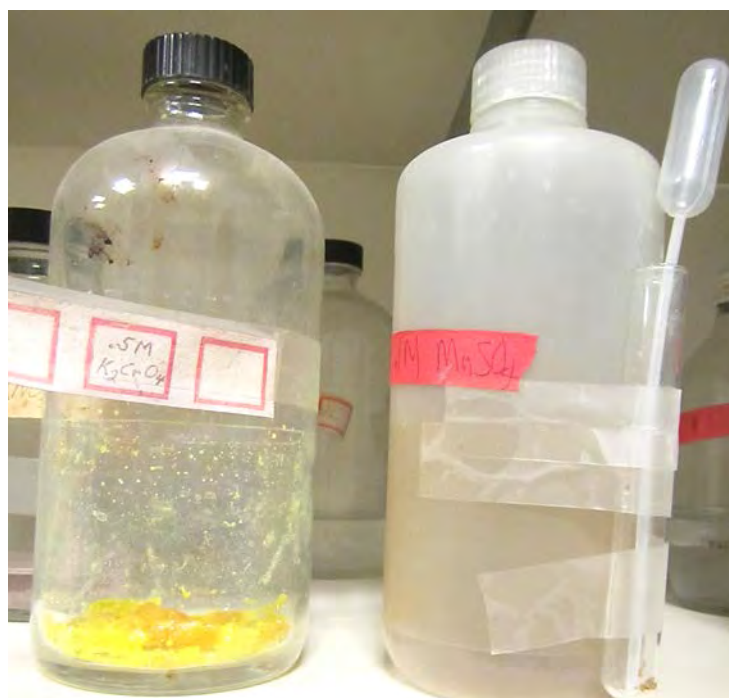
Picture 14

Chemical crystallization due to evaporation

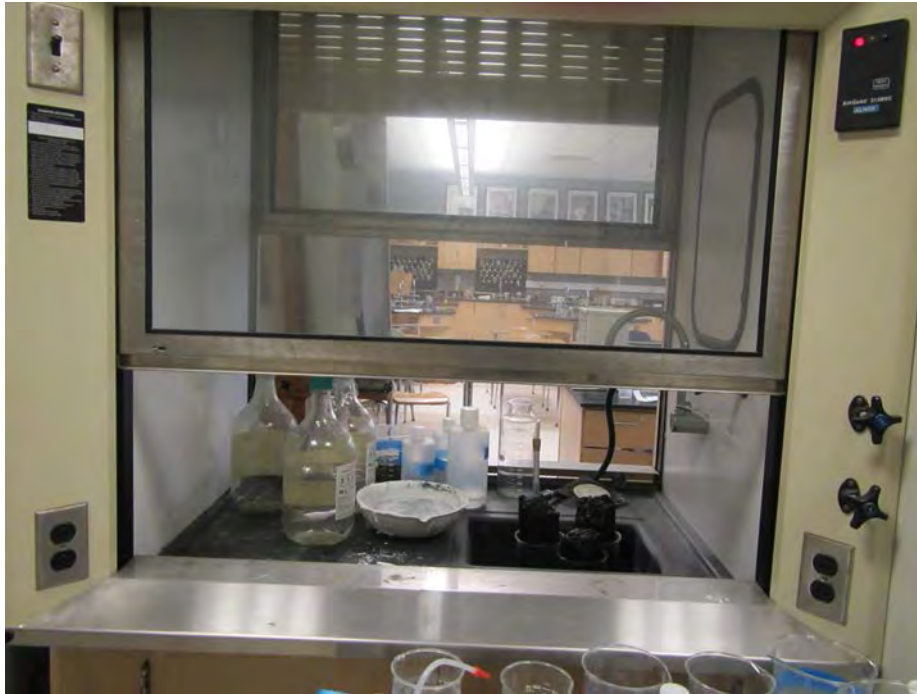
Picture 15

Items stored in chemical hood

16. Institute an annual calibration program for all chemical lab hoods to ensure proper function.
17. Do not store materials in lab hoods. Return materials to stock/proper storage cabinets upon completion of experiments.

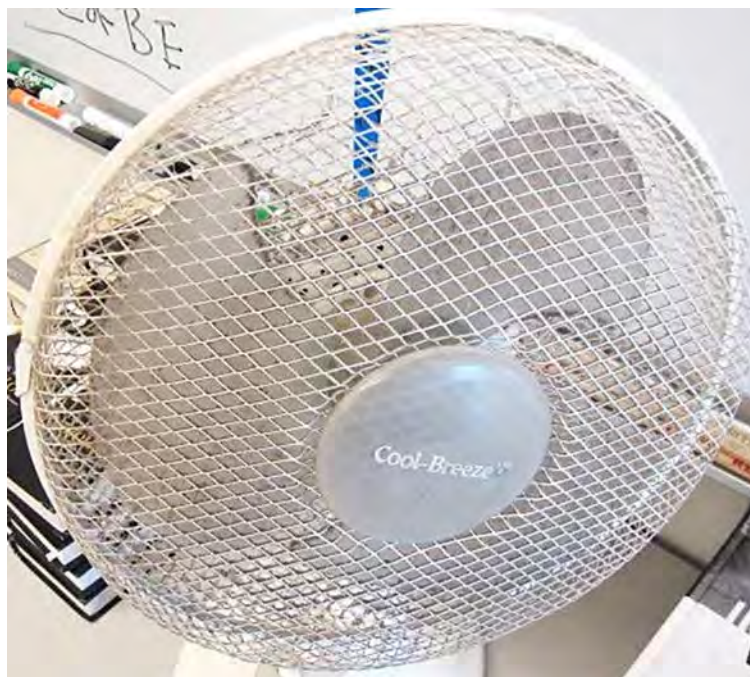
Picture 16

Accumulated dust/debris on fan blades in classroom

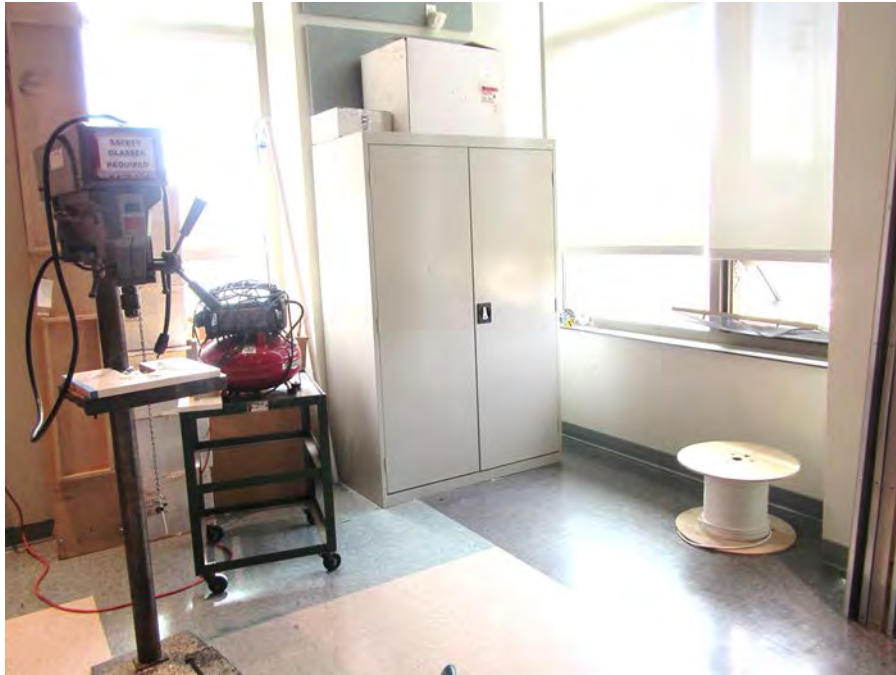
Picture 17

Room F114 is used as an industrial shop class (Picture 17). However, the room was not designed for these activities. As a result, no dedicated exhausts for woodworking and soldering are available. These activities produce airborne dust, fume, and particulates and require dedicated exhaust equipment to prevent respiratory irritation.

Woodworking equipment lacking dedicated wood dust collection system

13. Consult with teacher and an HVAC specialist on obtaining proper exhaust equipment for woodworking and soldering in room F114.
14. Remove non-working kiln in room D207 and relocate the working kiln directly below the exhaust.

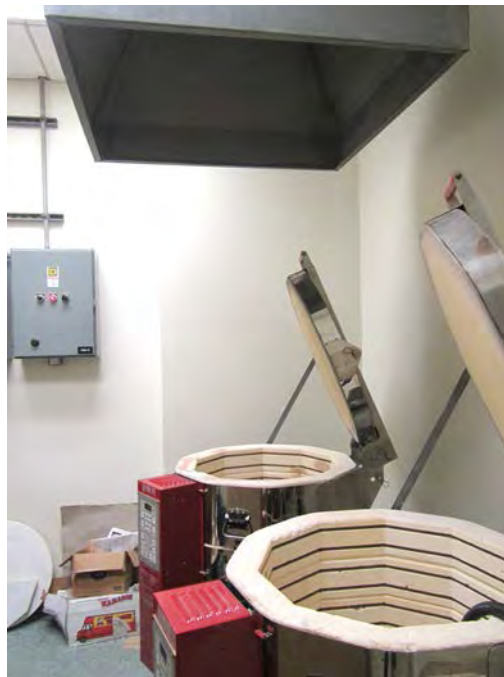
Picture 18

Finally, the kiln room, D207 contains two kilns that share a single dedicated exhaust hood (Picture 18). At the time, one kiln was not working. Each kiln should have its own dedicated exhaust to ensure vapors and dusts are adequately removed during the firing process. Any dust/debris that escapes the kiln should be cleaned.

Kiln vent shared between two kilns
