# INDOOR AIR QUALITY ASSESSMENT

**EOHHS Service Center  
300 Howard Street  
2<sup>nd</sup> Floor Department of Children and Families  
Framingham, Massachusetts**

Prepared by:  
Massachusetts Department of Public Health  
Bureau of Environmental Health  
Indoor Air Quality Program  
February 2016

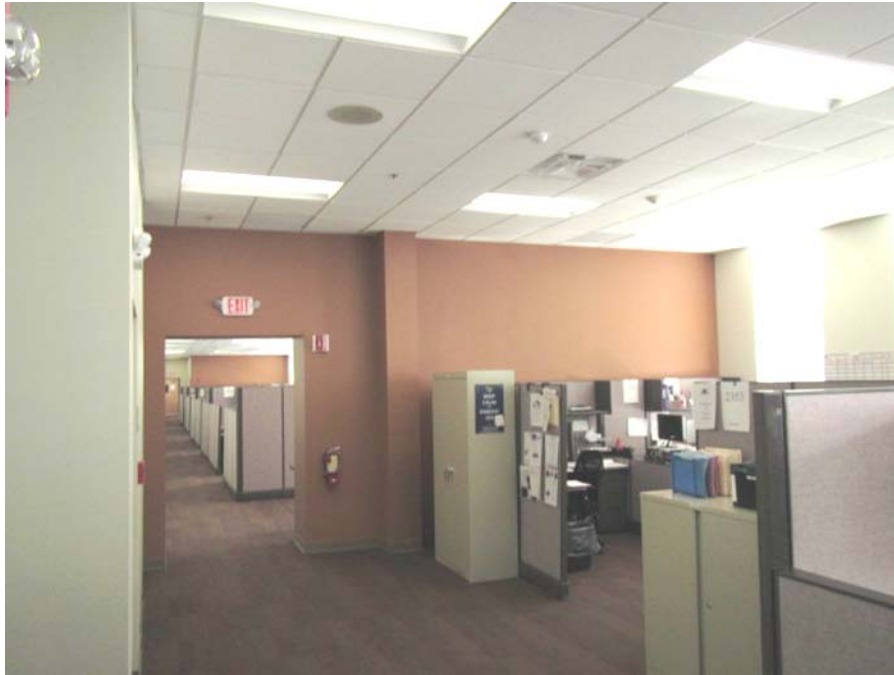
**Picture 1**

The office space consists of large open work area “sections” configured in a linear fashion. The odors were reported to be isolated to the middle office area section known as section 4 (Picture 1). Slight odors were detected upon crossing the threshold walking westerly from section 3 into section 4. The natural gas-like odors dissipated/were not detected upon entry crossing from section 4 into section 5.

**DCF Section 4 where odors were reported/detected**

1. If possible, relocate symptomatic staff in the affected area to a different location until the problem has been resolved.
2. Ensure the HVAC system for section 4 is thoroughly examined, cleaned, and repaired by a person or group of people with expertise in both plumbing and HVAC systems. Start with the unit on the roof:

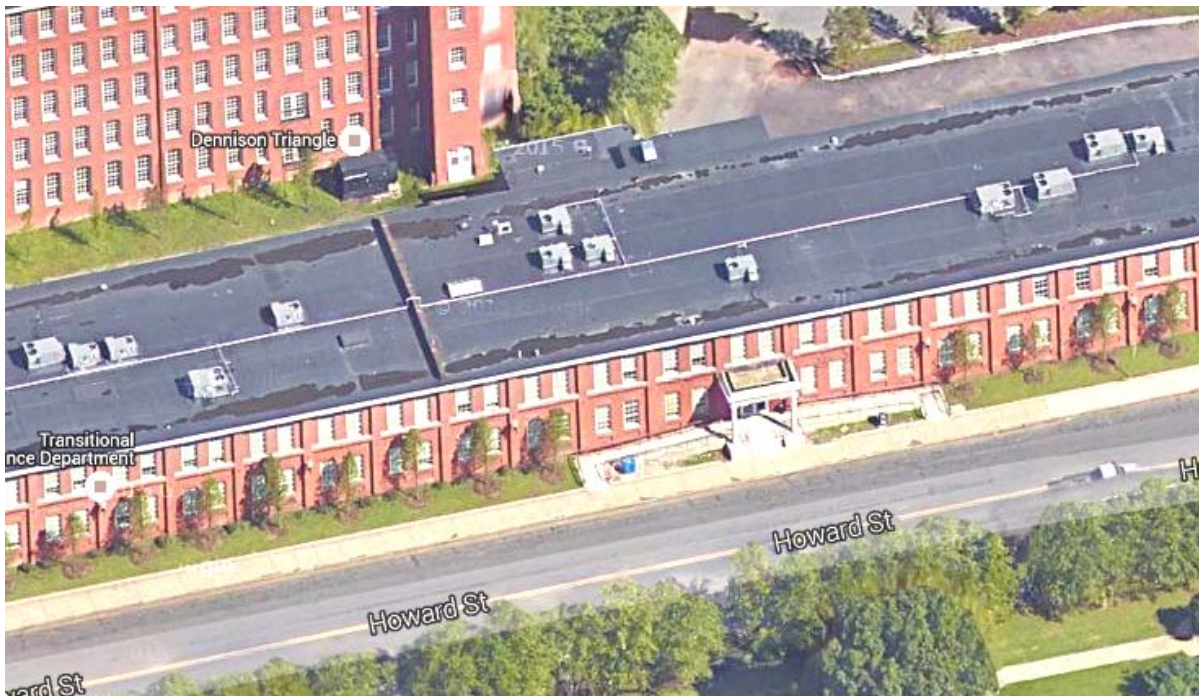
**Picture 2**

The heating, ventilation, and air conditioning (HVAC) system consists of rooftop air-handling units (AHUs, Picture 2). Conditioned outside air is drawn in through intakes at roof level and distributed to occupied areas via ducted ceiling vents (Picture 3) and is returned to the AHUs by ducted ceiling- or wall-mounted return vents (Picture 2).

**Rooftop air handling units**

- a. Fully examine to ensure there are no fuel leaks;
  - b. Ensure combustion and related activities are well controlled and occurring in accordance with system requirements;

- c. Examine all filtration to ensure it is installed and seated properly and of a suitable type; and
  - d. Ensure no breaches in the AHU system which may lead to odors.

3. Examine the rooftop area around the unit for sources of odors including leaking gas pipes, exhaust vents, and improperly stored materials.
4. Continue the examination with all associated ductwork as it enters the building. Use ladders or lifts inside section 4 to examine the fresh air distribution, return and exhaust system in its entirety, looking for cross connections, improperly set dampers, and breaches that may draw in odors from other areas.

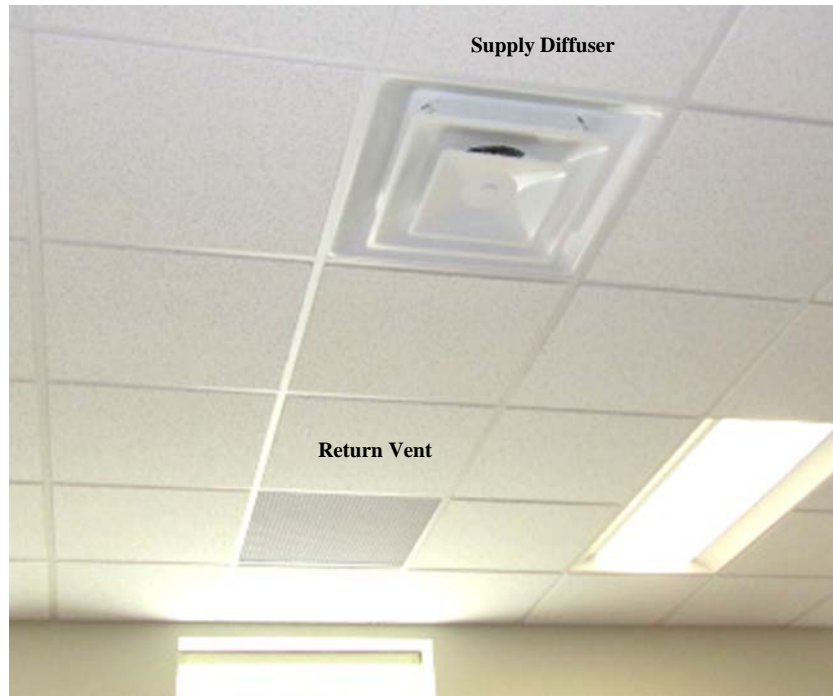
**Picture 3**

**Typical ceiling-mounted supply and return vents**
