INDOOR AIR QUALITY REASSESSMENT

**Wilbraham Middle School
Hampden-Wilbraham School District
Stony Hill Road
Wilbraham, Massachusetts**

Prepared by:
Massachusetts Department of Public Health
Bureau of Environmental Health Assessment
March, 2000

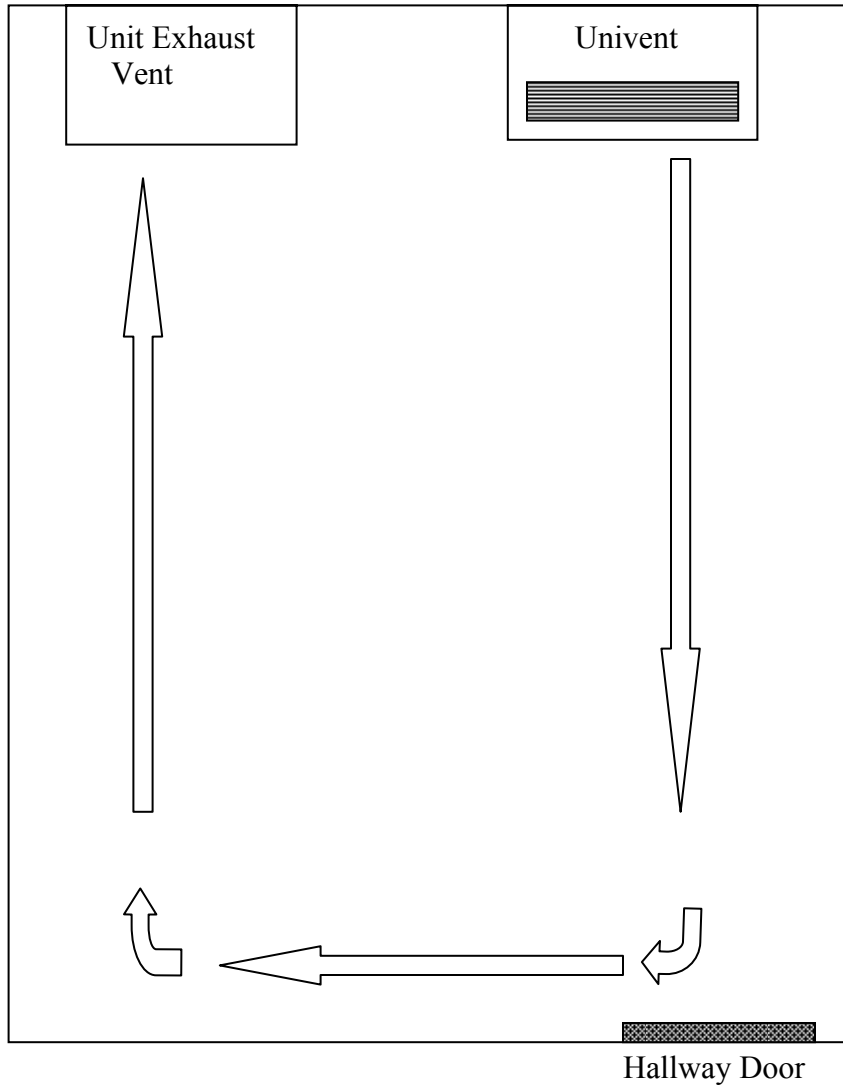
Figure 2

Of note is the configuration of the univents to the unit exhaust ventilators in classrooms. Both the univent and unit exhaust ventilator are located in the exterior wall in opposite corners (see Figure 2). This design requires the univent to propel air from the window towards the classroom hallway wall. The unit exhaust ventilator draws exhaust air. Both the univent and unit exhaust ventilator must propel/draw air with sufficient velocity to create airflow in parts of the classroom furthest from these vents. If impeded by obstructions, the ability of the HVAC system to create airflow throughout the classroom can be impeded (see Figure 3). In addition to increasing the airflow of this equipment, obstructions to airflow within the classroom should be minimized.

Design of Airflow in Classroom

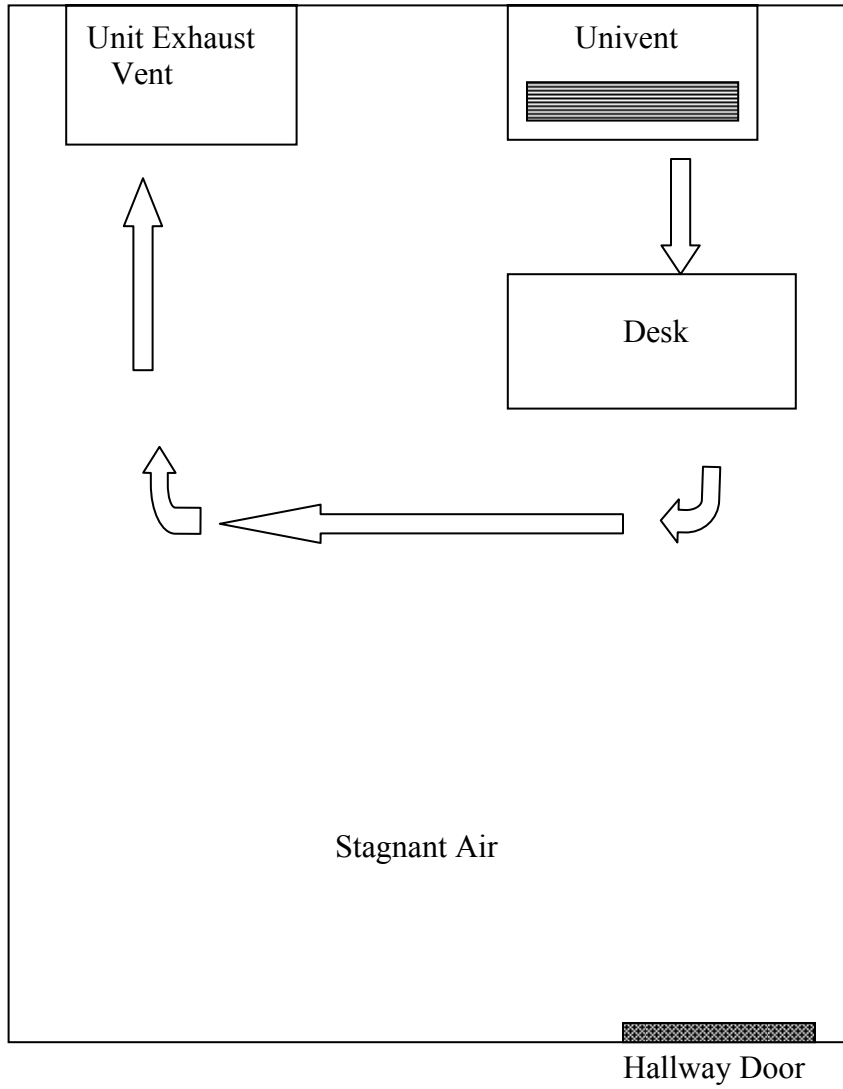
Figure 3

Design of Airflow in Classroom
