INDOOR AIR QUALITY ASSESSMENT

**William E. Welch, Sr. Elementary School
3 Swampscott Avenue
Peabody, Massachusetts**

Prepared by:
Massachusetts Department of Public Health
Bureau of Environmental Health Assessment
July, 2000

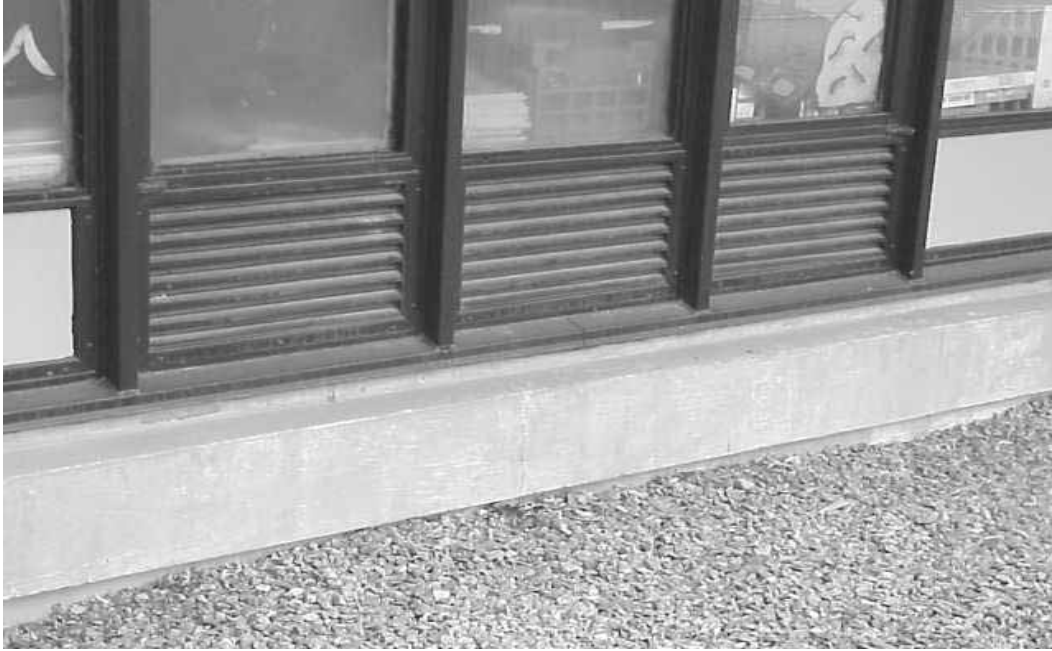
Picture 2

Fresh air in classrooms is supplied by a unit ventilator (univent) system (see Picture 1). Univents draw air from outdoors through a fresh air intake located on the roof or exterior walls of the building (see Pictures 2 & 3) and return air through an air intake located at the base of each unit (see [Figure 1](#)). Fresh air and return air are mixed, filtered, heated and provided to classrooms through a fresh air diffuser located in the top of the unit. Univents were deactivated in the majority of classrooms surveyed. BEHA staff activated several of these units to observe function using univent power switches (see Tables).

Univent Fresh Air Intakes on Exterior of Building

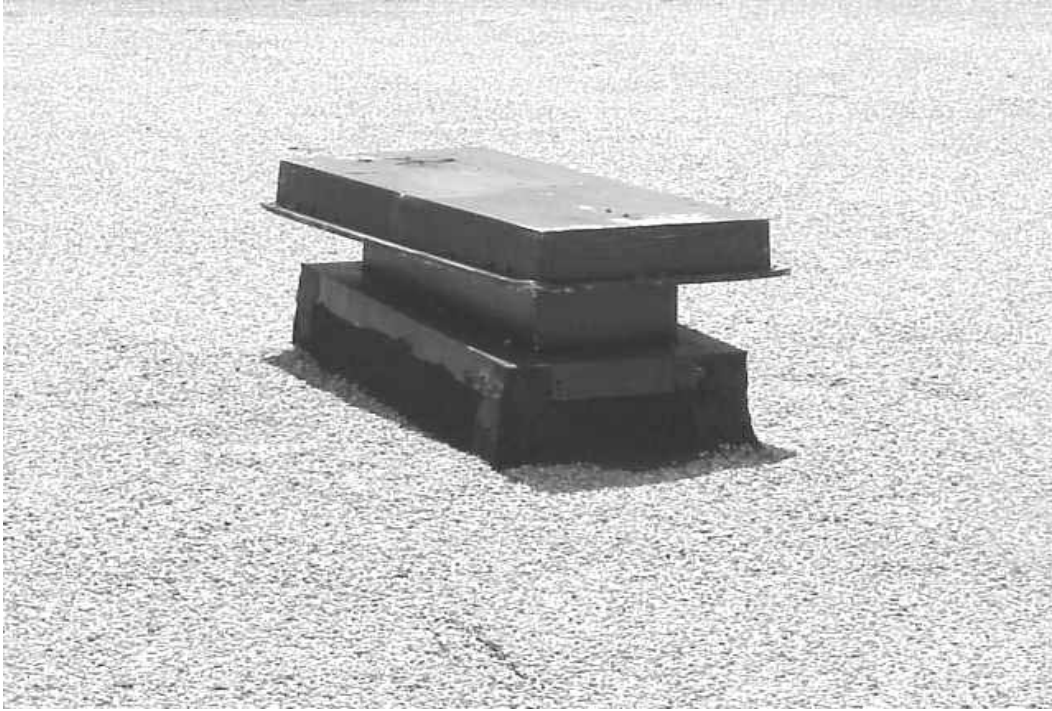
Picture 3

Rooftop Univent Fresh Air Intake for Interior Classrooms

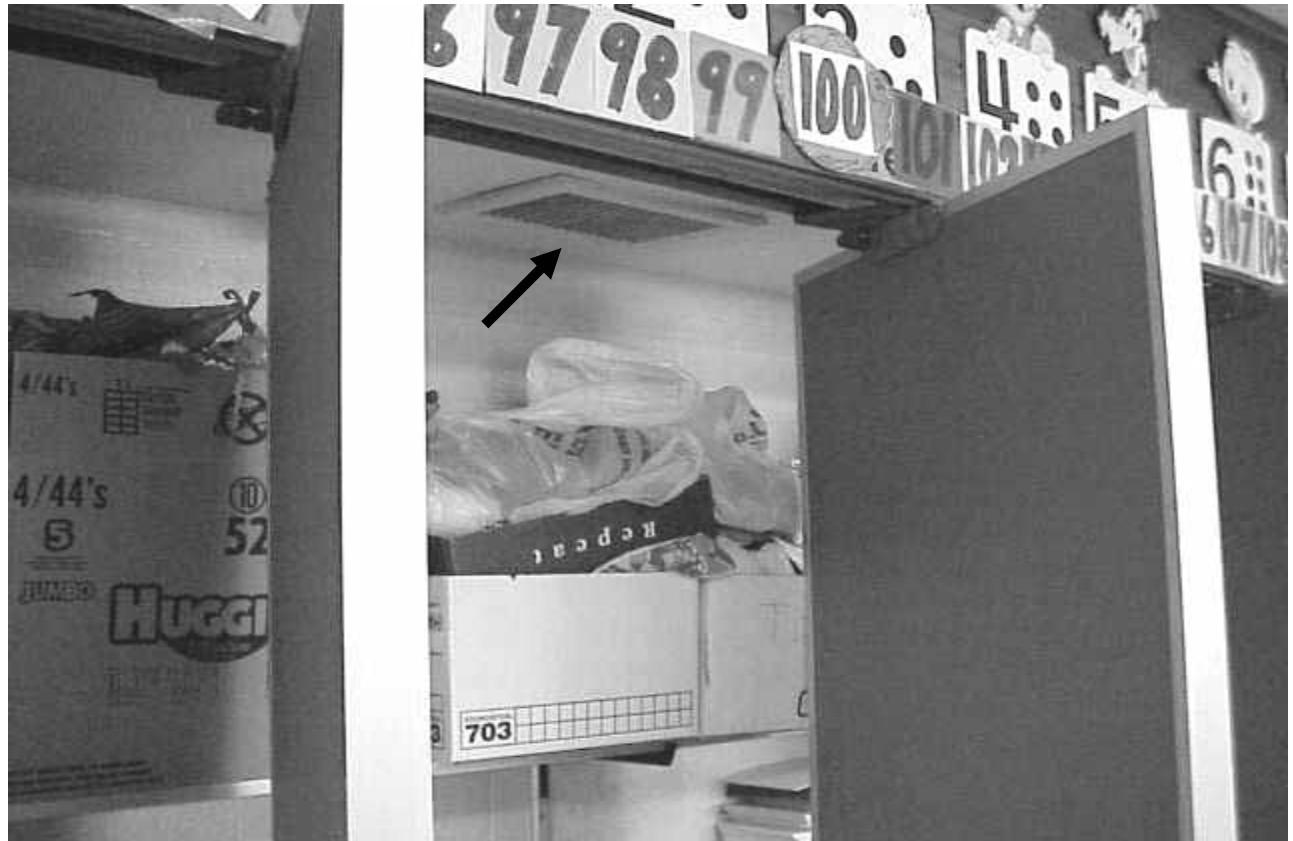
Picture 4

The mechanical exhaust ventilation system in each classroom consists of ceiling-mounted vents located inside of the classroom coat closets (see Picture 4) and powered by roof top exhaust motors (see Picture 5). Coat closet doors are undercut to allow exhaust air to be pulled into the closet and out the vent (see Picture 6). This design allows for these vents to be easily blocked by stored materials. In a number of classrooms, vents were blocked with books, boxes and other obstructions. As with the univents, many of the exhaust vents were not operating at the time of the assessment. BEHA staff examined exhaust motors on the roof and determined that several motors were not functioning (see Tables under “Roof Notes”). In order to function as designed, exhaust vents must also be activated, cleared and remain free of obstructions.

Ceiling-Mounted Exhaust Vent Noted in Classroom Coat Closets

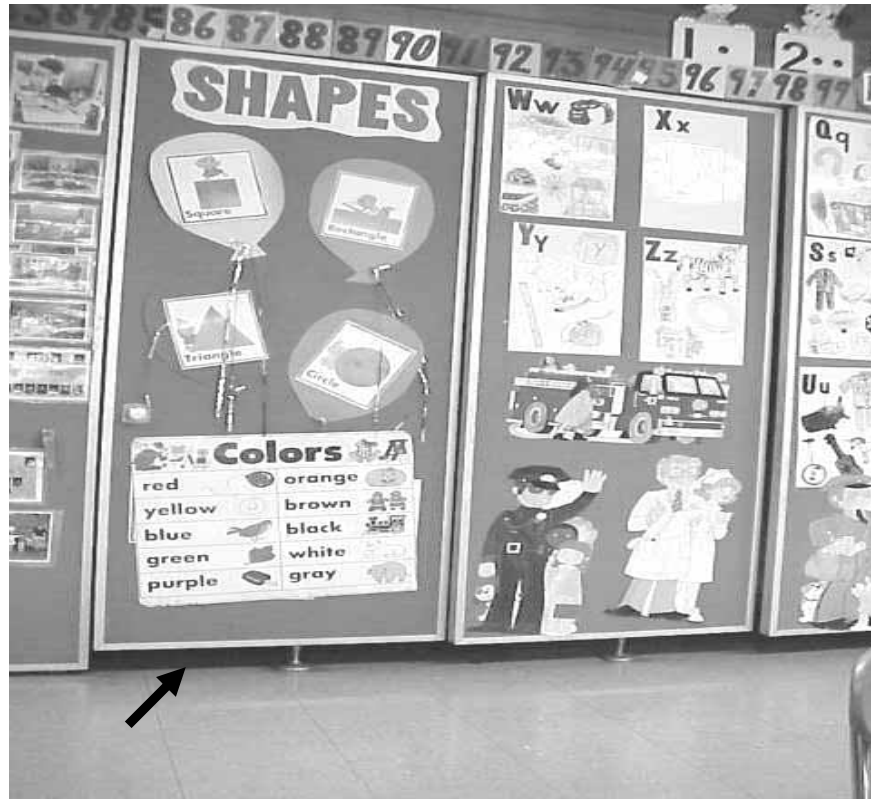
Picture 6

Doors of Classroom Coat Closets: Note Doors are Undercut to Facilitate Exhaust Ventilation
