INDOOR AIR QUALITY ASSESSMENT
Supplemental Relative Humidity/Water Penetration Evaluation

Virginia Blanchard Elementary School
65 East Hartford Street
Uxbridge, Massachusetts

Prepared by:
Massachusetts Department of Public Health
Bureau of Environmental Health Assessment
April, 2002

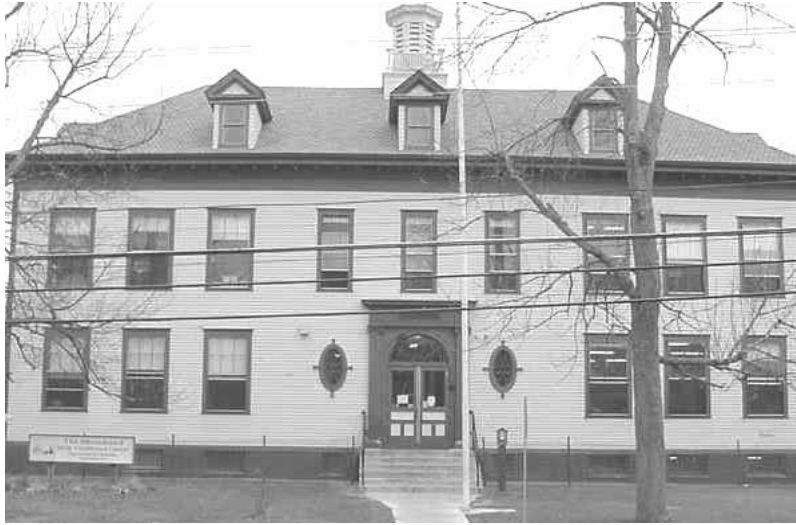
Picture 1

The school is a two-story structure with a wood-clapboard exterior. The original school building was constructed in 1870 (see Picture 1). An addition was constructed in 1900 to the rear of the building (see Picture 2). The building has had several renovations to the interior of the building since 1900, with the latest occurring in 1985 that subdivided the school administrative offices with an interior wall. Windows are openable throughout the building and appear to be original wooden sash windows. Classrooms exist in the second, first and basement levels of the building. The front of the building has a finished attic that is currently used for storage. An unfinished attic space exists over the rear of the building and the 1900 addition. The basement of the building contains a classroom, kitchen, cafeteria (which is also used for classes), several storerooms, restrooms and the boiler room.

The Original School Building, Constructed In 1870

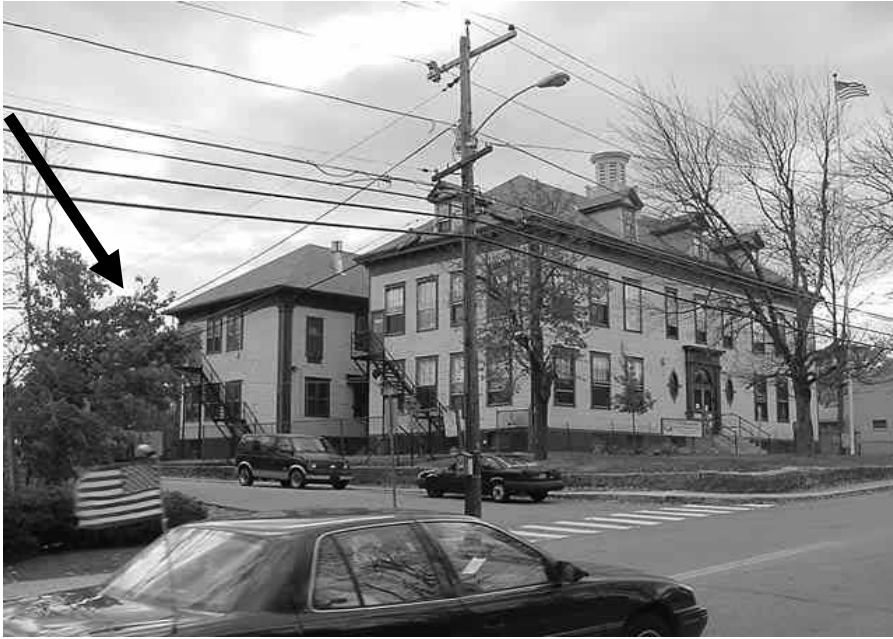
Picture 2

1900 Addition
