# **INDOOR AIR QUALITY ASSESSMENT**

**Chicopee Public Safety Building  
Fire Department Headquarters  
80 Church Street  
Chicopee, Massachusetts**

Prepared by:  
Massachusetts Department of Public Health  
Bureau of Environmental Health Assessment  
Emergency Response/Indoor Air Quality Program  
March 2003

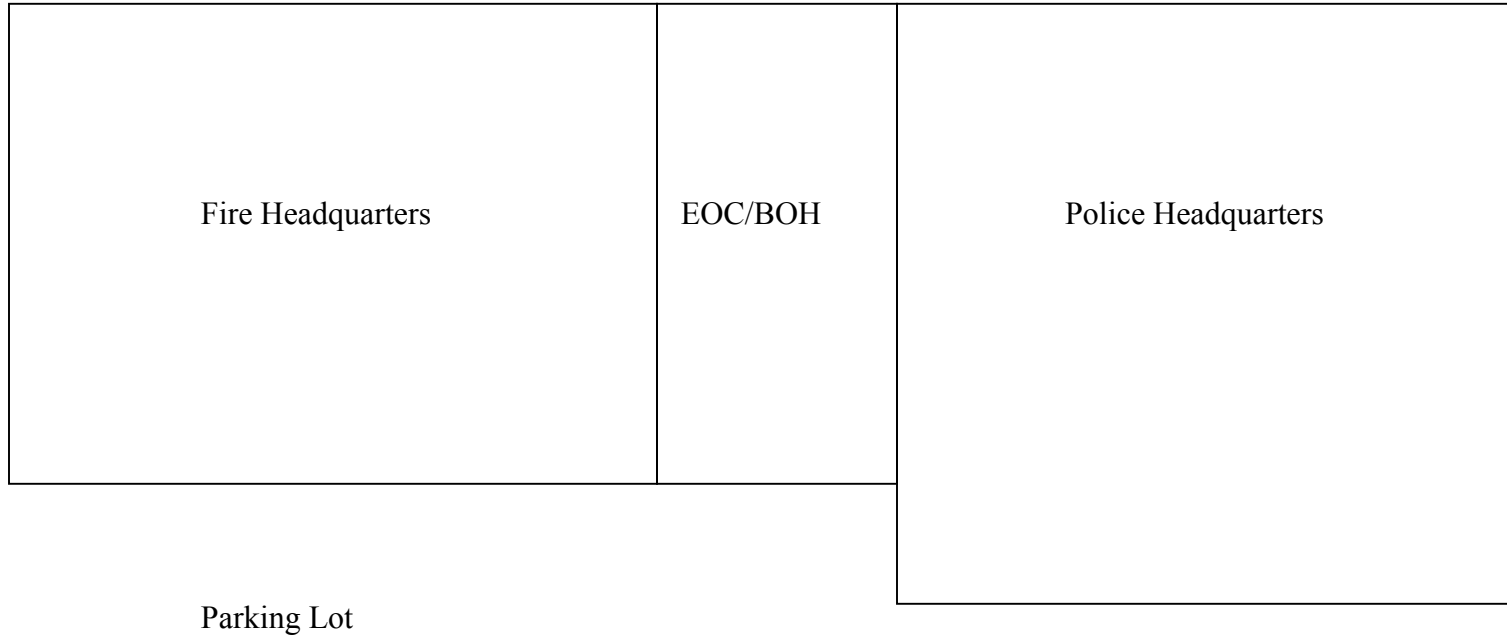
**Figure 1**  
**Configuration of Chicopee Public Safety Building**

The CPSC was constructed in 1976. The fire station is a three-story structure in the northern portion of the CPSC, with the EOC/BOH on its south wall (see Figure 1). The second floor of the fire station contains the bunkhouse, kitchen, alarm room, recreation room and showers/restrooms. The first floor houses the engine bays and fire department offices. The ground floor contains the fire equipment repair shop with three engine bays. No openable windows exist in this structure.
