INDOOR AIR QUALITY ASSESSMENT

**Massachusetts Department of Developmental Services
Charles River West Area Office
255 Elm Street, Suite 205
Somerville, MA 02144**

Prepared by:
Massachusetts Department of Public Health
Bureau of Environmental Health
Indoor Air Quality Program
October 2009

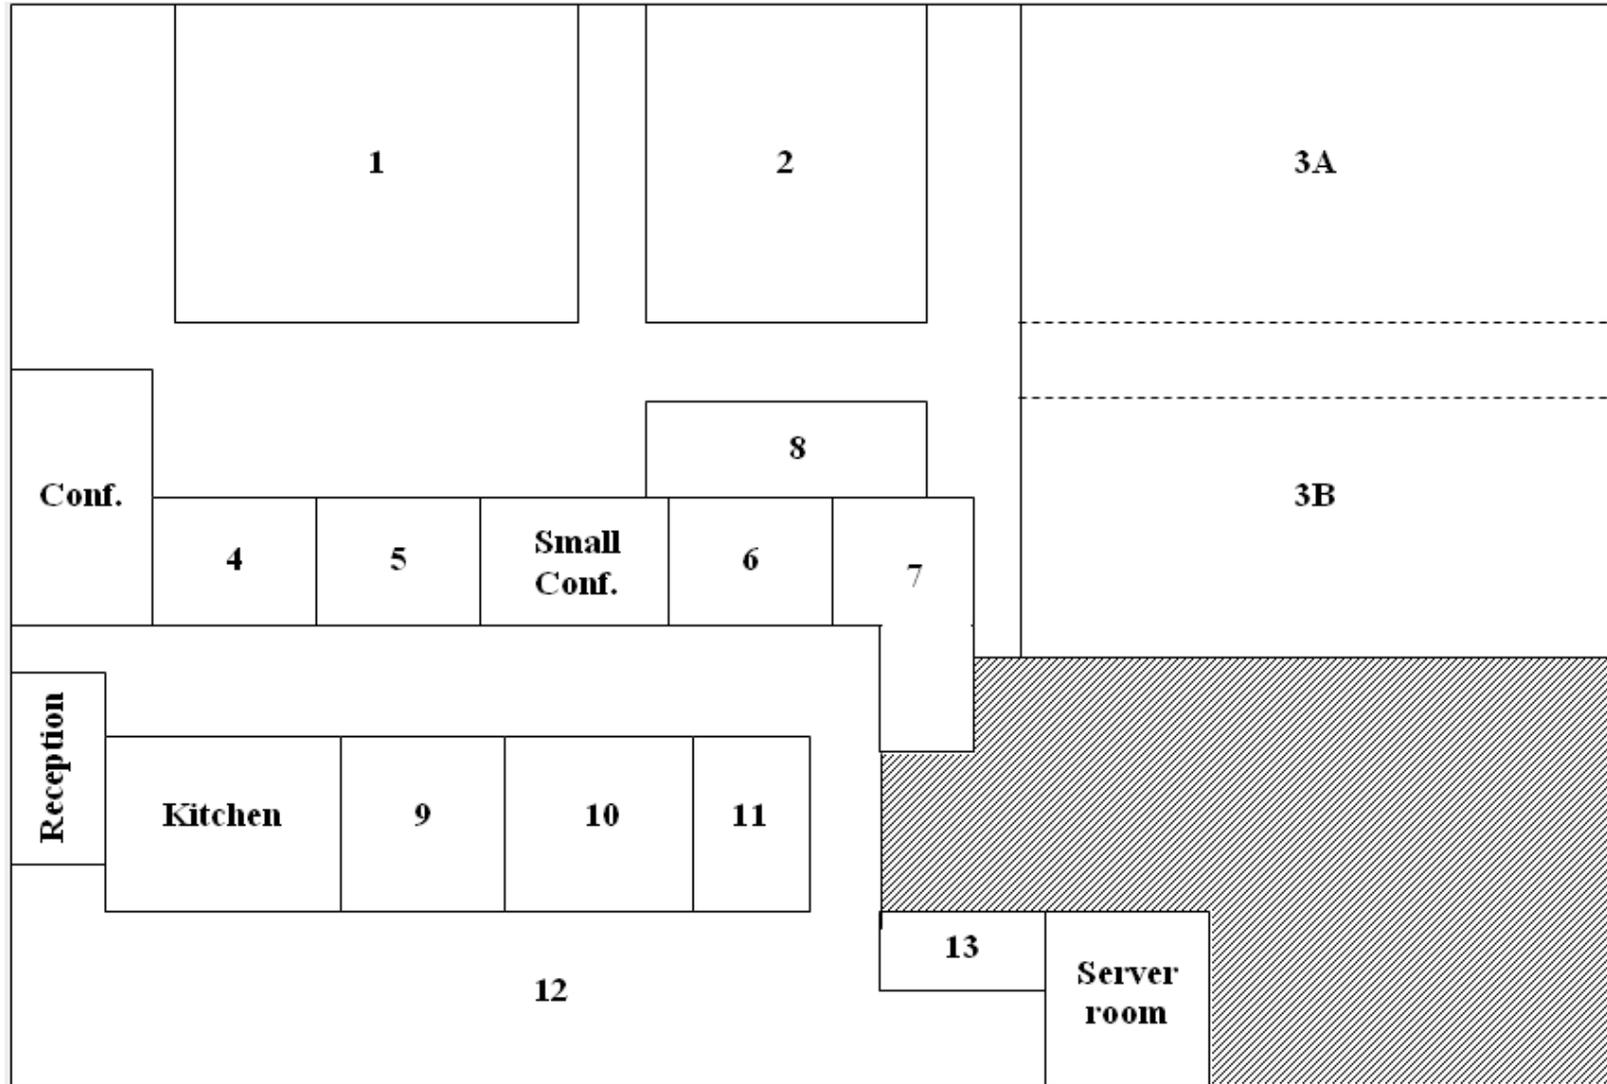
Figure 1

The MDDS has an employee population of approximately 30 and can be visited by up to 10 people daily. Testing was conducted during normal operations and results appear in Table 1. Locations of tests are indicated in Figure 1.

Approximate Layout of MDDS Suite
