# **INDOOR AIR QUALITY ASSESSMENT**

**Massachusetts Emergency Management Agency  
Region 3 and 4 Office  
1002 Suffield Street  
Agawam, Massachusetts**

Prepared by:  
Massachusetts Department of Public Health  
Bureau of Environmental Health  
Indoor Air Quality Program  
April 2010

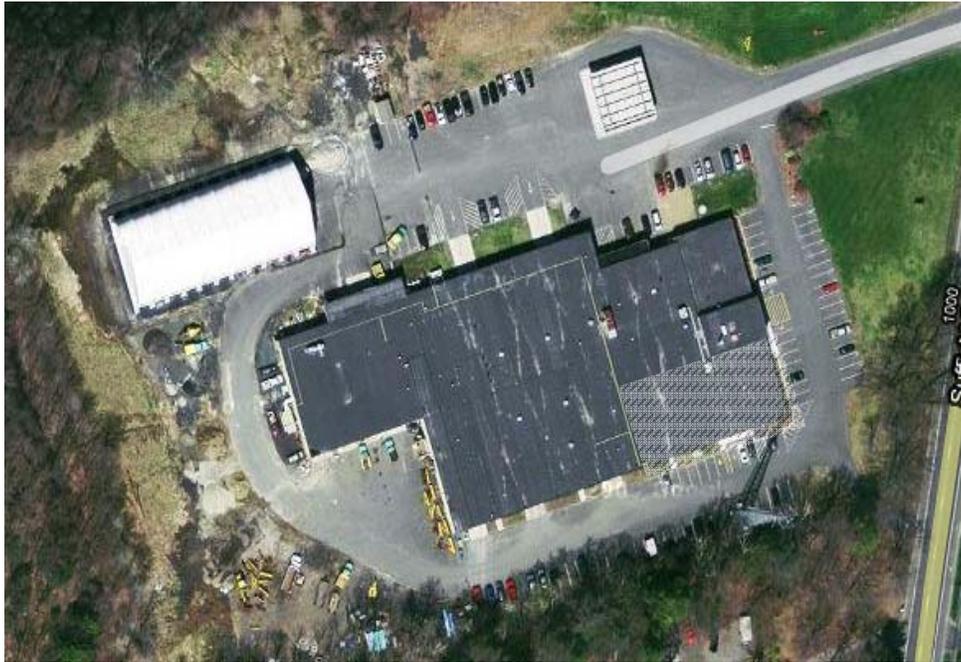
**Picture 1**

**Aerial View of MEMA Building, Shaded Area Indicated Approximate Location of Town of Agawam Offices and Garage**
