INDOOR AIR QUALITY ASSESSMENT

**C.D. Hunking Middle School
98 Winchester Street
Haverhill, MA**

Prepared by:
Massachusetts Department of Public Health
Bureau of Environmental Health
Indoor Air Quality Program
April 2012

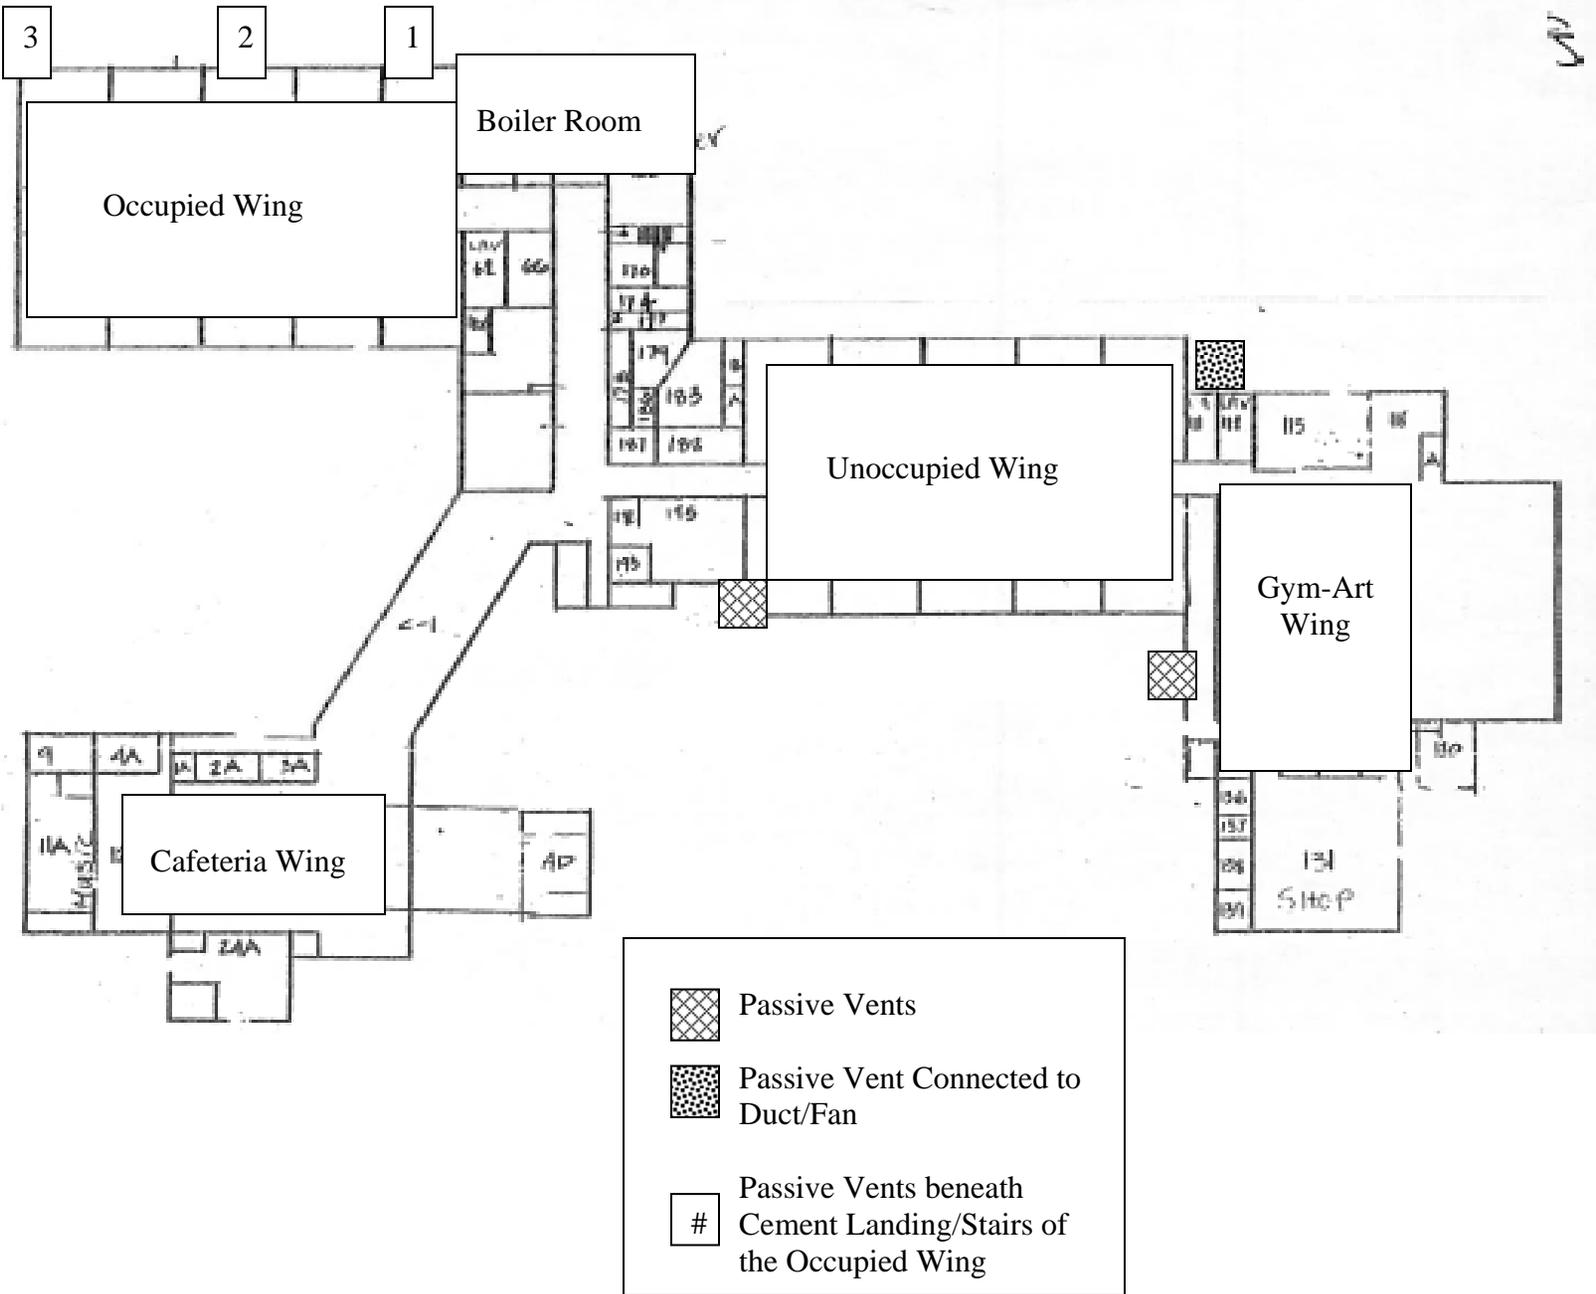
Figure 3: Location of Installed Crawlspace Passive Vents

Passive vents are typically installed to allow water vapor and other materials in a crawlspace to be removed or diluted. Such vents were observed beneath classroom exterior doors on the western side of the occupied wing (Picture 10). These vents were installed in a manner to create cross-ventilation in the crawlspace. Of note is the orientation of the exterior doors and their stairs/landings, which likely takes advantage of New England's prevailing westerly wind direction. The stairs at position 1 face northwest, while the stairs at positions 2 and 3 face southwest (Figure 3; Picture 11). Depending on the orientation of the wind, the cement stairs/landings either form an air scoop to direct air into the passive vents (windward side) or provide a sheltered location for air to escape from the crawlspace (leeward side). For example, a southwest wind can force air to enter the space formed by the stairs and landing in Positions 2 and 3, creating pressurization that forces air in the crawlspace to escape via the passive vent in Position 1. This airflow created through passive ventilation allows water vapor to escape the crawlspace.

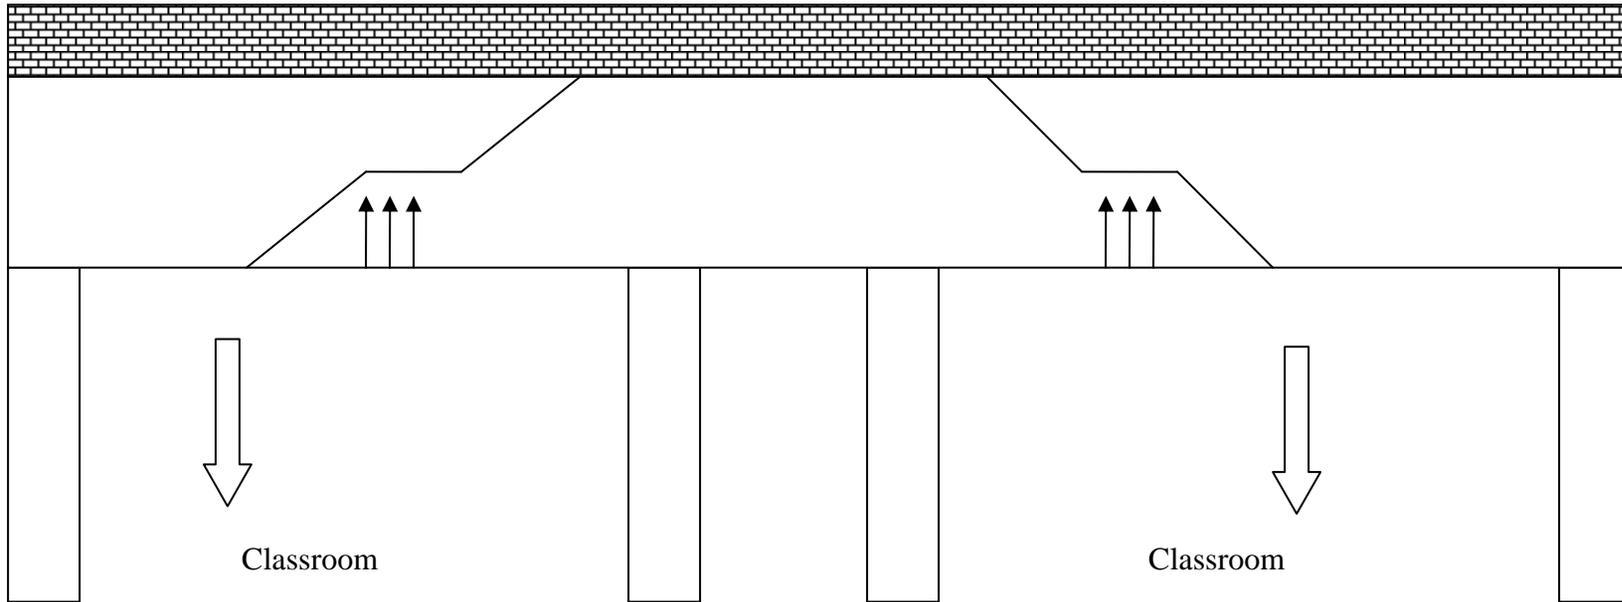
Figure 4: Theoretical Orientation of How Roof Beams Should Have Been Installed to Provide Support for Entire Roof Deck

According to the report by AECOM (2011) and observations made by BEH staff, the roof support system at the HMS consists of three components: two classroom beams and a hallway beam (Figure 4). Bolts join the beams to create a system consisting of classroom beam - hallway beam - classroom beam (Picture 17); this beam system traverses the building. Seams where beams were joined were observed to be roughly one-quarter the distance from the interior wall within the classroom. This configuration creates a discontinuous system from the exterior wall to the interior wall within the classroom.
