MOLD ASSESSMENT

**Old Mill Pond Elementary School
4107 Main Street
Palmer, Massachusetts**

Prepared by:
Massachusetts Department of Public Health
Bureau of Environmental Health
Indoor Air Quality Program
August 2013

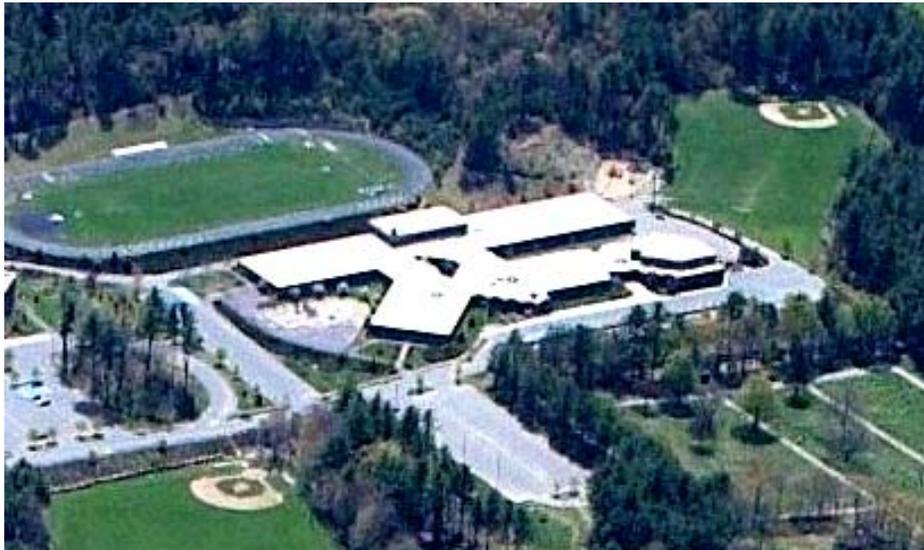
The OMPES is a single-level building, which had been originally constructed as a middle school in 1991 (Figure 1). The OMPES is not air-conditioned apart from a few locations with window-mounted air conditioners. Windows are openable throughout the building.
