# **Mold/Water Damage Investigation**

**Weymouth High School  
One Wildcat Way  
Weymouth, Massachusetts**

Prepared by:  
Massachusetts Department of Public Health  
Bureau of Environmental Health  
Indoor Air Quality Program  
August 2010

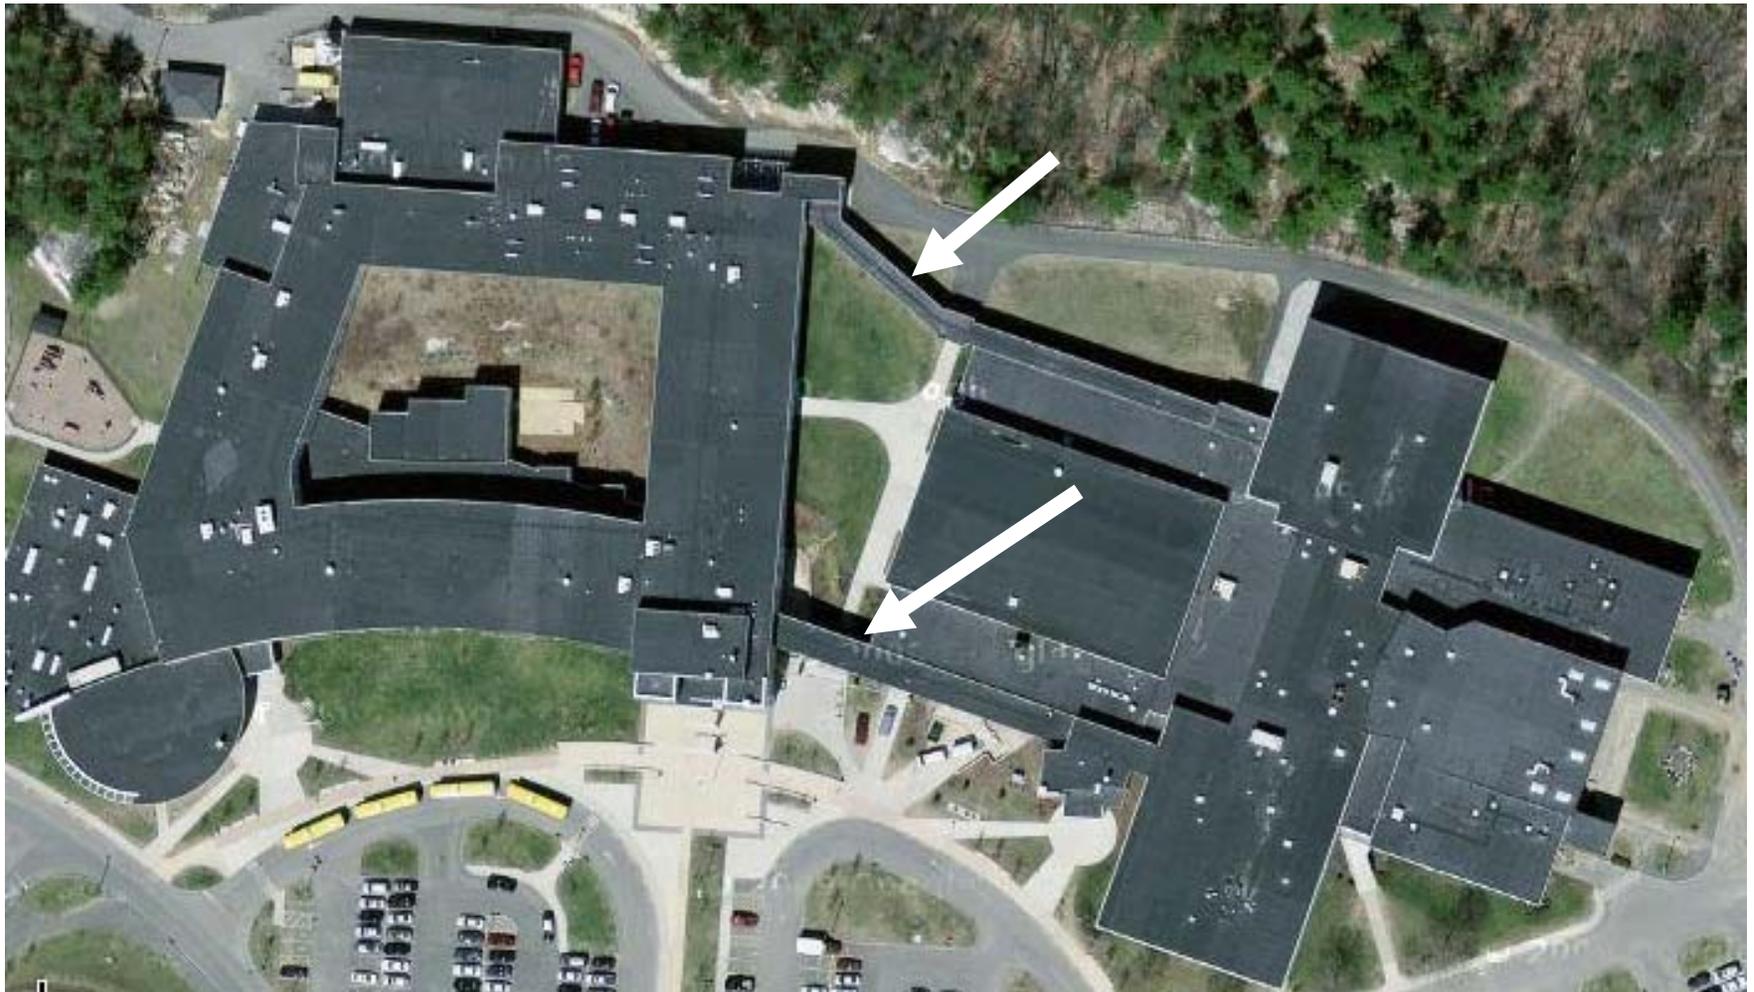
**Picture 1**

**Exterior Hallways (Indicted by Arrows) Connecting Gold Building (Left) and Maroon Building (Right)**

The WHS consists of two main buildings, "gold" and "maroon". The gold building is a newly constructed addition completed in 2004. The maroon building, which formally served as the South Middle School, was completely renovated as part of the expansion project. The maroon house is connected to the gold house via two hallways (Picture 1).
